W:\18187-B-FY18_Channel_Prioritization\GIS\Appendix_E_Culverts\Map_Janet\Map_04_2018

Assessment Results

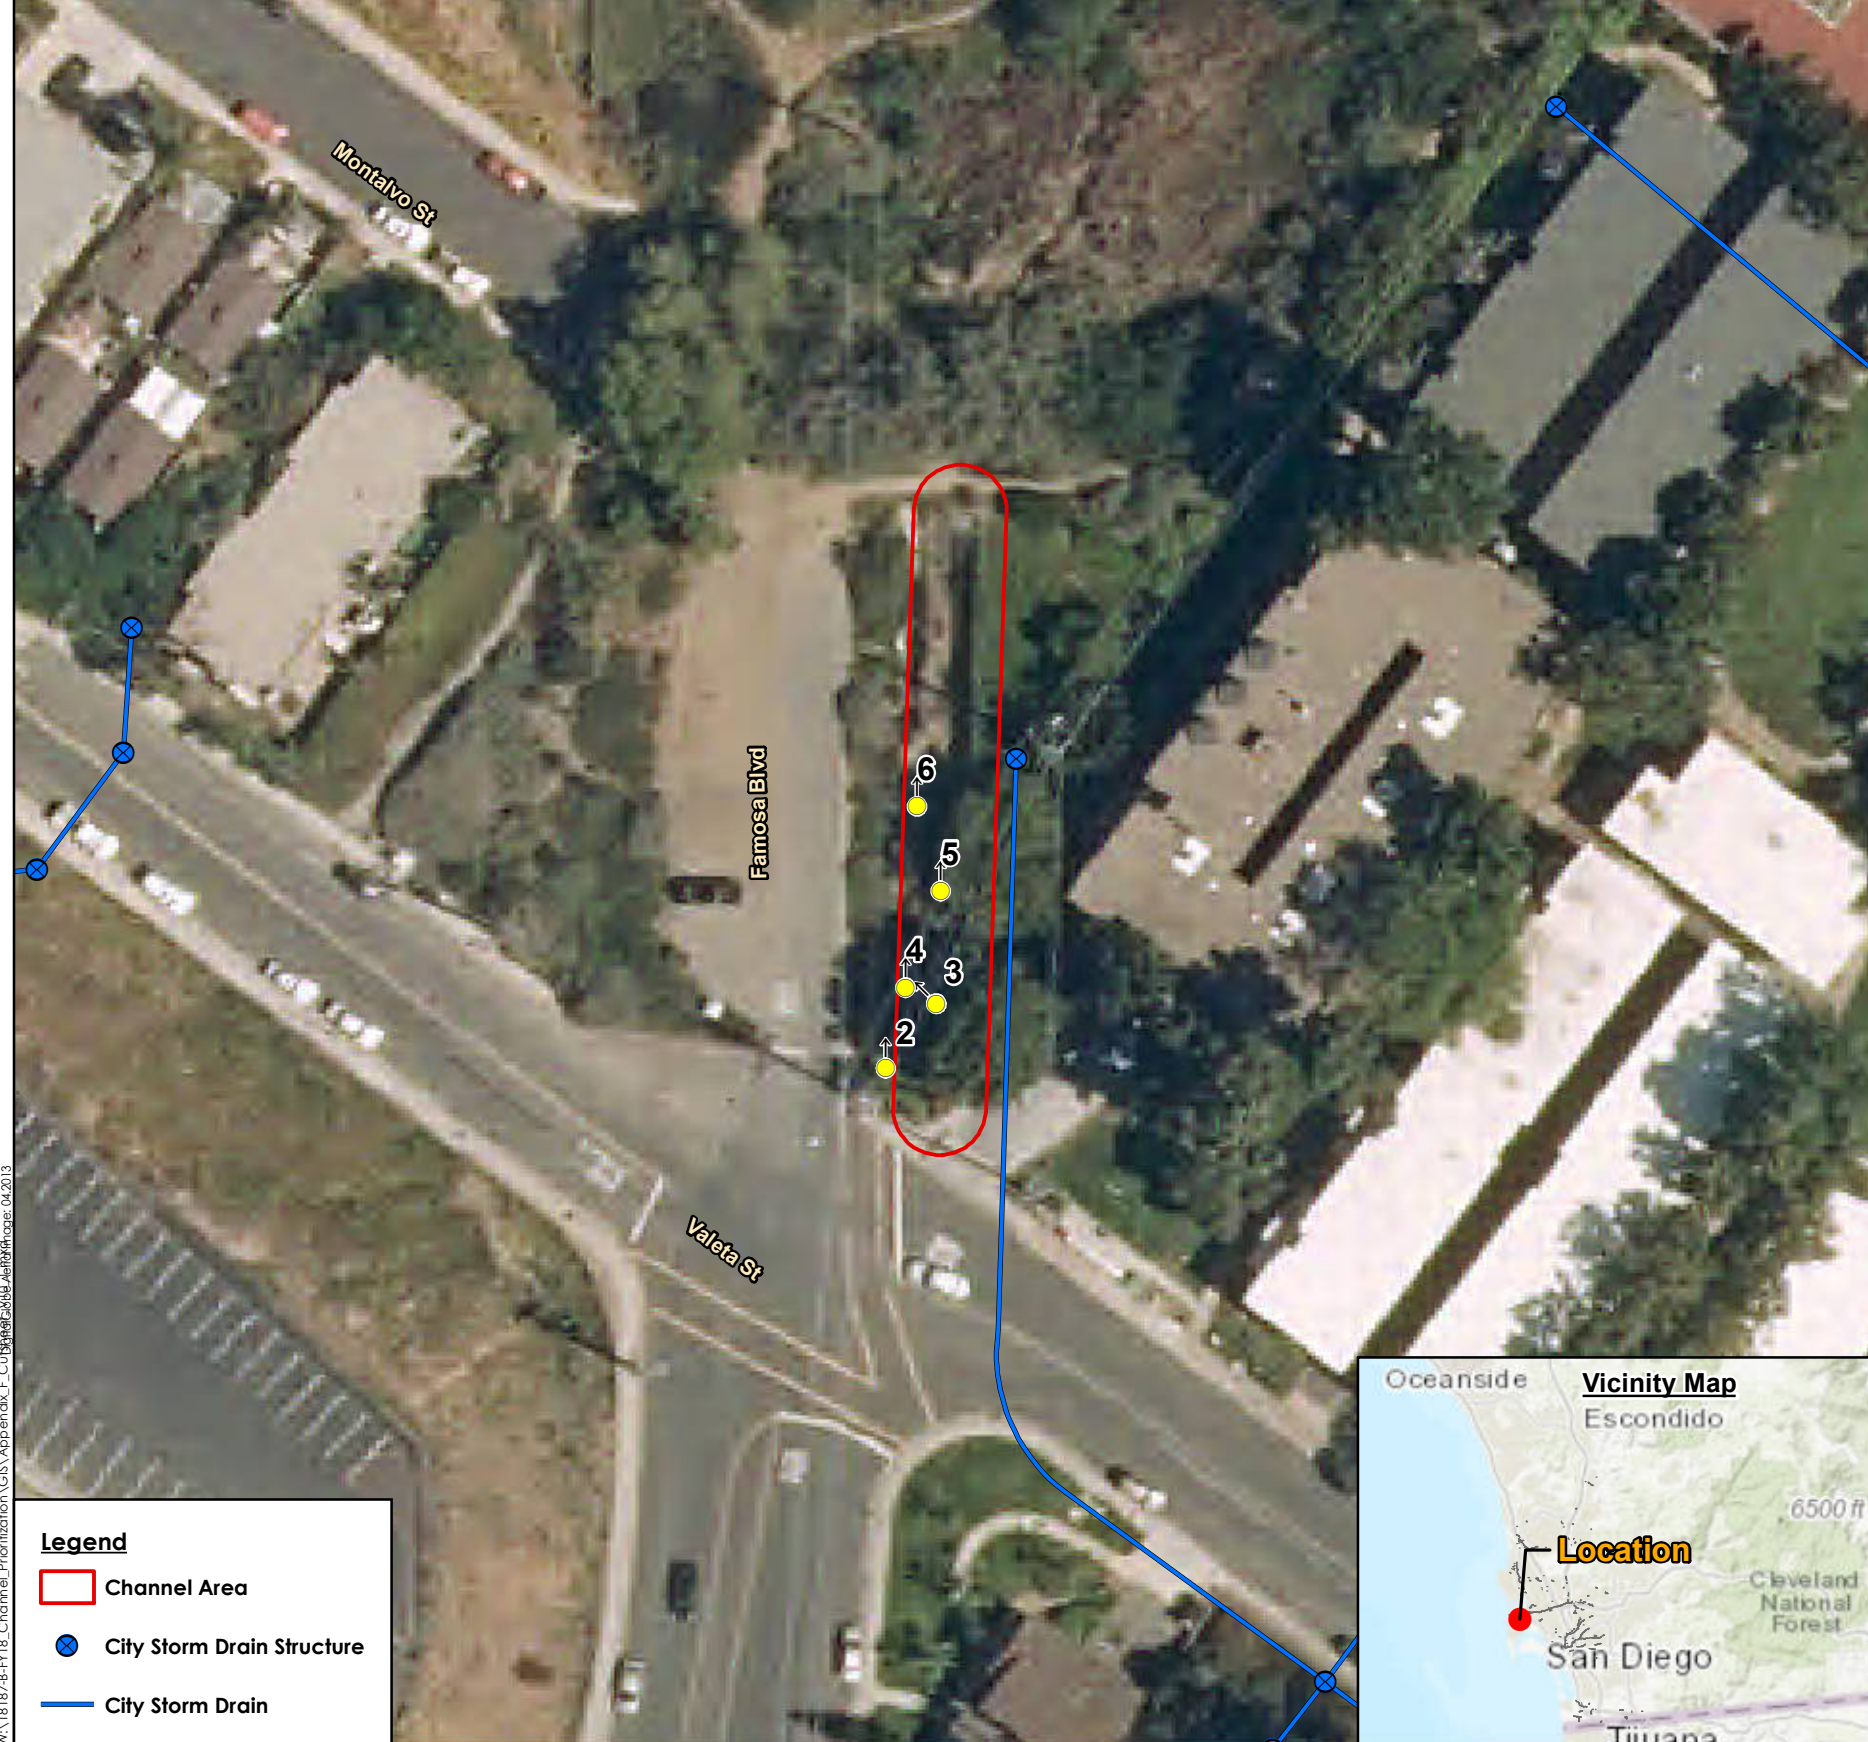
- Channel Prioritization Score: *69.7 out of 100*
- Capacity Prior to Maintenance: *Less than 2-year storm event*
- Capacity After Maintenance (As-built Capacity) : *50-year storm event*
- Clogging Potential: *MEDIUM*
- Approximate Invasive Vegetation Coverage: *LOW*
- Surrounding Area: *Residential*
- Infrastructure Failures: *NONE*
- Site Evaluation Date: *February 22, 2018*
- Notes/Comments: *The upstream culvert is almost completely blocked by vegetation.*
