Master Storm Water System Maintenance Program Annual Report

Transportation & Storm Water Department
Storm Water Division

SEPTEMBER 2016

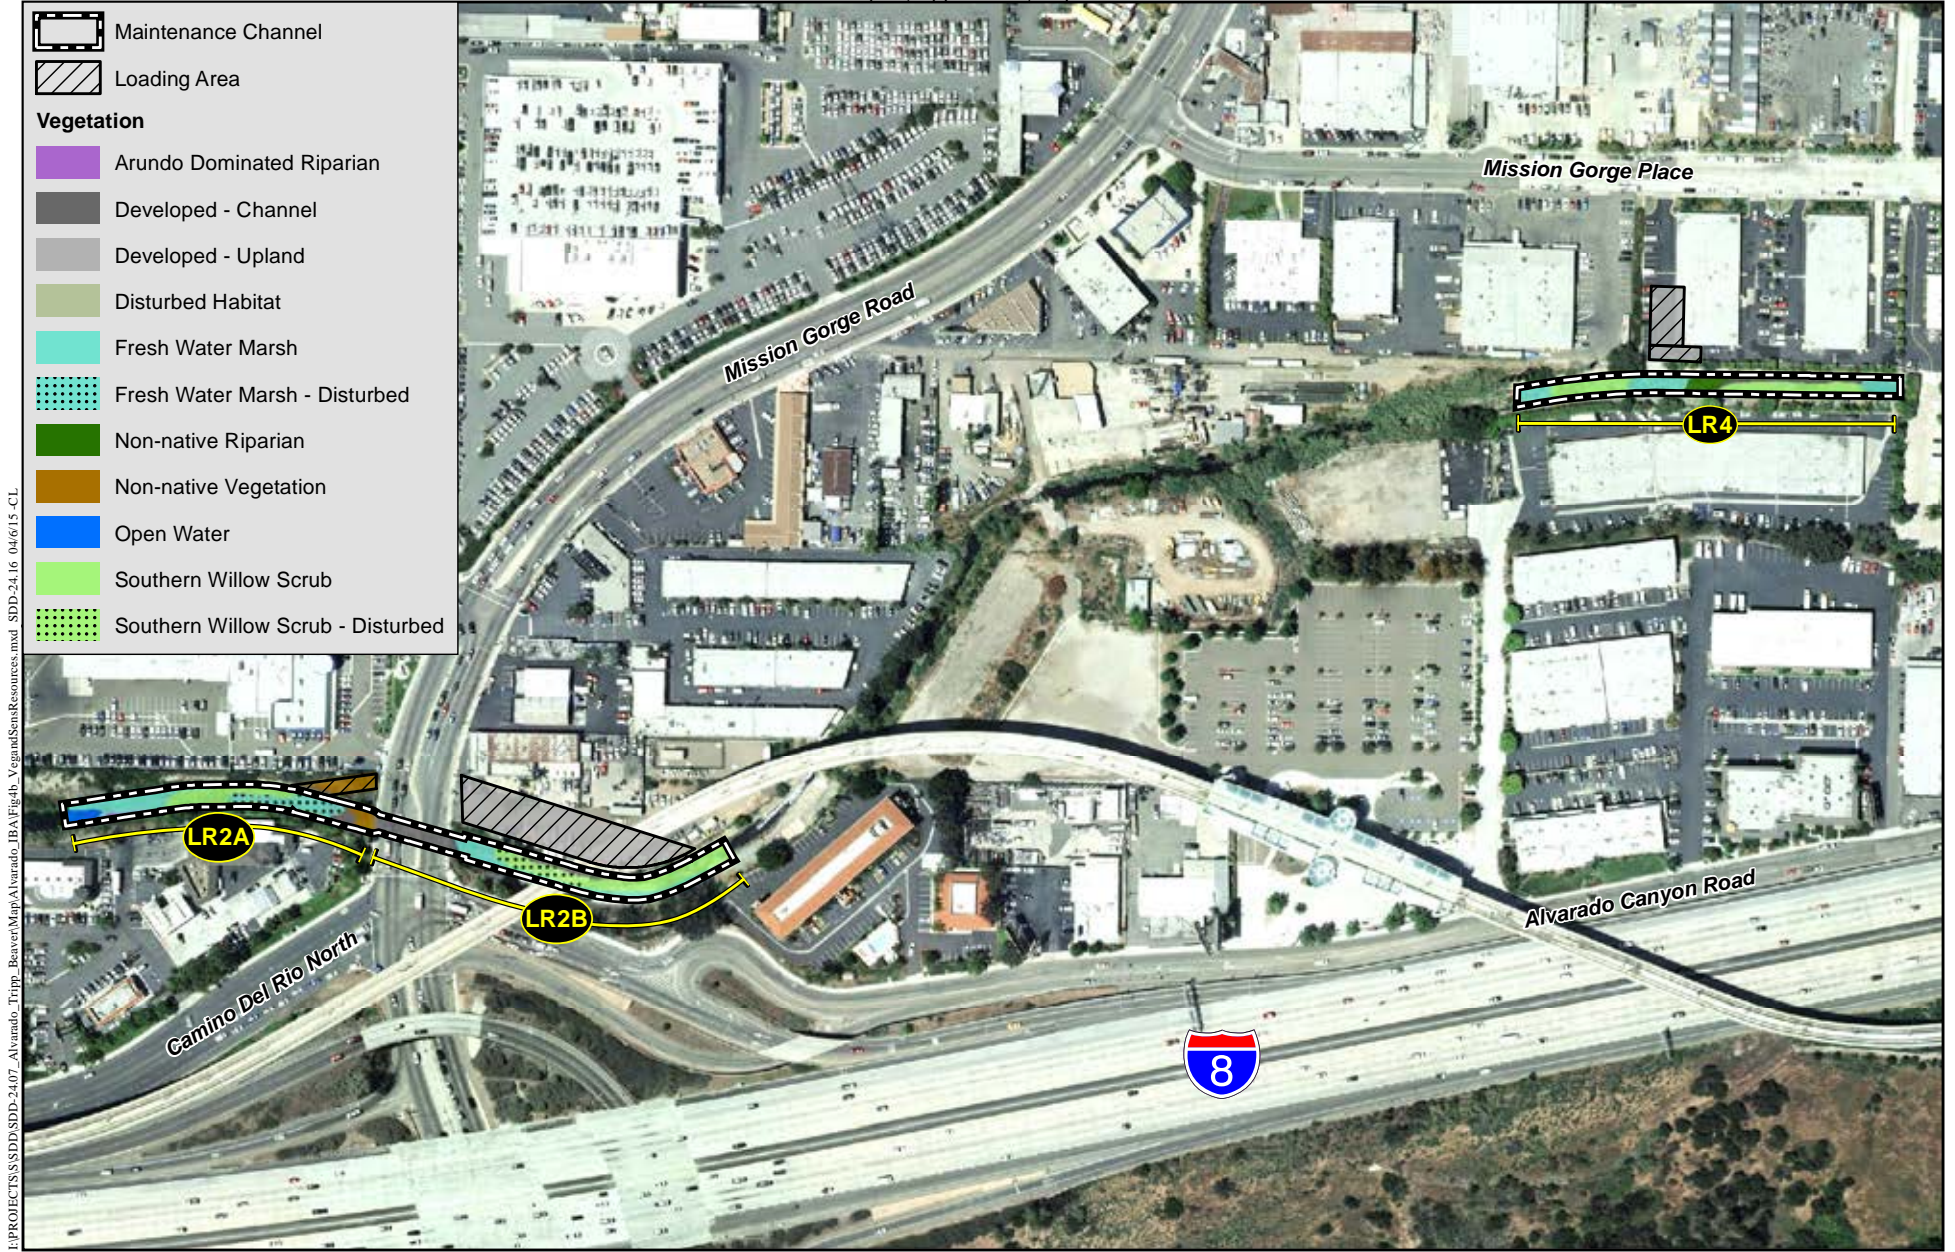
Pre-Maintenance Vegetation and Sensitive Biological Resources, Lower Alvarado

STORM WATER FACILITY MAPS 59, 60, AND 64
 (UPPER/LOWER ALVARADO CREEK CHANNELS)

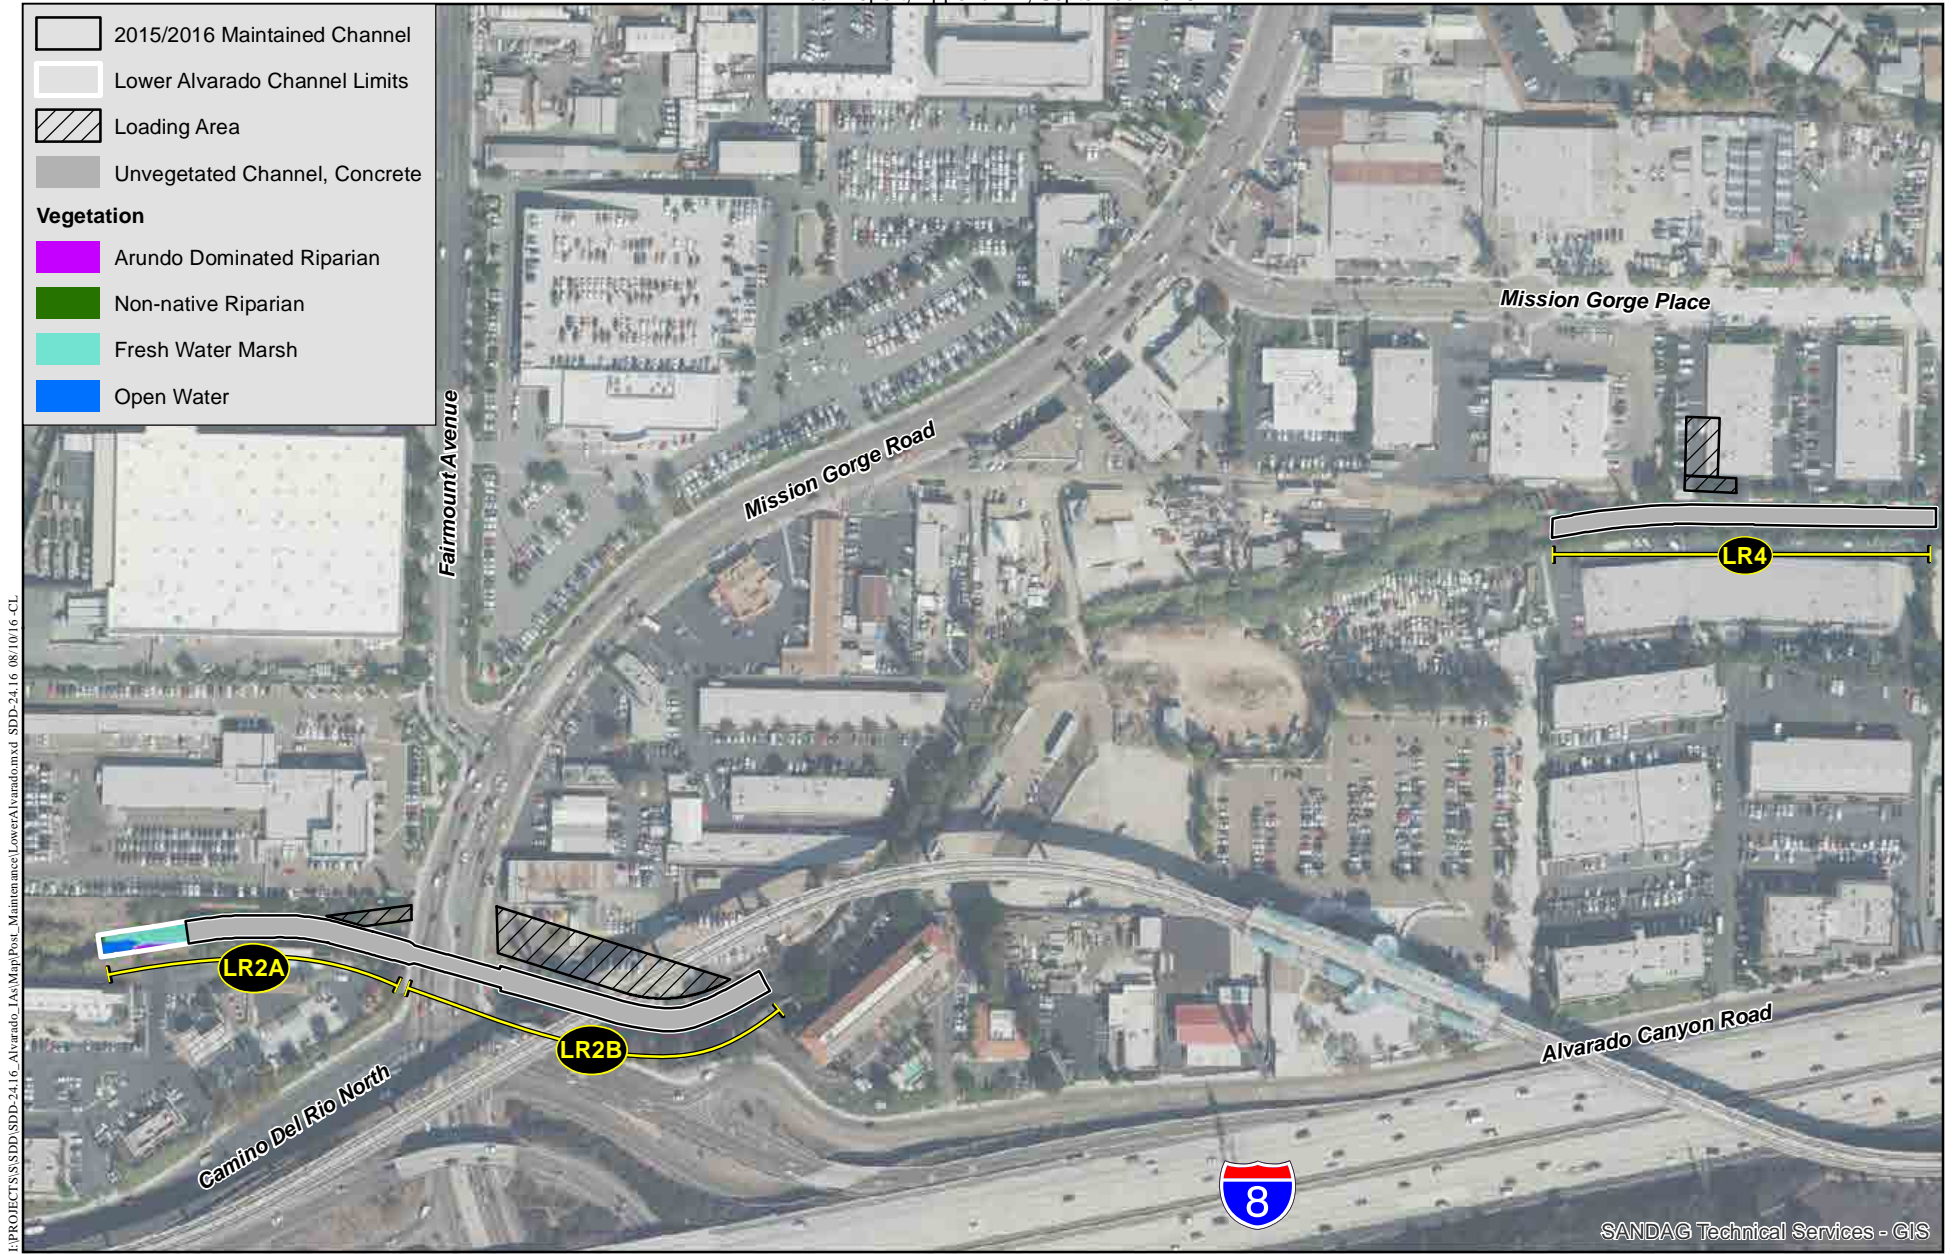
Post-Maintenance Conditions 2016, Lower Alvarado

STORM WATER FACILITY MAPS 59, 60 AND 64
(UPPER/LOWER ALVARADO CREEK CHANNELS)

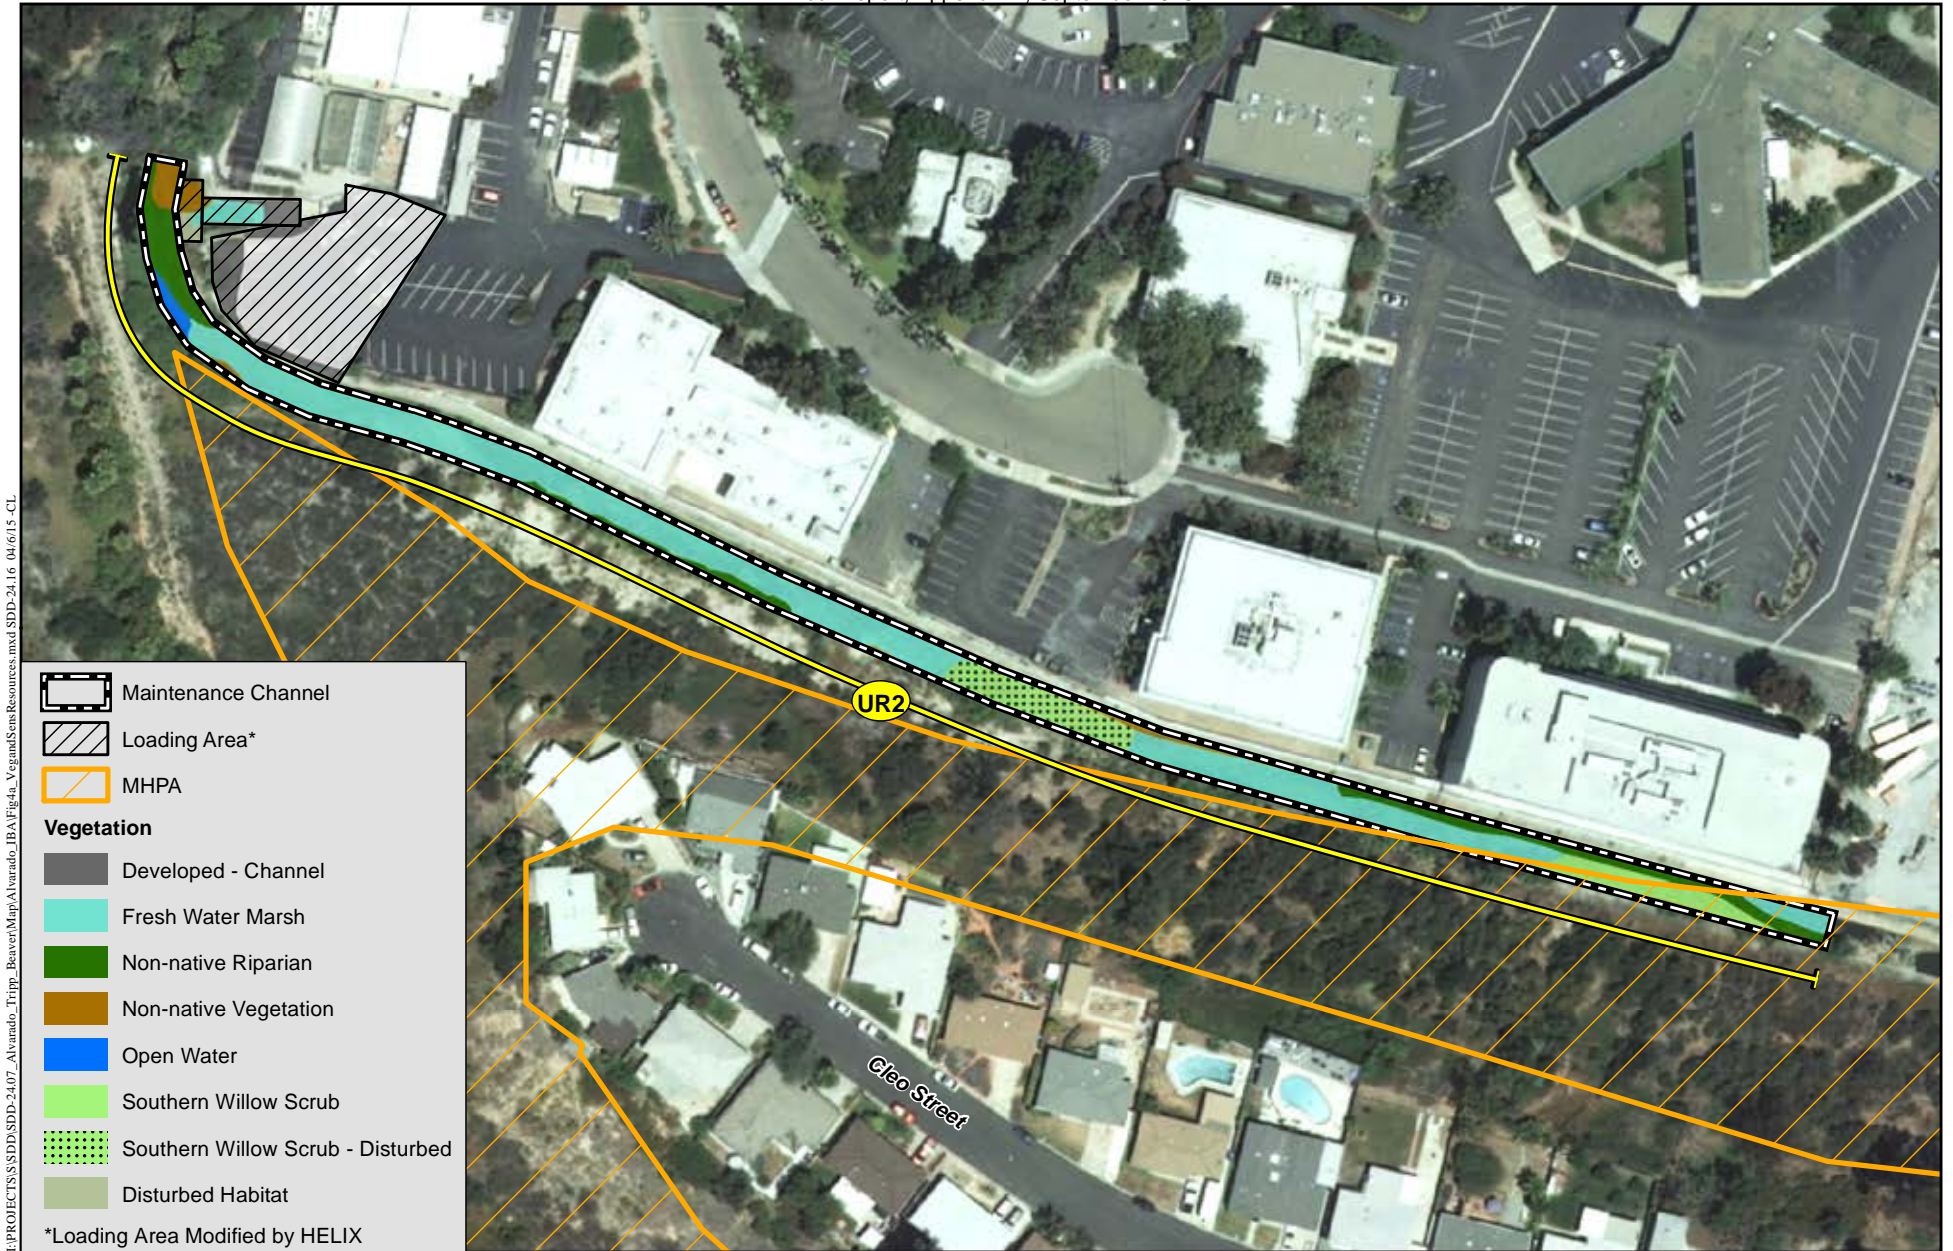
Pre-Maintenance Vegetation and Sensitive Biological Resources, Upper Alvarado

STORM WATER FACILITY MAPS 59, 60, AND 64
(UPPER/LOWER ALVARADO CREEK CHANNELS)

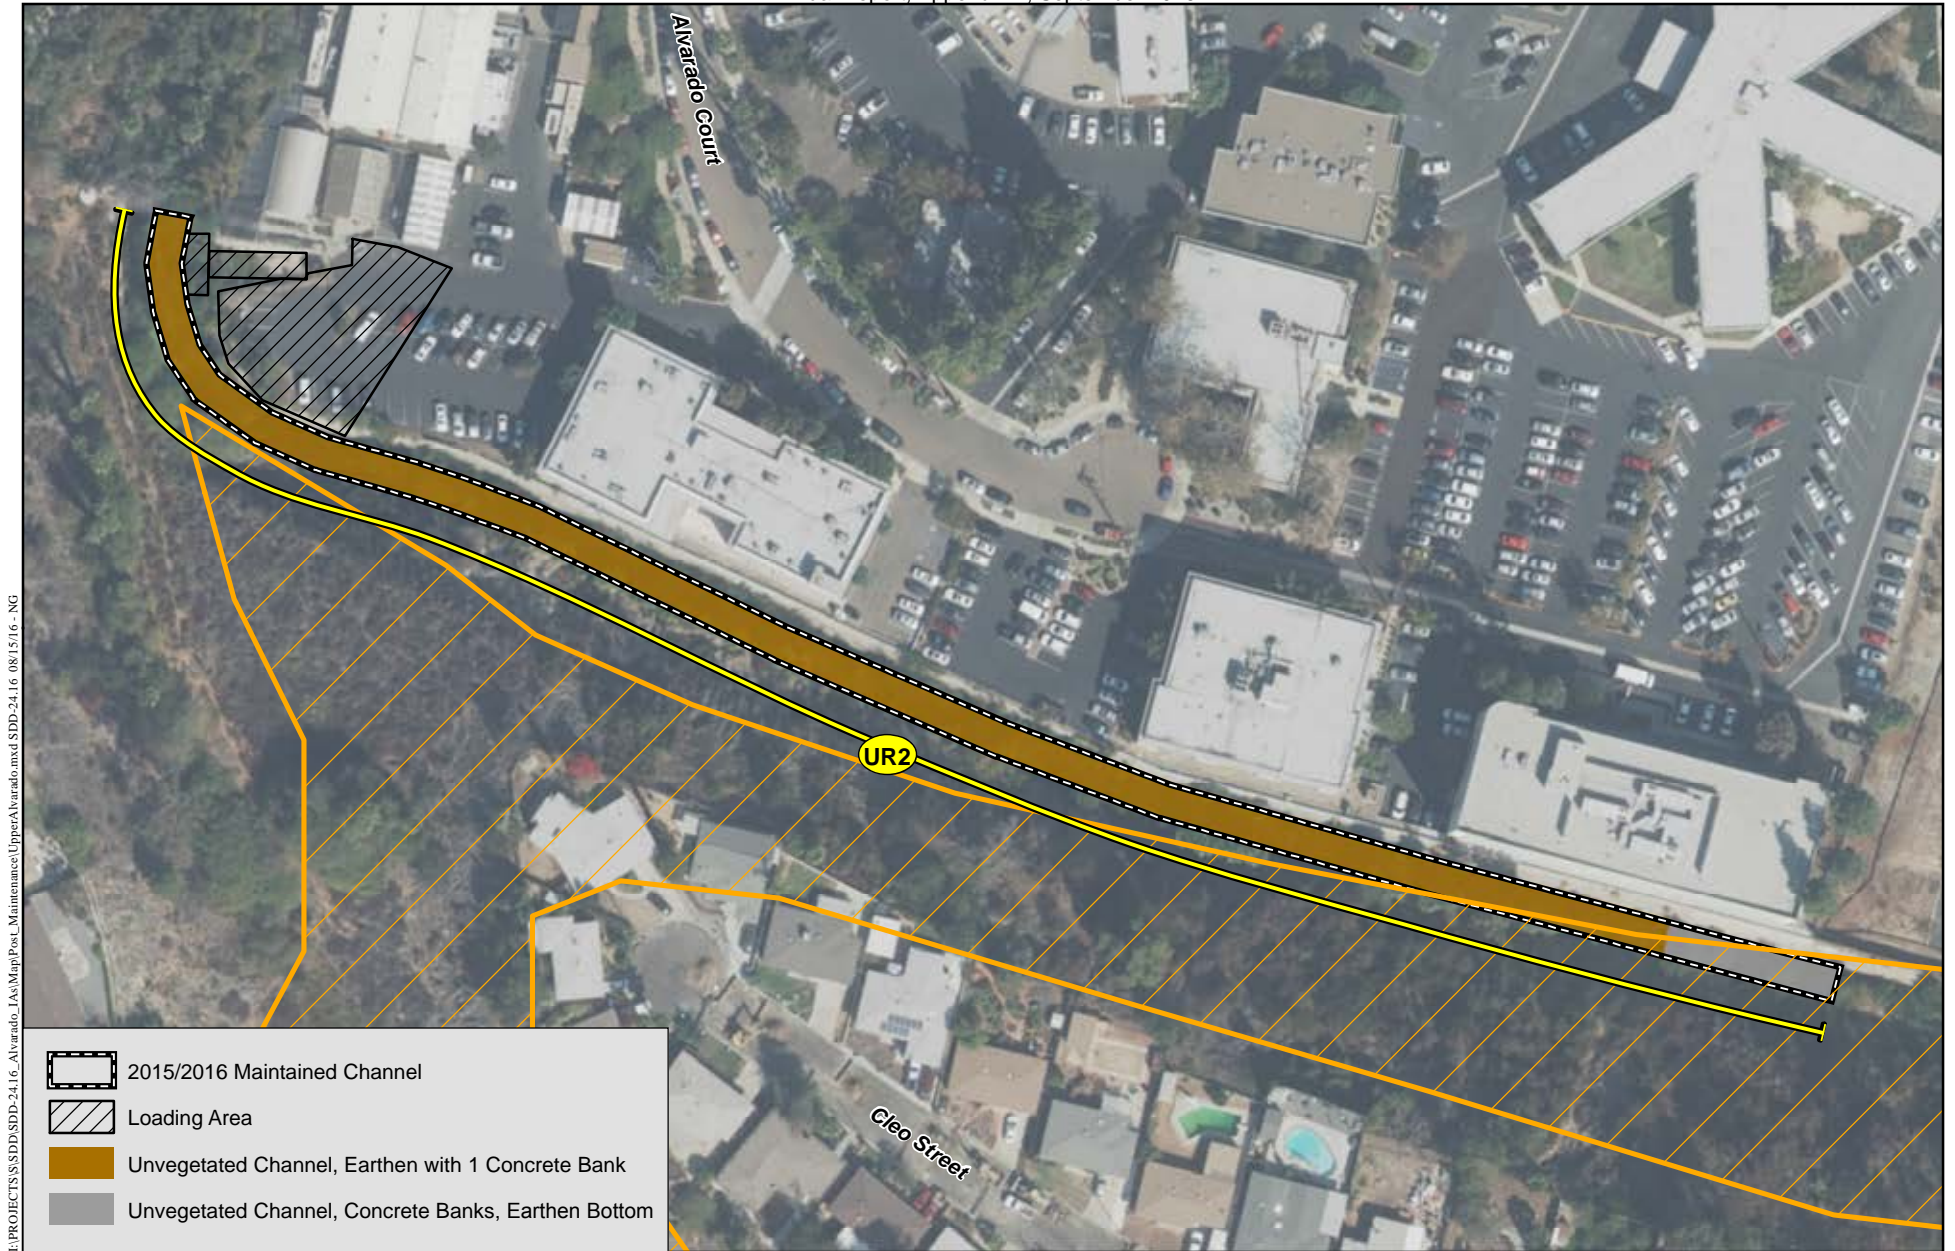
Post-Maintenance Conditions 2016, Upper Alvarado

STORM WATER FACILITY MAPS 59, 60 AND 64
(UPPER/LOWER ALVARADO CREEK CHANNELS)

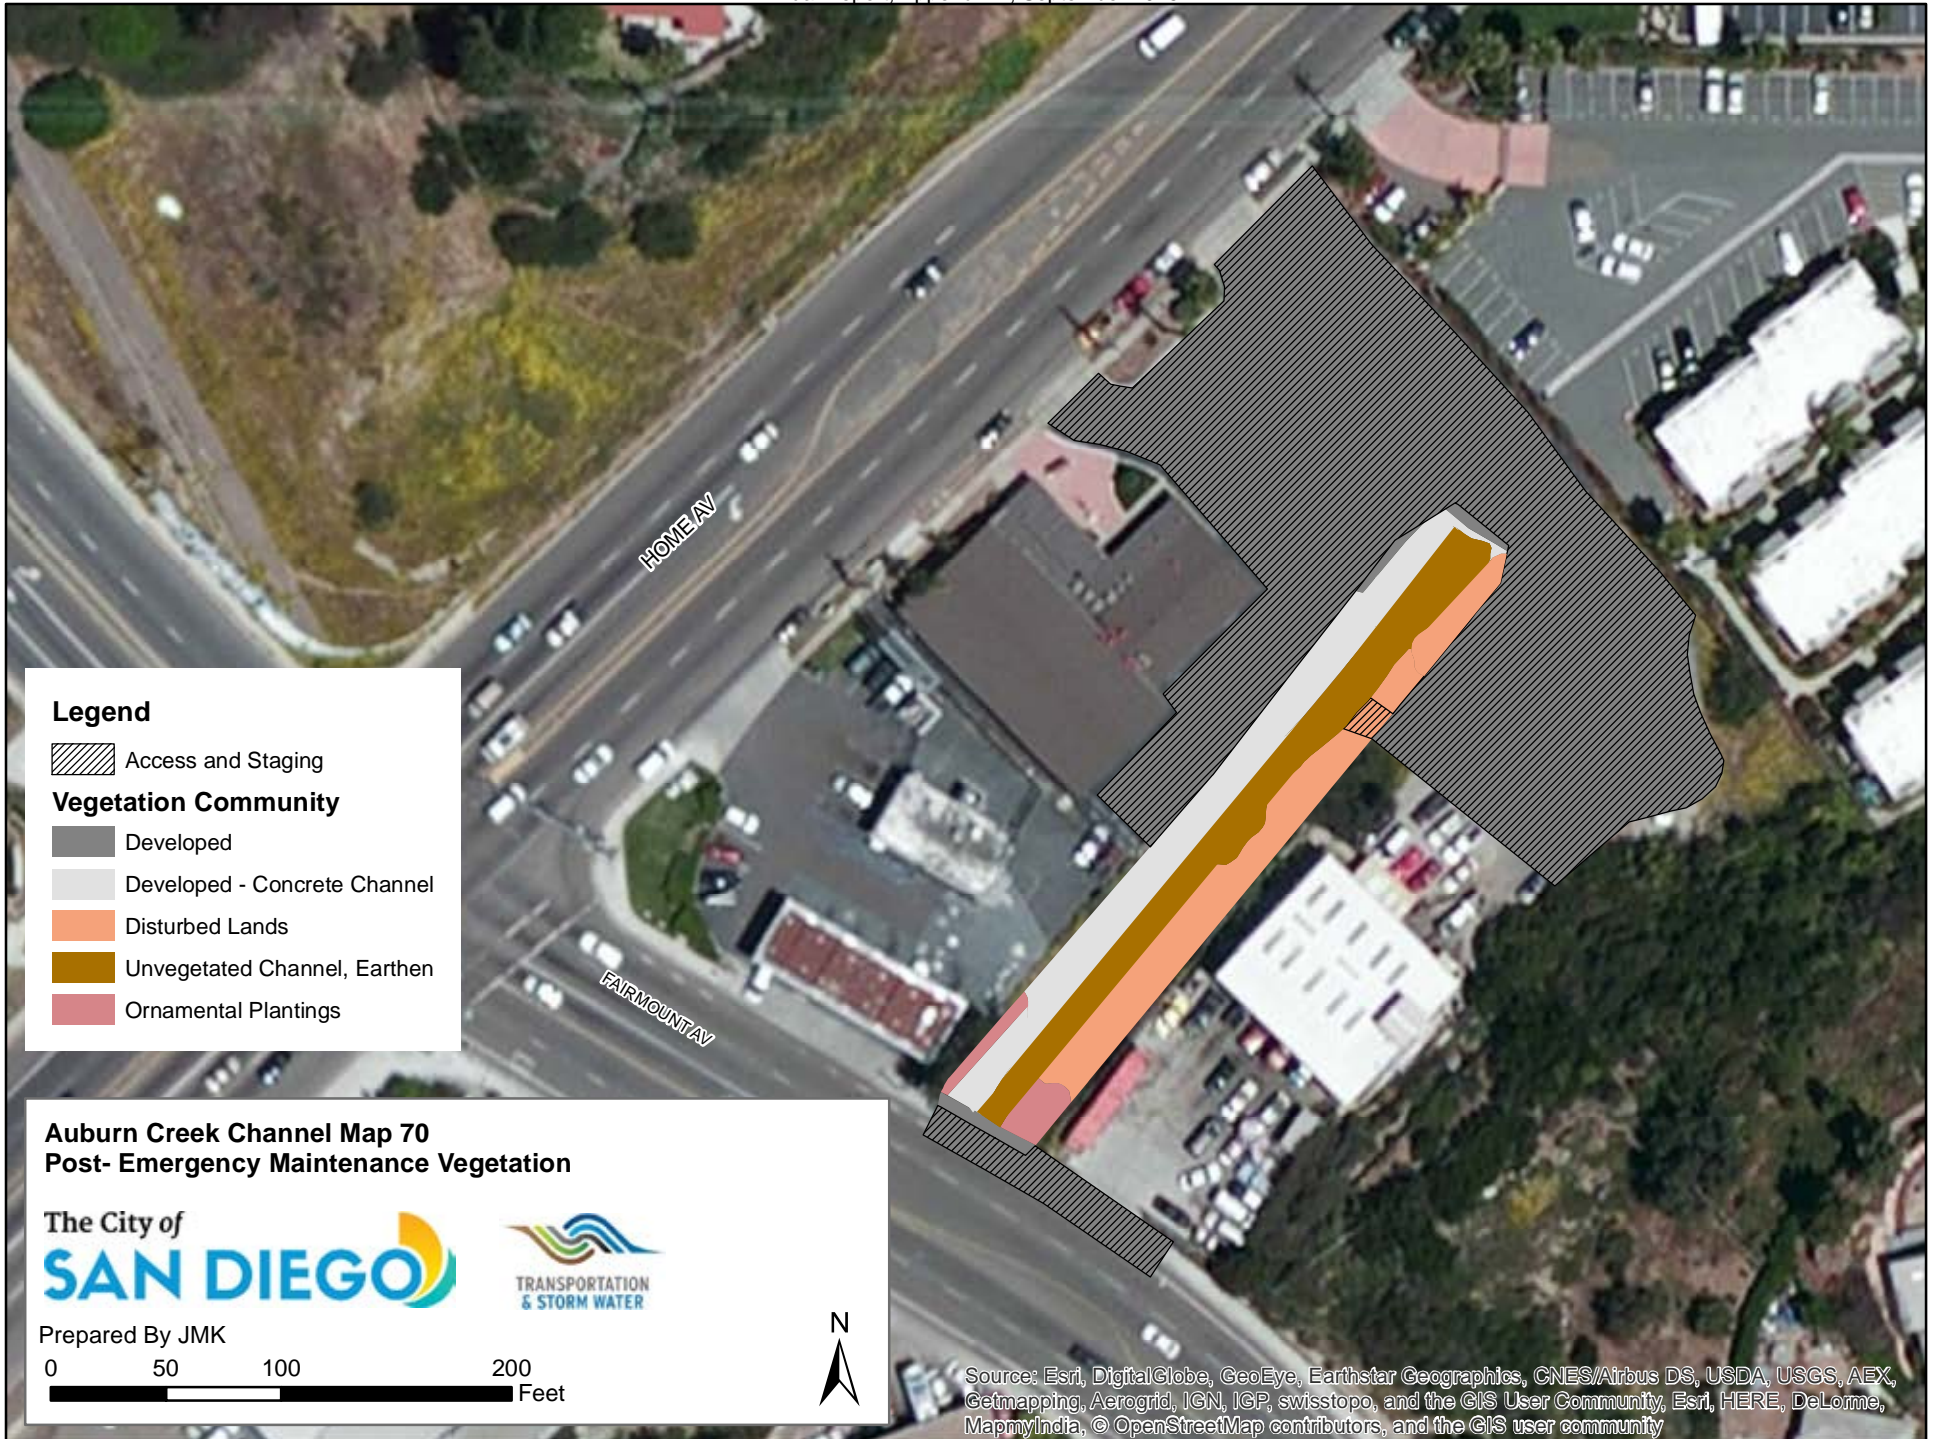
Annual Report, Figure 16

MMP Map 70
Pre-Maintenance Auburn Creek Channel Biological Resources and Impacts

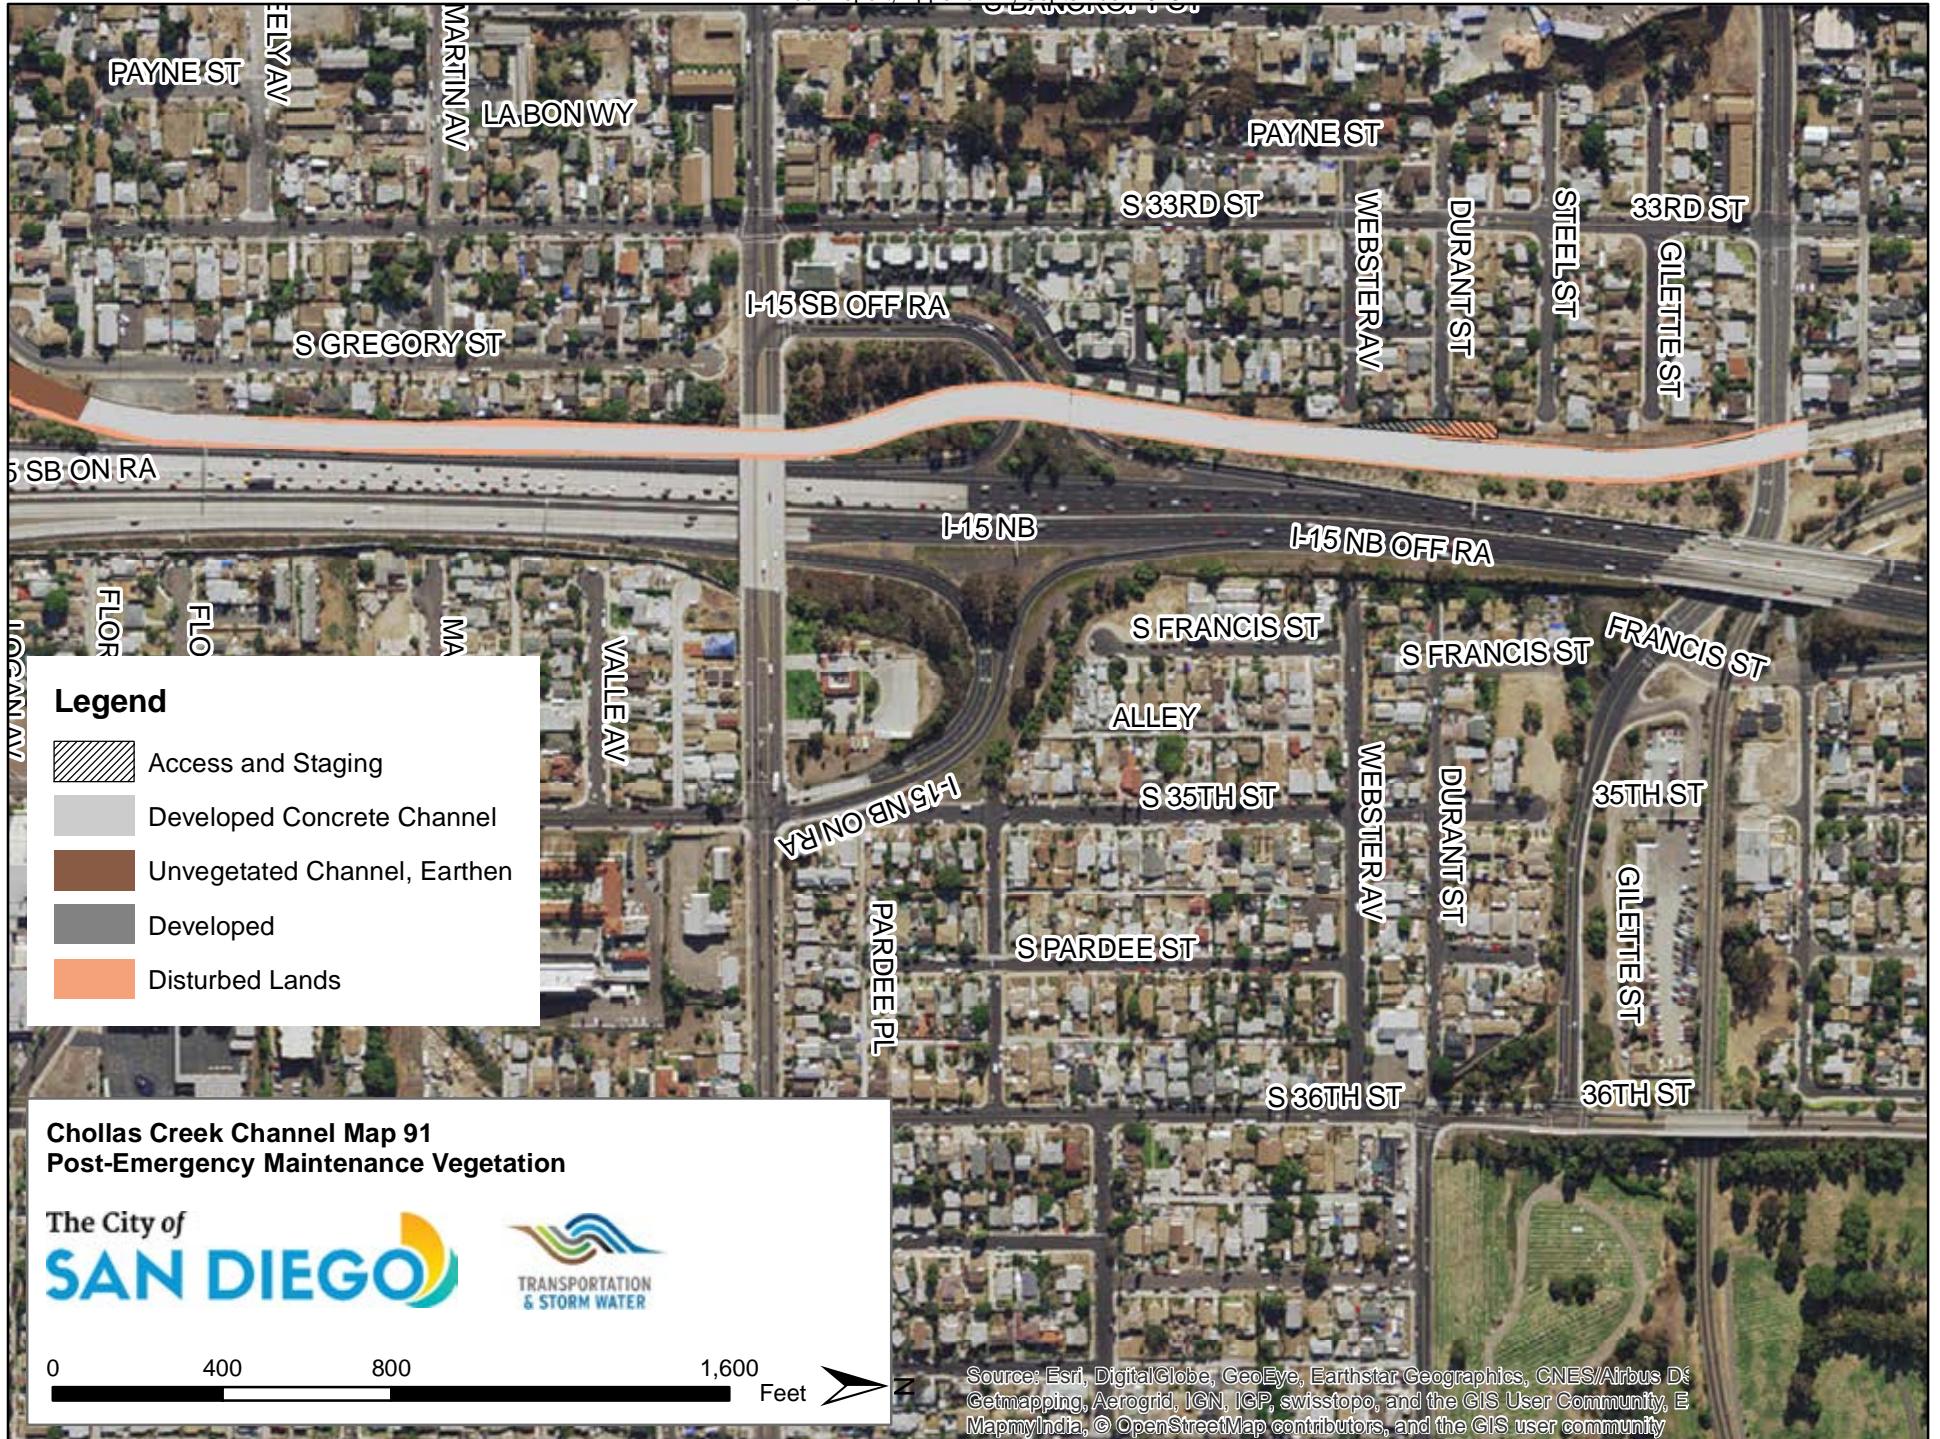
Annual Report, Figure 21

The Chollas Creek emergency maintenance project included emergency repair and protection activities and the mechanized removal of sediment, vegetation, trash and debris in several sections of MMP Maps 91 (Figures 21 and 22) and 93 (Figures 23 and 24). The emergency repair and protection activities were conducted under emergency permit authorization.

Pre-Maintenance Biological Resources and Impacts

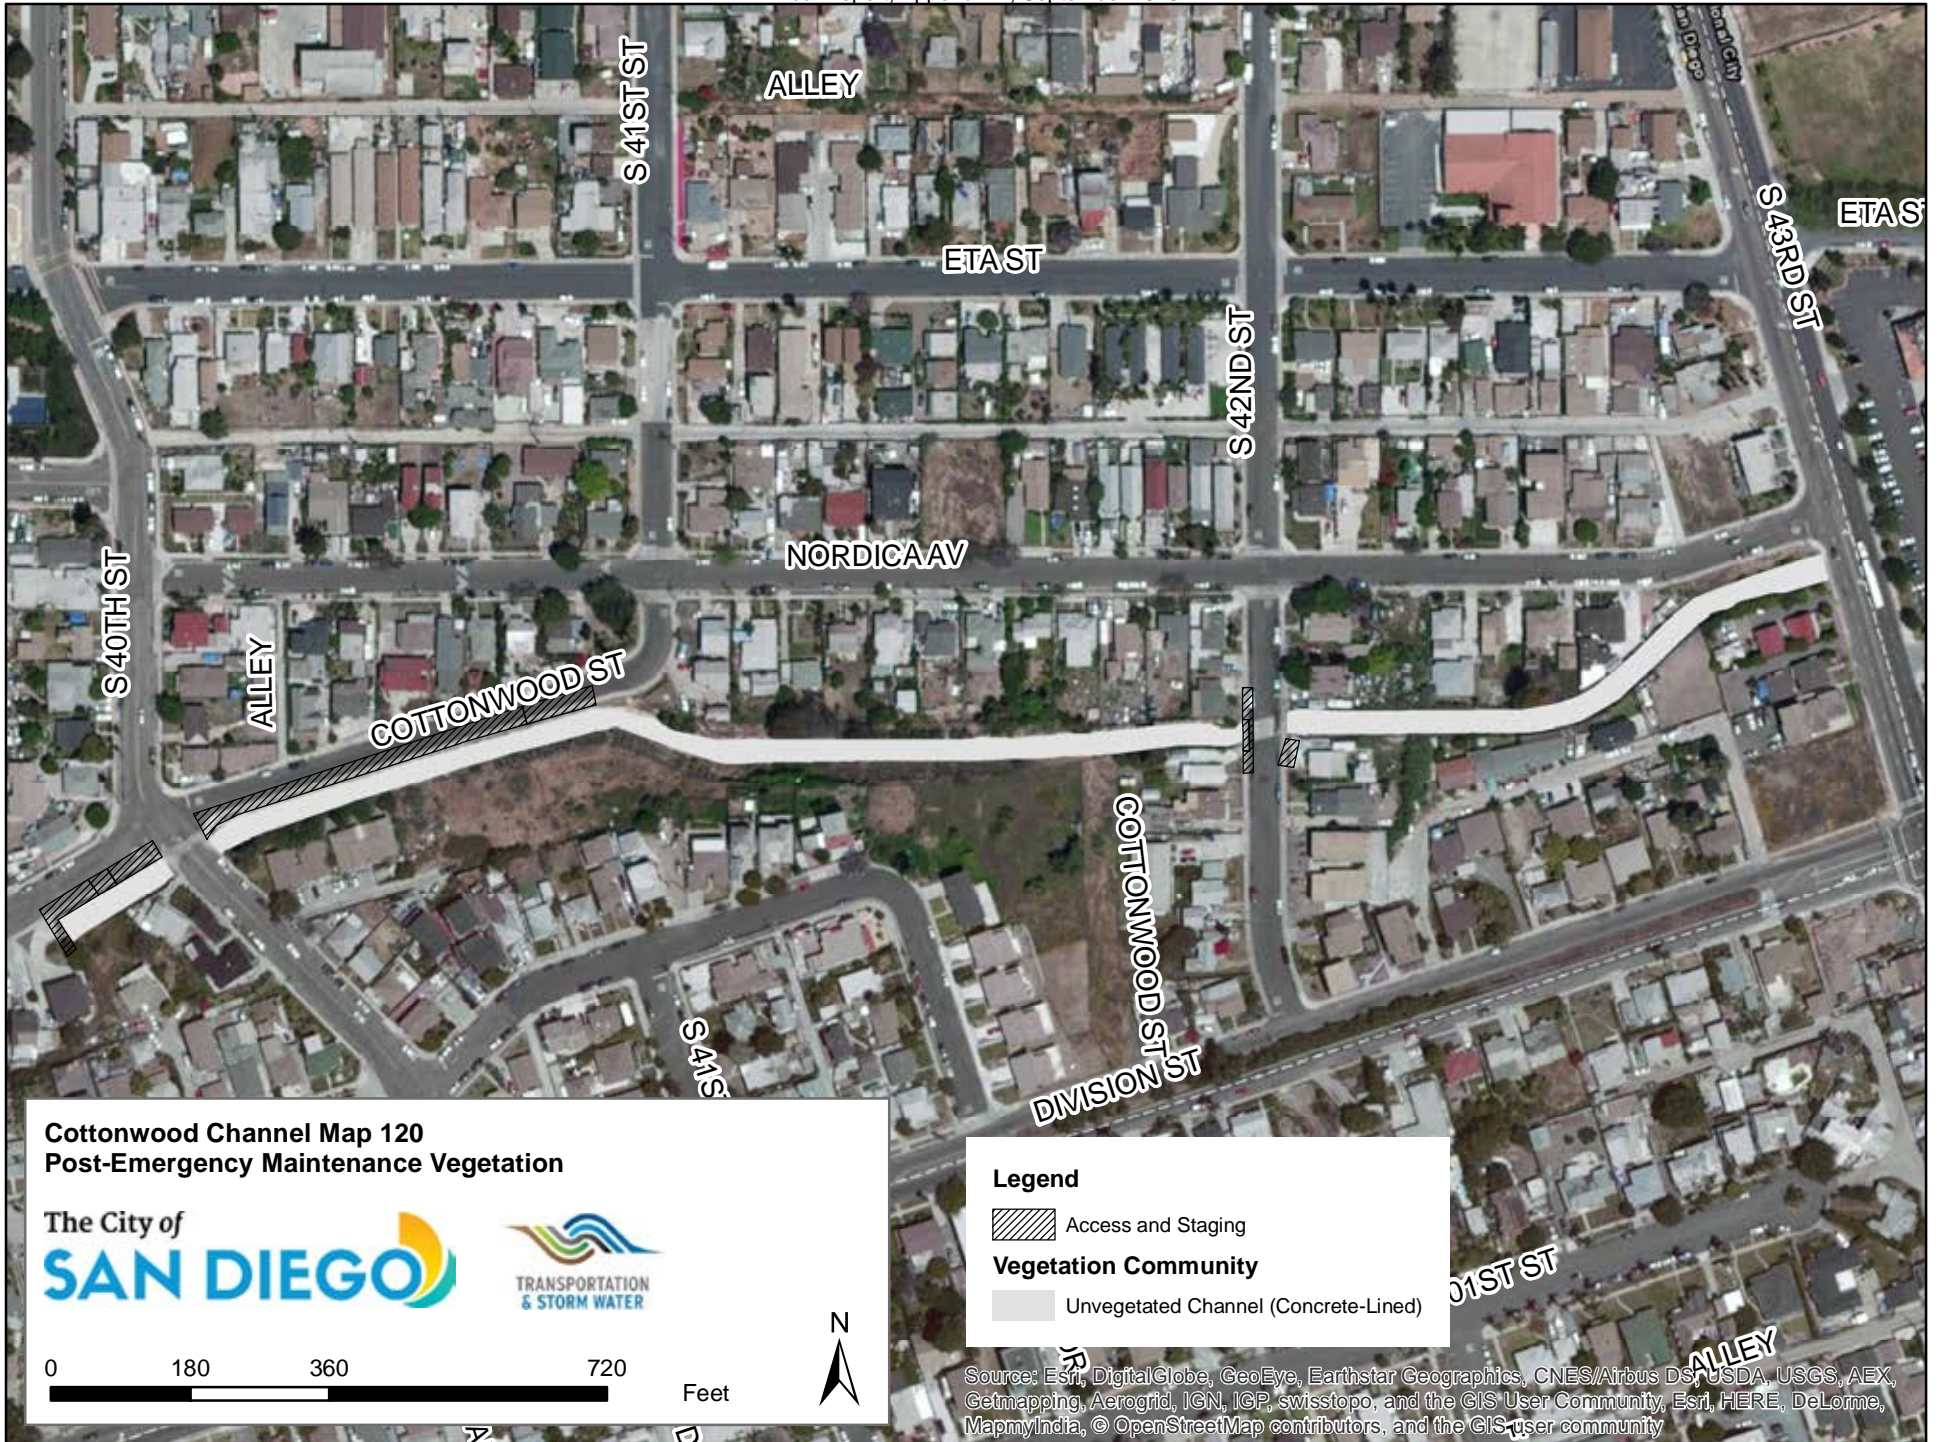
Annual Report, Figure 25

The Cottonwood channel emergency maintenance project included the mechanized removal of sediment, vegetation, trash and debris in several sections of MMP Maps 120 (Figures 25 and 26) and 121 (Figures 27 and 28). Assessments by City crews were conducted during the first week of November 2015 and determined that overall vegetation accumulation, combined with the large amounts of exotic vegetation within the channel and the high likelihood of this vegetation being

Pre-Maintenance Biological Resources and Impacts

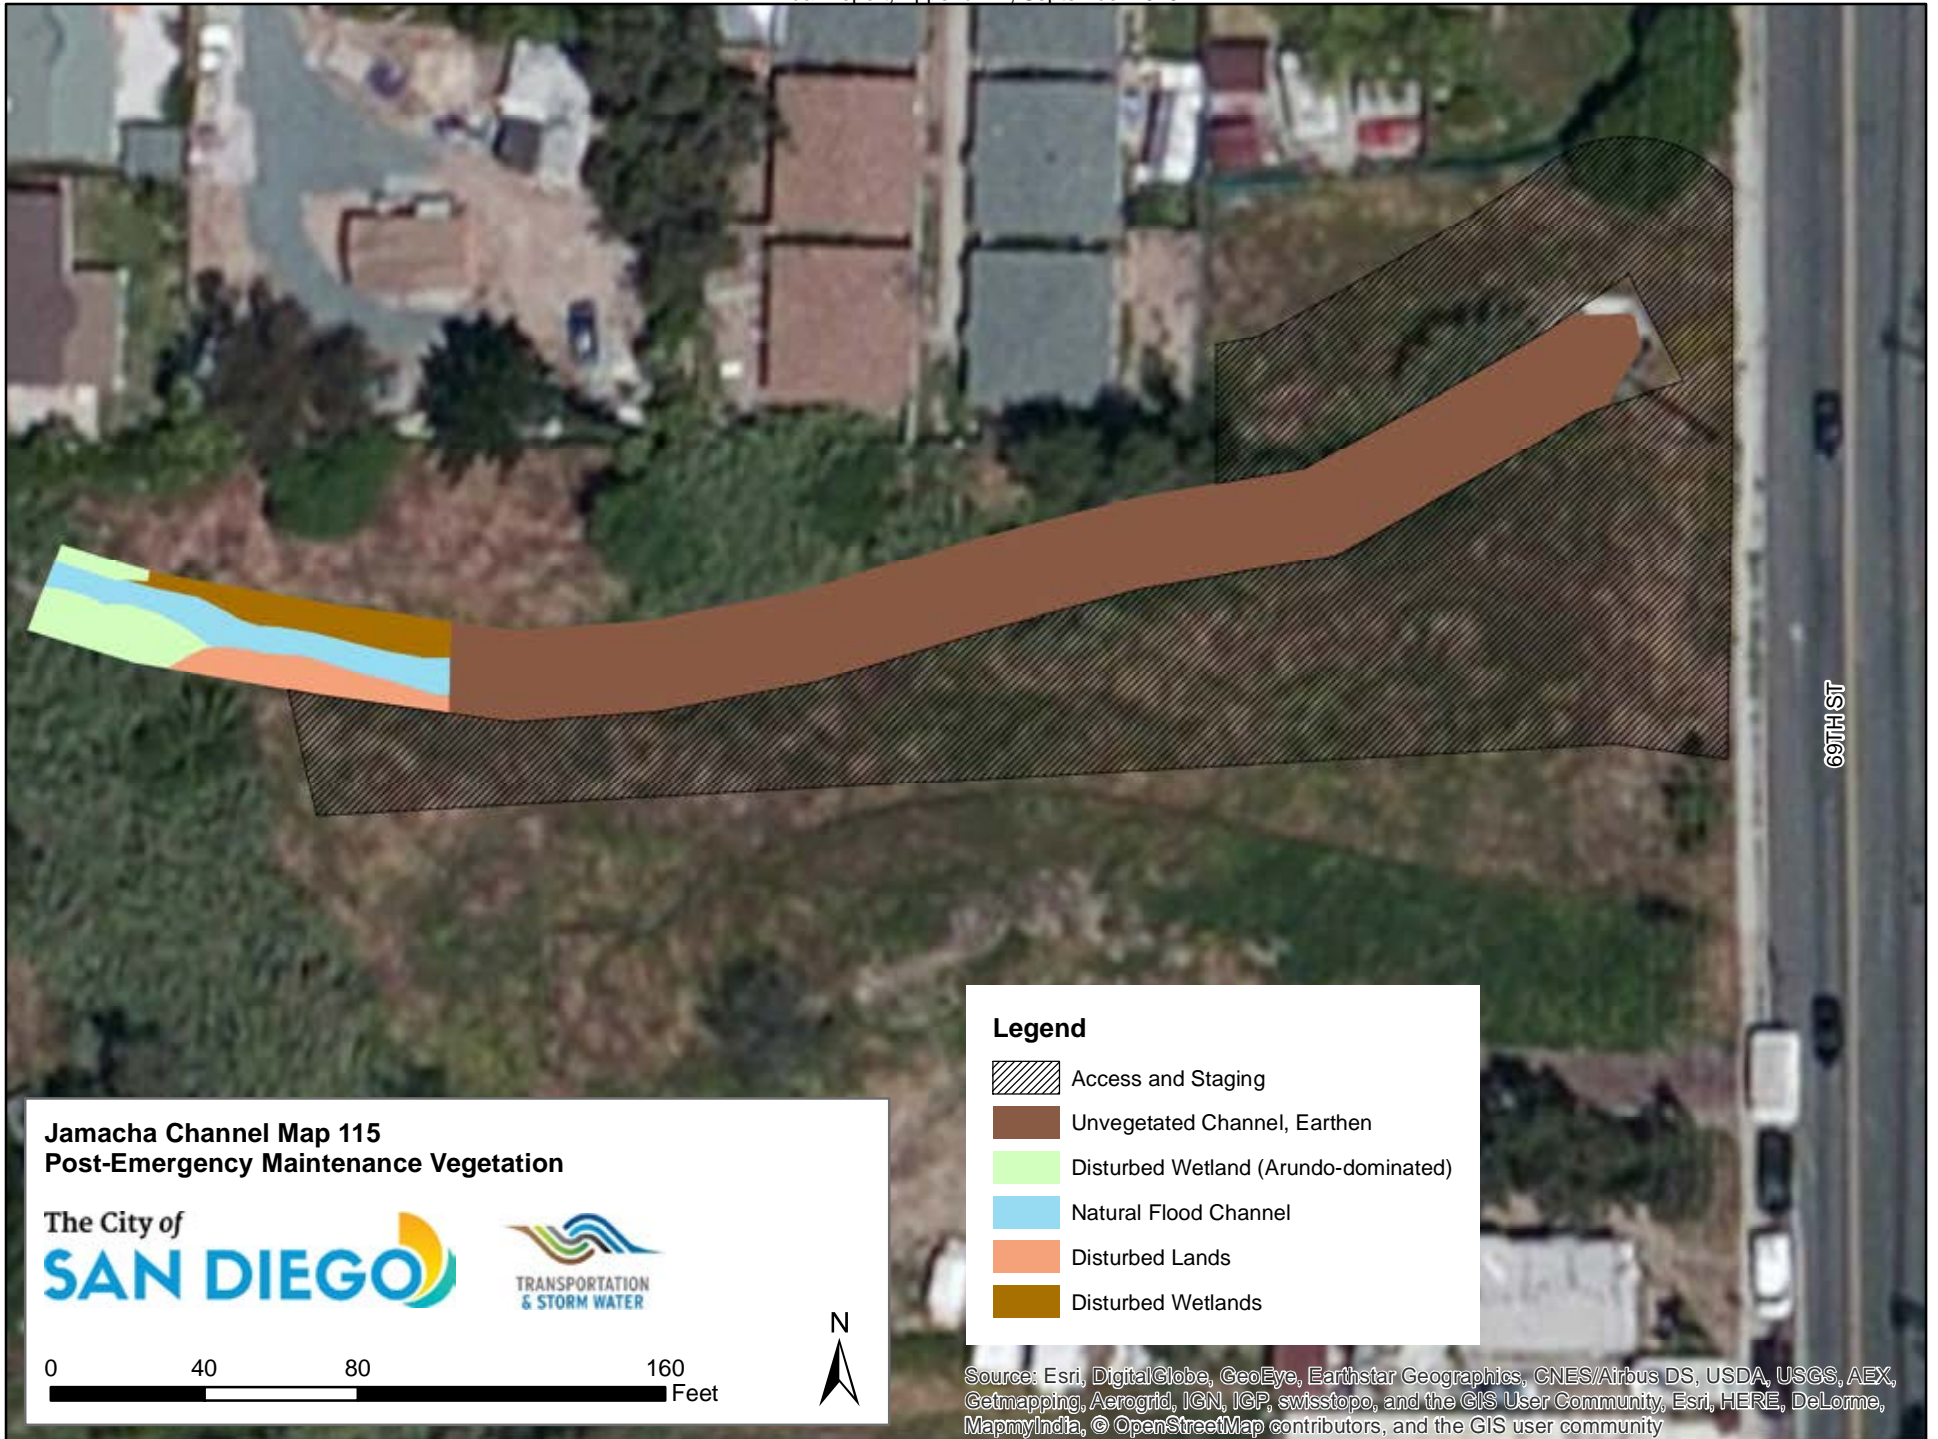
Annual Report, Figure 29

The Jamacha channel emergency maintenance project included the mechanized removal of sediment, vegetation, trash and debris in several sections of MMP Map 115 (Figures 29 and 30). Assessments by City crews were conducted on December 11, 2015 and December 18, 2015 and determined that sediment accumulation had narrowed the channel in several locations resulting in an approximately 50% reduction in flow capacity.. The reduced channel capacity and accumulation of exotic vegetation (primarily *Arundo*), were anticipated to cause a backwater effect that posed an imminent flood risk to adjacent residences. There have been repeated reports of residential flooding adjacent to the Jamacha channel in this area during prior rain events. In light of the condition of the earthen bottom drainage channel observed during the December 2015 assessments, and with the prediction of El Niño storms and expected heavy rains during the 2015-2016 storm season, the City determined that the residential properties adjacent to this section of the Jamacha Channel were under imminent threat of severe damage from storm flows.

MMP Map 115
Pre-Maintenance Biological Resources and Impacts
