Master Storm Water System Maintenance Program Annual Report

Transportation & Storm Water Department
Storm Water Division

SEPTEMBER 2016

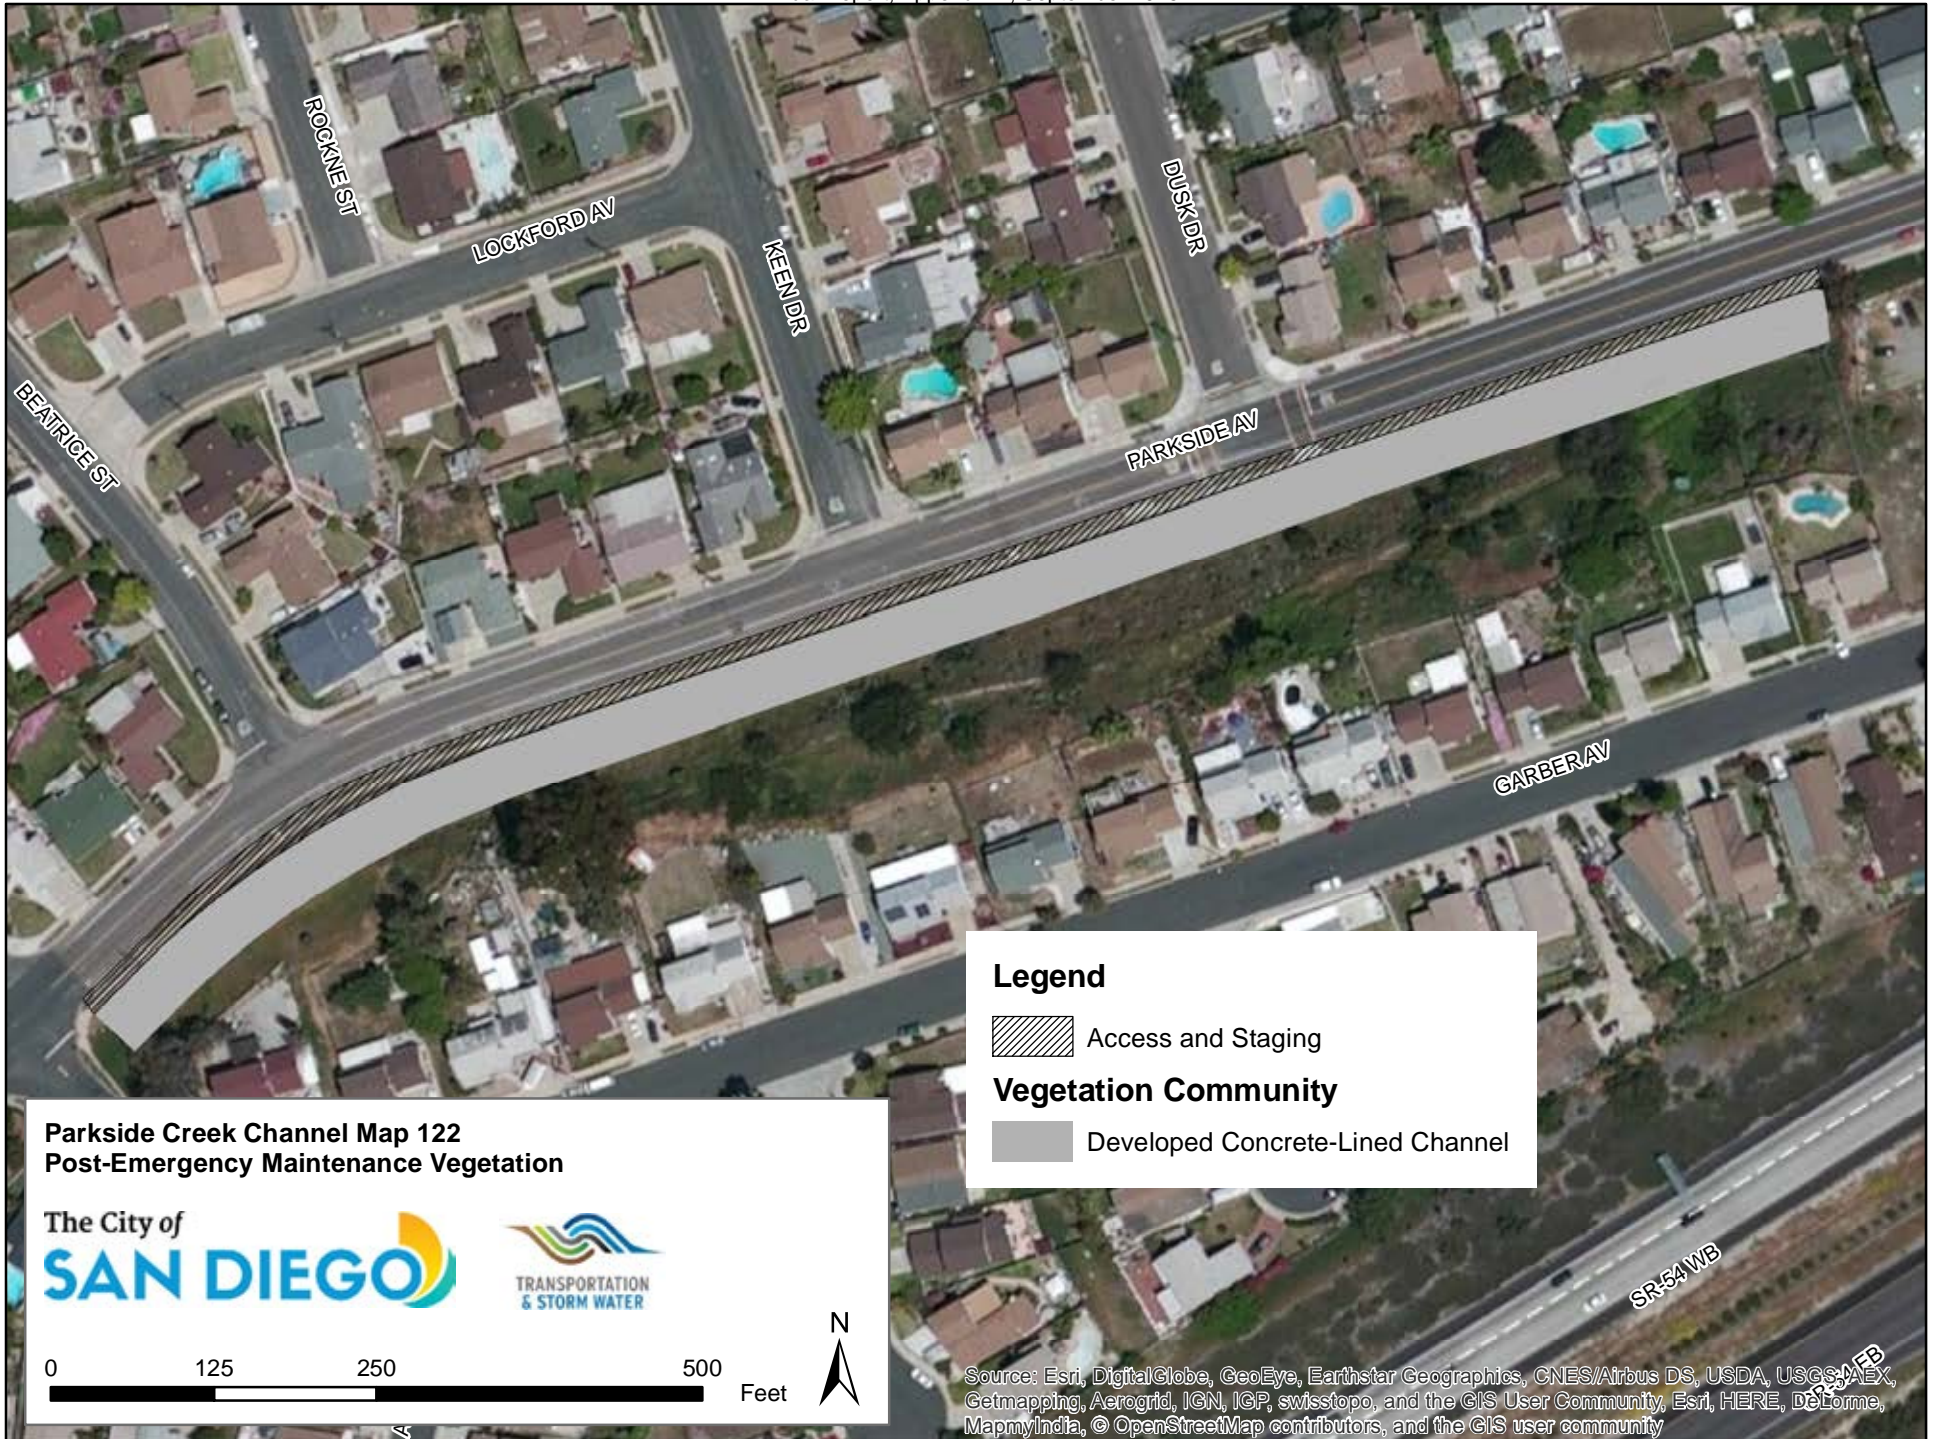
Annual Report, Figure 33

The Parkside Channel emergency maintenance project included the mechanized removal of sediment, vegetation, trash and debris in MMP Map 122 (Figures 33 and 34). Initial assessments conducted by City crews during the first week of November 2015 determined that overall vegetation accumulation, combined with the large amount of invasive exotic vegetation within the channel, posed an imminent risk of clogging downstream sections and increased flood risk. City crews estimated there was a high likelihood that accumulated vegetation could be dislodged from the concrete-lined channel bottom during predicted heavy flows. The north and western sides of the Parkside Channel abut City roads and private residences. In light of the condition of the concrete-lined channel observed during the November 2015 assessment, and with the prediction of El Niño

Pre-Maintenance Biological Resources and Impacts

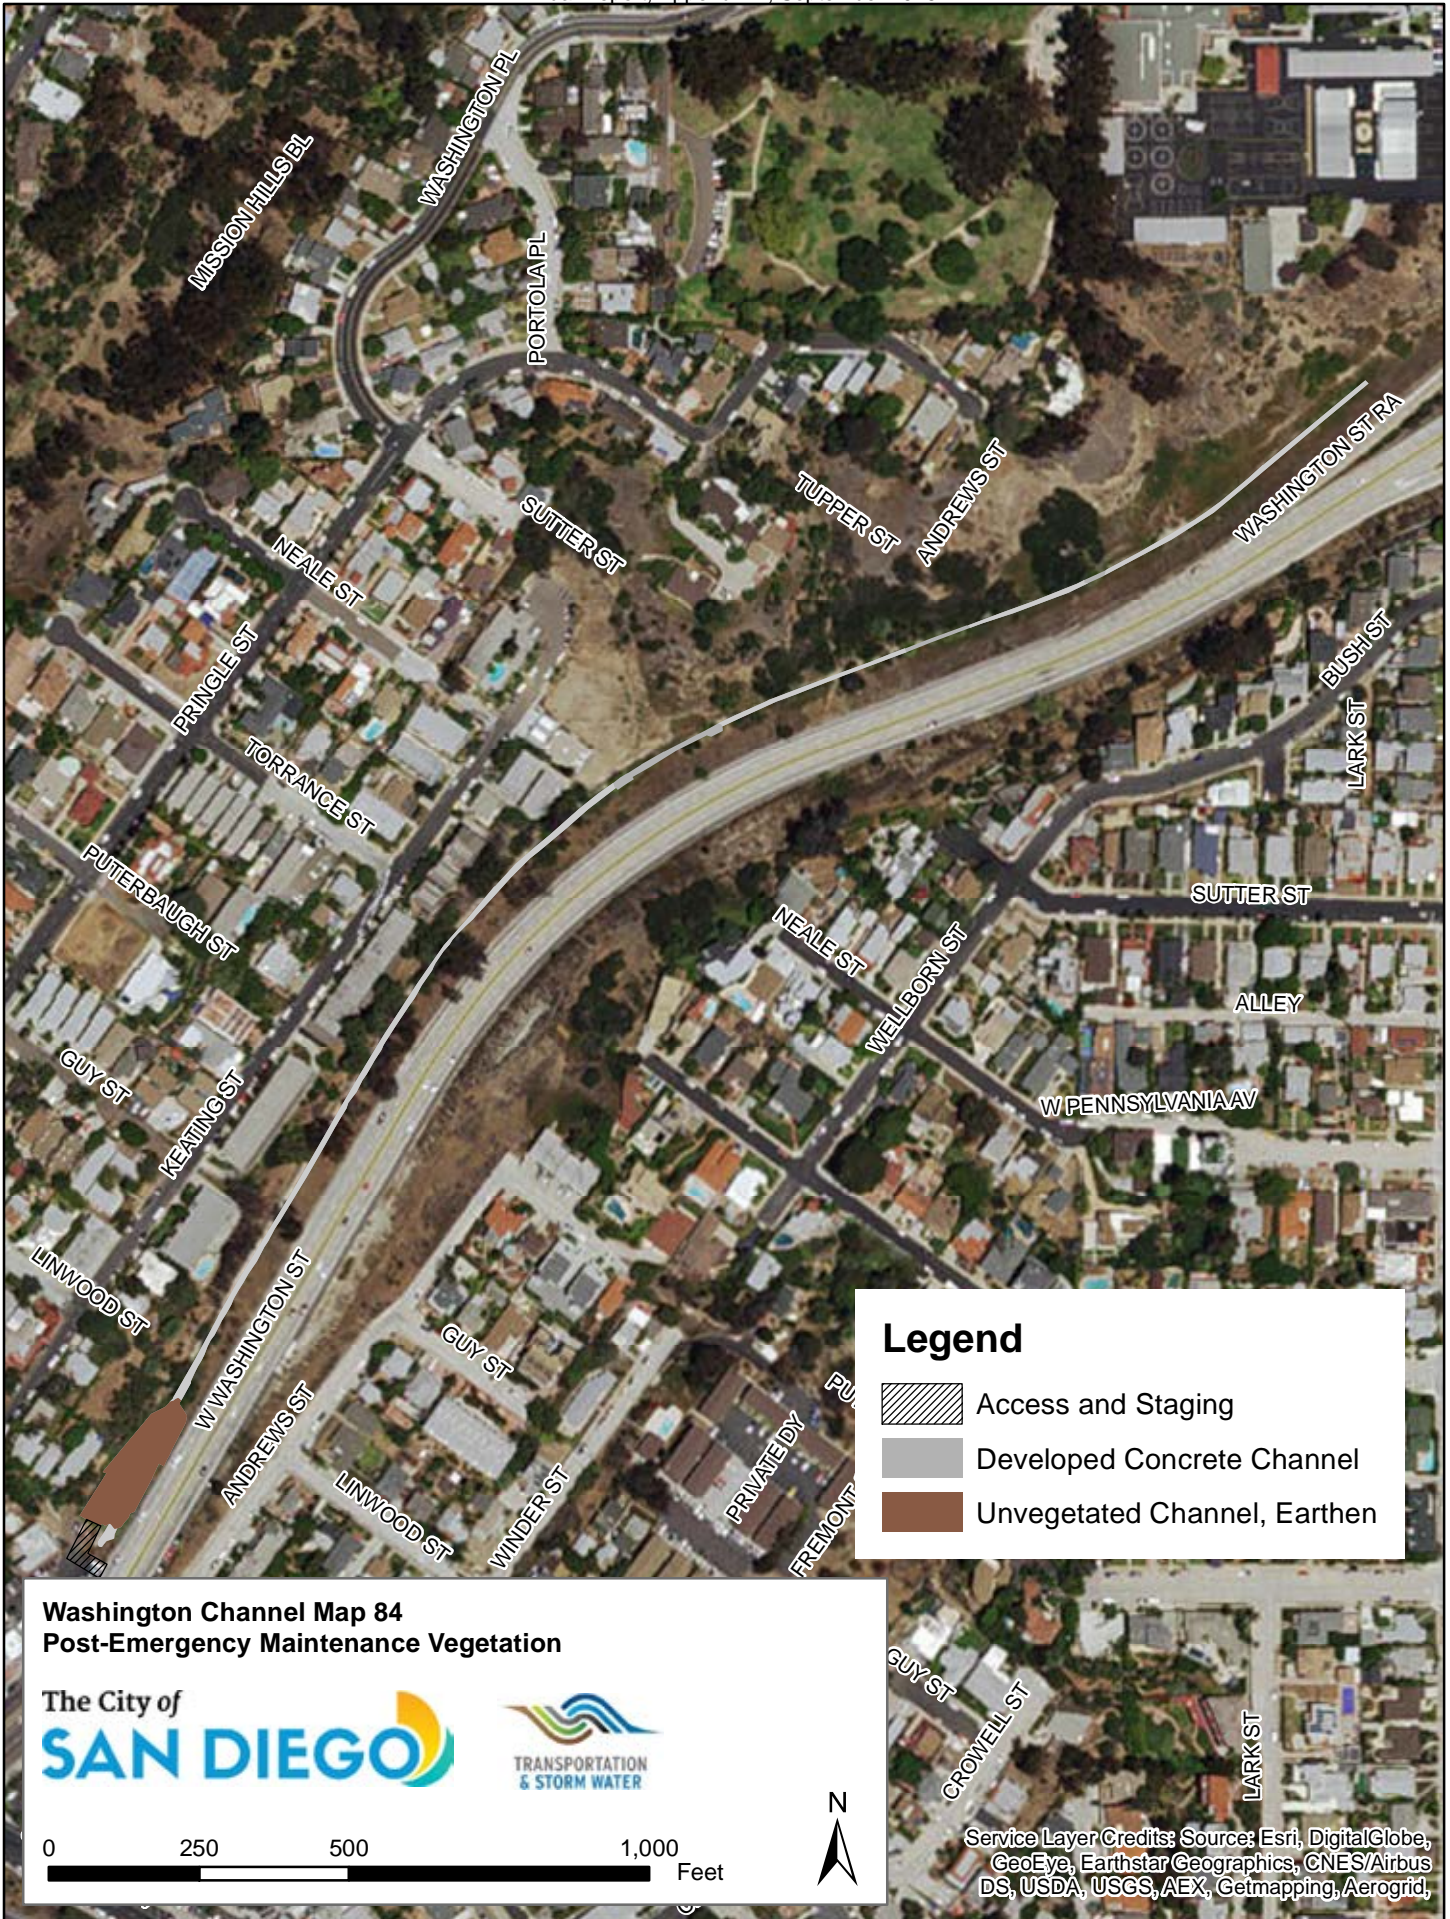
Annual Report, Figure 35

The Washington Channel emergency maintenance project included the mechanized removal of sediment, vegetation, trash and debris in MMP Map 84 (Figures 35 and 36). Assessments by City crews were conducted on November 19 and December 29, 2015. The City's assessments determined that sediment and vegetation had accumulated in various sections within the channel, constricting flows and increasing the risk of flooding. The channel is primarily concrete-lined with a small earthen-bottom section at the west end.

Pre-Maintenance Biological Resources and Impacts

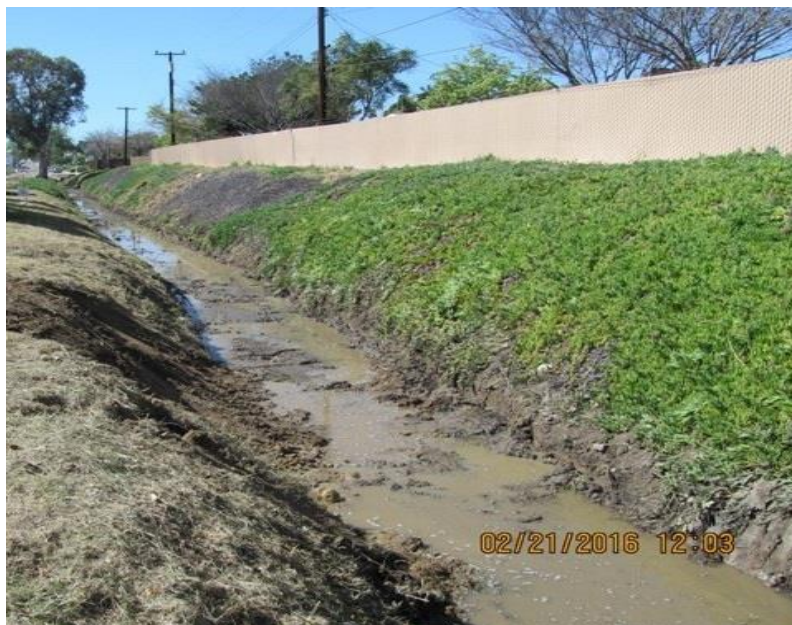
Photo 2. Pacific Beach Dr/Olney Street Channel Map 37 Post-Maintenance 2/21/16

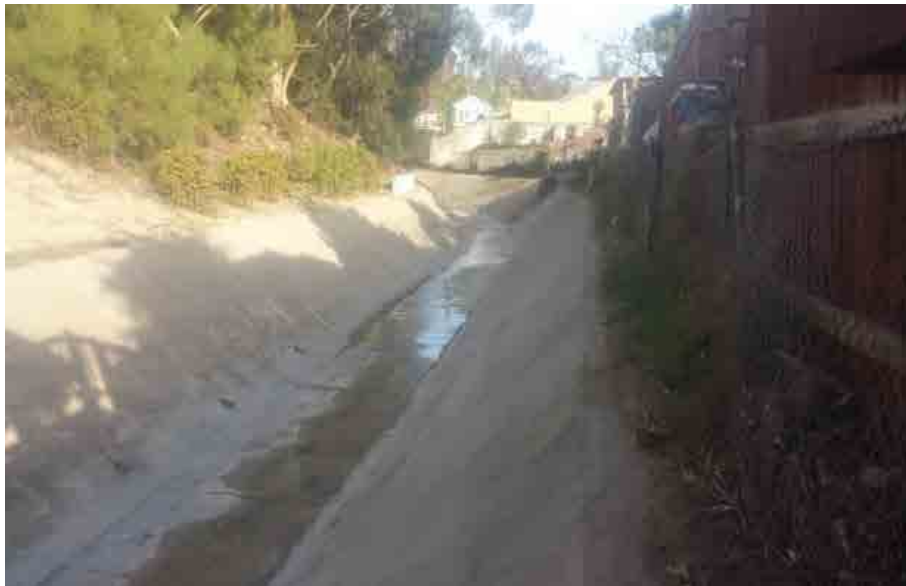
Photo 14. Via de la Bandola Channel (MMP Map 130a) Post-Maintenance 12/6/15

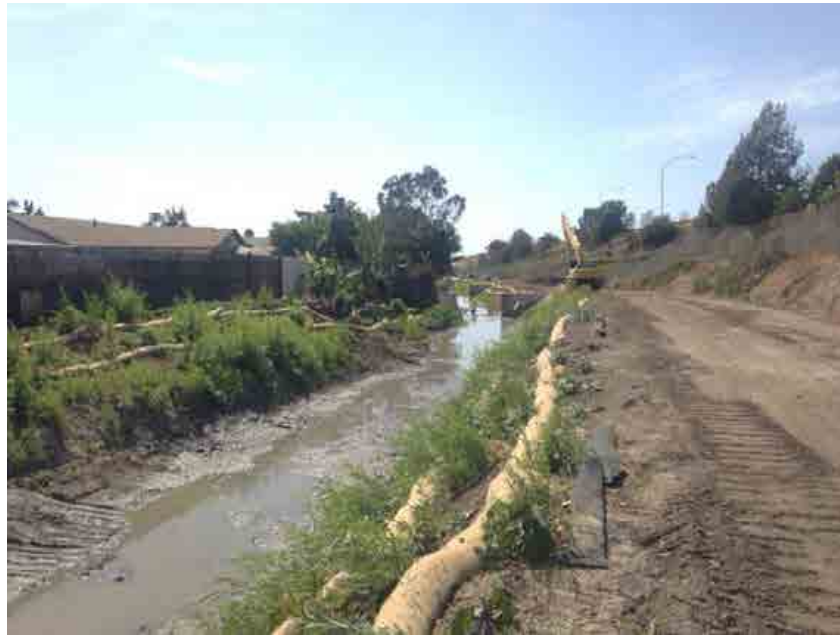
Photo 30. Smythe Channel (MMP Map 130) Post-Maintenance 4/26/16

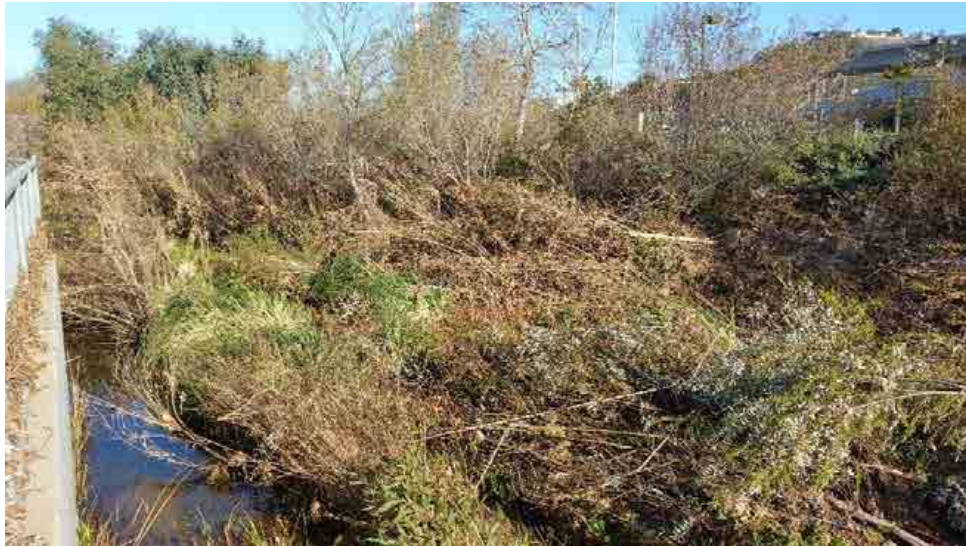
Photo 33. Sorrento Valley (Soledad Creek) Map 11 Channel Emergency Maintenance Pre-Maintenance 1/25/16

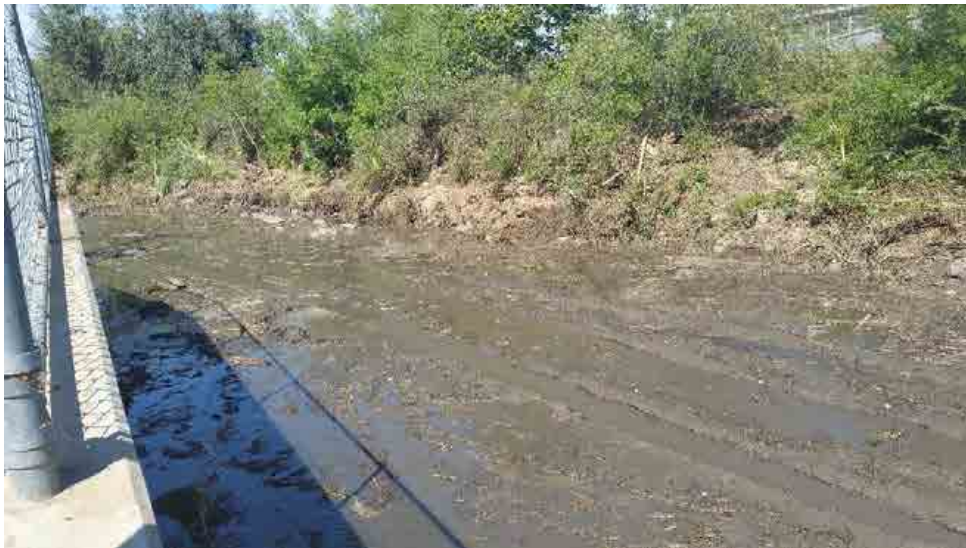
Photo 34. Sorrento Valley (Soledad Creek) Map 11 Channel Emergency Maintenance Post-Maintenance 3/5/16
