#### Facility Maintenance Plan

# Green Valley Creek - Paseo del Verano Facility Group

Segment Name (Facility number): Paseo del Verano 1 (1-04-200)

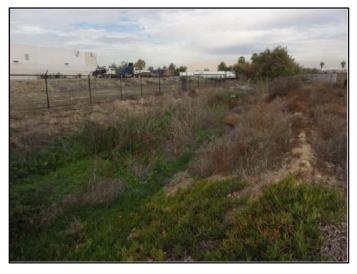
Figure 1: December 2016, downstream portion looking south towards the shared detention facility

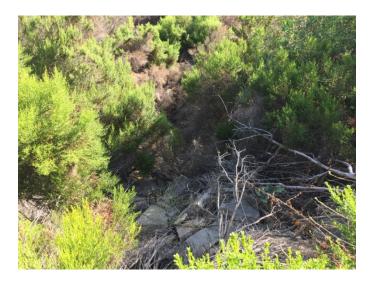
Figure 1: July 2017, photo of 10405 Sorrento Valley Road

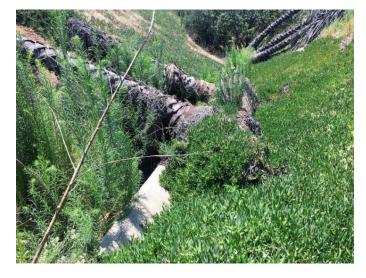
Figure 1: July 2017, photo of 1331 Washington

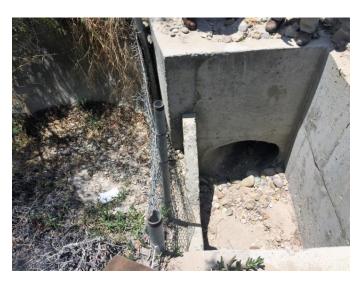
Figure 1: July 2017, photo of 1277 Camino del Rio South

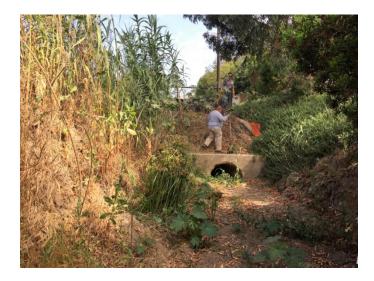
Figure 1: July 2017, photo of 5505 Friars Road

Current Conditions Affecting Facility Capacity	The outlet is a headwall structure with 1 to 2 feet of sediment and debris deposition at the headwall. Previously placed riprap was not visible due to the sediment and debris deposition. It appears that the sediment deposition is also creating a plug downstream of the outlet. Large vegetation regrowth is occuring with in the previously maintained portion of the outlet.
Maintenance Recommendation	Recommend to remove sediment for an approximately 50 foot length to restore previous maintenance area and allow the outlet to drain
In-Stream Post-Maintenance Erosion Control Recommendation	As-built includes a riprap energy dissipator at the outlet. Additional analysis is needed to determine if the as-built condition reduces velocities below permissible levels.

Structure Name	5505 Friars Road
Coastal Zone	No
MWMP Proposed Maintenance	Maintenance of structure per as-built dimensions and Hydrology and
	Hydraulics Recommendation
Hydrology and Hydraulics	Recommend to remove sediment for an approximately 50 foot length to
Recommendation	restore previous maintenance area and allow the outlet to drain
Maintenance Activities	Vegetation grubbing, trimming, and removal
	Invasive plant species treatment and removal
	Sediment removal
	Concrete repair
Maintenance Method	Excavation; mechanized equipment in facility
	Temporary access/loading
	Temporary staging
	Temporary diversions
	Hand removal of vegetation
Bank Repair	No
Concrete Repair	Yes; see Appendix A-4
Concrete/Gabion Structure Repair	No
and Maintenance	
Culvert Maintenance	Yes; see Appendix A-4
Post-Maintenance Erosion Control	Subject to further analysis to determine need and type
Recommendation	
Trash/Debris Fence Repair and	No

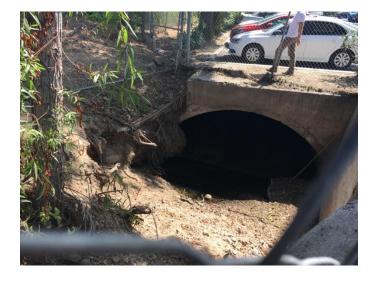
Figure 1: July 2017, photo of 1660 Hotel Circle North

Current Conditions Affecting Facility Capacity	Maintenance recently performed at this location, so outlet area was clear. Previously the area had 5 to 10 feet of sediment deposition and vegetation growth.
Maintenance Recommendation	Recommend to keep the outlet clear as sediment and vegetation build up
In-Stream Post-Maintenance Erosion Control Recommendation	Subject to further analysis to determine need and type

Structure Name	1660 Hotel Circle North
Coastal Zone	No
MWMP Proposed Maintenance	Maintenance of structure per as-built dimensions and Hydrology and
	Hydraulics Recommendation
Hydrology and Hydraulics	Recommend to keep the outlet clear as sediment and vegetation build up
Recommendation	
Maintenance Activities	Vegetation grubbing, trimming, and removal
	Invasive plant species treatment and removal
	Sediment removal
	Concrete repair
Maintenance Method	Excavation; mechanized equipment inside and outside of facility
	Temporary access/loading
	Temporary staging
	Temporary diversions
	Hand removal of vegetation
Bank Repair	No
Concrete Repair	Yes; see Appendix A-4
Concrete/Gabion Structure Repair	No
and Maintenance	
Culvert Maintenance	Yes; see Appendix A-4
Post-Maintenance Erosion Control	Subject to further analysis to determine need and type
Recommendation	
Trash/Debris Fence Repair and	No
Maintenance	
Structure Type	Outlet

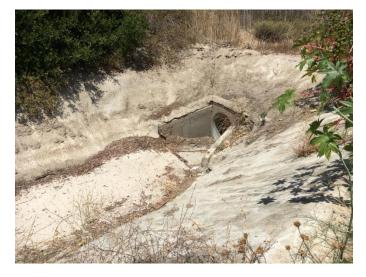
Figure 1: July 2017, photo of 901 Hotel Circle South

Current Conditions Affecting Facility Capacity	The inlet is a headwall structure with sediment and debris deposition near the headwall and behind the debris fences. The concrete channel behind the debris fence is missing large section of concrete/gunite from the channel bottom. The downstream debris fence has a gap at the bottom and looks to be in need of repairs.
Maintenance Recommendation	Recommended to remove sediment and debris from the structure as well as repair the missing concrete/gunite and the debris fence
In-Stream Post-Maintenance Erosion Control Recommendation	No

Structure Name	901 Hotel Circle South
Coastal Zone	No
MWMP Proposed Maintenance	Maintenance of structure per as-built dimensions and Hydrology and
	Hydraulics Recommendation
Hydrology and Hydraulics	Recommended to remove sediment and debris from the structure as well
Recommendation	as repair the missing concrete/gunite and the debris fence
Maintenance Activities	Vegetation grubbing, trimming, and removal
	Invasive plant species treatment and removal
	Sediment removal
	Concrete repair
	Structure/Trash fence repair
Maintenance Method	Excavation; mechanized equipment in and outside of facility
	Temporary access/loading
	Temporary staging
	Temporary diversions
	Hand removal of vegetation
Bank Repair	No
Concrete Repair	Yes; see Appendix A-4
Concrete/Gabion Structure Repair	No
and Maintenance	
Culvert Maintenance	No
Post-Maintenance Erosion Control	No
Recommendation	
Trash/Debris Fence Repair and	Yes; see Appendix A-4

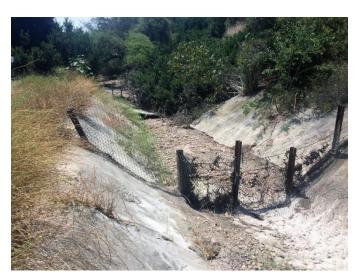
Figure 3: July 2017. Photo of 901 Hotel Circle South debris fence

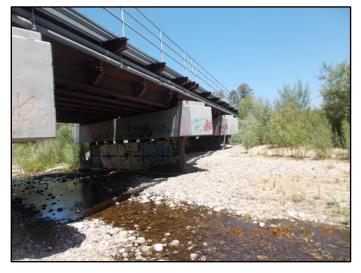
Figure 1: July 2017, looking downstream at channel bottom near the upstream side of railroad bridge

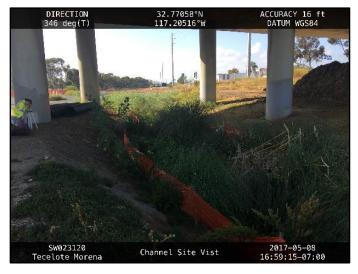
Figure 1: May 2017, looking downstream, representative of thick vegetation in the channel

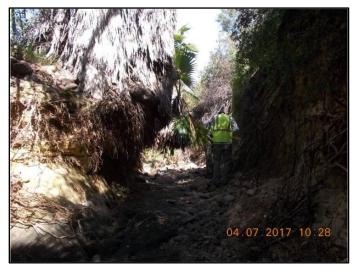
Figure 1: April 2017, looking downstream at vegetation, erosion in facility

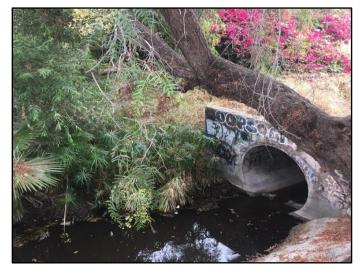
Figure 1: August 2017, looking upstream at RCP storm drain system outlet

<b>Current Conditions</b>	S Affecting	Dense vegeta	tion was observe	ed and little ev	idence of sedime	ent deposition.
<b>Facility Capacity</b>		Standing water was observed at the upstream culvert outlet.				
Hydrologic Peak Flo	)WS					
Storm Event	2-year	5-year	10-year	25-year	50-year	100-year
Q (cubic feet per	86	127	160	248	360	450
second [cfs])						
Hydraulic Capacity of Facility						
Curr	ent Capacity		450 cfs			
Proposed MWM	IP Maintained	Capacity	N/A			
Maintenance Recommendation		No maintenance is recommended at this time		this time		
In-Stream Post-Maintenance Erosion Control Recommendation		N/A (no maintenance)

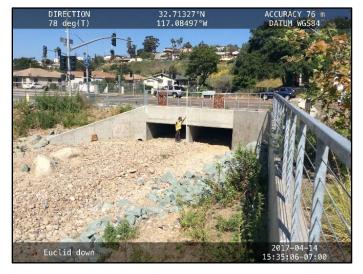
Figure 1: April 2017, representative of earthen with cobble portion of channel

Current Conditions Affecting Facility Capacity		The channel was relatively clean with light vegetation and little evidence of sediment deposition in the riprap				
Hydrologic Peak Flows						
Storm Event	2-year	5-year	10-year	25-year	50-year	100-year
Q (cubic feet per	540	1,250	2,000	3,000	3,900	5,300
second [cfs])						
Hydraulic Capacity of Facility						
Current Capacity		1,250 cfs				
Proposed MWMP Maintained Capacity		N/A				
Maintenance Recommendation		No maintenance is recommended at this time				
In-Stream Post-Maintenance Erosion Control Recommendation		N/A (no maintenance)

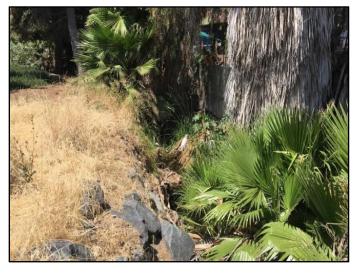
Figure 1: July 2017, downstream of Beacon Drive culvert (3-foot-diameter RCP), looking west. Riprap apron and dense vegetation present.

Current Conditions Facility Capacity			n was observed to vary from light to dense with evidence of osition near the culverts			h evidence of
Hydrologic Peak Flo	)WS					
Storm Event	2-year	5-year	10-year	25-year	50-year	100-year
Q (cubic feet per	200	256	300	361	408	455
second [cfs])						
<b>Hydraulic Capacity</b>	of Facility					
Current Capacity		250 cfs				
Proposed MWM	IP Maintained	Capacity	N/A			
Maintenance Recommendation		No maintenance is recommended at this time				
In-Stream Post-Maintenance Erosion Control Recommendation		N/A (no maintenance)

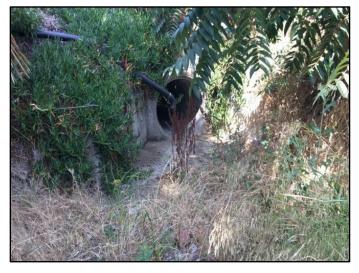
Figure 1: July 2017, looking upstream from Beacon Drive culvert (3-foot-diameter RCP)

<u> </u>		of vegetation was observed to vary from light to dense with ediment deposition near the culverts				
Hydrologic Peak Flo	ws					
Storm Event	2-year	5-year	10-year	25-year	50-year	100-year
Q (cubic feet per second [cfs])	178	227	266	320	362	403
Hydraulic Capacity of Facility						
Current Capacity		40 cfs				
Proposed MWMP Maintained Capacity			N/A			
Maintenance Recommendation		No maintenance is recommended at this time				
In-Stream Post-Maintenance Erosion Control Recommendation		N/A (no maintenance)

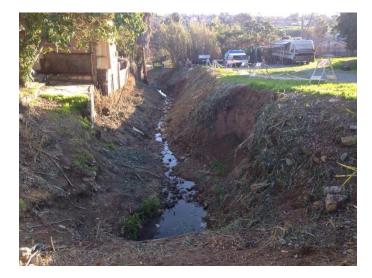
Figure 1: July 2017, looking downstream

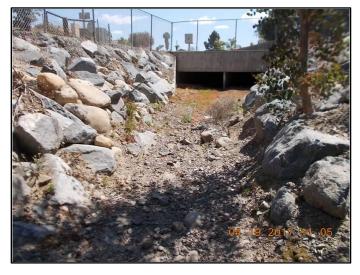
Figure 1: April 2017, looking upstream vegetation and outlet of double 10-foot by 4-foot RCB culvert
