APPENDIX A-2

Basin FMPs

Facility Maintenance Plan

Green Valley Creek - Paseo del Verano Facility Group

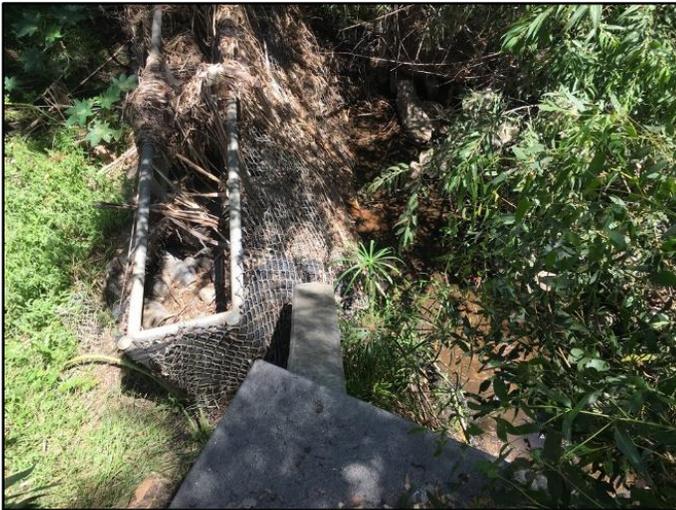
Figure 1: July 2017, riprap structure at outlet structure

Current Conditions Affecting Facility Capacity	Dense vegetation including tree growth was observed. Approximately 2 feet of sediment deposition was estimated on the upstream side of the rock gabion.
---	--

Maintenance Recommendation	Remove accumulated sediment, debris and vegetation from basin bottom to restore the as-built condition. Trim vegetation on side slopes of the basin. Repair gabion rock-filled barrier walls to as-built condition.
-----------------------------------	---

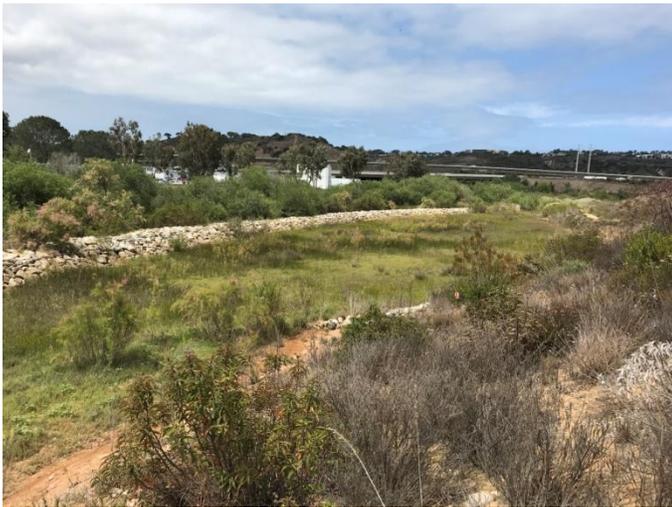
Figure 1: May 2018, looking west into the desilting basin with Penasquitos Creek visible on the outside of the rip rap berm

Current Conditions Affecting Facility Capacity	Moderate vegetation was observed throughout the basin with a minor amount of sediment deposition
Maintenance Recommendation	Remove vegetation from basin inlet and side weir, and restore to the as-built condition. Remove any accumulated sediment and debris from basin.
In-Stream Post-Maintenance Erosion Control Recommendation	N/A (basin)

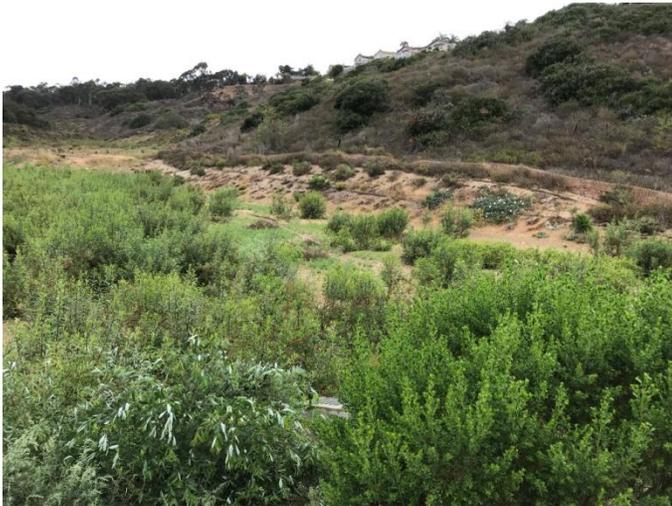
Figure 1: May 2018, looking north east into the detention basin from the south western end with the grated concrete culvert partially visible in the foreground

Dense vegetation including trees and accumulated sediment/debris were observed in the detention basin. The sediment depth was estimated to be approximately 1 foot deep across the basin and inlets and outlets were observed to be partially surrounded by vegetation.

Remove accumulated sediment, debris, and vegetation from basin bottom, from around inlet structure at the far north end of the basin, and from outflow structure at the south end of the basin to restore the as-built condition.
Remove accumulated debris from storm drain outlet structures upstream of the basin.

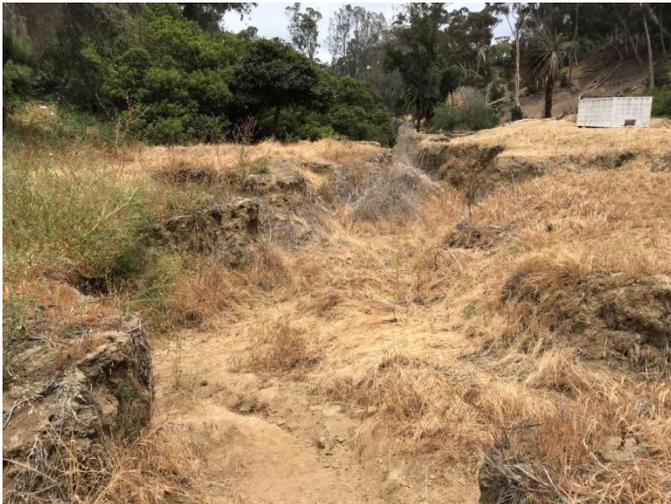
Figure 1: May 2018, looking east from the detention basin at the incised natural flood channel upstream

Current Conditions Affecting Facility Capacity	Light vegetation was observed and sediment accumulation, including sand, silt, and small cobble varied from 0.5 to 5 feet deep
---	--

Maintenance Recommendation	Remove accumulated sediment, debris, and vegetation from the desilting basin
-----------------------------------	--

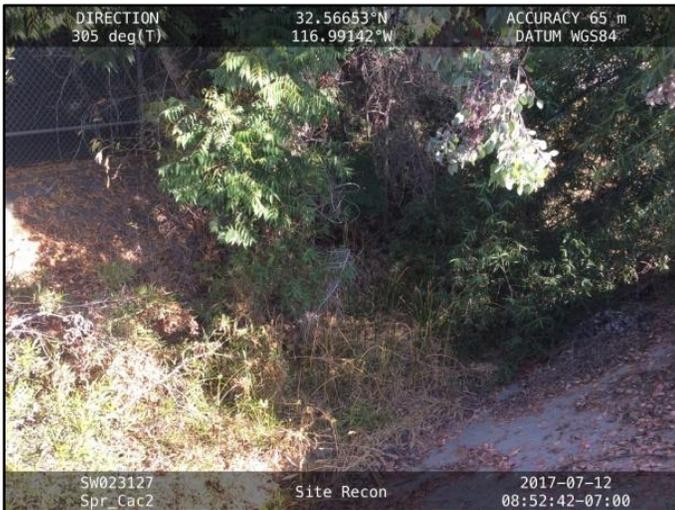
Figure 1: July 2017, standing water and vegetation growth in the basin

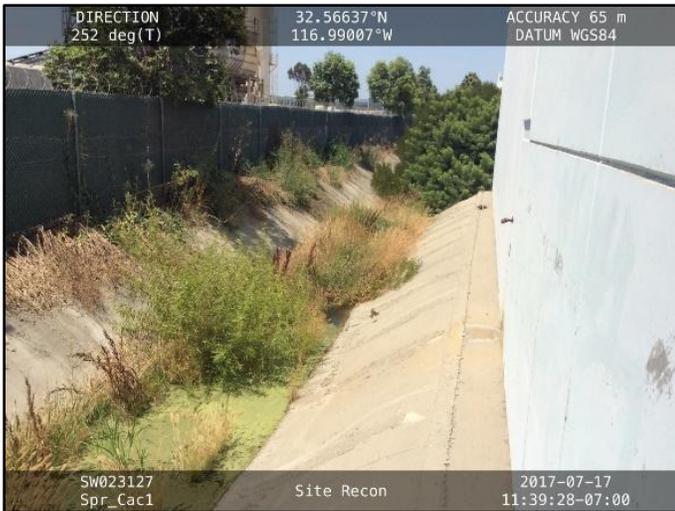
Figure 1: July 2017, sediment, debris deposition and vegetation growth in basin

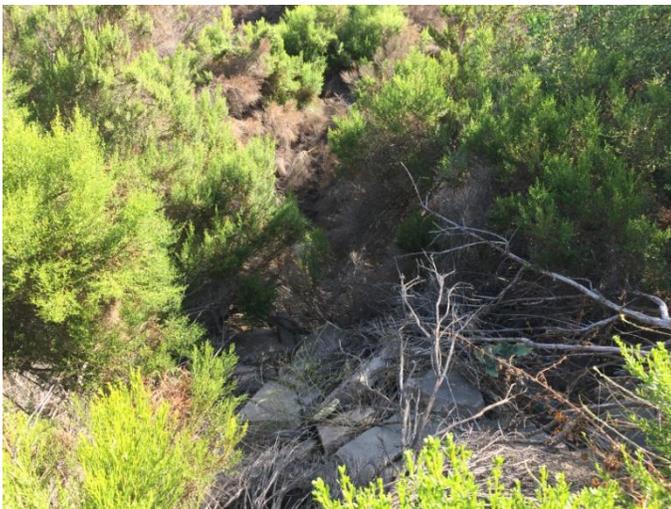
Figure 1: July 2017, photo of 10405 Sorrento Valley Road

Current Conditions Affecting Facility Capacity	The inlet is a headwall structure with approximately 0.5 feet of sediment and debris deposition. A large piece of construction debris is located near culvert entrance.
---	---

Maintenance Recommendation	Recommend removal of construction debris and sediment and rock debris at the culvert entrance
-----------------------------------	---

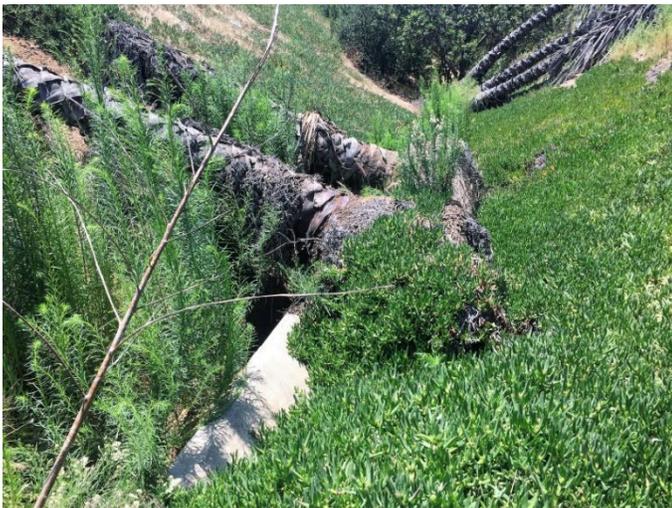
Figure 1: July 2017, photo of 1331 Washington

Current Conditions Affecting Facility Capacity	Vegetation (ice plant and a palm tree) is growing in the ditch and near the outlet. Large debris (fallen palm trees) partially blocking the ditch.
---	--

Maintenance Recommendation	Recommend trimming the vegetation out of the concrete ditch, removing palm trees from within the ditch, and removing the fallen trees. Backfill voids under concrete structure to ensure structural integrity or stability.
-----------------------------------	---

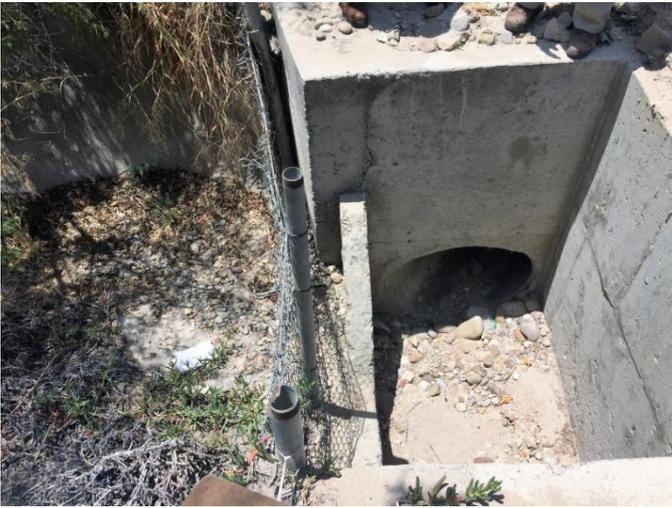
Figure 1: July 2017, photo of 1277 Camino del Rio South

Current Conditions Affecting Facility Capacity	The engineered concrete inlet is a concrete-drop-type structure with some sediment, vegetation, and debris accumulation. There is evidence of erosion on either side of the drop structure, with a major cavitation on the left side. It appears some of the runoff goes into the parking lot and not the drop structure.
---	---

Maintenance Recommendation	Recommend to remove sediment debris, and vegetation from drop structure. Further studies are recommended to investigate the cause of the erosion near the structure.
-----------------------------------	--

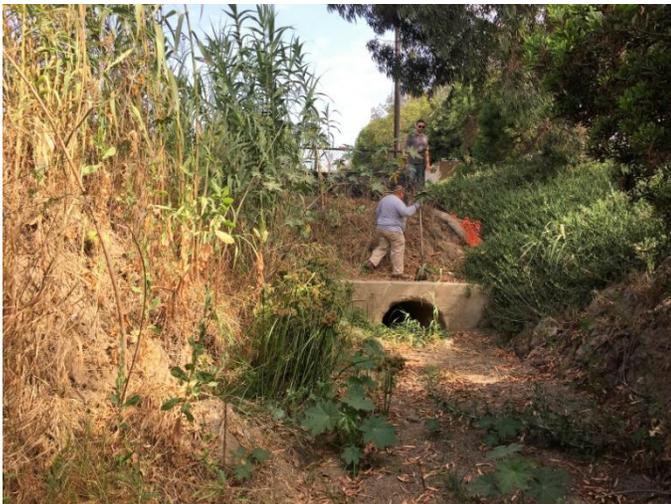
Figure 1: July 2017, photo of 5505 Friars Road

Current Conditions Affecting Facility Capacity	The outlet is a headwall structure with 1 to 2 feet of sediment and debris deposition at the headwall. Previously placed riprap was not visible due to the sediment and debris deposition. It appears that the sediment deposition is also creating a plug downstream of the outlet. Large vegetation regrowth is occurring with in the previously maintained portion of the outlet.
---	--

Maintenance Recommendation	Recommend to remove sediment for an approximately 50 foot length to restore previous maintenance area and allow the outlet to drain
-----------------------------------	---

In-Stream Post-Maintenance Erosion Control Recommendation	As-built includes a riprap energy dissipator at the outlet. Additional analysis is needed to determine if the as-built condition reduces velocities below permissible levels.
--	---

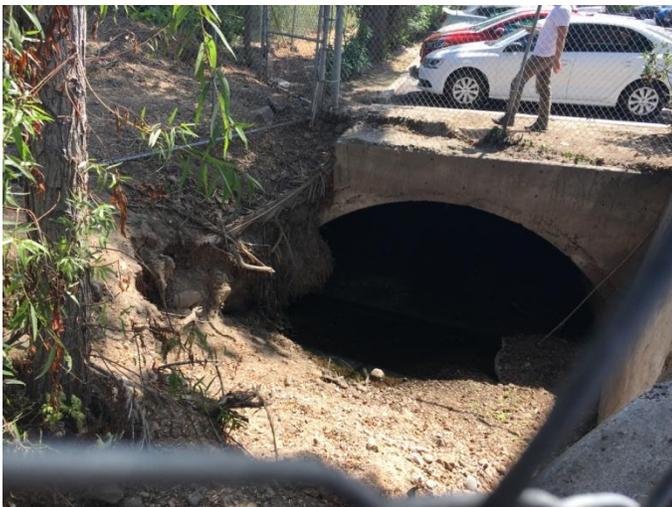
Figure 1: July 2017, photo of 1660 Hotel Circle North

Current Conditions Affecting Facility Capacity	Maintenance recently performed at this location, so outlet area was clear. Previously the area had 5 to 10 feet of sediment deposition and vegetation growth.
---	---

Maintenance Recommendation	Recommend to keep the outlet clear as sediment and vegetation build up
-----------------------------------	--

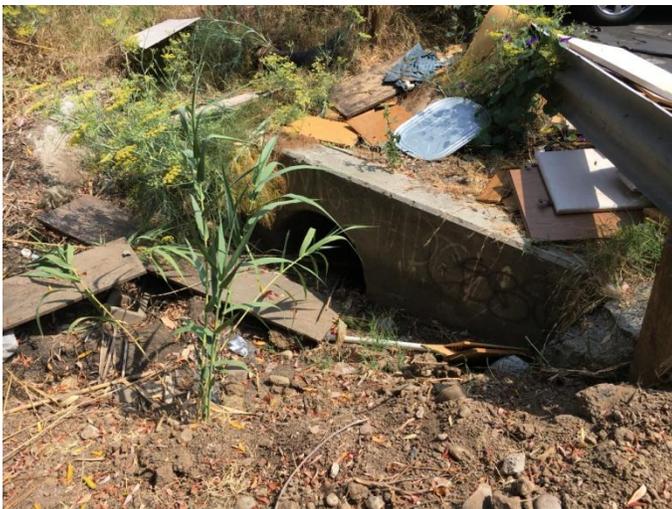
Figure 1: July 2017, photo of 4202 J Street

Current Conditions Affecting Facility Capacity	The outlet is a headwall with approximately 0.5 feet of sediment and debris deposition. Additional sediment deposition (approximately 1–2 feet) and vegetation growth immediately downstream of the outlet creates a blockage for lower flows.
---	--

Maintenance Recommendation	Recommend removal of sediment and vegetation at the outlet headwall to allow outlet to drain
-----------------------------------	--

In-Stream Post-Maintenance Erosion Control Recommendation	As-built includes a riprap energy dissipator at the outlet. Additional analysis is needed to determine if the as-built condition reduces velocities below permissible levels.
--	---

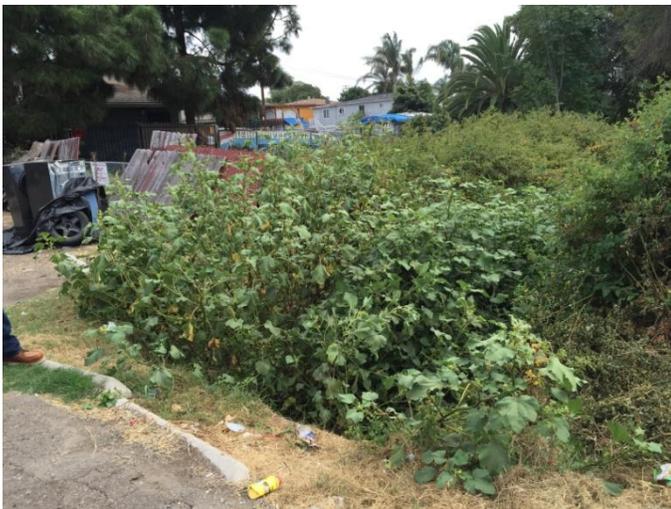
Figure 1: July 2017, photo of 1206 Goodyear

Current Conditions Affecting Facility Capacity	The outlet is a headwall structure with sediment and debris deposition and vegetation growth at the headwall
Maintenance Recommendation	Recommend removal of sediment and vegetation at the culvert headwall to allow outlet to drain Repair rip rap energy dissipator at outlet per as-built (DWG 20676-D)
In-Stream Post-Maintenance Erosion Control Recommendation	As-built includes a riprap energy dissipator at the outlet. Additional analysis is needed to determine if the as-built condition reduces velocities below permissible levels.

In-Stream Post-Maintenance Erosion Control Recommendation	As-built includes a riprap energy dissipator at the outlet. Additional analysis is needed to determine if the as-built condition reduces velocities below permissible levels.

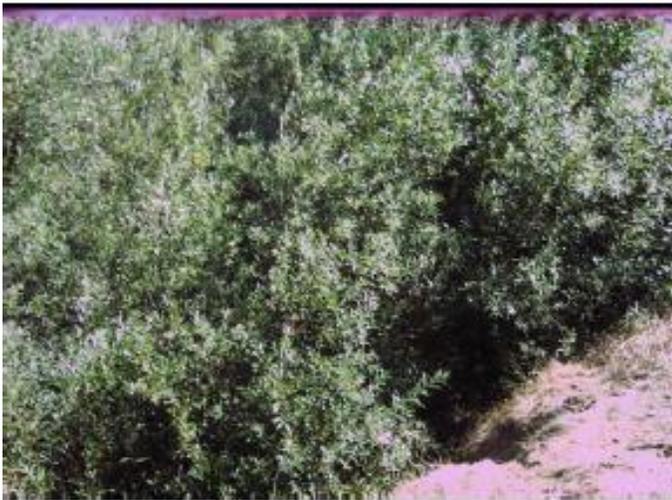
Figure 1: October 2010, looking upstream at the vegetation along the banks

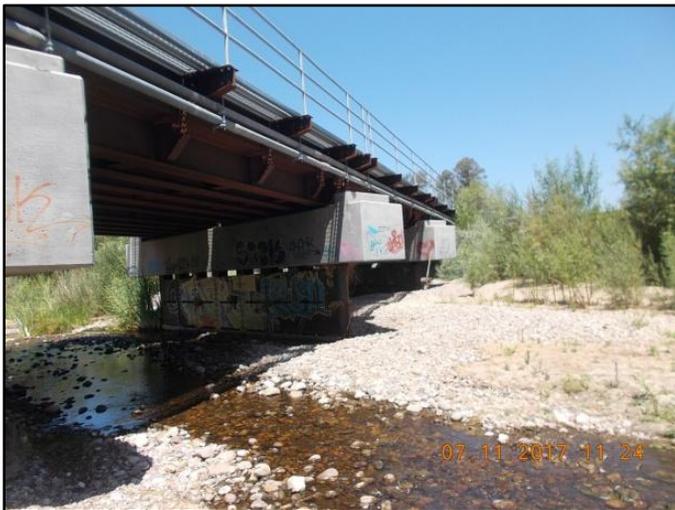
Figure 1: July 2017, looking downstream at channel bottom near the upstream side of railroad bridge

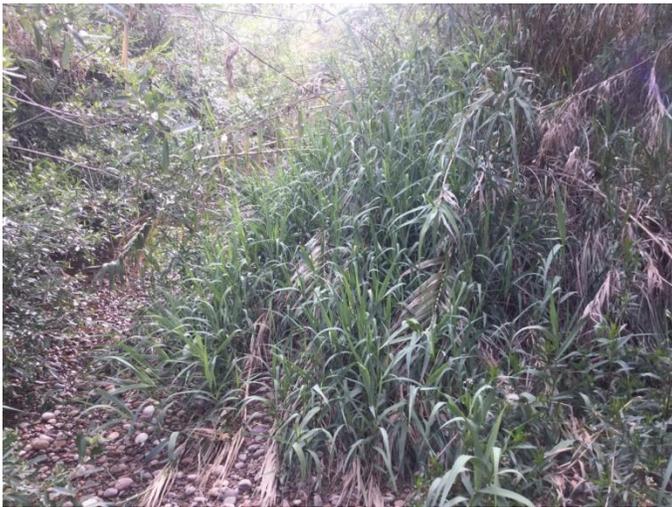
Figure 1: May 2019, looking downstream at vegetation density

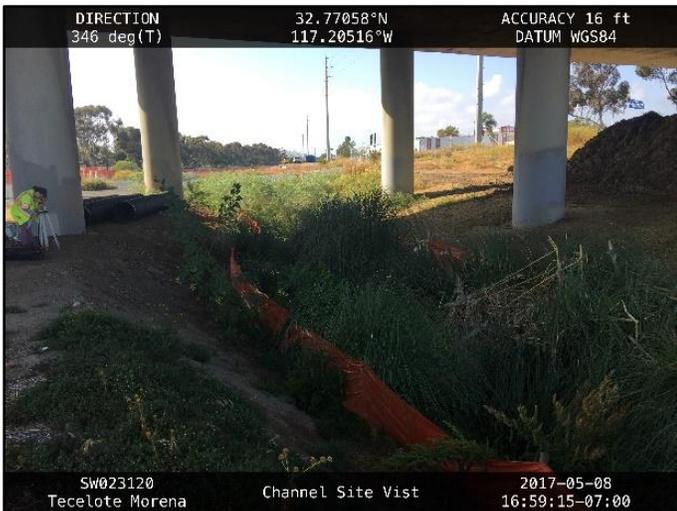
Figure 1: May 2017, looking downstream, representative of thick vegetation in the channel

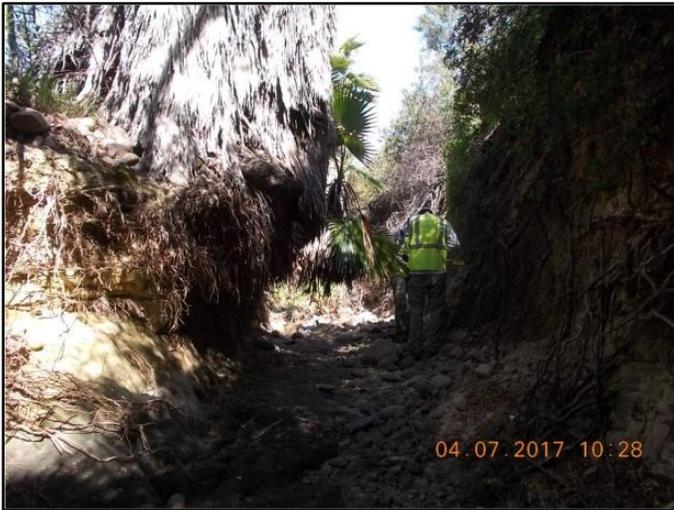
Figure 1: April 2017, looking downstream at vegetation, erosion in facility

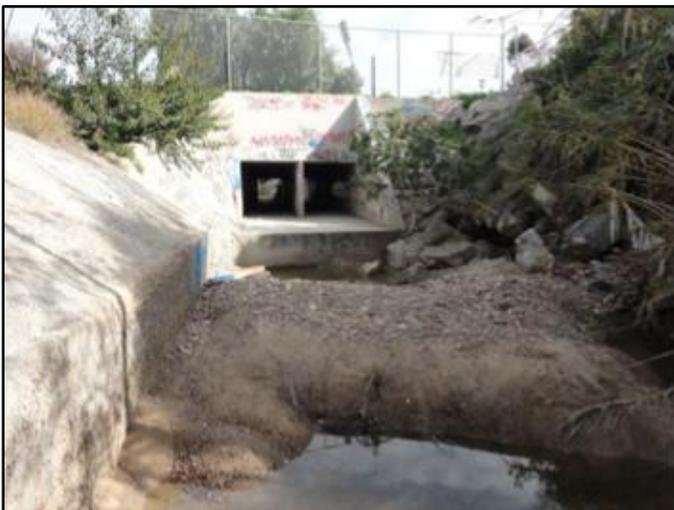
Figure 1: March 2016, looking upstream at the double 6-foot wide by 6-foot tall RCB culvert. Note the standing water and erosion at culvert outlet.

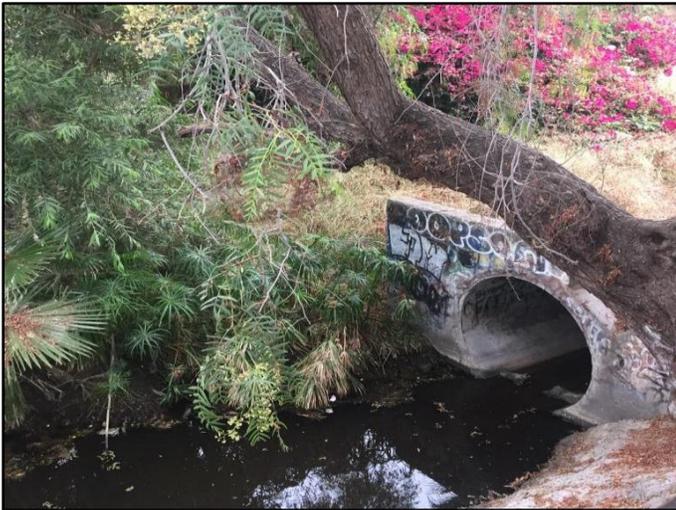
Figure 1: August 2017, looking upstream at RCP storm drain system outlet

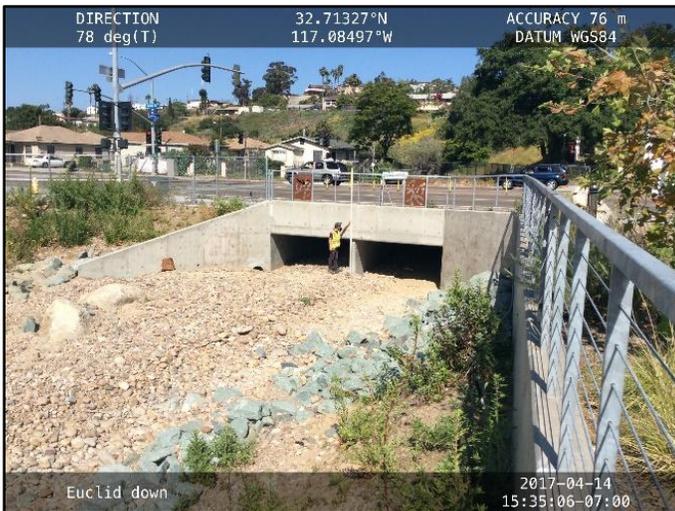
Figure 1: April 2017, representative of earthen with cobble portion of channel

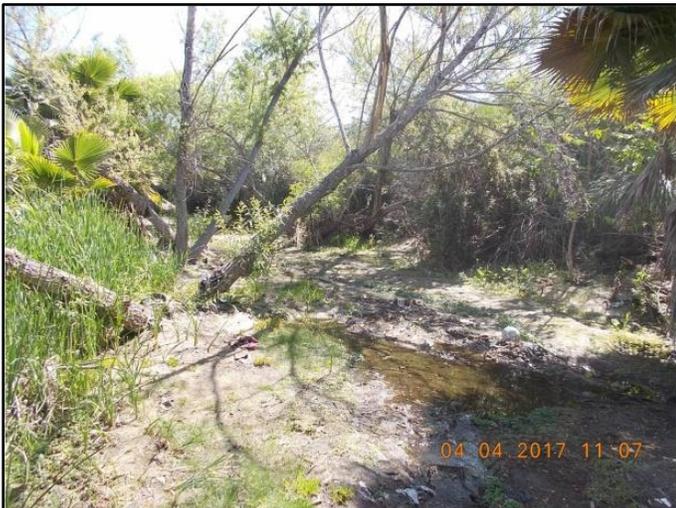
Figure 1: April 2017, looking downstream of Orange Line bridge at vegetation

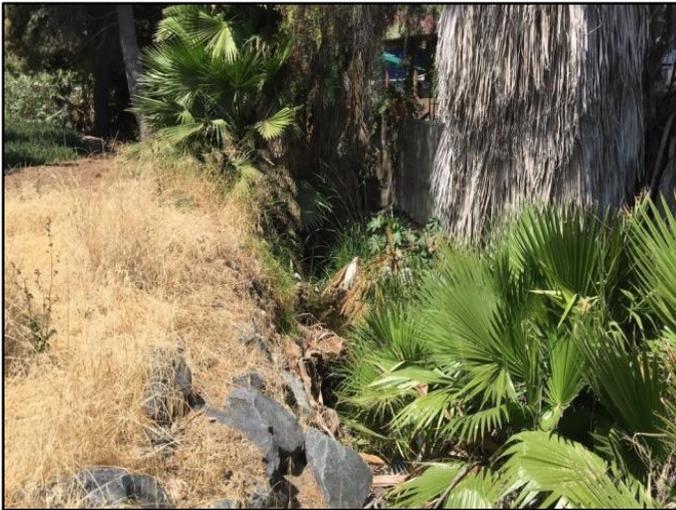
Figure 1: July 2017, downstream of Beacon Drive culvert (3-foot-diameter RCP), looking west. Riprap apron and dense vegetation present.

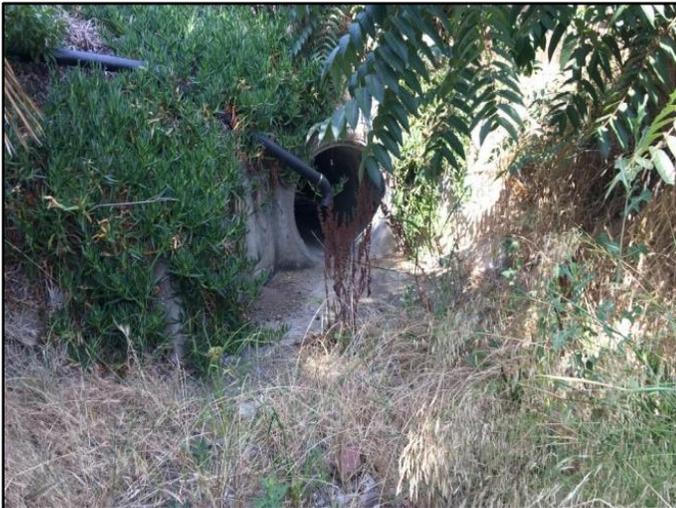
Figure 1: July 2017, looking upstream from Beacon Drive culvert (3-foot-diameter RCP)

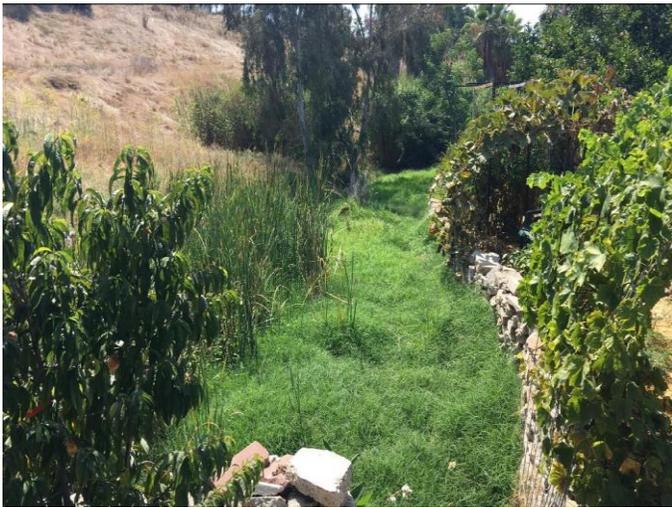
Figure 1: April 2016, looking downstream at the dense grass in channel

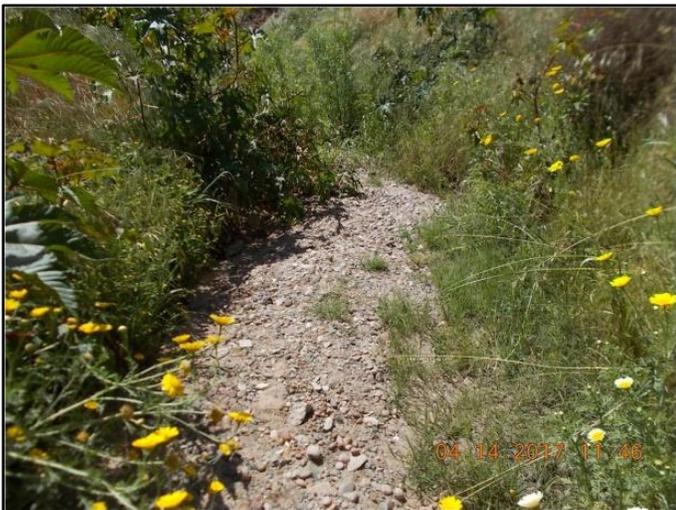
Figure 1: April 2017, looking downstream at vegetation

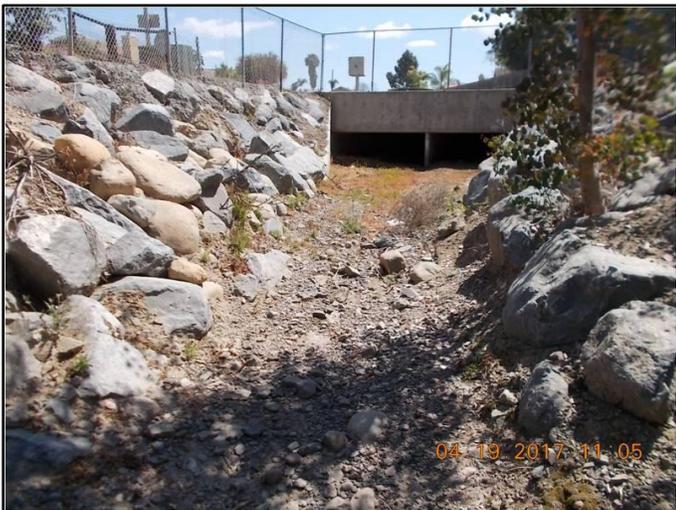
Figure 1: April 2017, looking upstream vegetation and outlet of double 10-foot by 4-foot RCB culvert
