APPENDIX A

Hydrology and Hydraulics Fact Sheets

Hydrology and Hydraulics Fact Sheet

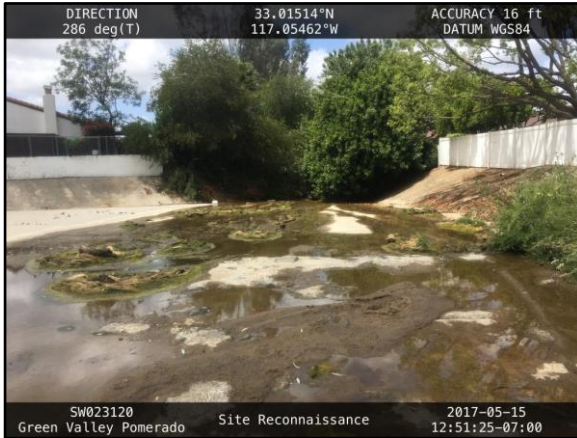
1. Pomerado 2: Looking upstream at upstream end of segment.

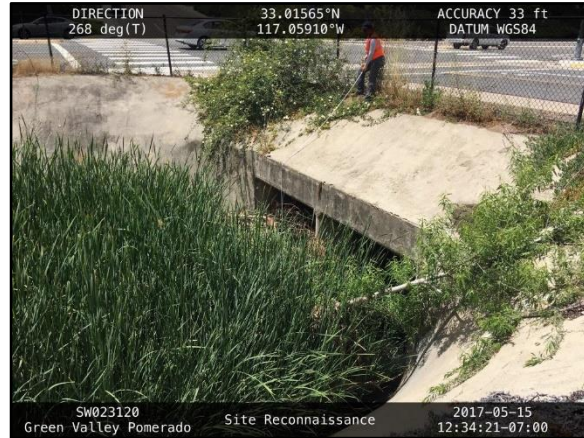
2. Pomerado 2: Looking downstream at double box culvert.

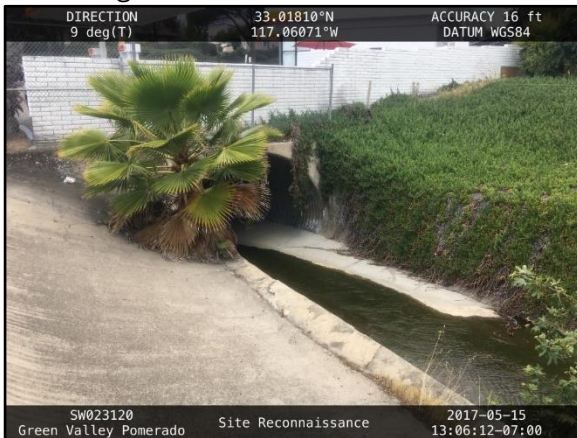
3. Pomerado 2: Looking downstream at CMP culvert at downstream end of segment.

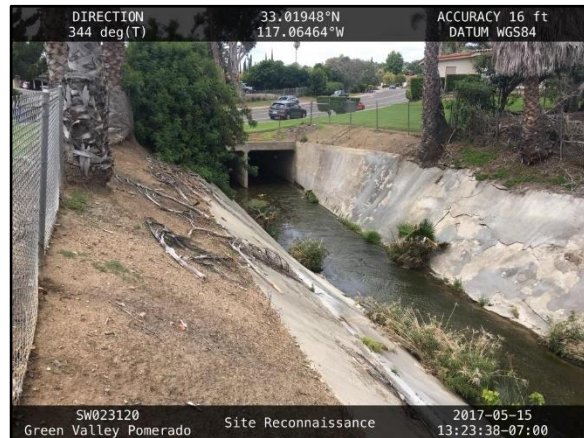
4. Pomerado 1: Looking downstream at double box culvert.

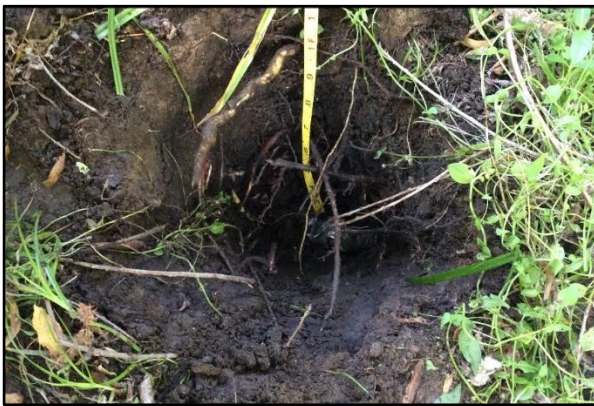
The baseline condition for the Paseo del Verano facility group was determined to be the current condition as observed during a site visit in July 2017. Heavy vegetation, tree growth, and accumulated sediment/debris were observed in the desilting basin. The sediment depth was estimated to be approximately 2 feet deep across the basin. Ponded water was not observed in the

1. Paseo del Verano 1: Sediment deposition in the basin.

The recommended maintained condition for the Paseo del Verano facility group was determined to be the as-built condition as reflected in as-built drawing no. 17603-8-D. The accumulated sediment/debris and vegetation within the basin bottom is removed, and the total basin depth is restored to 11 feet. Maintenance is recommended to reduce potential impacts to the adjacent roadway and residential properties.

When applying the 50% maintenance threshold described in Section 4.2.2 of the *Hydrology and Hydraulics Technical Report*, maintenance is necessary. Sediment deposition is approximately 2 feet deep in the baseline condition, and when compared to the overflow height of 4 feet (gabion height in front of the outlet structure), approximately 50% of the sediment storage is occupied by sediment, which meets the permanent desilting basin maintenance threshold. Therefore, vegetation and sediment/debris removal from the bottom of the basin is recommended to restore the capacity of the desilting basin. The frequency will be established based on annual inspection of the basin and outlet.

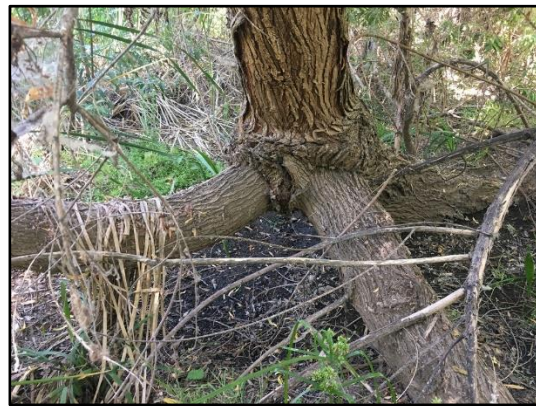
2. Paseo del Verano 1: Vegetation growth in the basin.

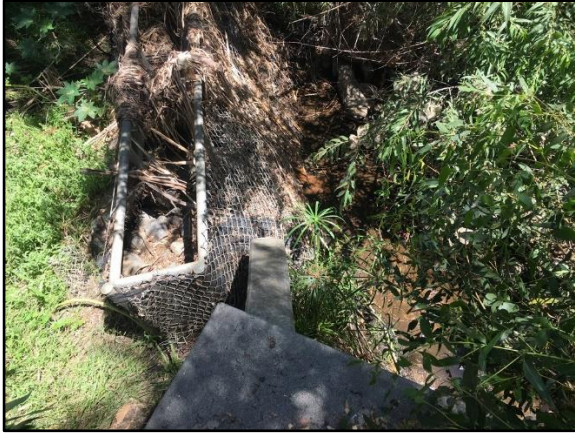
3. Paseo del Verano 1: Gabion wall structure at outlet structure.

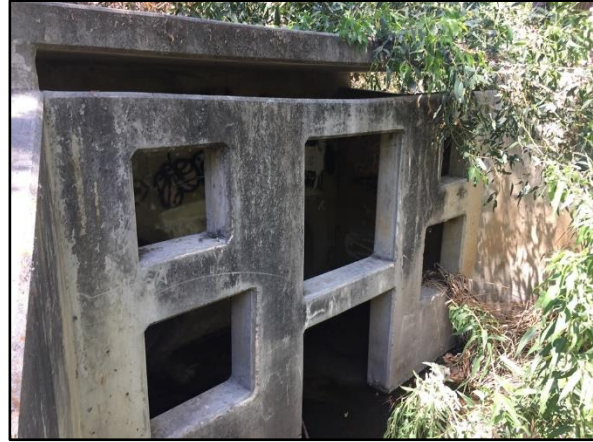
4. Paseo del Verano 1: Basin outlet structure.

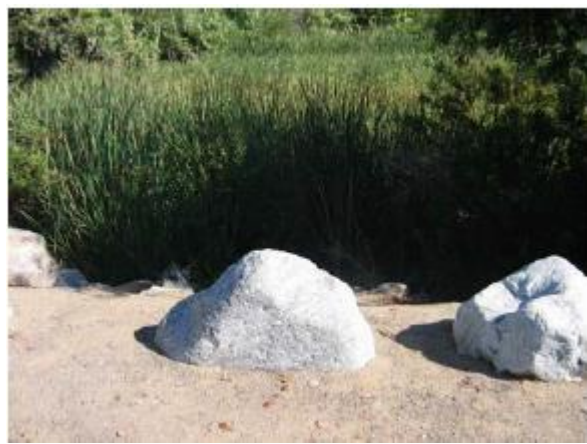
IHHA 2. Sorrento Valley 1: Looking east at vegetation.

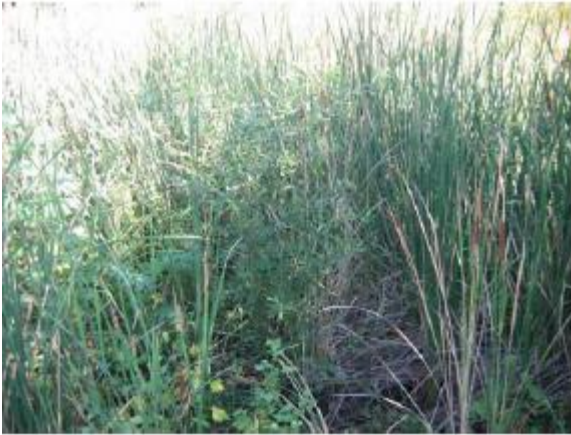
IHHA 3. Sorrento Valley 1: Looking east at vegetation.

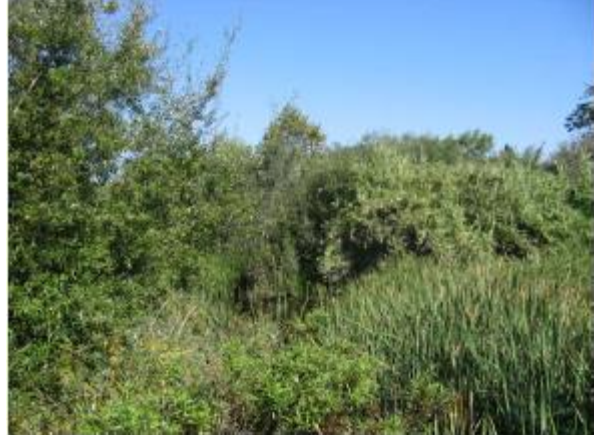
IHHA 4. Sorrento Valley 1: Looking east at vegetation.

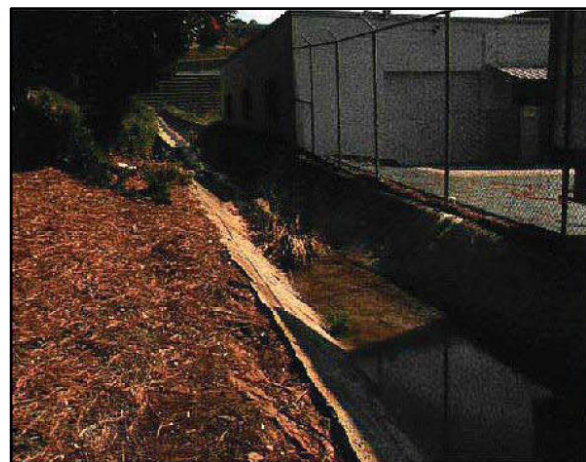
2. IHHA 4. Industrial 1, Reach 3: Looking upstream at minor vegetation and sediment within concrete segment.

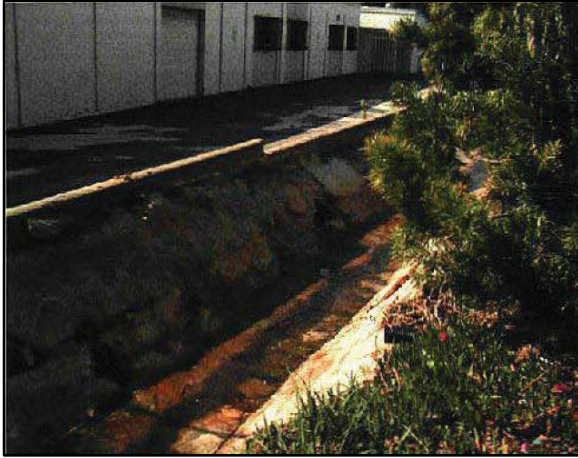
3. IHHA 5. Industrial 1, Reach 2: Looking downstream at concrete segment.

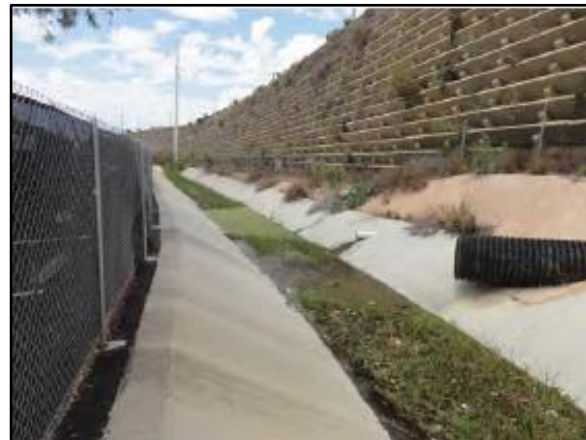
2. IHHA 3. Tripp 1, Reach 3: Looking downstream.

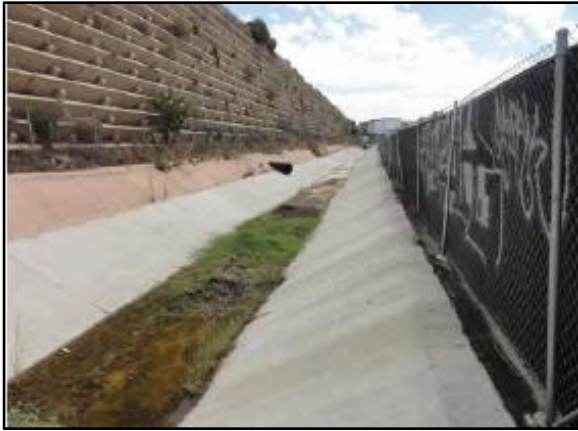
3. IHHA 4. Tripp 1, Reach 4: Looking upstream at end of reach.

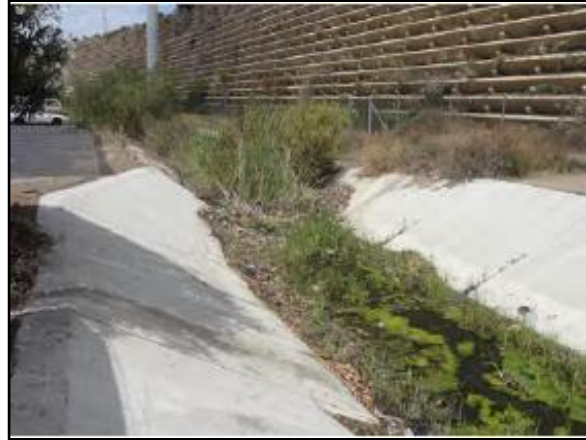
4. IHHA 7. Tripp 1, Reach 3: Looking downstream.

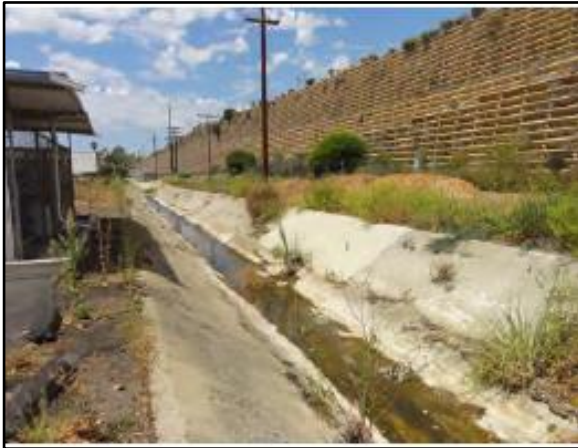
5. IHHA 9. Tripp 1, Reach 2: Looking downstream.

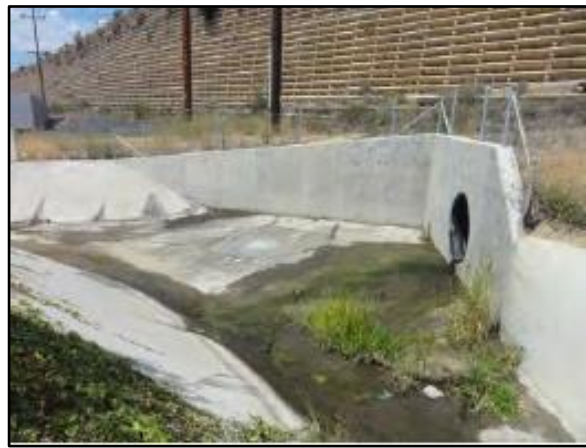
6. IHHA 10. Tripp 1, Reach 2: Looking downstream at 90-degree bend, at downstream end of reach.

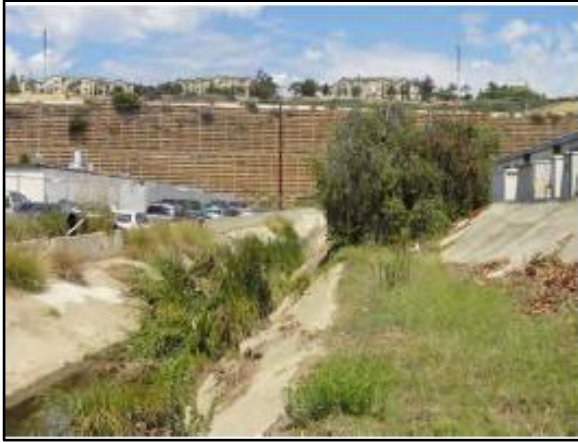
7. IHHA 14. Tripp, Reach 1: Looking upstream from double-barrel 57-inch RCP culvert entrance at downstream end of facility group.

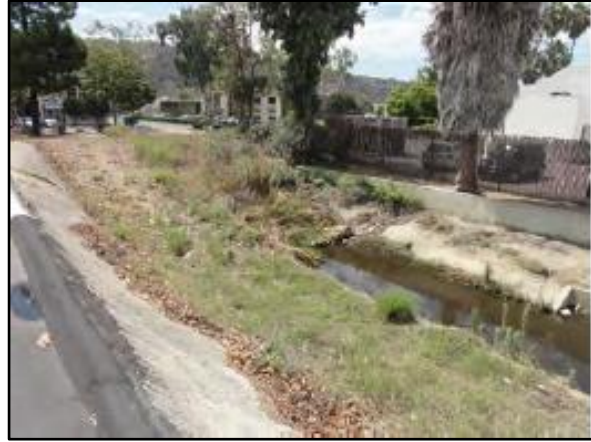
8. IHHA 15. Tripp, Reach 1: Looking downstream at double-barrel 57-inch RCP culvert entrance; downstream end of facility group.

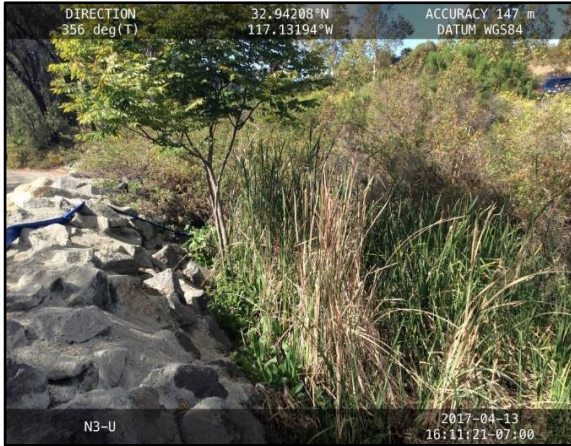
1. Black Mountain 1: Looking towards the upstream end of the segment.

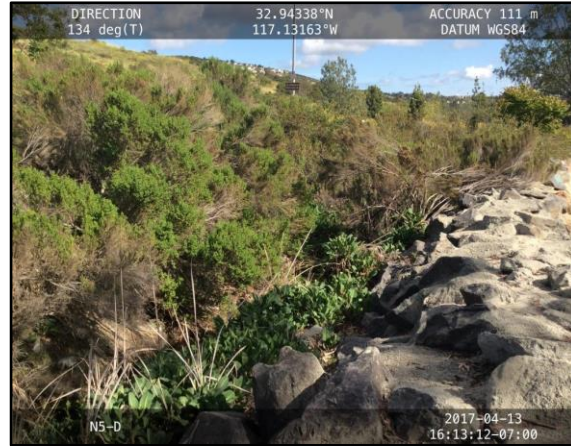
2. Black Mountain 1: Looking downstream at segment.

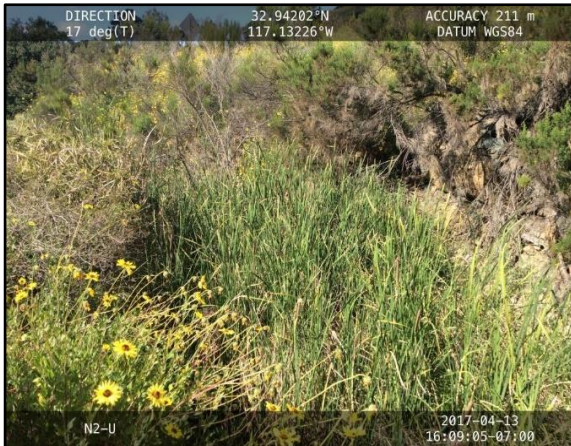
3. Black Mountain 1: Looking upstream near mid-distance along the segment length.

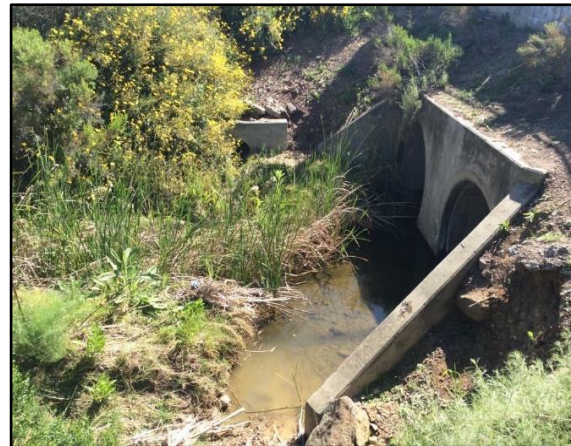
4. Black Mountain 1: Looking downstream at the double barrel 72-inch-diameter RCP culvert.

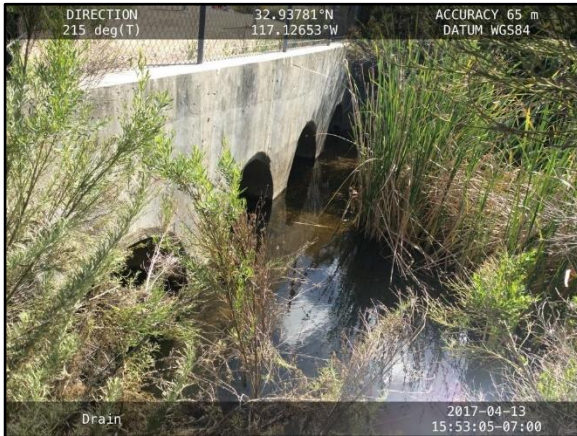
1. Black Mountain 2: Looking upstream at quadruple-barrel 72-inch-diameter RCP storm drain outlet at Mercy Road.

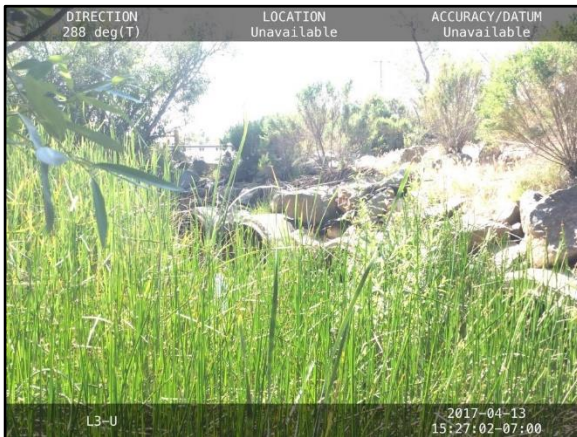
3. Black Mountain 2: Looking downstream at the seven-barrel 54-inch-diameter RCP culvert beneath the Canyonside Ranch driveway.

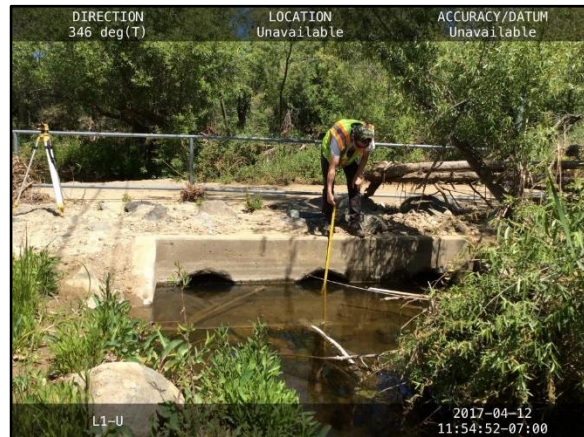
4. Black Mountain 2: Looking downstream at triple barrel 24-inch-diameter RCP beneath the Los Peñasquitos Canyon Trail.

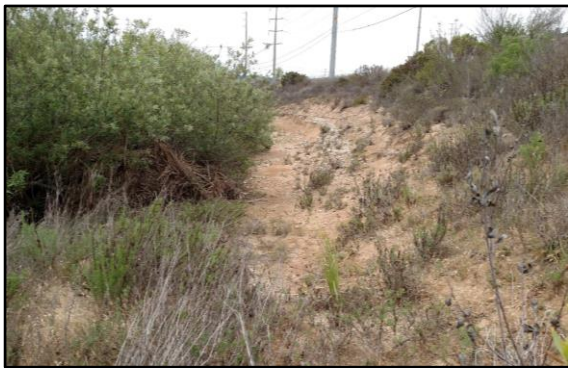
1. 5-805 Basin: Looking downstream at heavily vegetated inlet to basin from upstream end.

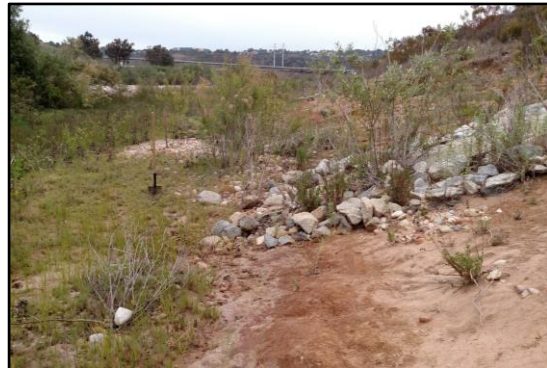
2. 5-805 Basin: Looking at downdrain outfall into basin on north side.

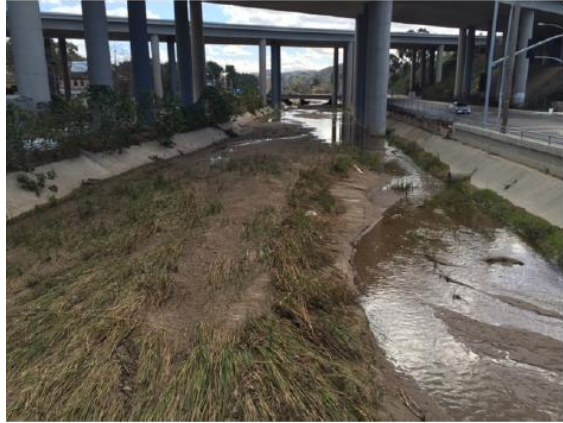
2. Roselle 2: Looking upstream from the northwest side of the I-5 overpass.

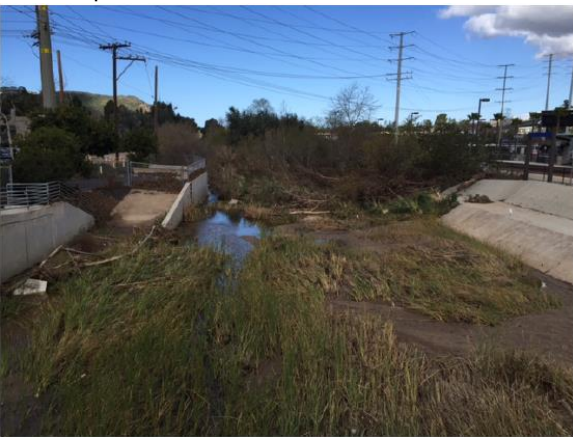
3. Roselle 2: Looking downstream at the transition area between Roselle 1 and 2.

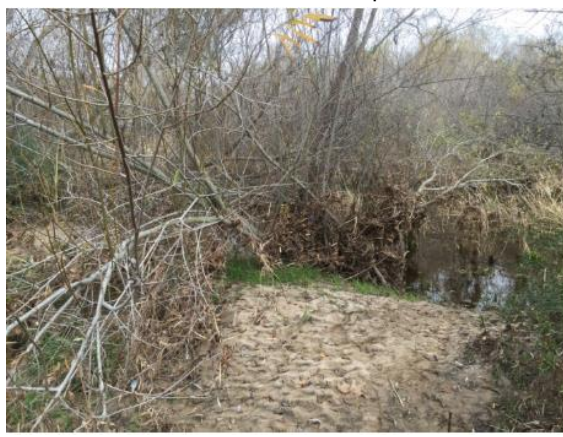
4. Roselle 1: Looking downstream at the upstream end of Roselle 1.

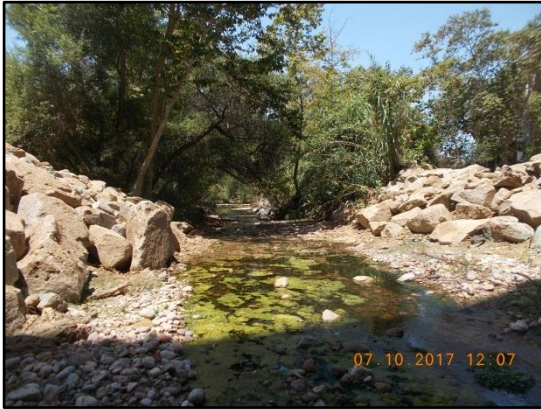
1. Upstream Domain of Analysis: Looking downstream (from the west side of I-8) at vegetation density and riprap located upstream from Reach 6.

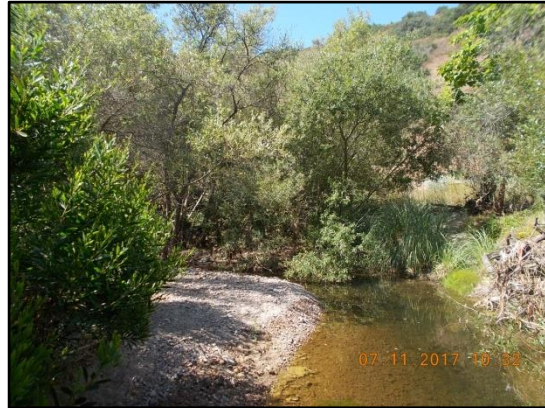
2. Sorrento Valley 1: Looking downstream at vegetation density upstream from the Reach 2/Reach 3 transition.

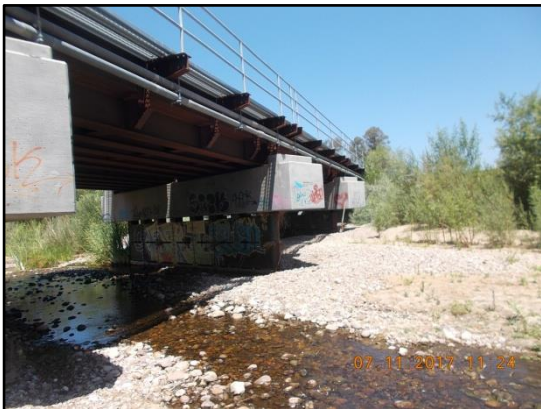
3. Sorrento Valley 1 Reach 2: Looking downstream at channel bottom near the upstream side of railroad bridge.

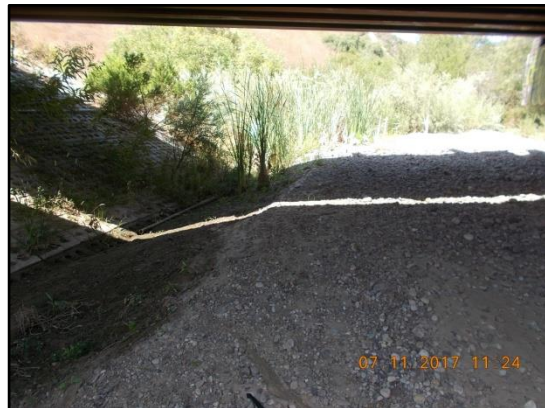
4. Sorrento Valley 1, Reach 1: Looking downstream at channel bottom under the railroad bridge and vegetation density immediately downstream.

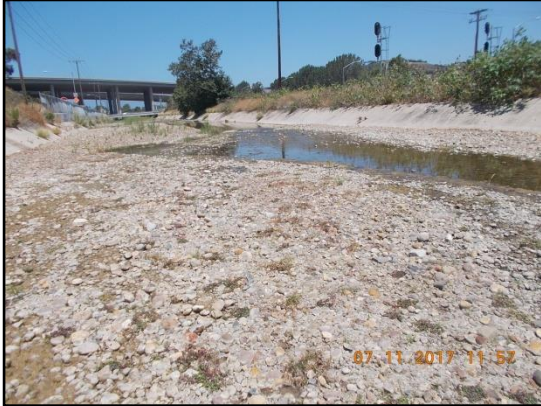
5. Downstream Domain of Analysis: Looking downstream near the upstream end of the concrete lined channel (Roselle 2).

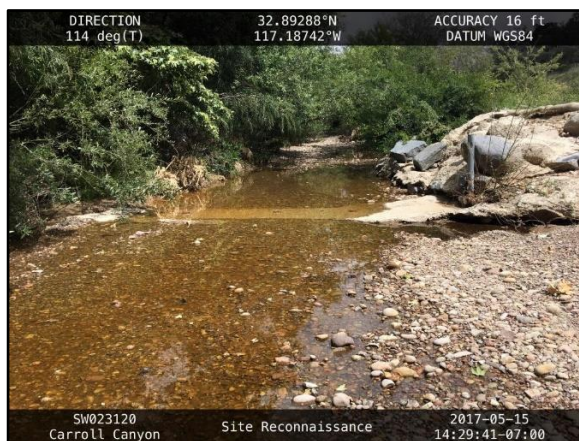
1. Carroll Canyon 1: Natural channel upstream of double 10-foot-wide by 5-foot-tall RCB culvert.

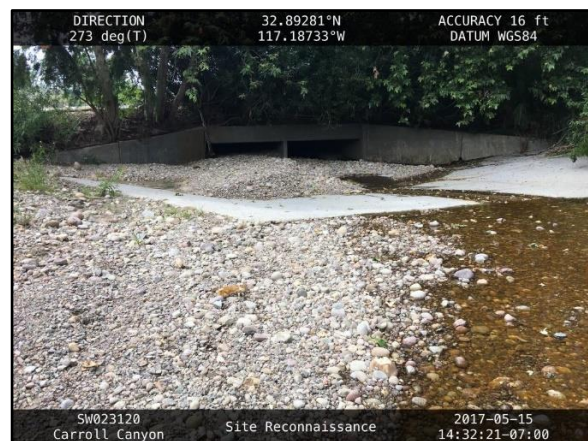
2. Carroll Canyon 1: Sediment and cobbles accumulated on concrete inlet apron upstream of the culvert.

Facility Type	Bed: Concrete, Riprap, Earthen Banks: Concrete, Riprap, Earthen	Category 2
Is Maintenance Recommended?	Yes ¹	
Extent of Maintenance	<ul style="list-style-type: none">Remove accumulated sediment/debris and overgrown vegetation from channel bottom and temporary diversion berm from Station 58² to Station 178 and from Station 497 to Station 561.Removed sediment/debris in culvert from Station 178 to Station 497.	
Benefit	<ul style="list-style-type: none">Increases level of service from >2-year storm event (400 cfs) to >5-year storm event (900 cfs).Reduces the risk of clogging the culvert from Station 497 to Station 178.

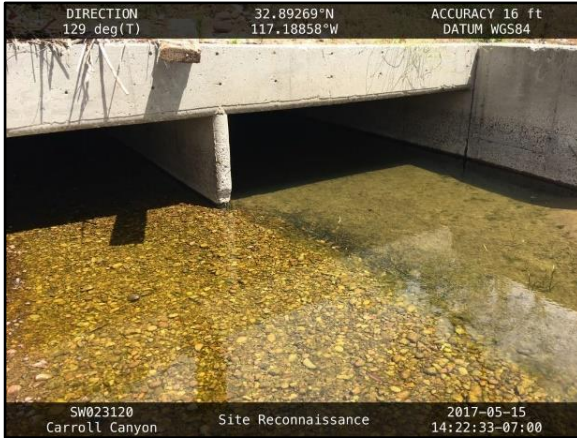
3. Carroll Canyon 1: Sediment and gravel accumulated at the culvert outlet.

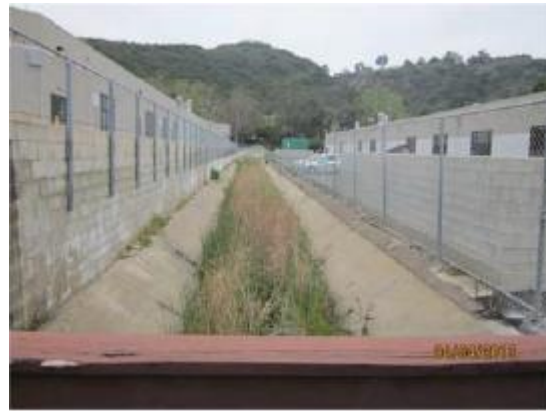
IHHA 69. Flintkote 1: Looking west from approximately 400 feet east of Flintkote Avenue.

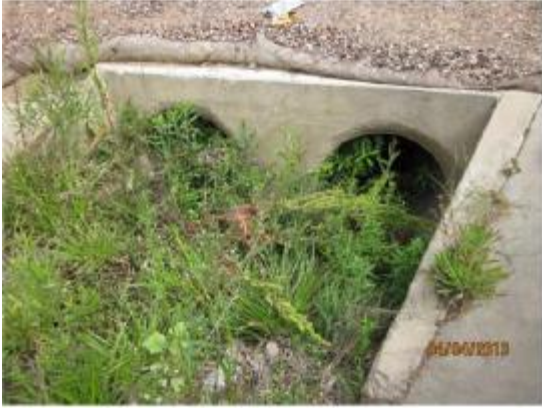
IHHA 79. Flintkote 1: Looking downstream at the double-barrel 36-inch RCP culvert entrance at downstream end of facility group.

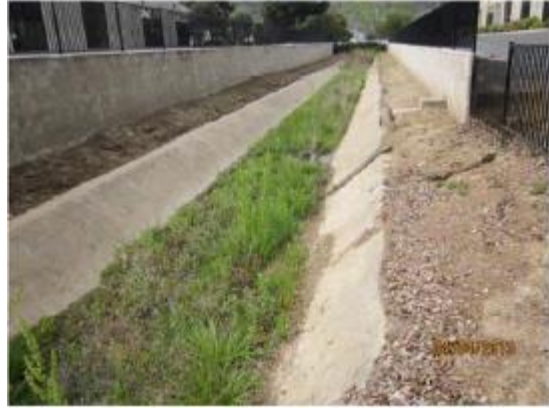
IHHA 87. Flintkote 1: Looking upstream direction from at the double-barrel 36-inch RCP culvert entrance at downstream end of facility group.

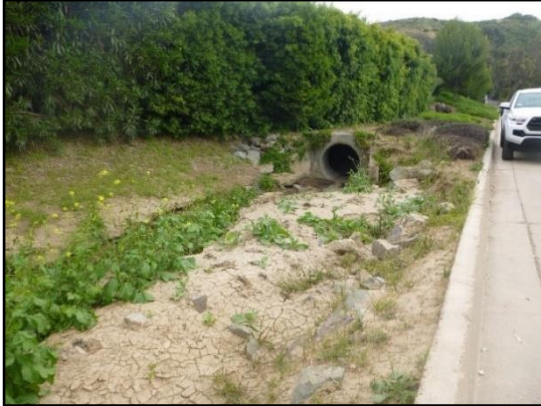
1a. Dunhill 1: Looking upstream at 42-inch-diameter RCP outfall.

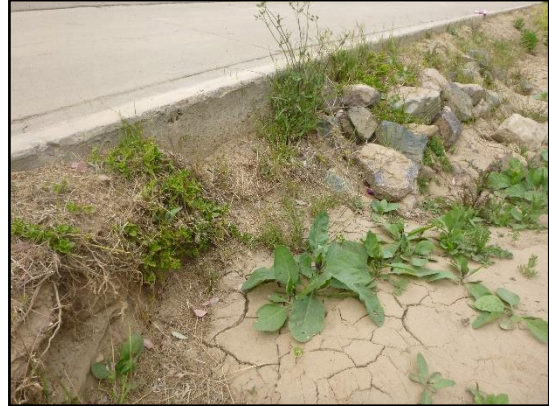
1b. Dunhill 1: Looking at bank erosion along Dunhill Street.

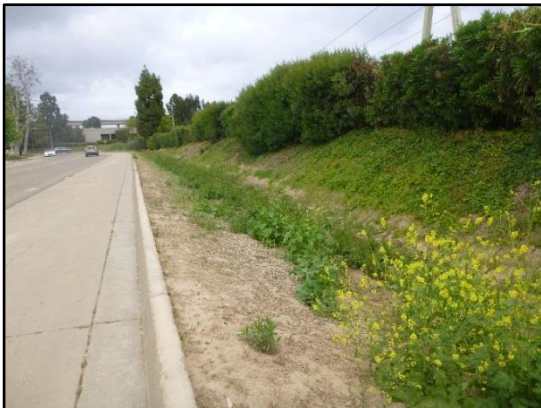
2. Dunhill 1: Looking downstream at vegetation and sediment in Dunhill segment.

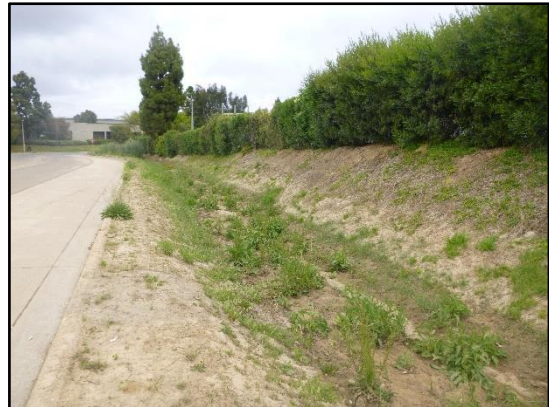
3. Dunhill 1: Looking downstream at vegetation and sediment in Dunhill segment.

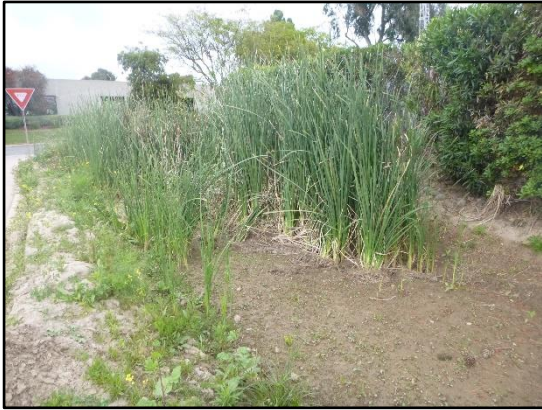
4. Dunhill 1: Looking downstream at vegetation and sediment/debris near downstream culvert inlet.

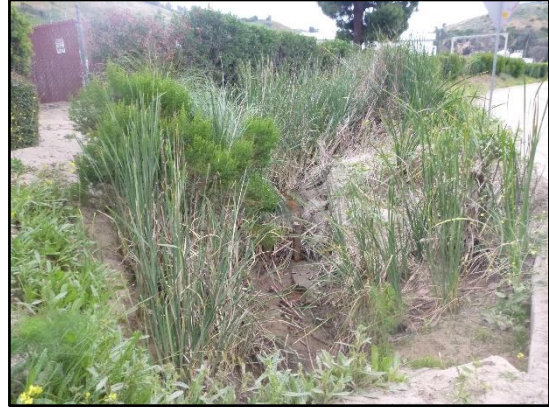
5. Dunhill 1: Looking upstream at debris fence, vegetation, and sediment/debris from downstream culvert inlet.

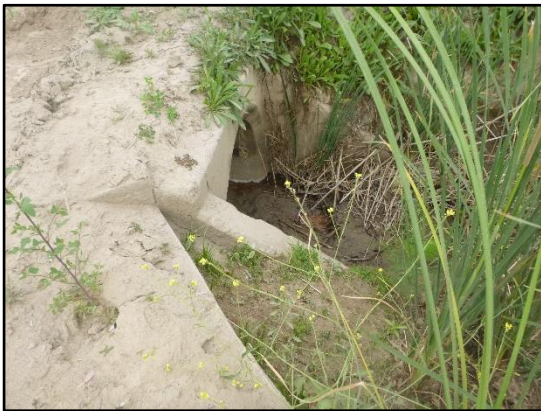
6. Dunhill 1: Looking downstream at entrance to 54-inch-diameter RCP culvert inlet.

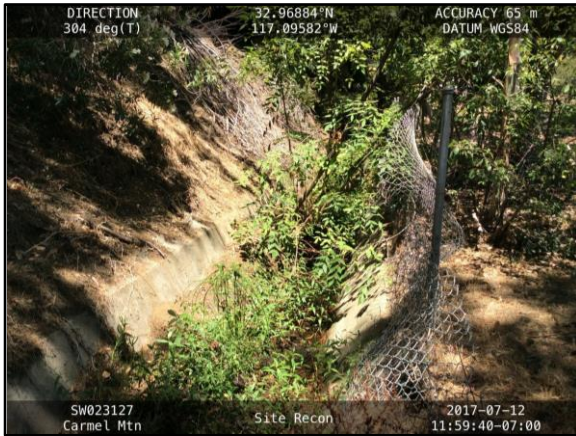
1. Via San Marco 1: Representative of segment with moderate vegetation, looking upstream.

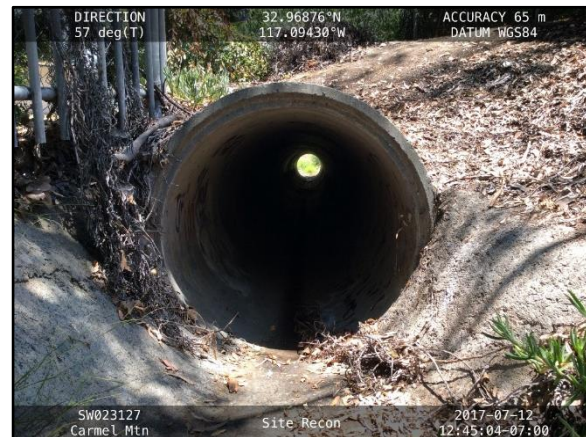
4. Via San Marco 1: Pipe culvert at downstream end of segment, looking northeast (Station 179).

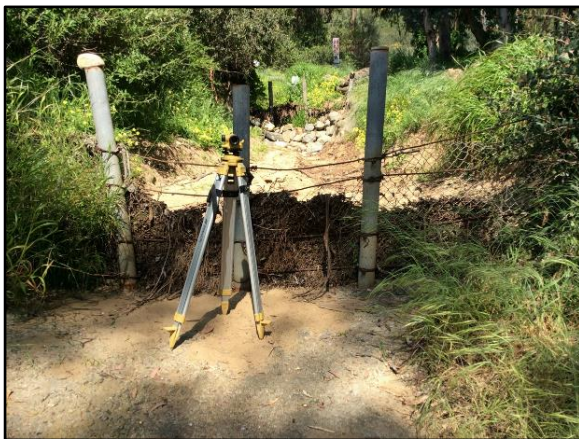
1. Torrey Pines 1: Looking upstream at check dams.

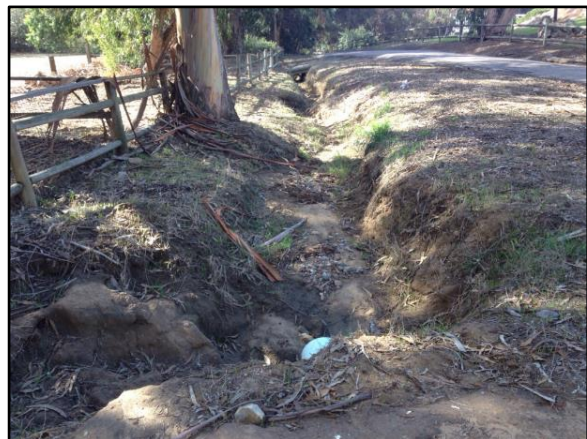
2. Torrey Pines 1: Representative of light weeds in the channel segment.

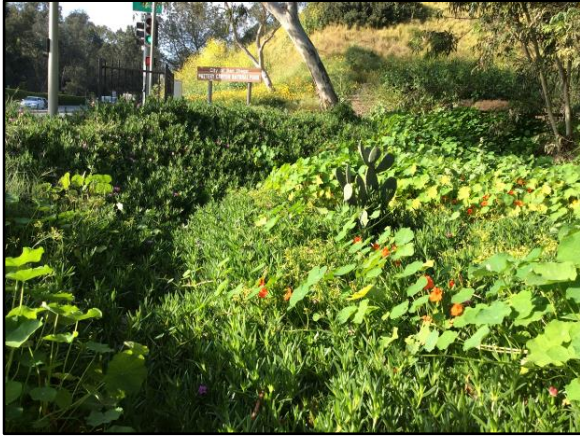
3. Torrey Pines 1: Looking upstream, representative of thick brush in the channel segment.

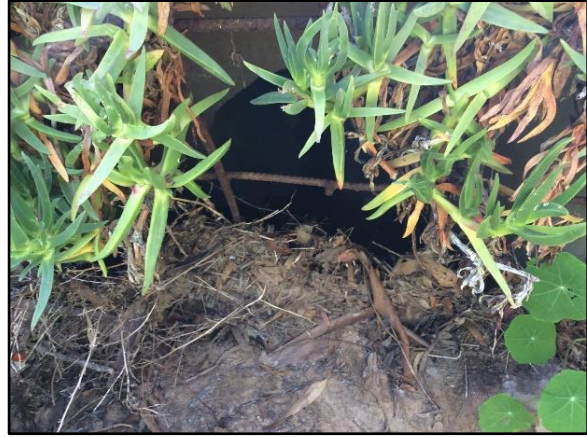
4. Torrey Pines 1: The drop inlet at the downstream end of the channel.

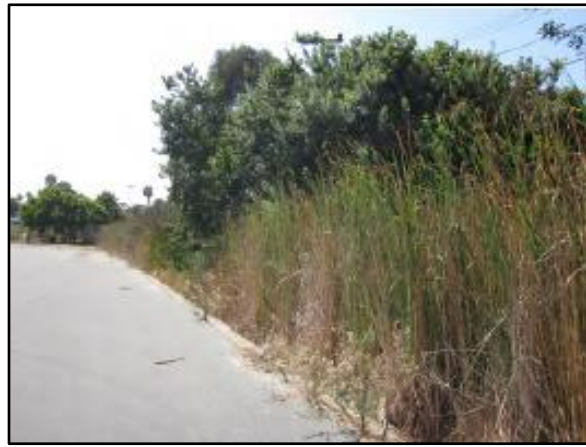
2. IHHA 30. MBHS 1: North edge of southern parking lot looking south. Existing vegetation is 8–10 feet high within the concrete channel.

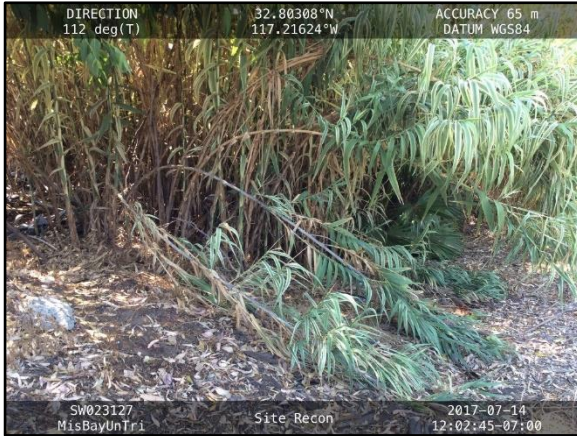
1. Mission Bay Drive 1: At upstream end of channel; culvert not visible.

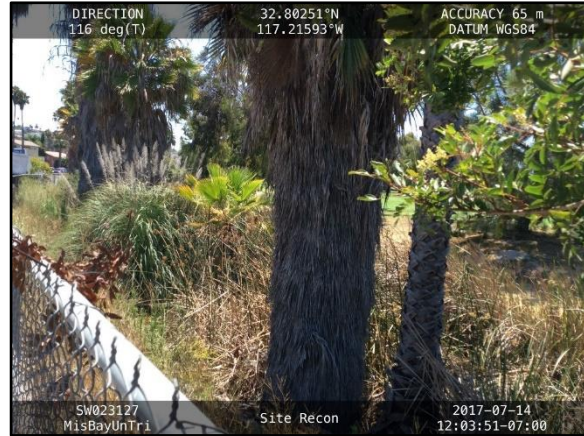
2. Mission Bay Drive 1: Representative upstream channel segment with dense vegetation.

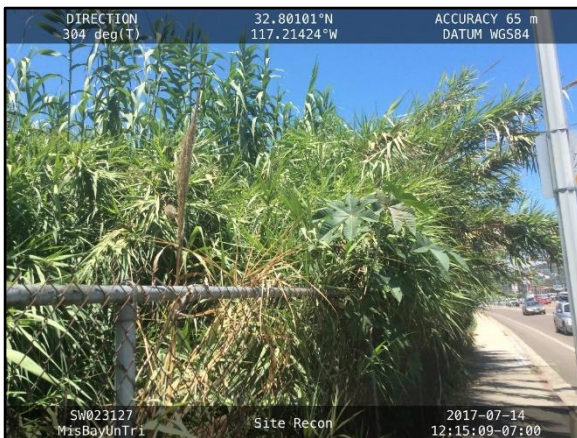
3. Mission Bay Drive 1: Representative downstream channel segment with dense vegetation.

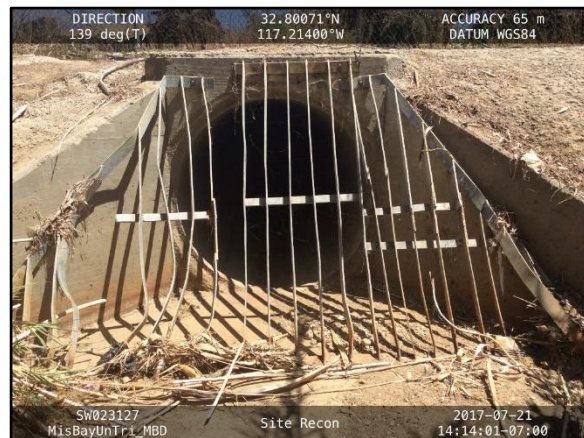
4. Mission Bay Drive 1: Recently maintained culvert inlet at downstream end of segment.

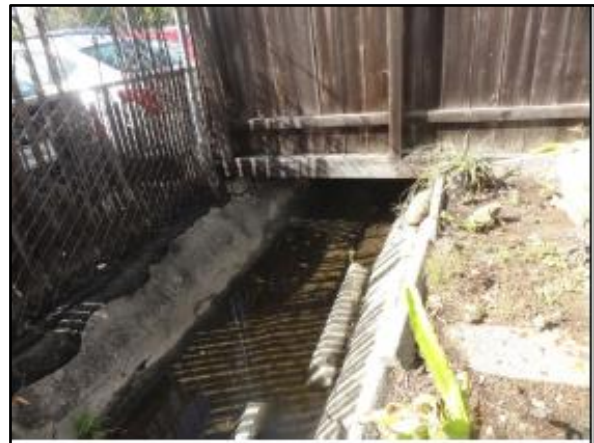
IHHA 6. Engineer 1 (Reach 2): Downstream portion of reach facing west (November 2015).

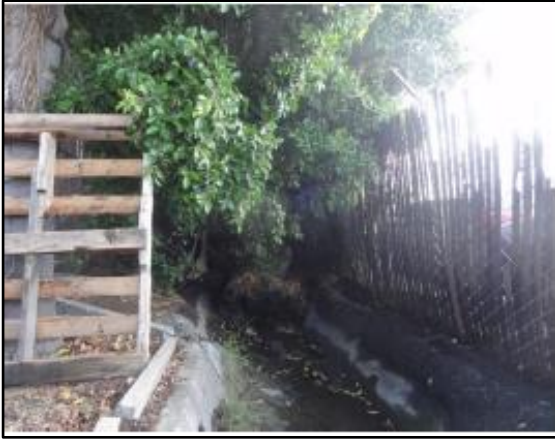
IHHA 8. Engineer 1 (Reach 2): Downstream portion of reach facing east at vegetation blocking the ditch (November 2015).

Facility Type	Bed: Concrete, Asphalt Banks: Concrete, Asphalt	Category 1
Is Maintenance Recommended?	Yes ¹	
Extent of Maintenance ²	<ul style="list-style-type: none"> Remove accumulated sediment/debris and vegetation from Station 12 to Station 1232. Remove accumulated sediment/debris and vegetation from culverts at Station 12 and Station 1232. 	
Benefit	<ul style="list-style-type: none"> Increases conveyance capacity from 15 cfs to 45 cfs; level of service remains <2-year storm event in Reach 1. Increases conveyance capacity from <10 cfs to 25 cfs; level of service remains <2-year storm event in Reach 2. Increases conveyance capacity from <10 cfs to 40 cfs; level of service remains <2-year storm event in Reach 3. Decreases water surface elevations, reducing the limits and frequency of flooding.

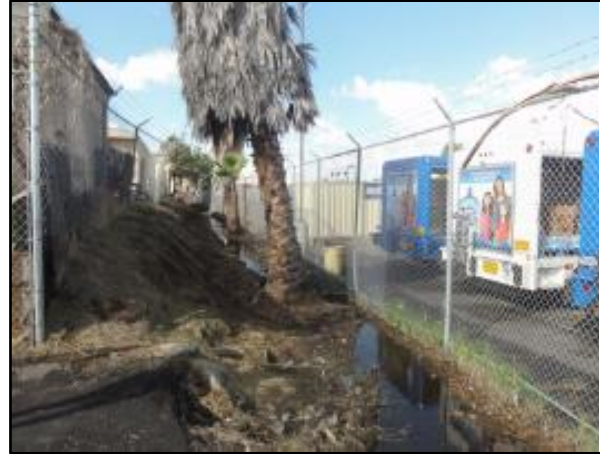
IHHA 15. Engineer 1 (Reach 2): Upstream portion of reach facing west, showing sediment and vegetation in ditch (November 2015).

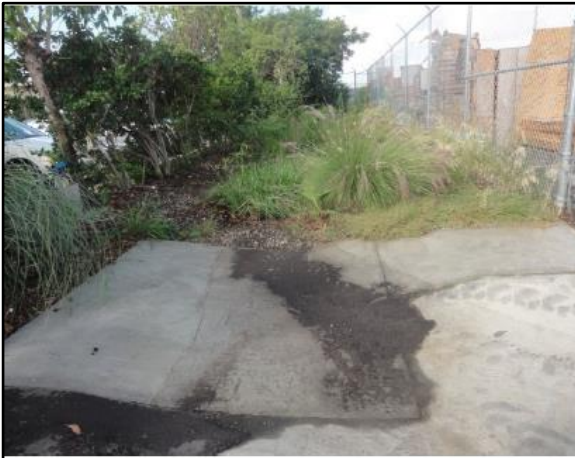
IHHA 20. Engineer 1 (Reach 3): Upstream end of facility group facing west.

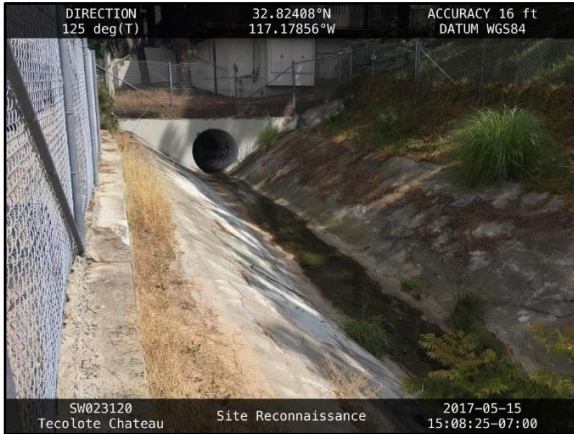
1. Chateau 1: Downstream of 72-inch-diameter CMP culvert beneath Chateau Drive at Paola Way.

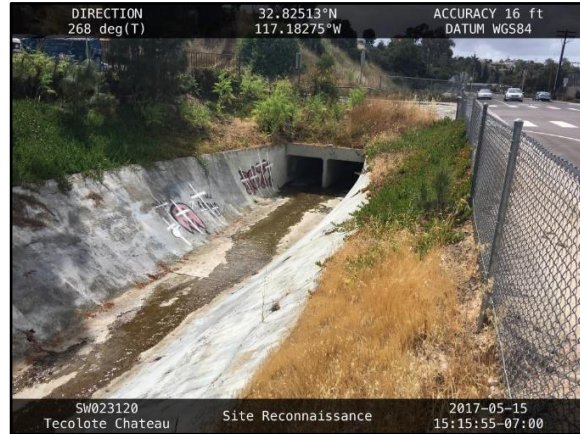
2. Chateau 1: Upstream of double 5-foot-wide by 4-foot-high RCB culvert beneath Derrick Drive.

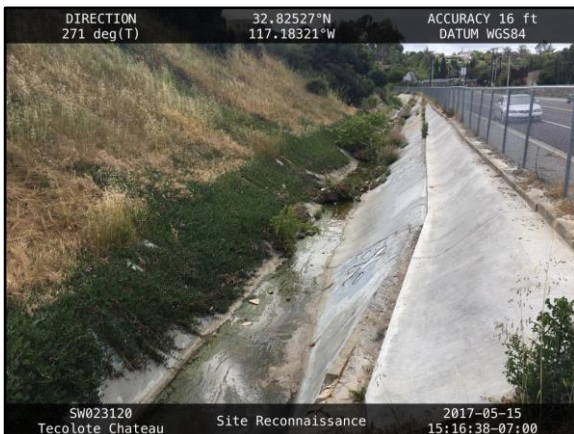
3. Chateau 1: Looking upstream from 10-foot-wide by 4-foot-high RCB culvert at Verley Court.

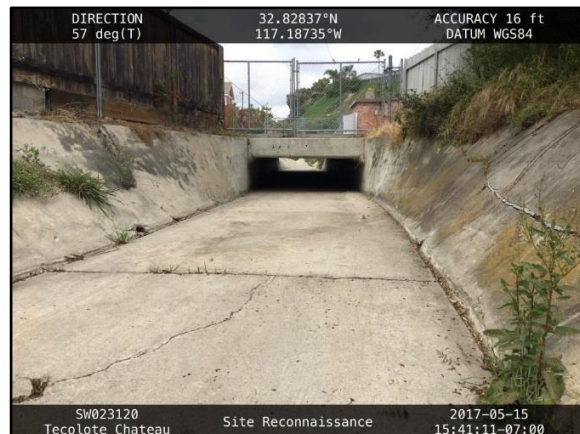
4. Chateau 2: Downstream of 10-foot-wide by 3-foot-high RCB culvert beneath Chateau Drive.

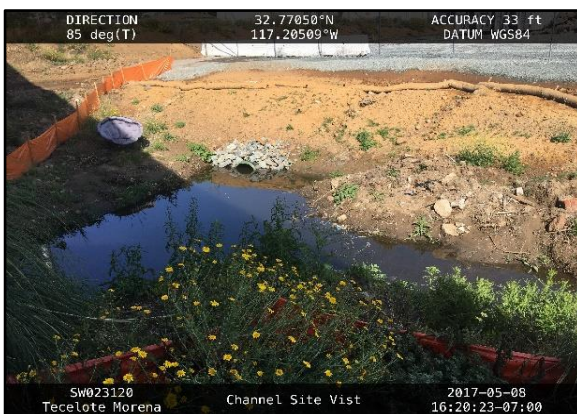
1. Morena 1: Looking upstream, culvert at upstream end of channel.

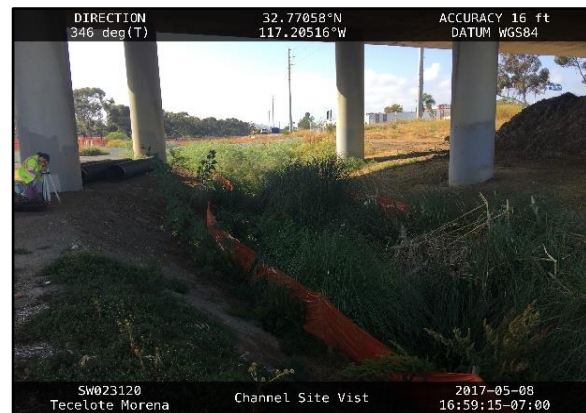
2. Morena 1: Looking downstream, representative of thick vegetation in the channel.

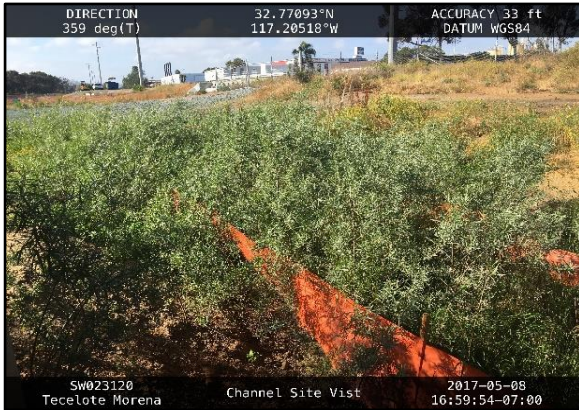
3. Morena 1: Looking downstream, culvert inlet at downstream end of channel covered in vegetation.

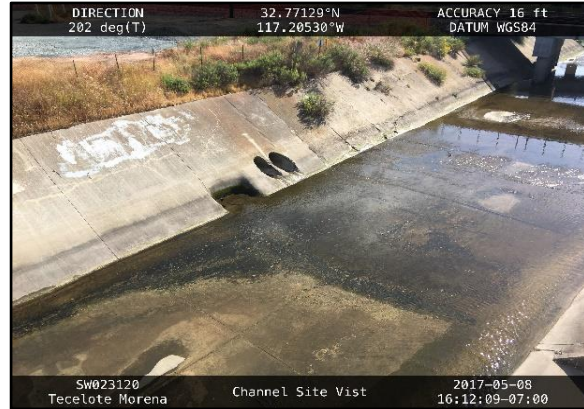
4. Morena 1: Downstream domain of analysis: Outfall into Tecolote Creek.

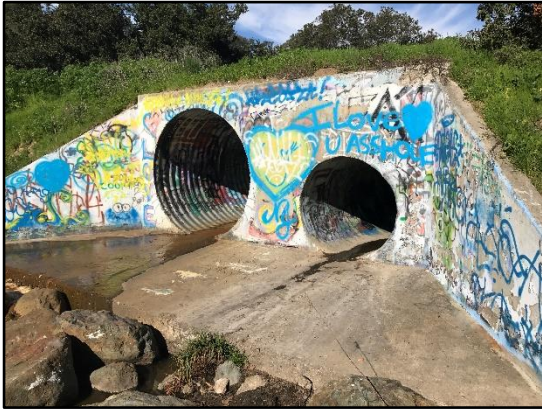
1. Genesee1: Looking upstream at dual 84-inch-diameter and 54-inch-diameter CMP culvert outlet.

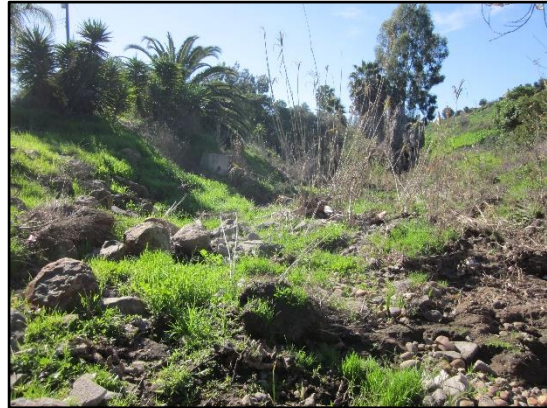
2. Genesee 1: Looking downstream at vegetation and sediment/debris.

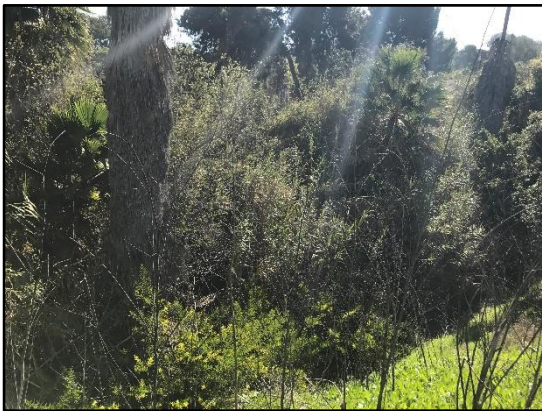
3. Genesee 1: Looking from the western bank (Genesee Avenue) at vegetation.

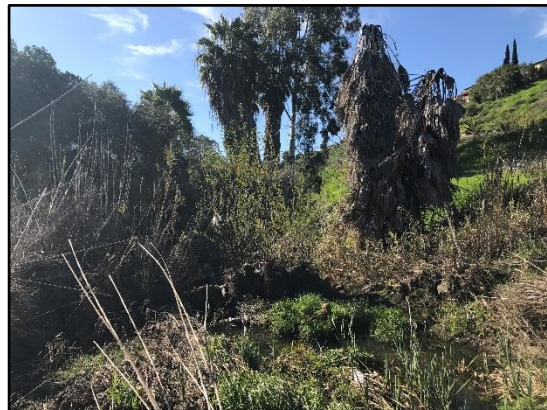
4. Genesee 1: Looking downstream at vegetation and sediment/debris.

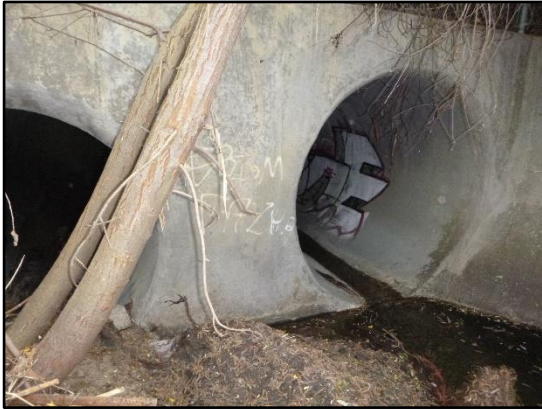
5. Genesee 1: Looking downstream at dual 84-inch-diameter and 72-inch-diameter RCP culvert inlet.

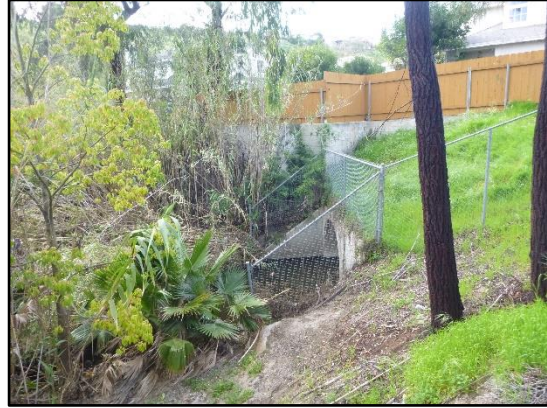
6. Downstream Domain of Analysis: Looking from east bank towards the culvert outlet.

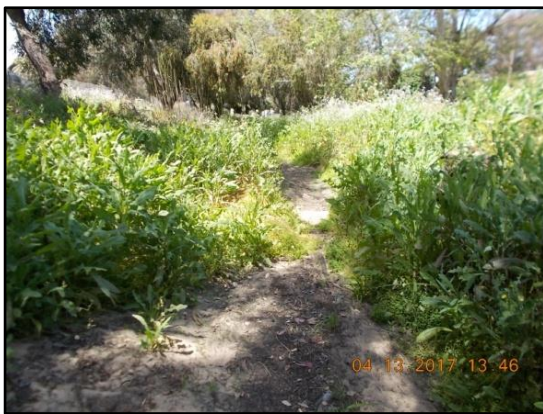
1. Nimitz 3: Looking downstream near upstream end of facility.

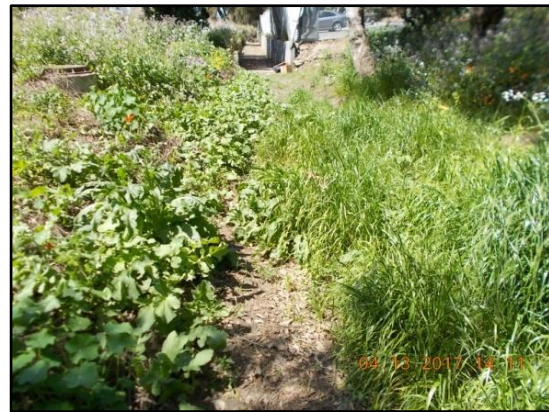
2. Nimitz 3: Looking downstream at vegetation, upstream of transition to Nimitz 2.

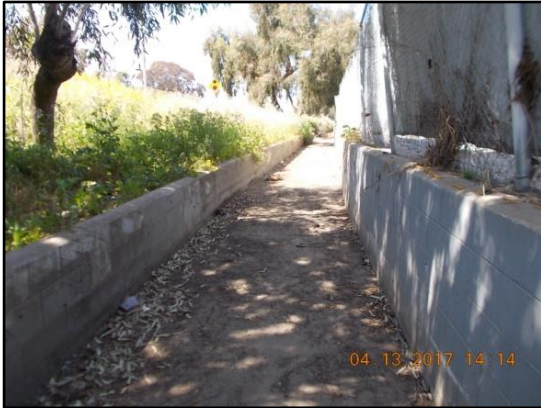
3. Nimitz 2: Looking downstream at debris/sediment at upstream end of concrete ditch.

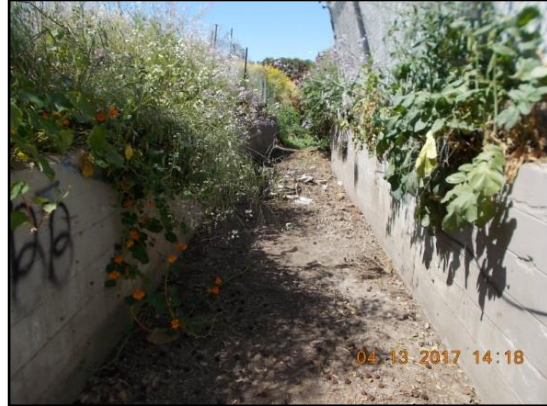
4. Nimitz 2: Looking downstream at sediment/debris near end of concrete ditch.
