APPENDIX A

Hydrology and Hydraulics Fact Sheets

Hydrology and Hydraulics Fact Sheet

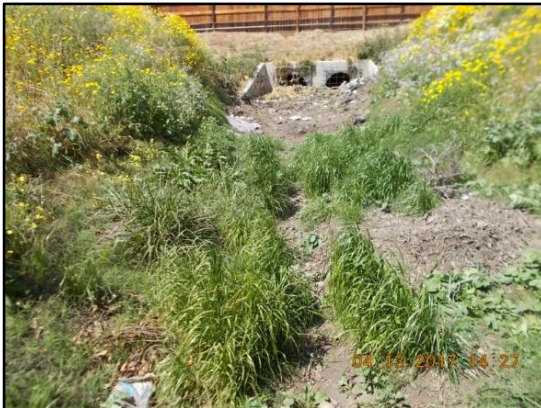
5. Nimitz 1: Looking downstream at sediment/debris in segment and at entrance to dual 54-inch diameter RCP culvert inlet.

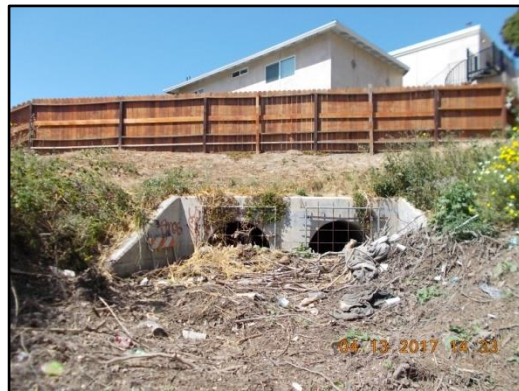
6. Nimitz 1: Looking downstream at dual 54-inch diameter RCP culvert inlet.

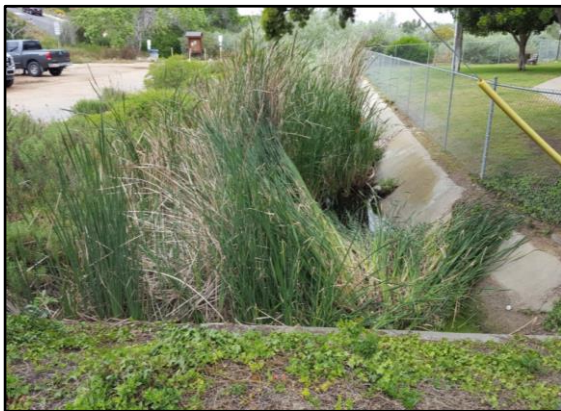
1. Valeta 1: Looking downstream over headwall and 48-inch-diameter and 30-inch-diameter RCP culvert outlet.

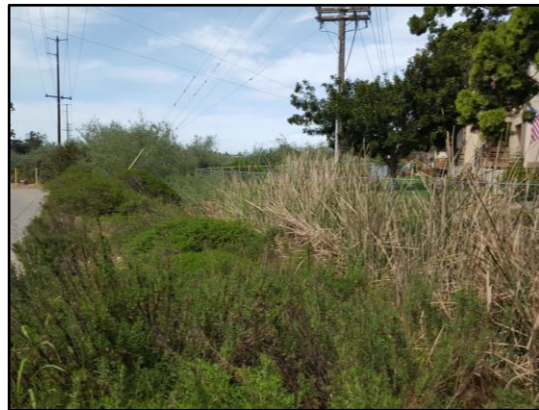
2. Valeta 1: Looking downstream at vegetation in the ditch from the parking lot to the west of the facility.

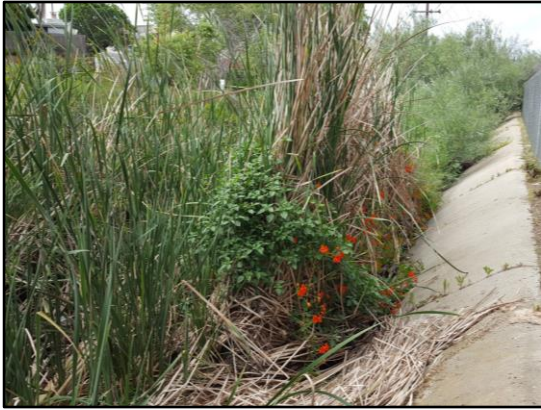
3. Valeta 1: Looking downstream at vegetation in concrete ditch.

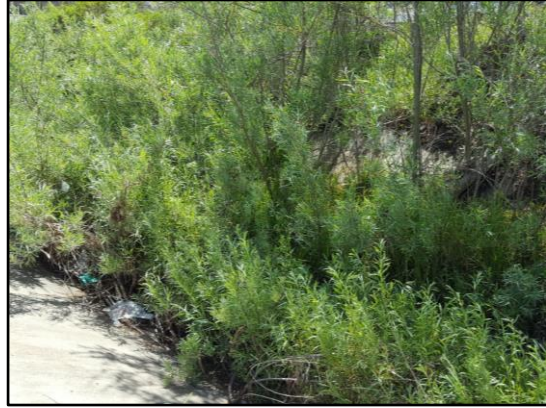
4. Valeta 1: Looking downstream at vegetation.

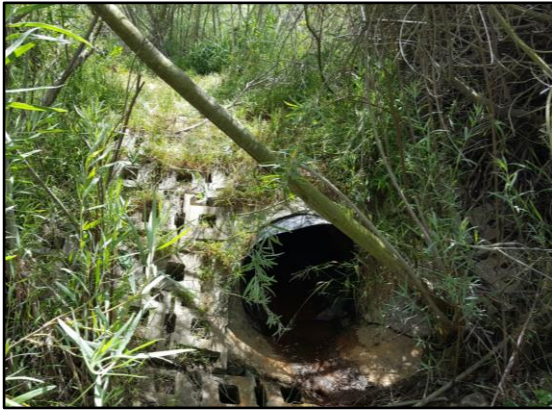
5. Downstream Domain of Analysis: Looking upstream at 24-inch-diameter PVC culvert through pedestrian trail.

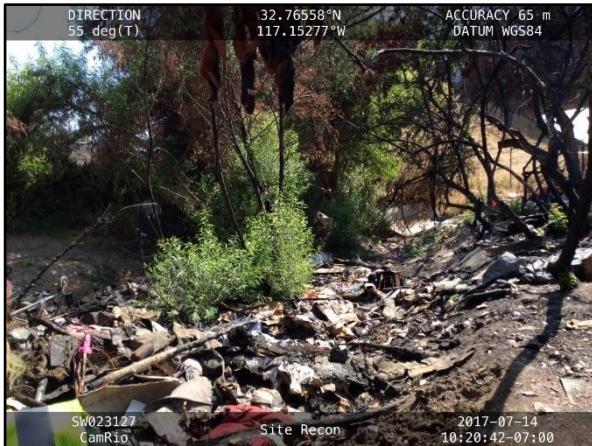
1. Camino del Rio 1: Looking upstream towards the 6.5-foot-wide by 6-foot-high RCB inlet of the Camino del Rio segment.

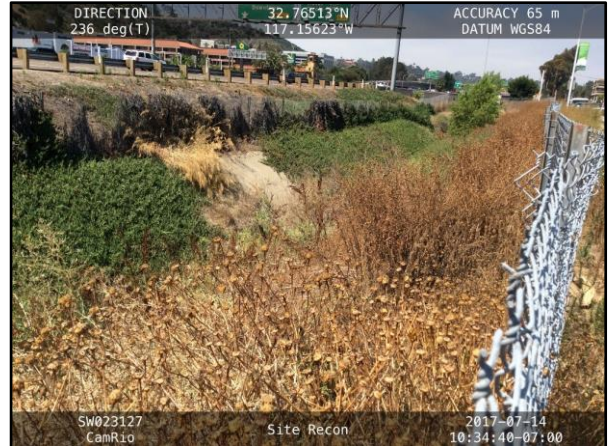
2. Camino del Rio 1: Representative of Camino del Rio segment, looking downstream.

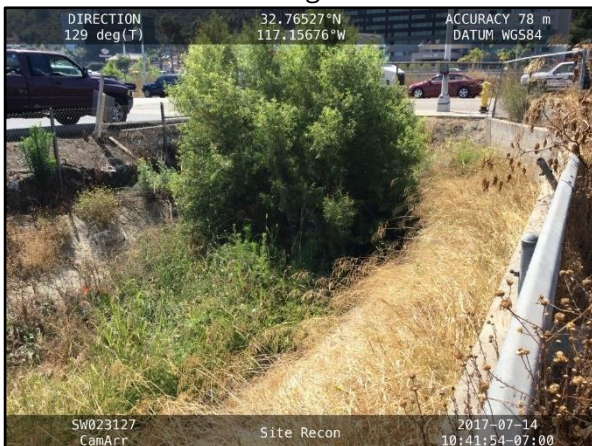
3. Camino del Arroyo 1: Looking upstream towards the 9-foot-wide by 6-foot-high RCB inlet of the Camino del Arroyo segment.

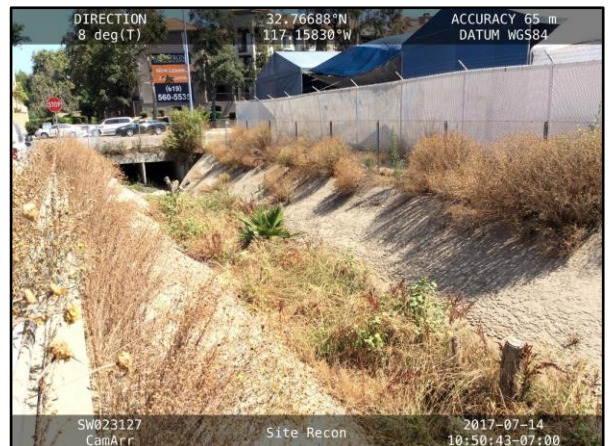
4. Camino del Arroyo 1: Representative of Camino del Arroyo segment, looking downstream.

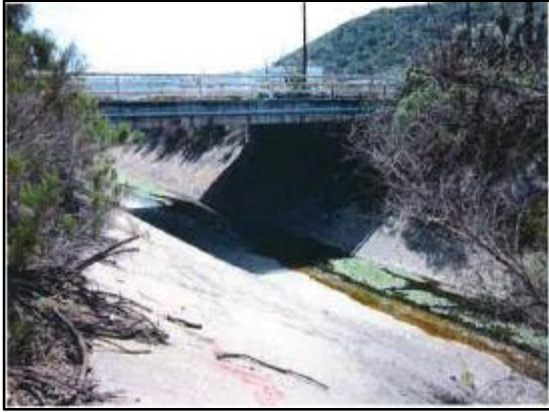
IHHA 20. Murphy Canyon 1, Map 1: Looking downstream towards access road bridge near the upstream limit of concrete channel lining (March 2013).

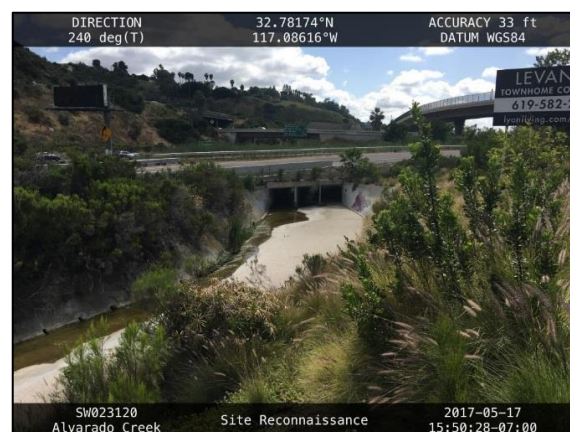
2. Mission Gorge 4, Map 1: Looking downstream at the triple 9-foot-wide by 8-foot- wide.

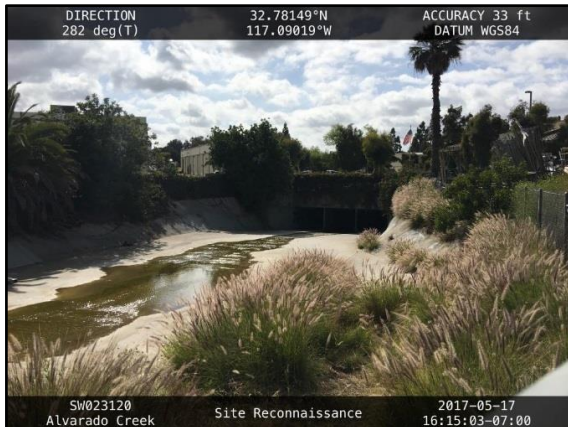
3. Mission Gorge 3, Map 1: Looking at downstream end of segment, towards the triple 11-foot-wide by 8-foot-high RCB culvert beneath Mission Gorge Place.

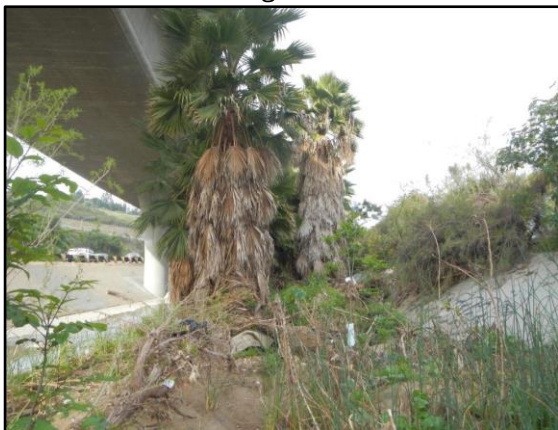
5. Mission Gorge 3, Map 1 (March 2019), Looking downstream adjacent to the overpass. Sediment accumulation, palms, and vegetation evident on right half of channel, left half (lined) is mostly clear).

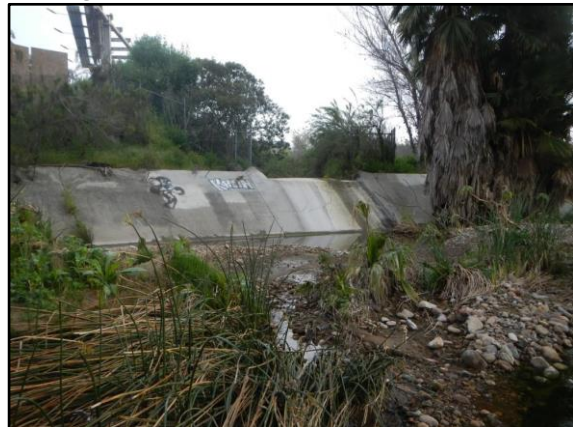
4. Mission Gorge 3, Map 1 (March 2019), Looking north at scour hole at outlet of tributary channel.

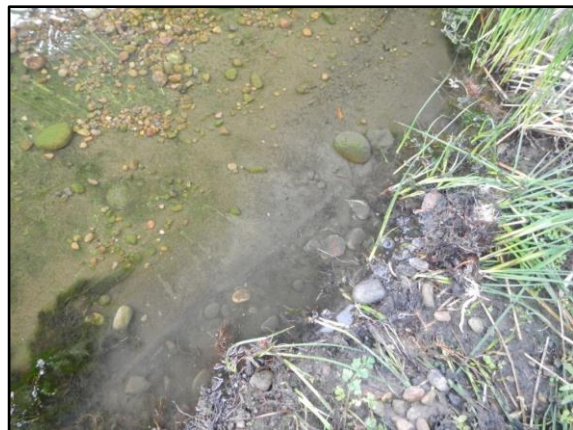
6. Mission Gorge 3, Map 1 (March 2019), Looking at channel bottom centerline where the concrete lining ends and the earthen bottom half width begins.

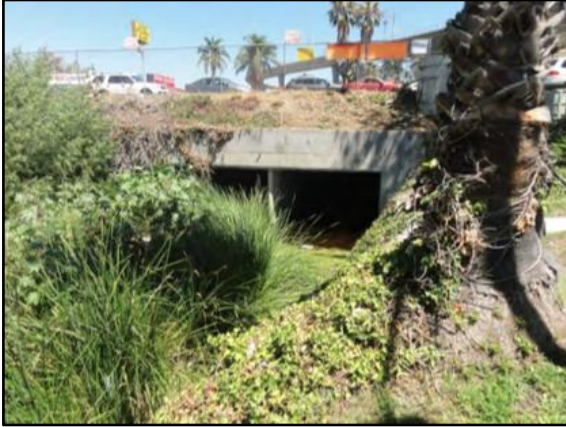
IHHA 3. Mission Gorge 1, Map 2: Looking upstream at the triple 8-foot-wide by 12-foot-tall RCB culvert beneath Fairmount Avenue.

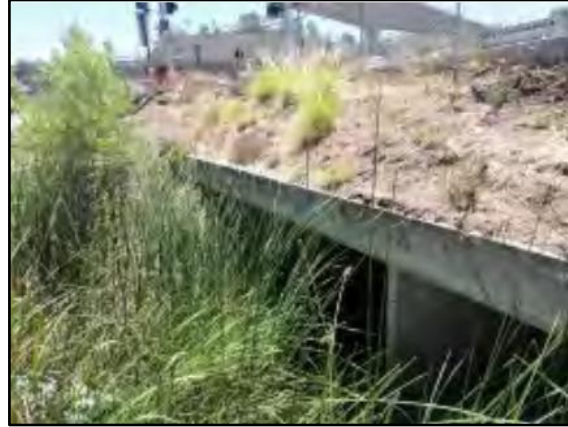
IHHA 5. Mission Gorge 1, Map 2: Looking at downstream end towards the triple 8-foot-wide by 12-foot-tall RCB culvert beneath Fairmount Avenue.

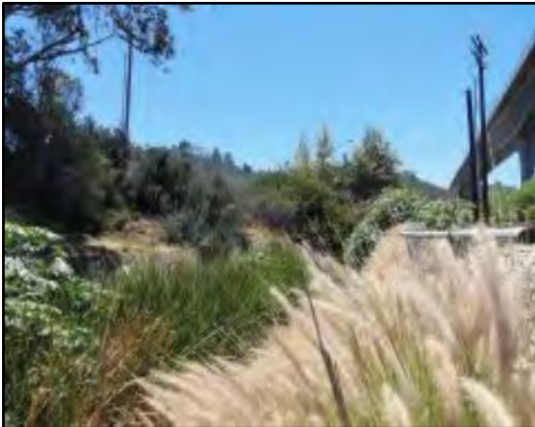
IHHA 6. Mission Gorge 1, Map 2: Looking downstream from upstream end of the segment.

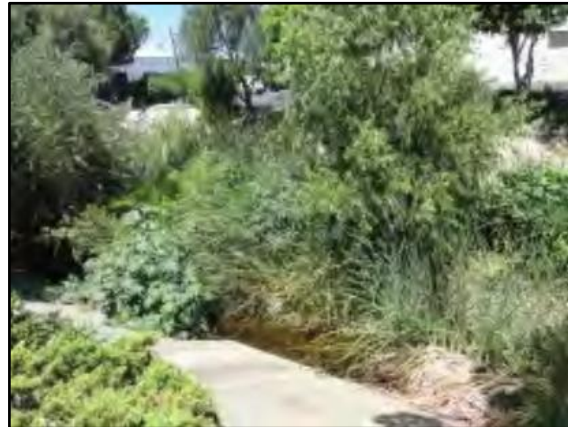
IHHA 12. Mission Gorge 2, Map 2: Looking downstream from the south side.

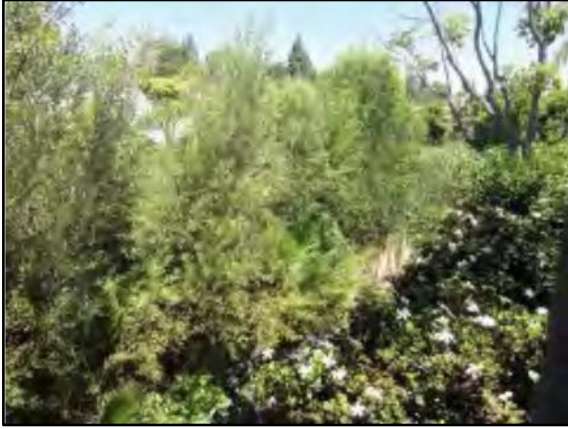
IHHA 13. Mission Gorge 2, Map 2: Looking upstream from south side.

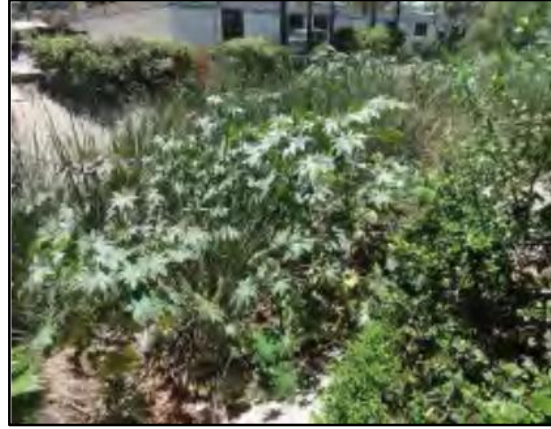
IHHA 14. Mission Gorge 2, Map 2: Looking downstream from the upstream end of the segment.

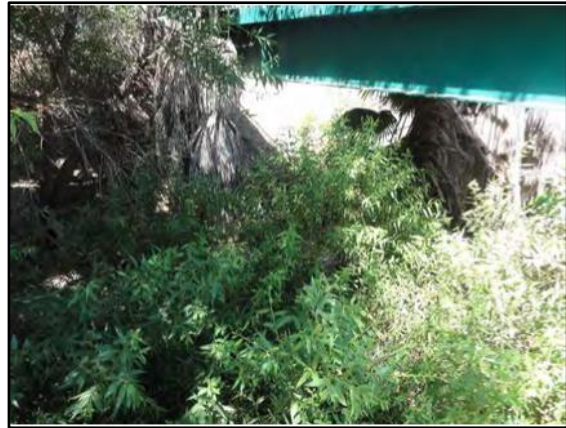
IHHA 3. Alvarado 1, Map 1: From northeast side of Reach 1, upstream of Alvarado Road near pedestrian crossing, looking slightly downstream.

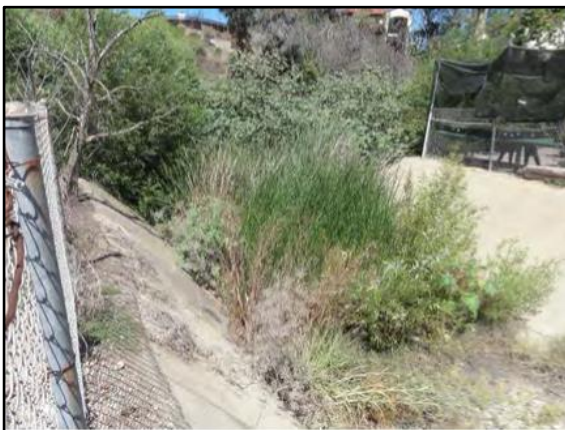
IHHA 5. Alvarado 1, Map 1: From east side of Reach 2, directly upstream of State of California maintenance boundary, looking downstream.

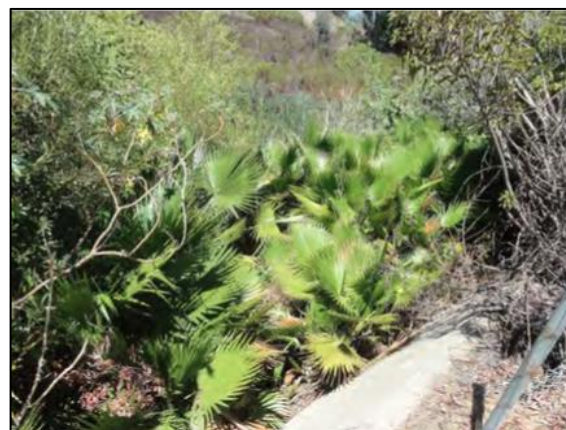
IHHA 6. Alvarado 1, Map 1: From east side of Reach 2, directly upstream of photo 5, looking upstream.

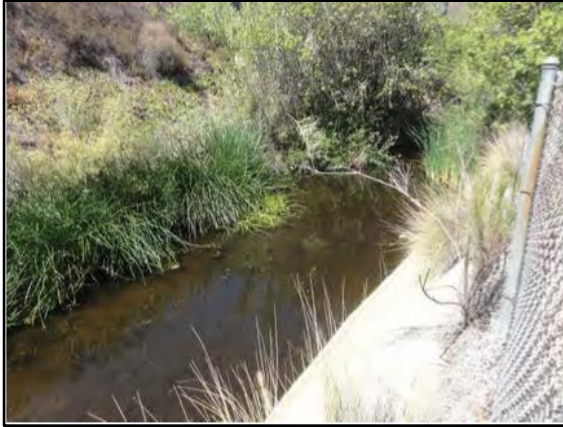
IHHA 7. Alvarado 2, Map 1: From north side of Reach 2, looking downstream.

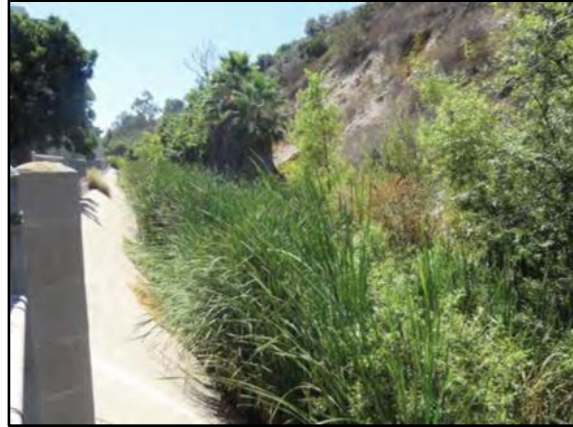
IHHA 11. Alvarado 2, Map 1: From north side of channel in Reach 2, looking upstream.

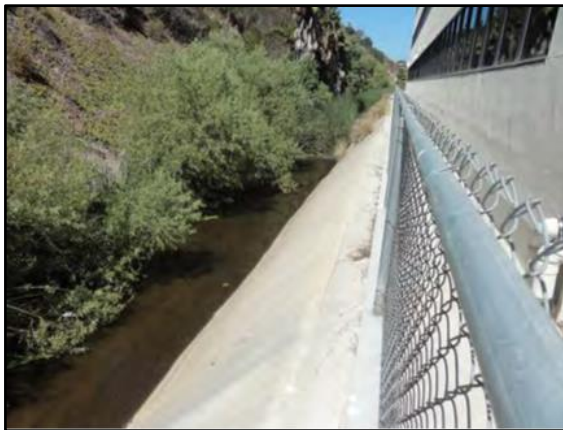
IHHA 12. Alvarado 2, Map 1: From north side of channel, at start of Reach 3, where channel becomes 100% concrete, looking downstream.

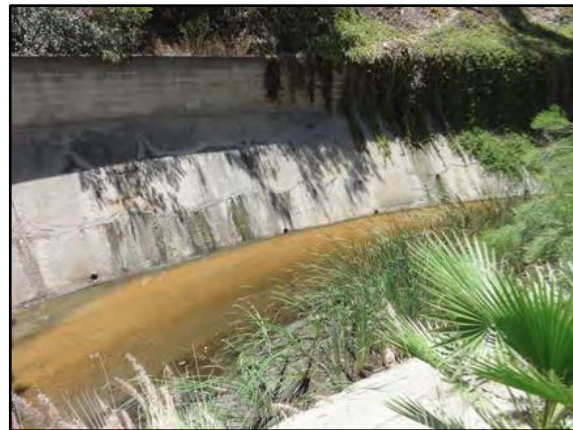
IHHA 13. Alvarado 2, Map 1: From north side of the channel in Reach 3, within 100% concrete portion of channel at 90-degree bend, looking downstream.

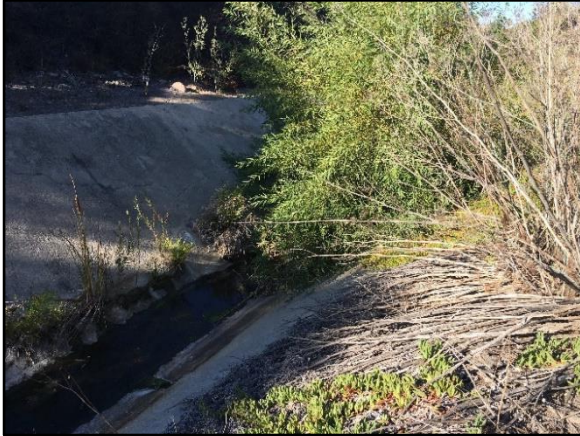
1. Cowles Mountain 1: Upstream of culvert near Station 780 (October 2018).

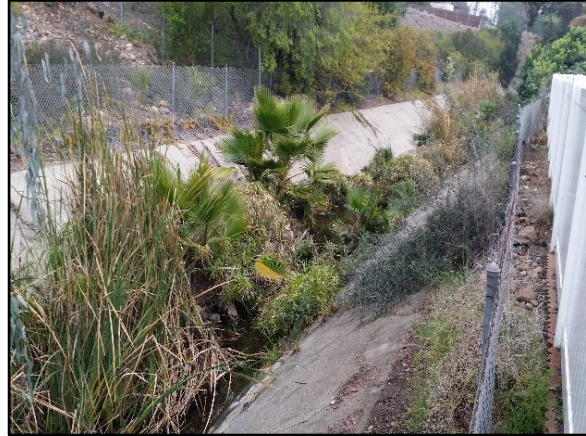
2. Cowles Mountain 2: Upstream of culvert at Station 785 (October 2014).

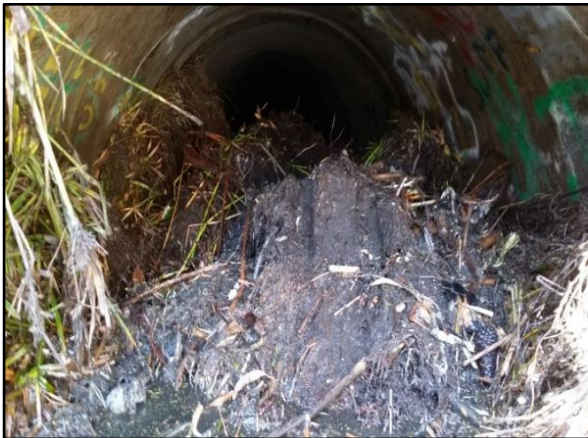
3. Cowles Mountain 2: Culvert under Lake Badin Avenue at Station 1855 (October 2014).

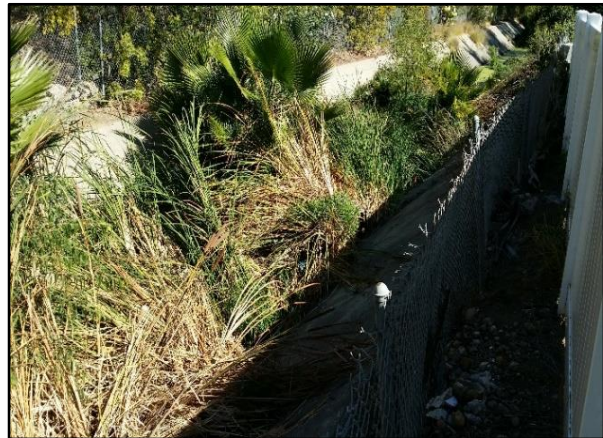
4. Cowles Mountain 2: Upstream of culvert at Lake Badin Avenue (October 2014).

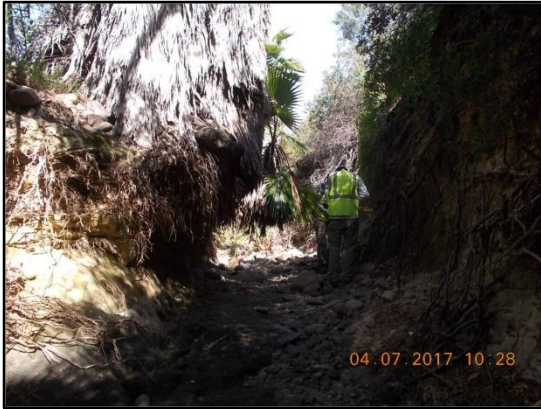
1. Aldine 1: Looking downstream at vegetation, erosion in facility.

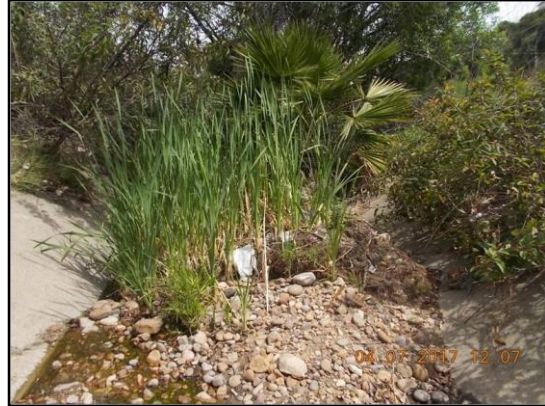
2. Fairmount 4: Looking downstream at sediment/debris and vegetation in concrete ditch.

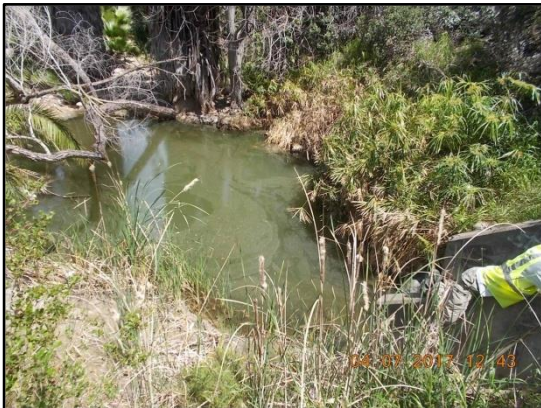
3. Fairmount 3: Looking downstream at scour pool at channel outfall.

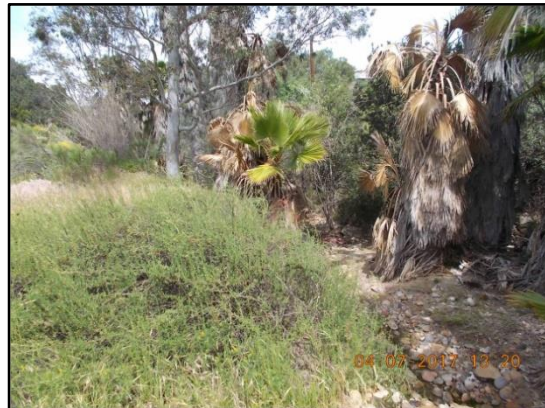
4. Fairmount 3: Looking downstream at vegetation in channel.

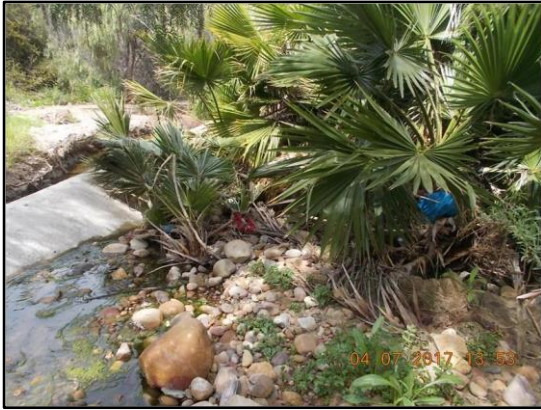
5. Fairmount 2: Looking downstream at sediment/debris and vegetation in concrete ditch.

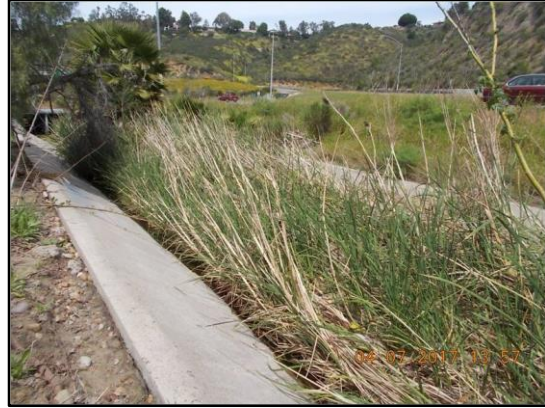
6. Fairmount 2: Looking downstream at vegetation concrete ditch.

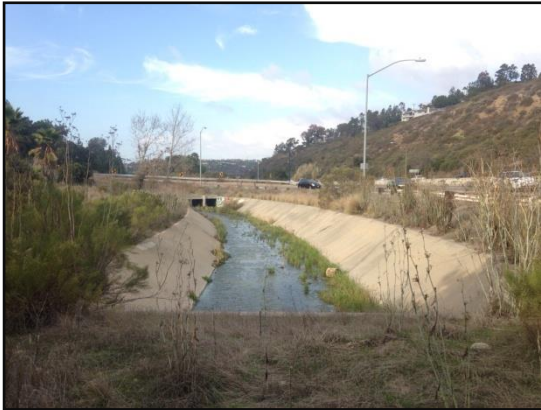
7. Fairmount 1: Looking downstream at concrete channel.

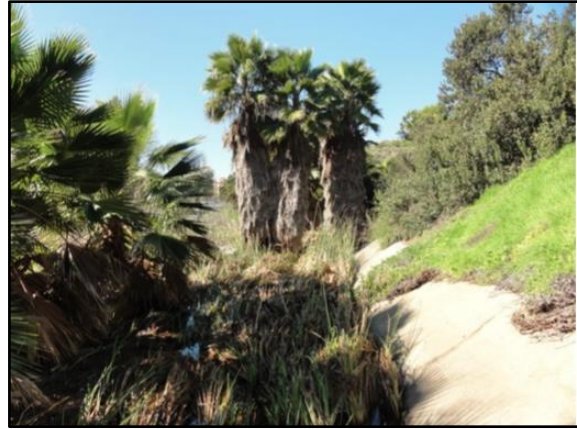
IHHA 7. Baja 1 (Reach 2): Facing downstream towards tulles and downstream palm tree stand.

The assigned Manning's coefficient value for Reach 2 in the recommended maintained condition was 0.11, used to represent the proposed 2-foot-tall palm tree stumps and retained freshwater marsh vegetation (Stations 281.1765 to 588.9762). A Manning's coefficient value of 0.018 was used to reflect concrete along the right side (looking downstream) of Reach 2 as well as the concrete lined channel immediately downstream of the existing 60-inch-diameter RCP underneath 54th Street (Stations 588.9762 to 618.9795). The proposed fence posts at Station 281.1765 were modeled under two preferred maintenance conditions: unobstructed, where the fence posts were modeled as 3-inch-wide obstructions, and obstructed, where the fence posts were modeled completely obstructed with trash and debris creating a 2.5-foot-high barrier spanning the width of the channel.

increase velocities above the permissible velocities for unlined channels. To mitigate this, the recommended maintained condition was modified. The existing palm trees should be cut down, leaving 2-foot-tall stumps with root balls attached, in the ground. All fallen palm tree trunks and debris should be removed. All other existing vegetation, including freshwater marsh species, should be left in place. Vegetation maintenance performed in this manner will increase velocities for earthen bottomed portions of the channel (Stations 281.1765 to 588.967).

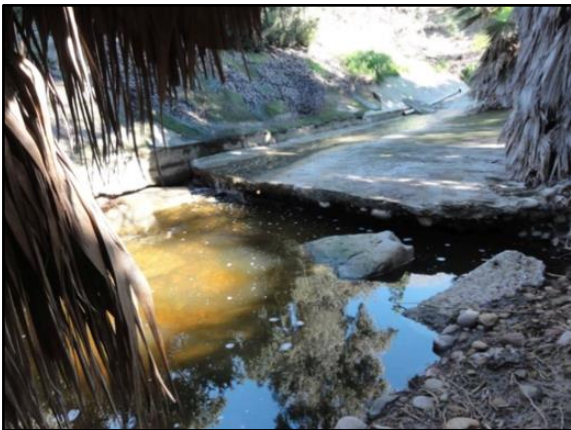
IHHA 9. Baja 1 (Reach 2): Facing the upstream end of Reach 2 towards transition from earthen bottomed to concrete lined immediately downstream of 60-inch-diameter RCP culvert beneath 54th Street.

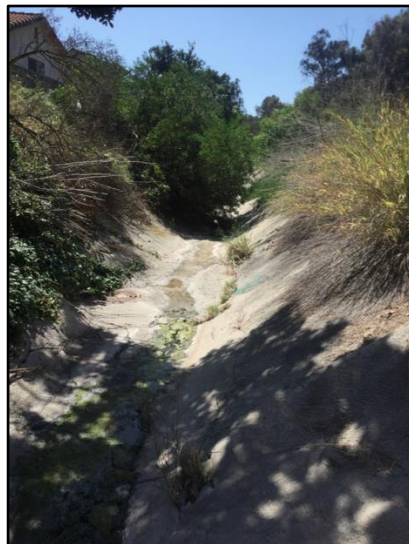
IHHA 13. Baja 1 (Reach 3): Facing the upstream end of the facility group.

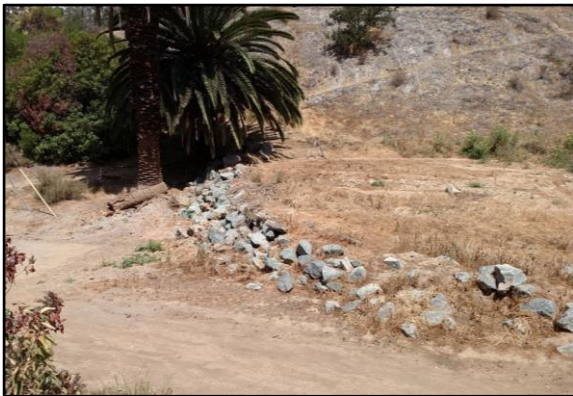
The baseline condition for the Maple Canyon facility group was determined to be the current condition as observed during a site visit in May 2018. The desilting basin is largely unvegetated and the sediment depth was estimated to be approximately 5 feet deep at the west end against the riprap embankment to less than 0.5 feet deep at the east (upstream) end of the basin. Ponded water was not observed within the basin area. The photos in the Representative Photos section below provide examples of the condition of the facility as observed during the May 2018 site visit.

3. Maple Canyon: Basin completely filled with sediment.

Facility Type	Desilting Basin: Earthen	Category 3
Is Maintenance Recommended?	Yes ¹	
Extent of Maintenance	<ul style="list-style-type: none">Remove accumulated sediment/debris and vegetation from the desilting basin.	
Benefit	<ul style="list-style-type: none">Reduces the amount of sediment that discharges from the canyon.

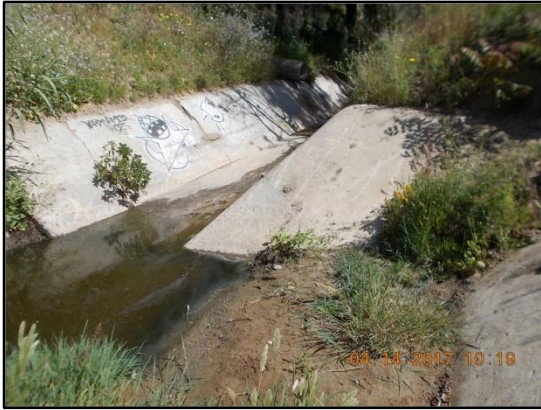
3. Washington 1: Looking upstream at transition from Washington 2 (April 2017).

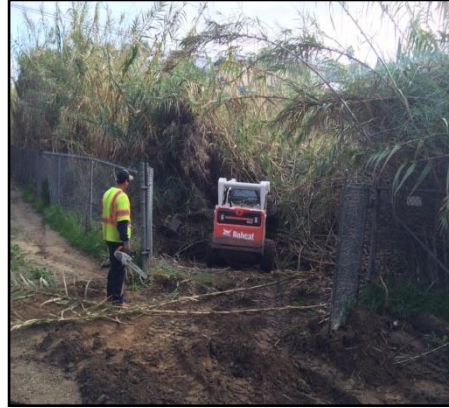
4. Washington 1: Looking downstream at vegetation during January 2016 maintenance.

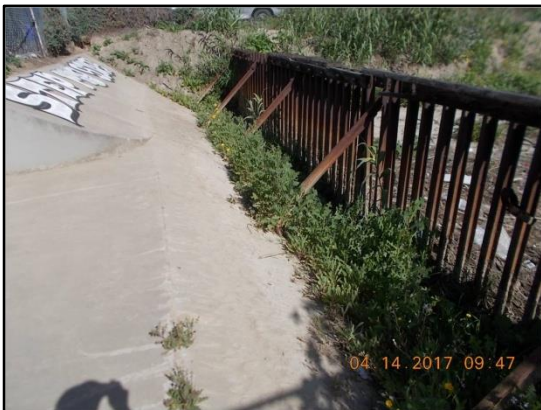
5. Washington 1: Looking northwest, across the facility at debris fence and elevated drop structure shown (April 2017).

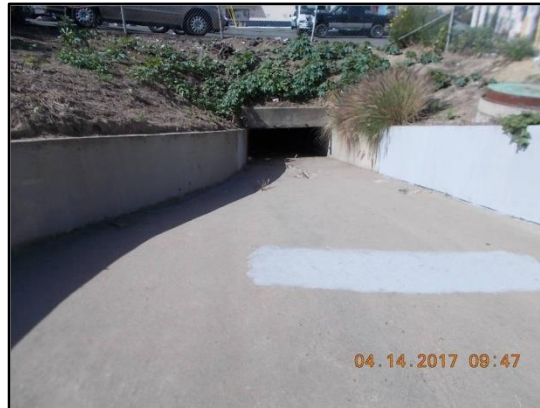
6. Downstream Domain of Analysis: Looking downstream at entrance to 2.5-foot by 6.5-foot RCB culvert inlet (April 2017).

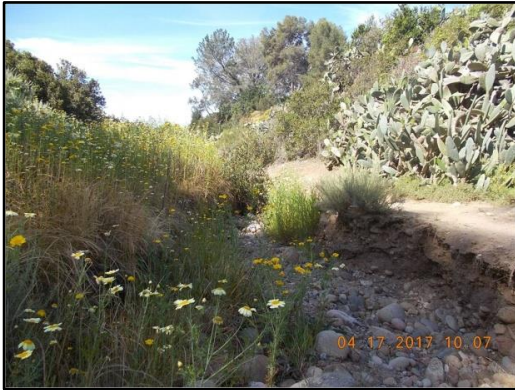
1. Titus 1: Upstream domain of analysis, Looking downstream at vegetation in canyon.

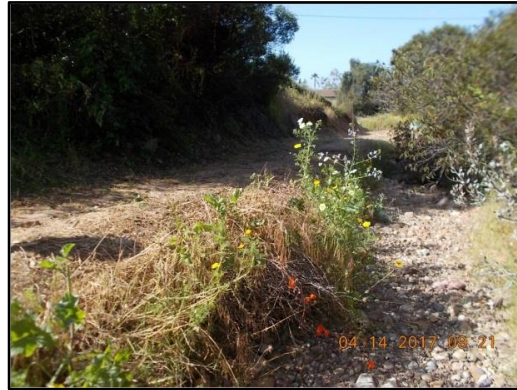
2. Titus 1: Looking downstream at vegetation

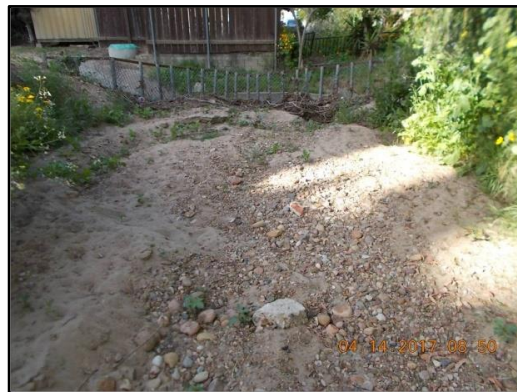
4. Titus 1: Looking downstream at sediment/debris accumulated at debris fence.

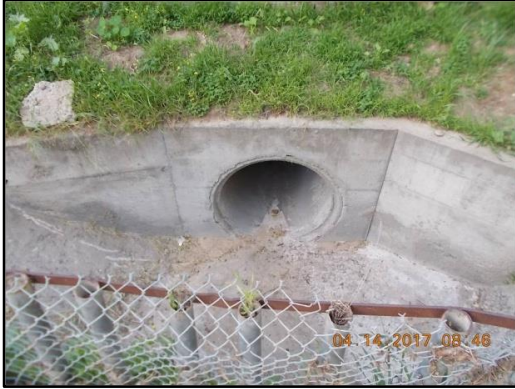
5. Titus 1: Looking downstream at 42-inch-diameter RCP culvert inlet.

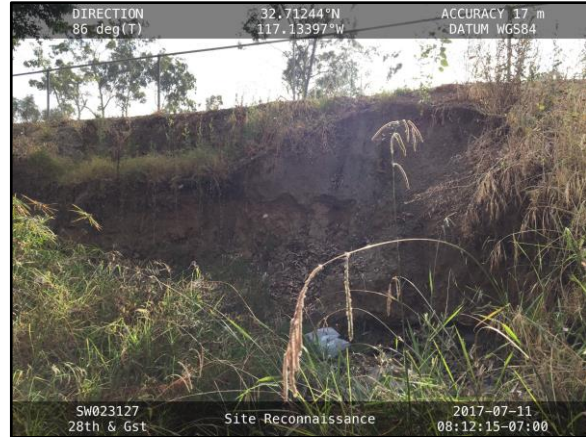
2. 28th St 1: Eroded eastern sidewall.

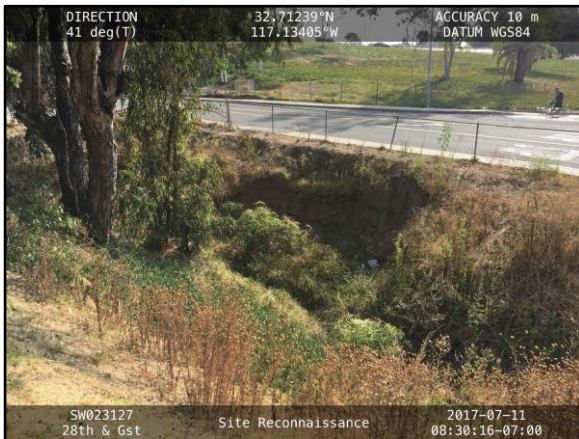
3. 28th St 1: Looking upstream towards the eroded eastern sidewall.

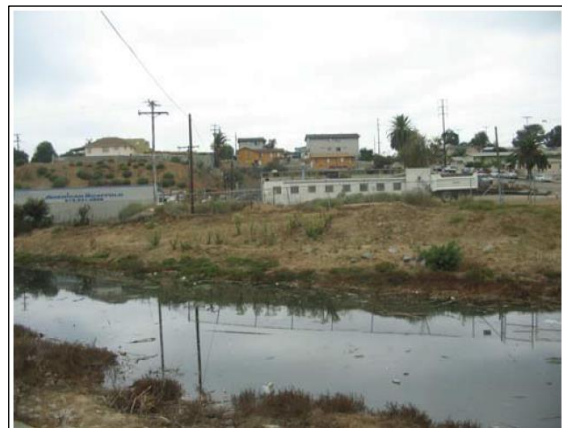
2. IHHA 4. National 1: Looking downstream, representative of low vegetation.

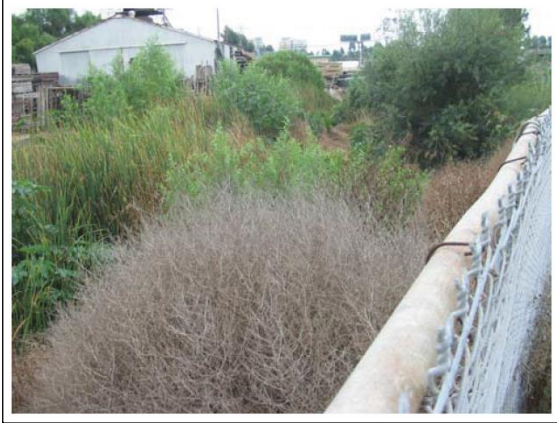
3. IHHA 5. National 2: Looking downstream, representative of dense vegetation.

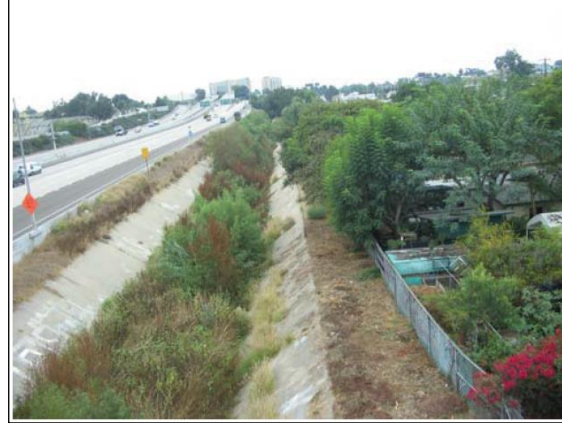
4. IHHA 6. National 2: Looking downstream, representative of medium to dense vegetation.

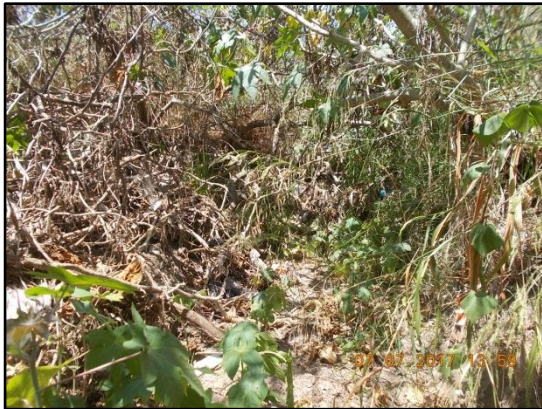
1. Martin 1: Looking upstream at vegetation density in upstream reach.

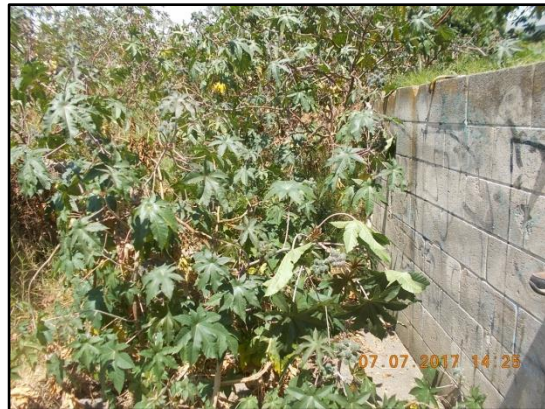
2. Martin 1: Looking upstream at retaining wall/walkway and vegetation in upstream reach.

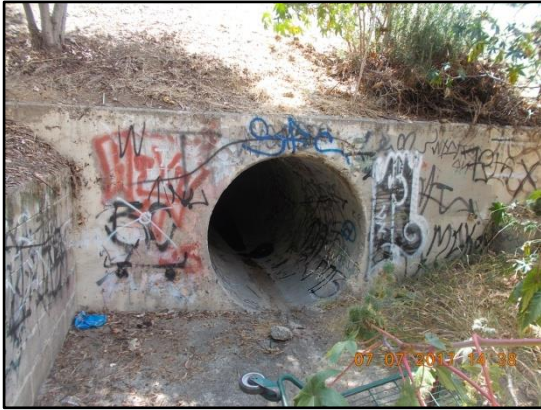
3. Martin 1: Looking downstream at 60-inch-diameter RCP culvert entrance under 35th Street.

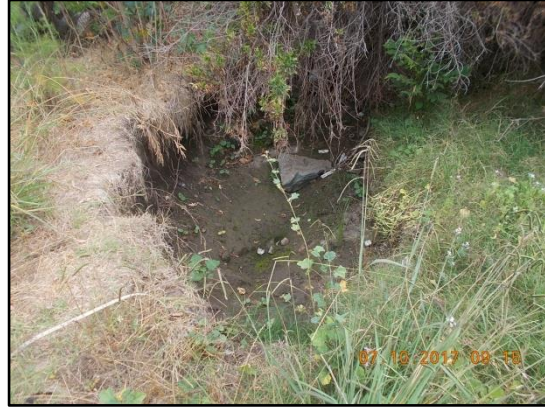
The recommended maintained condition for the Martin facility group is limited to repairing a scoured area between Station 616 and Station 496 within the downstream reach of the facility.

4. Martin 1: Looking downstream at scoured channel bed.

The recommended maintenance consists of filling and compacting of the scoured area and contouring the filled area of the channel bed with a constant slope from Station 616 to Station 496. The level of service after these maintenance activities will remain unchanged at less than the 50-year storm, or 228 cfs, due to the limited capacity of the culvert at Station 233.

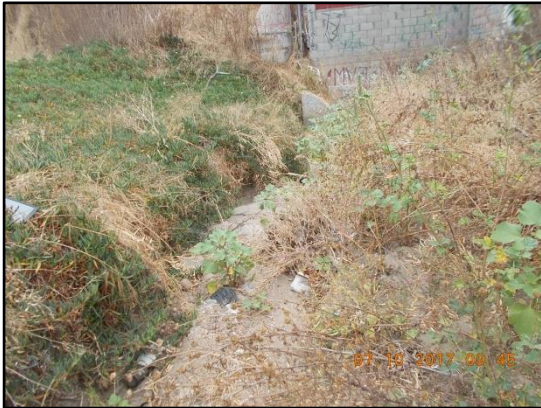
The HEC-RAS modeling results show that the conveyance capacity of the facility is restricted by the 60-inch-diameter RCP culvert under I-15, and the floodplain extends well within various private properties' open space areas. Therefore, additional analysis is recommended to evaluate potential increases in the level of service that could be achieved by capital improvements to address restrictions at the two 60-inch-diameter RCP culverts.

5. Martin 1: Looking downstream at 60-inch-diameter RCP culvert entrance (below concrete block wall).

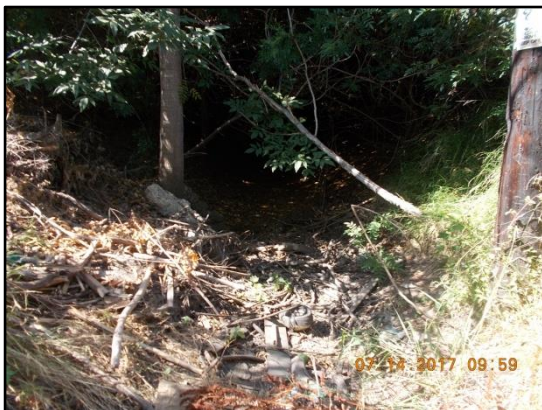
1. J St 1 (Reach 2): Looking downstream at vegetation in upstream reach

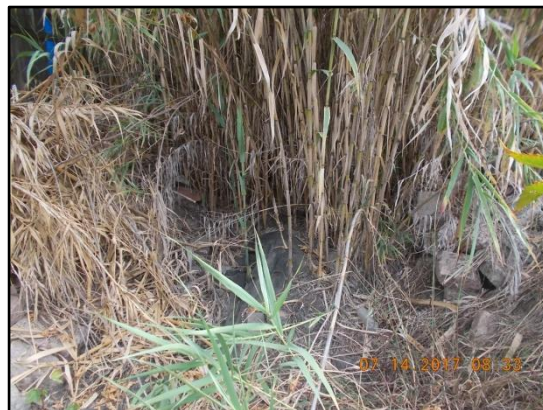
2. J St 1 (Reach 2): Looking upstream at invasive vegetation

The recommended maintained condition for the J Street facility group includes trimming vegetation and removal of invasive vegetation between Station 193 and Station 10. The Manning's coefficients in the recommended maintained condition vary from 0.018 for the concrete pad at the culvert entrance to 0.030 for the trimming/removal of invasive vegetation within the channel bottom. The Manning's coefficient values for Reach 2 upstream of Station 193 remained unchanged since no maintenance is proposed. Station 193 is the approximate end of the invasive vegetation that is recommended to be removed and the reach conveys the 100-year storm event in the current condition upstream of Station 220.

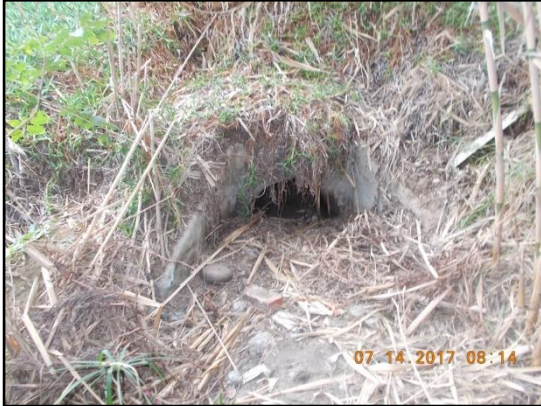
3. J St 1 (Reach 1): looking upstream at 24-inch-diameter culvert outlet

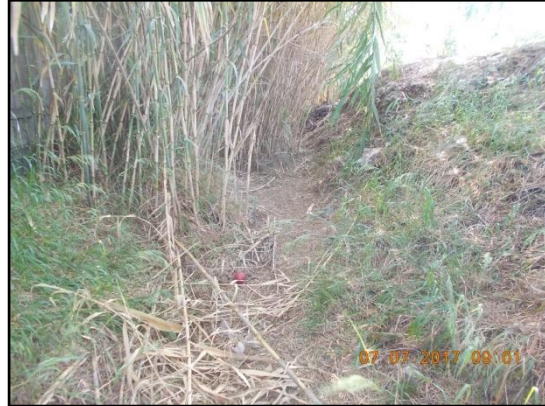
4. J St 1 (Reach 1): Looking upstream at invasive vegetation

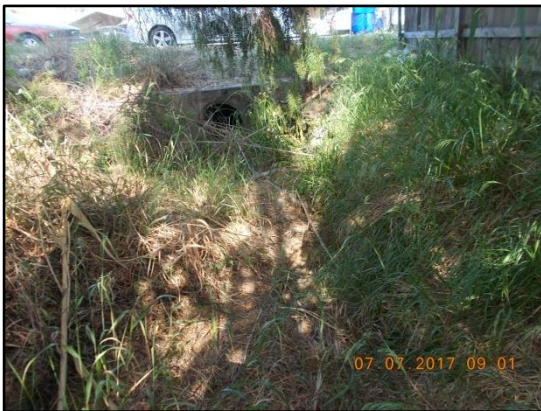
5. J St 1 (Reach 1): Looking downstream at 30-inch-diameter RCP culvert inlet on east side of Toyne Street

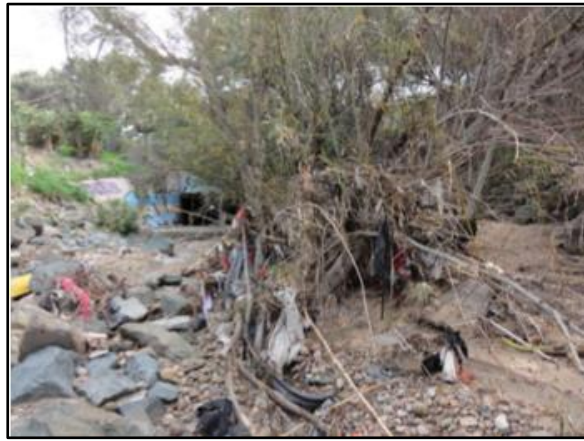
IHHA 4. Home 2, Map 1: Looking upstream at the vegetation and displaced riprap downstream of the double 7-foot wide by 6-foot tall RCB culvert.

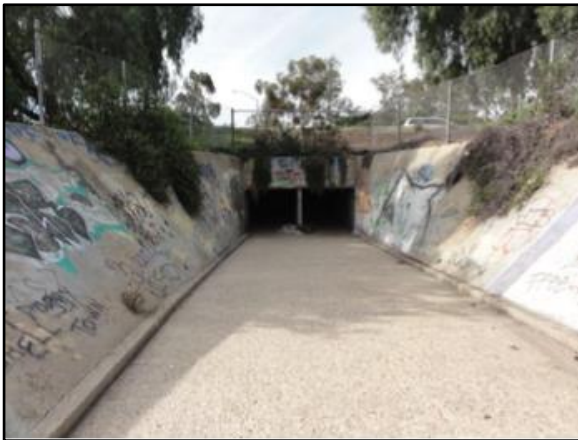
IHHA 6. Home 3, Map 1: Looking downstream towards 7-foot wide by 6-foot tall double RCB culvert. Note clean channel.

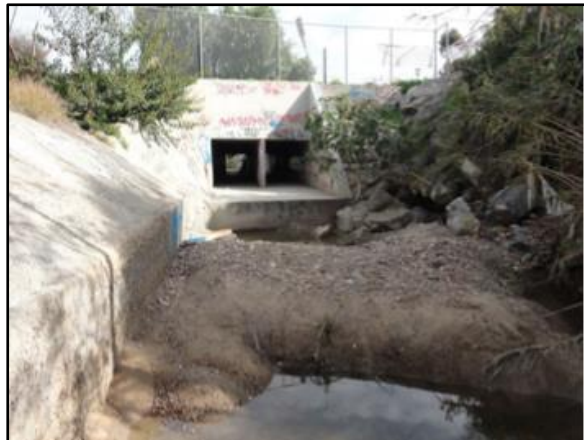
IHHA 10. Home 4, Map 1: Looking upstream at the double 6-foot wide by 6-foot tall RCB culvert. Note the standing water and erosion at culvert outlet.

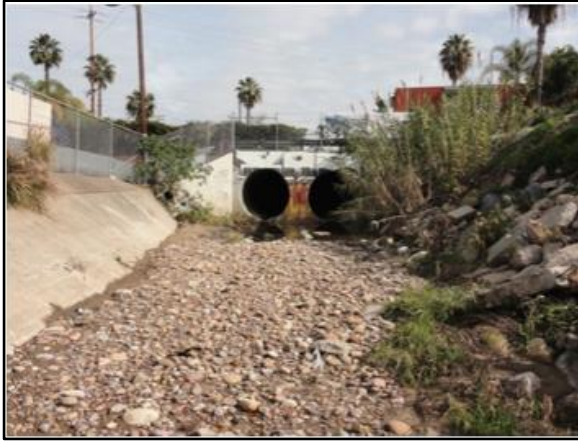
IHHA 13. Home 5, Map 1: Looking upstream at the double-barrel 74-inch-diameter RCP culvert.

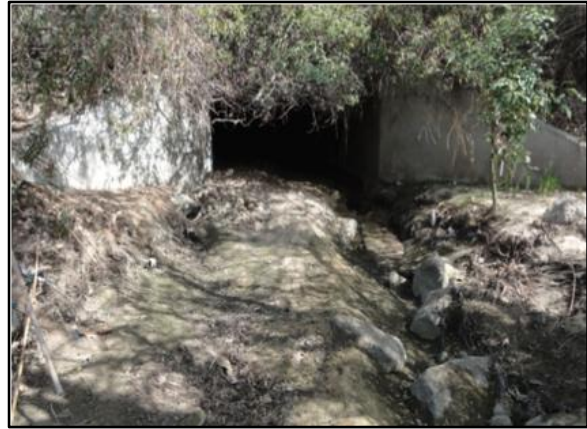
1. Home 1, Map 2: Looking the upstream end of the segment towards the 12-foot wide by 6-foot tall RCB culvert under Terrace View Villas.

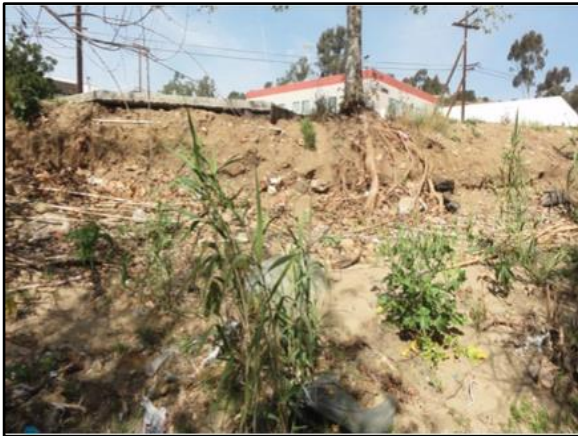
2. Home 1, Map 2: Standing at the upstream end the segment, looking west where erosion occurs along Home Avenue.

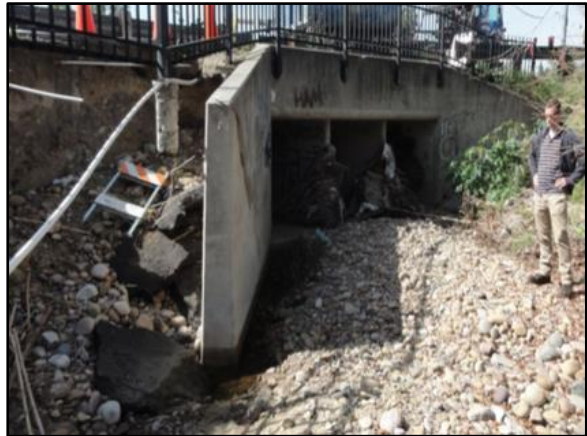
3. Home 1, Map 2: Standing along east bank of segment, looking southwest at erosion behind east wing wall at downstream end.

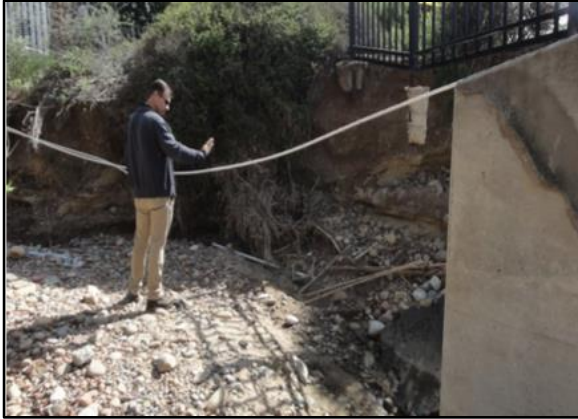
4. Home 1, Map 2: Standing at downstream end of segment, looking northeast at erosion along the east bank of the channel.

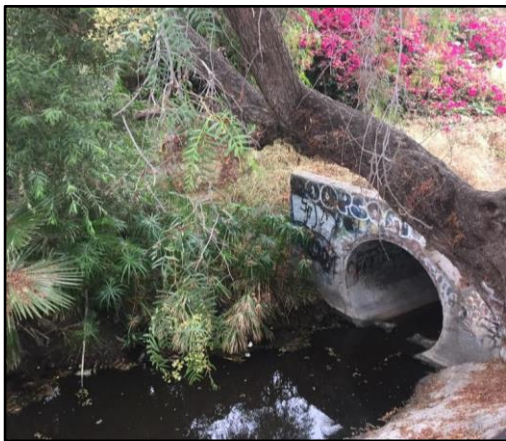
1. Oakcrest 1: Looking upstream at RCP storm drain system outlet.

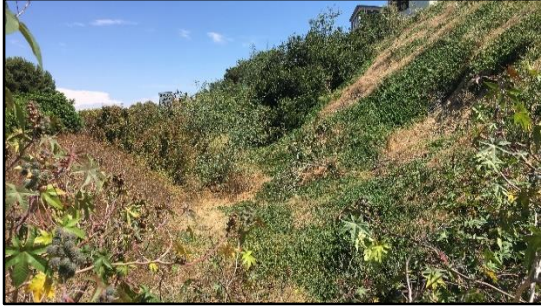
1. Megan 2: looking upstream near upstream end at vegetation.

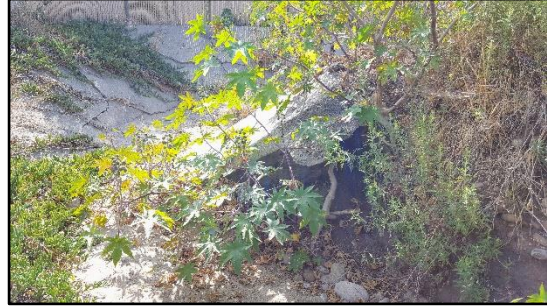
2. Transition between Megan 1 and 2: Looking downstream at eroded area behind right concrete bank.

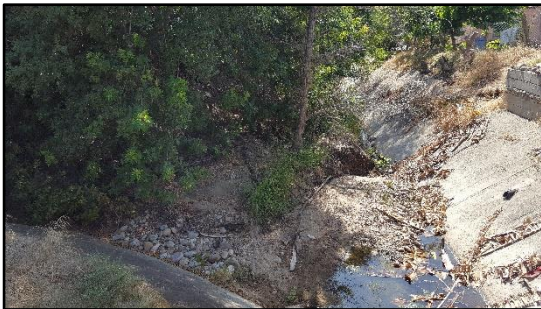
5. Megan 1, Reach 1: Looking downstream from 90-degree bend.

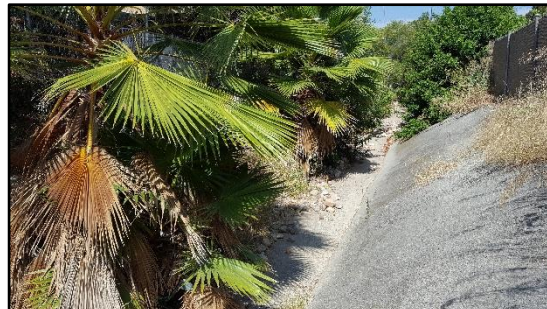
6. Megan 1, Reach 1: Looking upstream at concrete bank and vegetation.

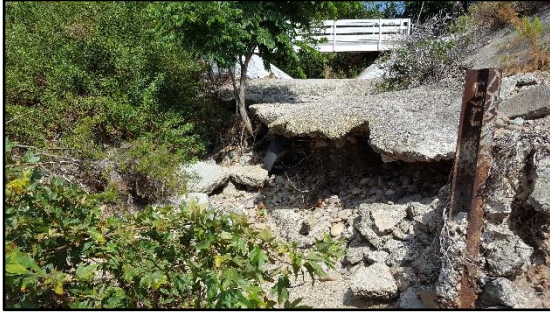
7. Megan 1, Reach 1: Looking upstream at erosion under concrete bottom at ditch outfall to Chollas Creek.
