# **APPENDIX I**

## ***Hydrology and Hydraulics Technical Report***

## A.1 Green Valley Creek – Pomerado

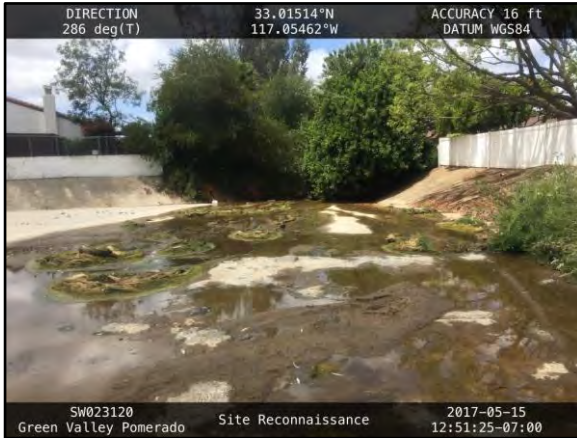
1. Pomerado 2: Looking upstream at upstream end of segment.

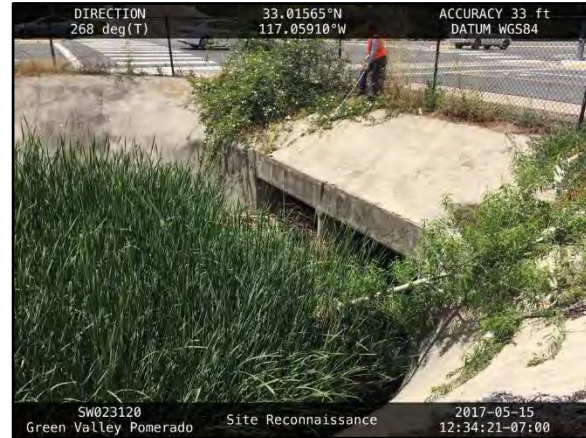
2. Pomerado 2: Looking downstream at double box culvert.

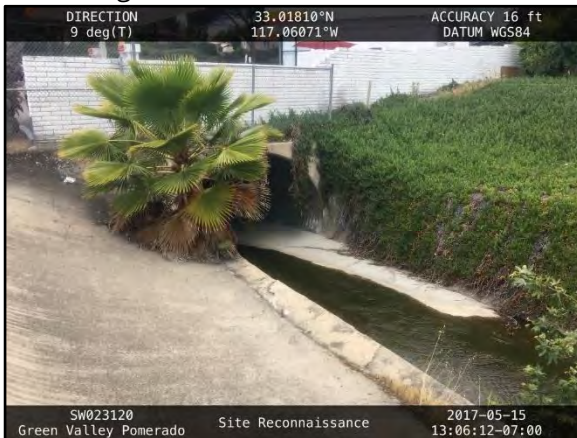
3. Pomerado 2: Looking downstream at CMP culvert at downstream end of segment.

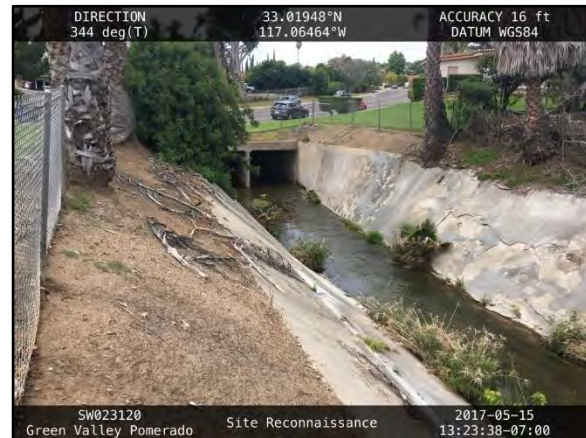
4. Pomerado 1: Looking downstream at double box culvert.

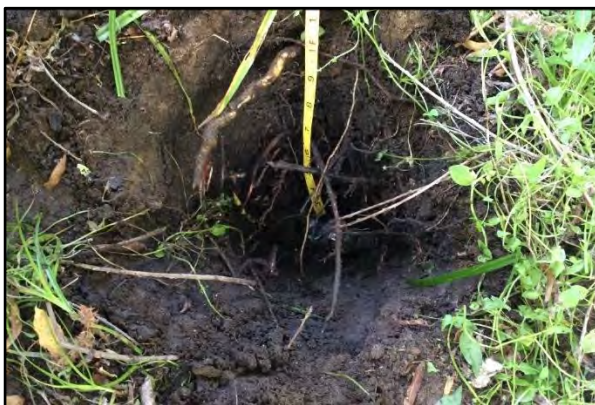
The baseline condition for the Paseo del Verano facility group was determined to be the current condition as observed during a site visit in July 2017. Heavy vegetation, tree growth, and accumulated sediment/debris were observed in the desilting basin. The sediment depth was estimated to be approximately 2 feet deep across the basin. Ponded water was not observed in the

1. Paseo del Verano 1: Sediment deposition in the basin.

When applying the 50% maintenance threshold described in Section 4.2.2 of the *Hydrology and Hydraulics Technical Report*, maintenance is necessary. Sediment deposition is approximately 2 feet deep in the baseline condition, and when compared to the overflow height of 4 feet (gabion height in front of the outlet structure), approximately 50% of the sediment storage is occupied by sediment, which meets the permanent desilting basin maintenance threshold. Therefore, vegetation and sediment/debris removal from the bottom of the basin is recommended to restore the capacity of the desilting basin. The frequency will be established based on annual inspection of the basin and outlet.

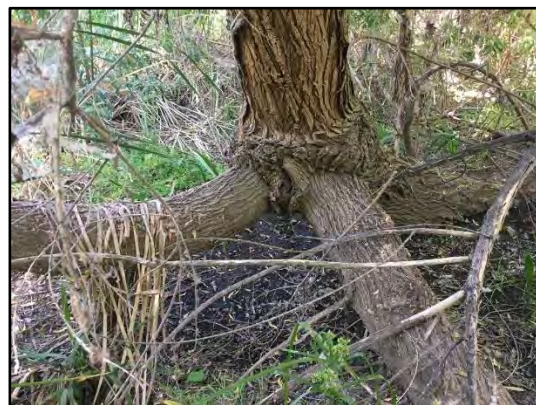
2. Paseo del Verano 1: Vegetation growth in the basin.

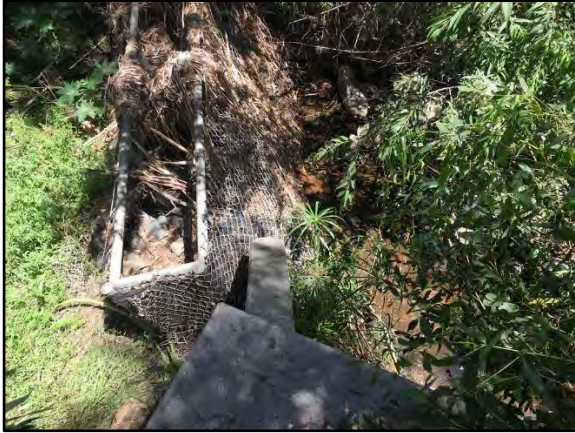
3. Paseo del Verano 1: Gabion wall structure at outlet structure.

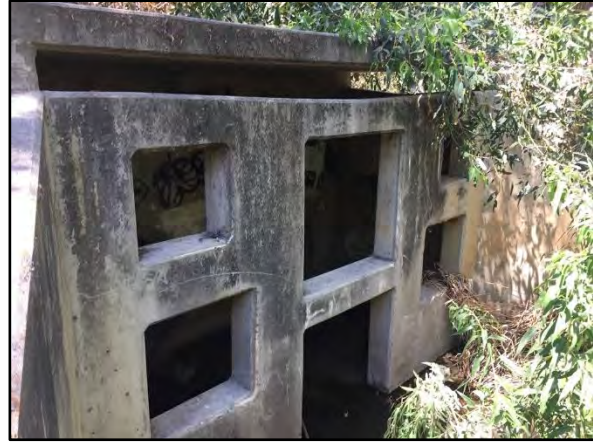
4. Paseo del Verano 1: Basin outlet structure.

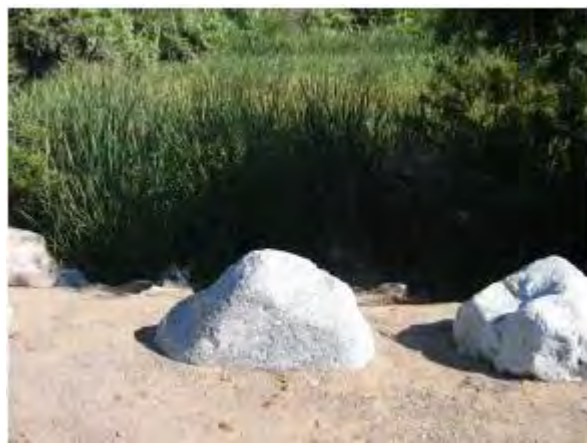
IHHA 2. Sorrento Valley 1: Looking east at vegetation.

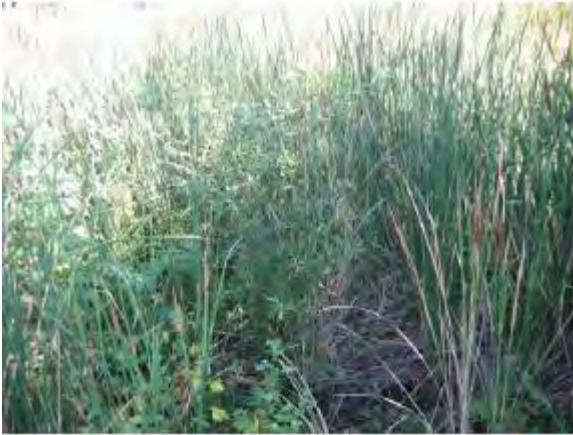
IHHA 3. Sorrento Valley 1: Looking east at vegetation.

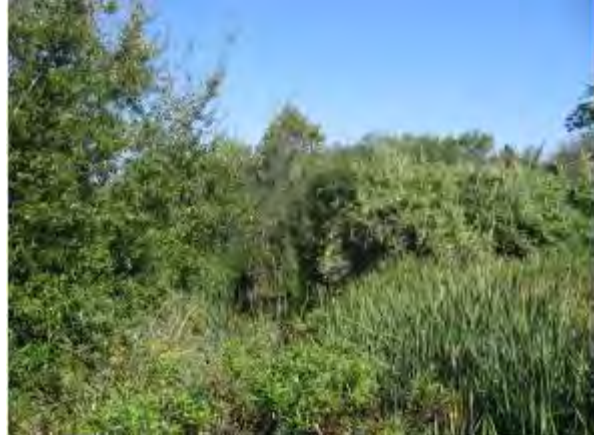
IHHA 4. Sorrento Valley 1: Looking east at vegetation.

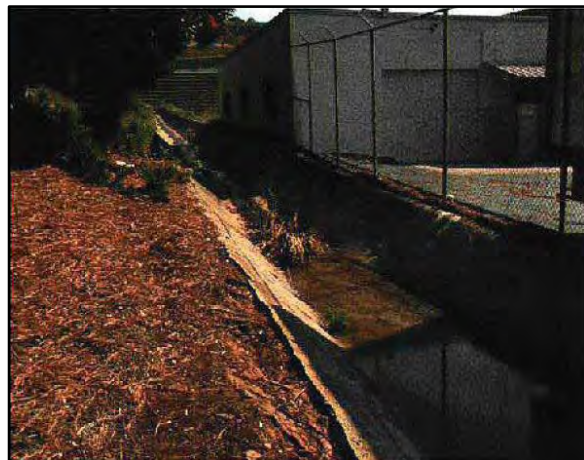
2. IHHA 4. Industrial 1, Reach 3: Looking upstream at minor vegetation and sediment within concrete segment.

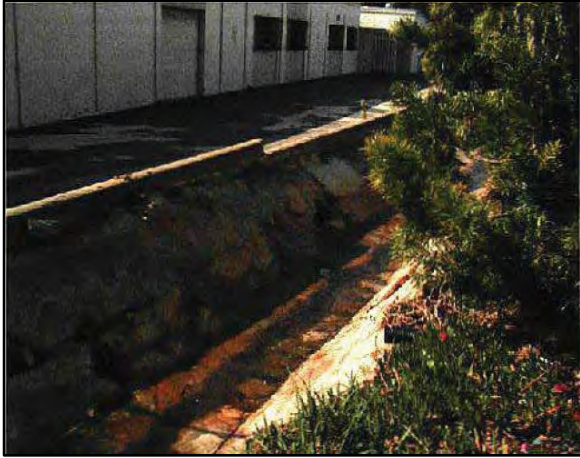
3. IHHA 5. Industrial 1, Reach 2: Looking downstream at concrete segment.

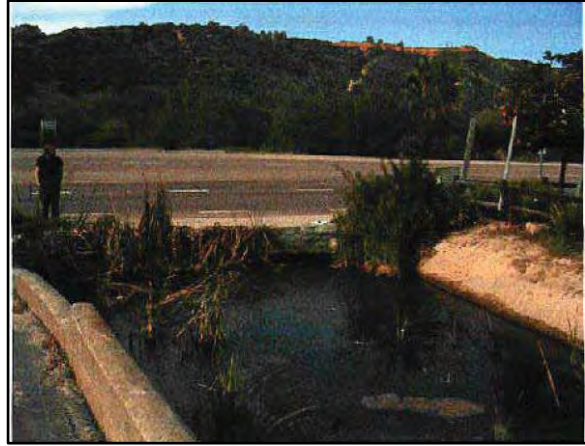
4. IHHA 9. Industrial 1, Reach 2: Looking downstream towards the double-barrel, 6-foot-wide by 2.75-foot-tall RCB culvert near downstream end of Reach 2. Culvert not visible due to dense vegetation.

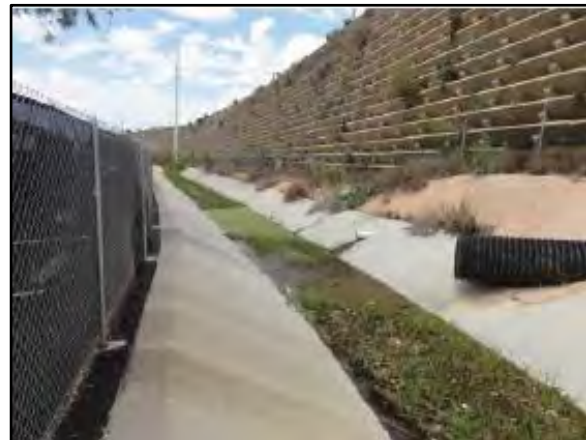
2. IHHA 3. Tripp 1, Reach 3: Looking downstream.

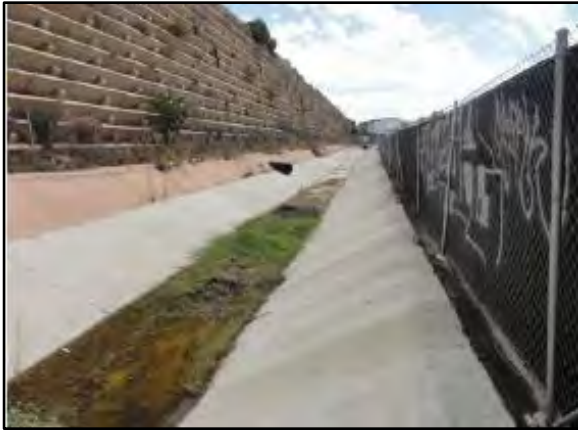
3. IHHA 4. Tripp 1, Reach 4: Looking upstream at end of reach.

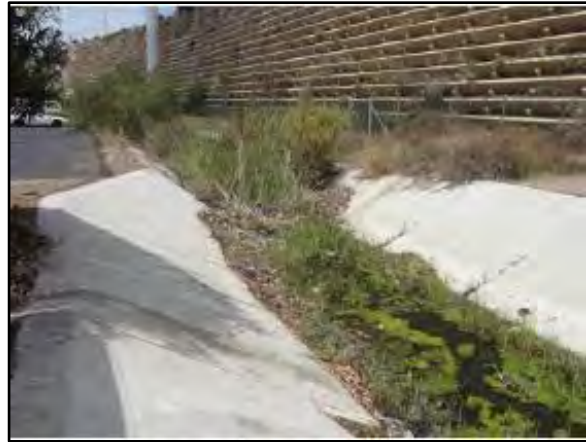
4. IHHA 7. Tripp 1, Reach 3: Looking downstream.

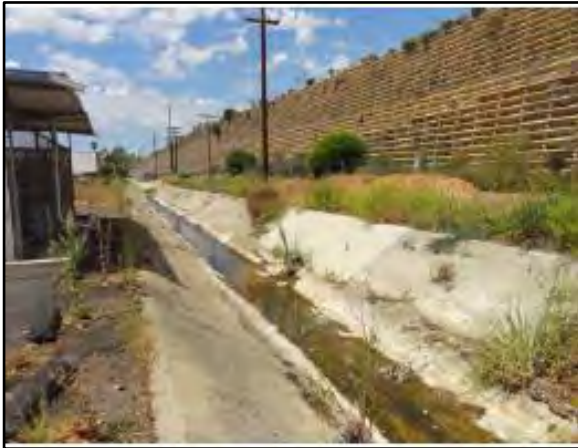
5. IHHA 9. Tripp 1, Reach 2: Looking downstream.

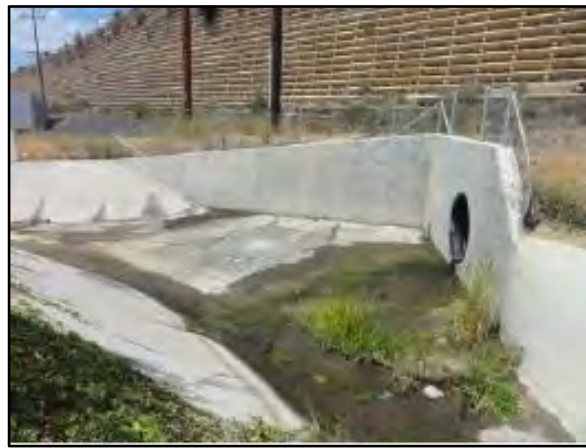
6. IHHA 10. Tripp 1, Reach 2: Looking downstream at 90-degree bend, at downstream end of reach.

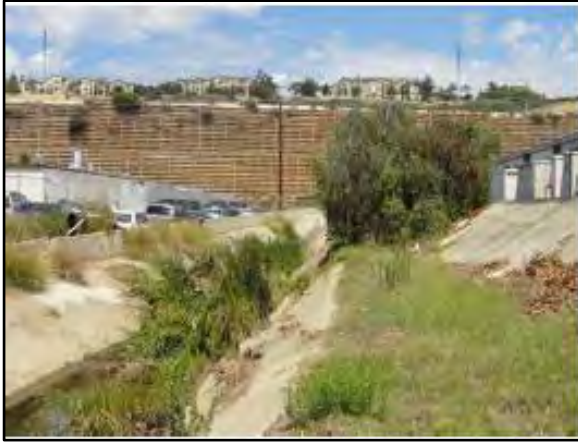
7. IHHA 14. Tripp, Reach 1: Looking upstream from double-barrel 57-inch RCP culvert entrance at downstream end of facility group.

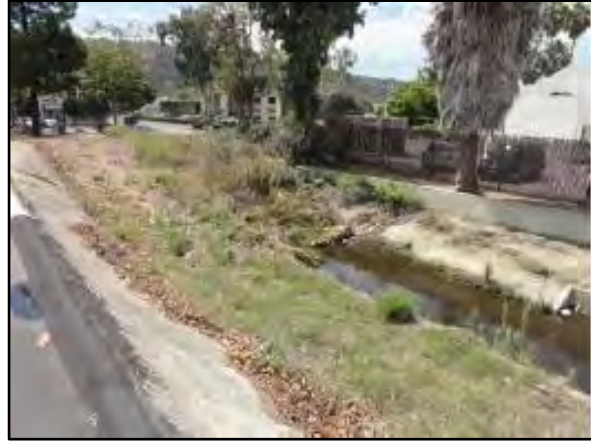
8. IHHA 15. Tripp, Reach 1: Looking downstream at double-barrel 57-inch RCP culvert entrance; downstream end of facility group.

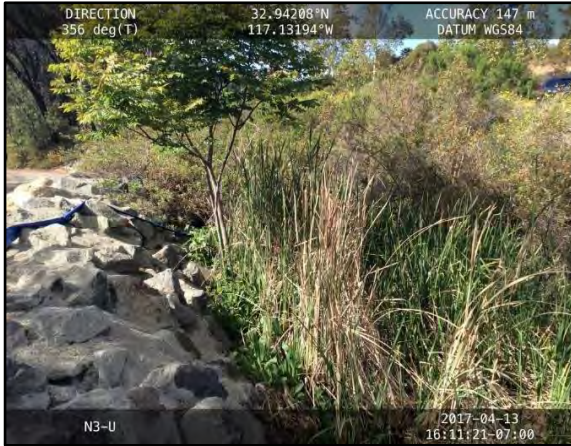
1. Black Mountain 1: Looking towards the upstream end of the segment.

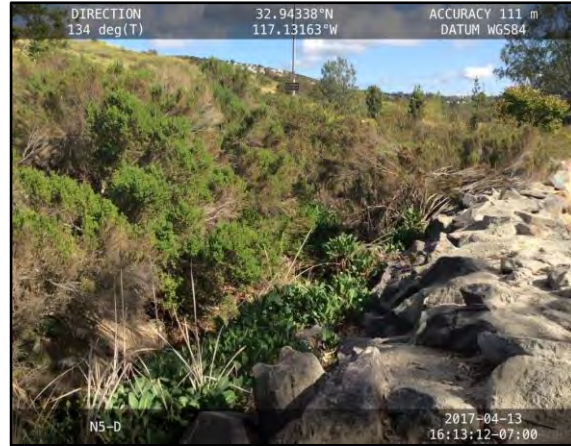
2. Black Mountain 1: Looking downstream at segment.

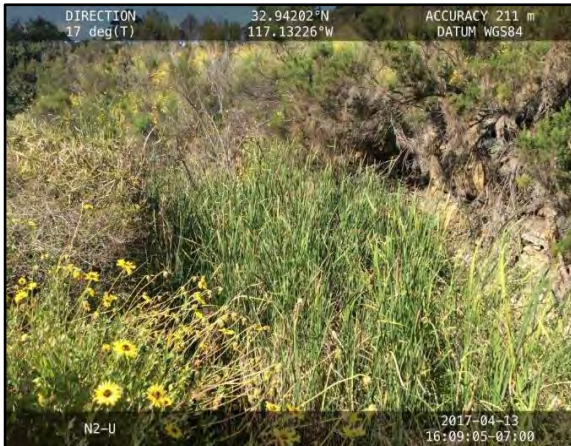
3. Black Mountain 1: Looking upstream near mid-distance along the segment length.

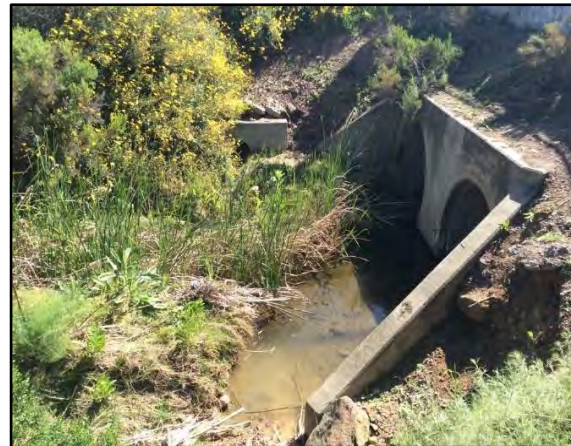
4. Black Mountain 1: Looking downstream at the double barrel 72-inch-diameter RCP culvert.

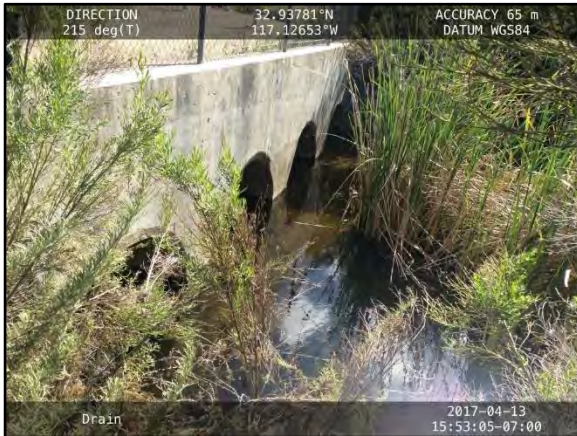
1. Black Mountain 2: Looking upstream at quadruple-barrel 72-inch-diameter RCP storm drain outlet at Mercy Road.

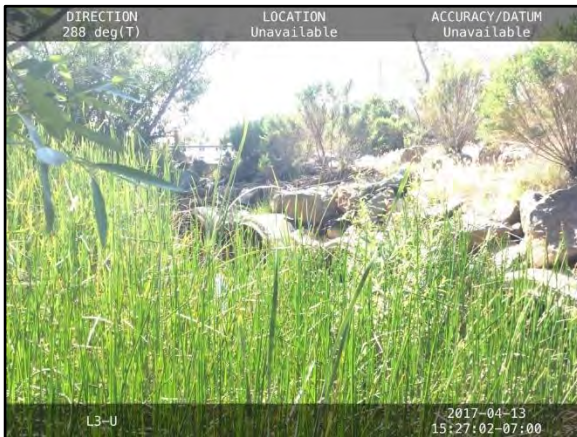
3. Black Mountain 2: Looking downstream at the seven-barrel 54-inch-diameter RCP culvert beneath the Canyonside Ranch driveway.

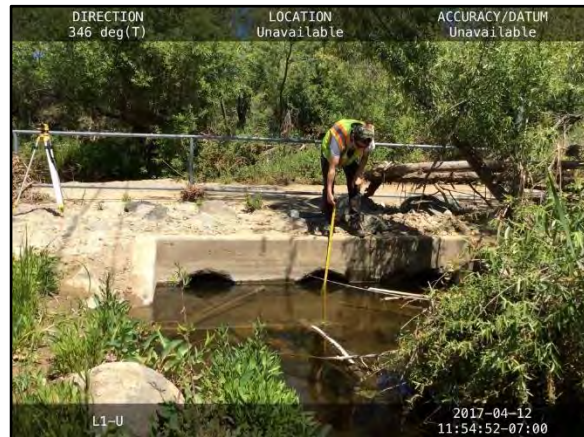
4. Black Mountain 2: Looking downstream at triple barrel 24-inch-diameter RCP beneath the Los Peñasquitos Canyon Trail.

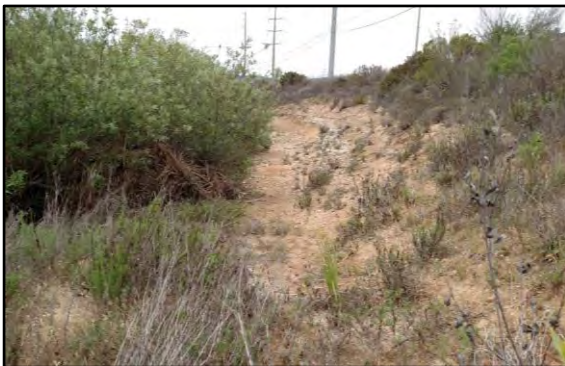
1. 5-805 Basin: Looking downstream at heavily vegetated inlet to basin from upstream end.

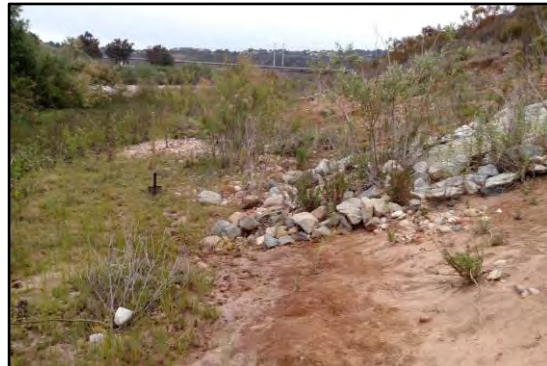
2. 5-805 Basin: Looking at downdrain outfall into basin on north side.

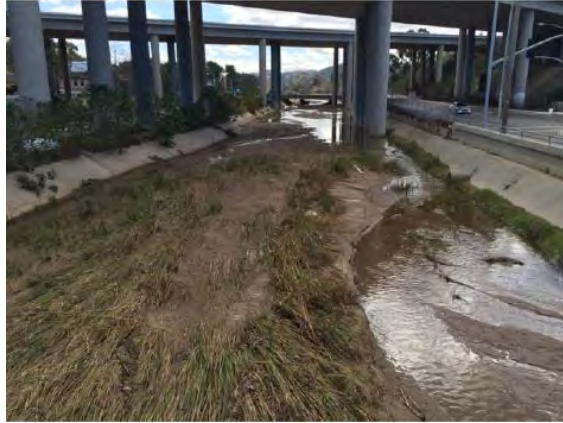
2. Roselle 2: Looking upstream from the northwest side of the I-5 overpass.

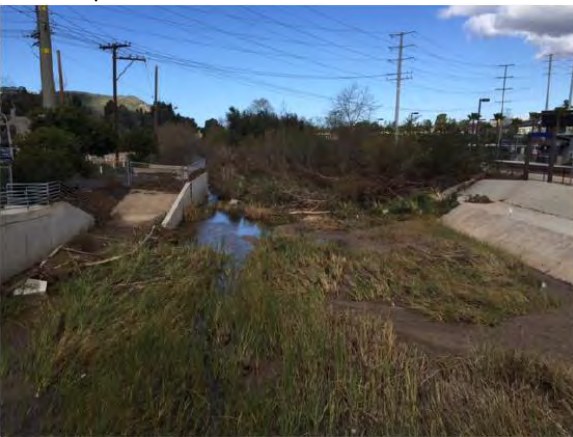
3. Roselle 2: Looking downstream at the transition area between Roselle 1 and 2.

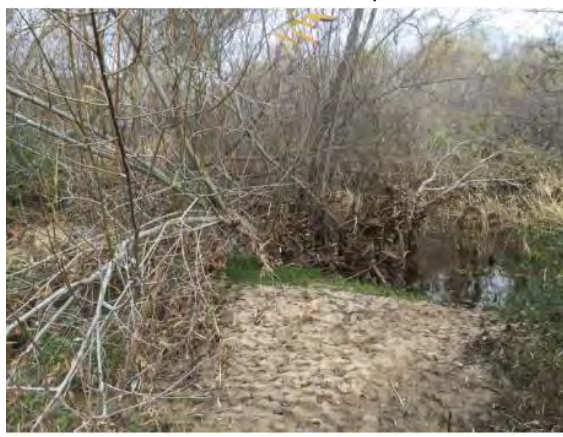
4. Roselle 1: Looking downstream at the upstream end of Roselle 1.

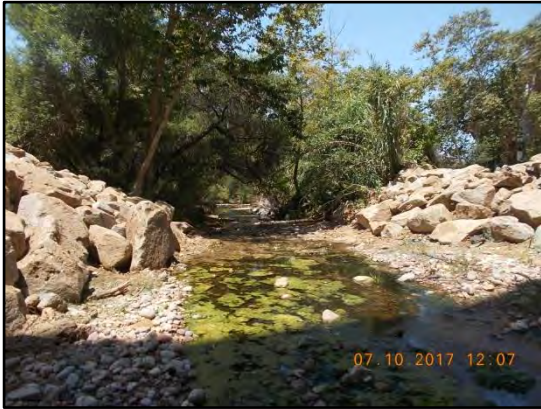
1. Upstream Domain of Analysis: Looking downstream (from the west side of I-8) at vegetation density and riprap located upstream from Reach 6.

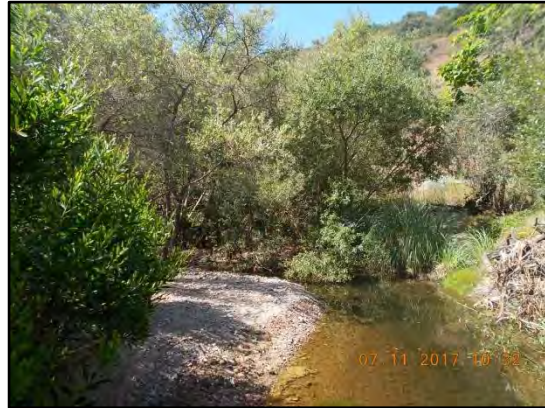
2. Sorrento Valley 1: Looking downstream at vegetation density upstream from the Reach 2/Reach 3 transition.

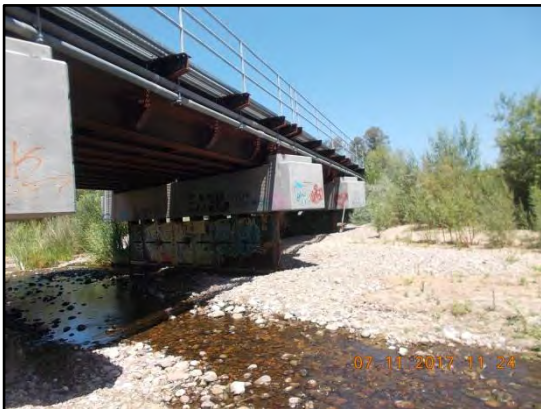
3. Sorrento Valley 1 Reach 2: Looking downstream at channel bottom near the upstream side of railroad bridge.

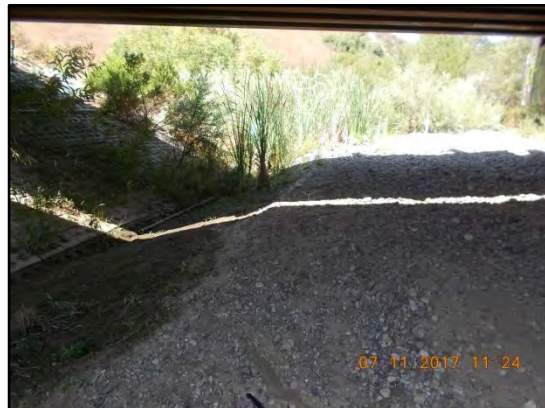
4. Sorrento Valley 1, Reach 1: Looking downstream at channel bottom under the railroad bridge and vegetation density immediately downstream.

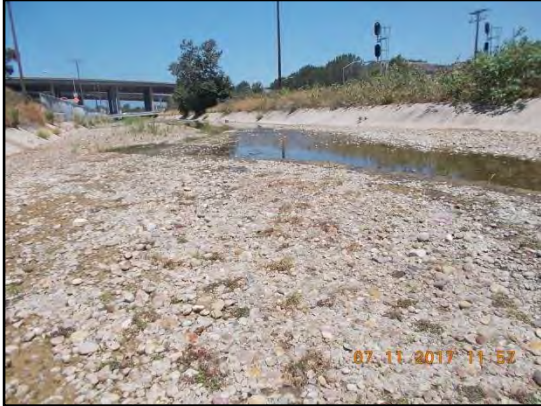
5. Downstream Domain of Analysis: Looking downstream near the upstream end of the concrete lined channel (Roselle 2).

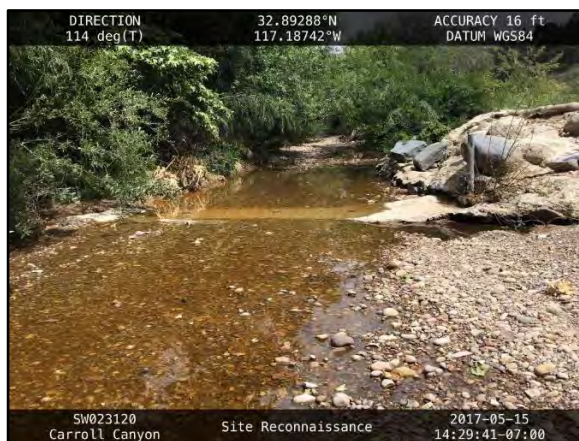
1. Carroll Canyon 1: Natural channel upstream of double 10-foot-wide by 5-foot-tall RCB culvert.

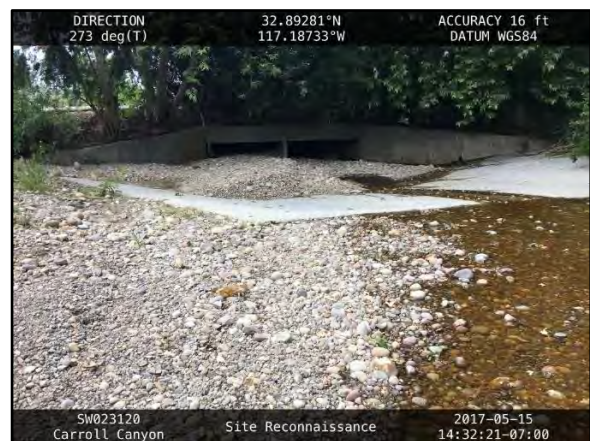
2. Carroll Canyon 1: Sediment and cobbles accumulated on concrete inlet apron upstream of the culvert.

Facility Type	Bed: Concrete, Riprap, Earthen Banks: Concrete, Riprap, Earthen	Category 2
Is Maintenance Recommended?	Yes <sup>1</sup>	
Extent of Maintenance	<ul style="list-style-type: none"> <li>Remove accumulated sediment/debris and overgrown vegetation from channel bottom and temporary diversion berm from Station 58<sup>2</sup> to Station 178 and from Station 497 to Station 561.</li> <li>Removed sediment/debris in culvert from Station 178 to Station 497.</li> </ul>	
Benefit	<ul style="list-style-type: none"> <li>Increases level of service from &gt;2-year storm event (400 cfs) to &gt;5-year storm event (900 cfs).</li> <li>Reduces the risk of clogging the culvert from Station 497 to Station 178.</li> </ul>

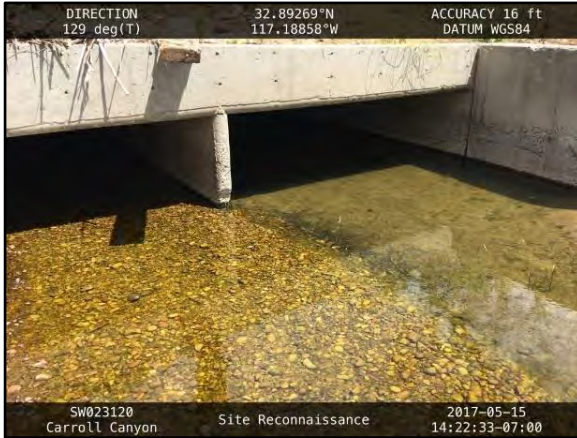
3. Carroll Canyon 1: Sediment and gravel accumulated at the culvert outlet.

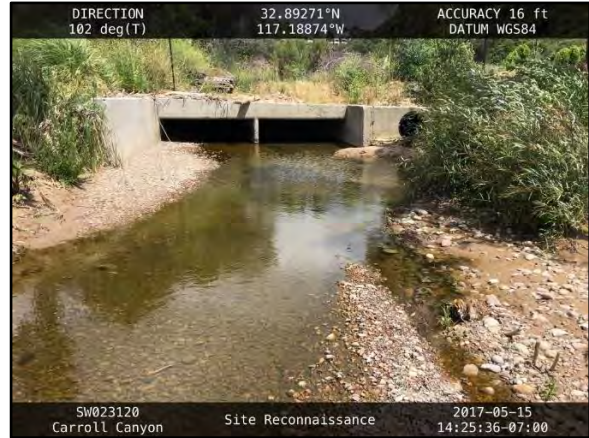
4. Carroll Canyon 1: Natural channel downstream of culvert.

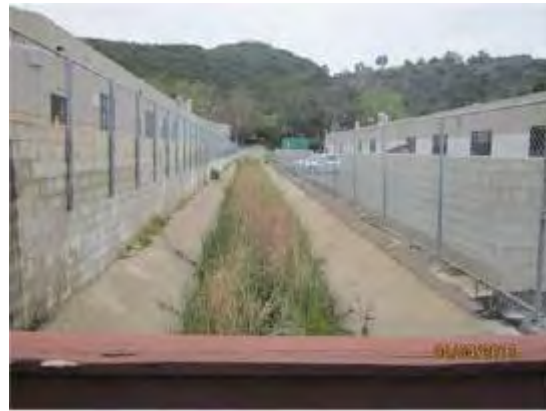
IHHA 69. Flintkote 1: Looking west from approximately 400 feet east of Flintkote Avenue.

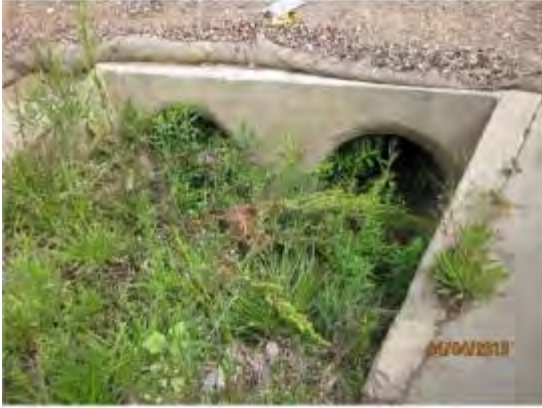
IHHA 79. Flintkote 1: Looking downstream at the double-barrel 36-inch RCP culvert entrance at downstream end of facility group.

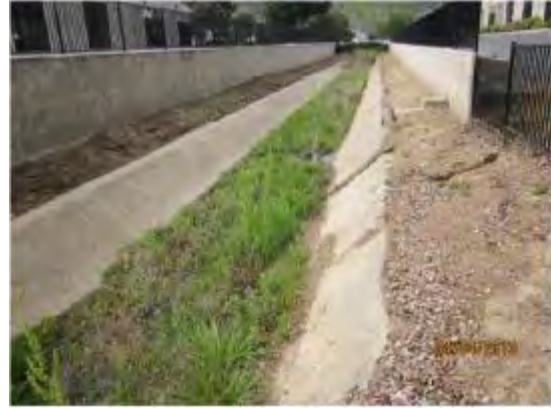
IHHA 87. Flintkote 1: Looking upstream direction from at the double-barrel 36-inch RCP culvert entrance at downstream end of facility group.

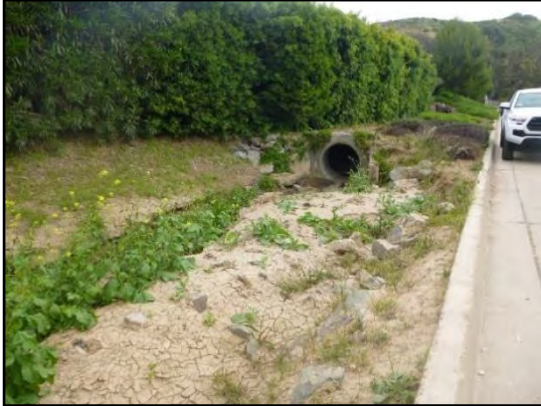
1a. Dunhill 1: Looking upstream at 42-inch-diameter RCP outfall.

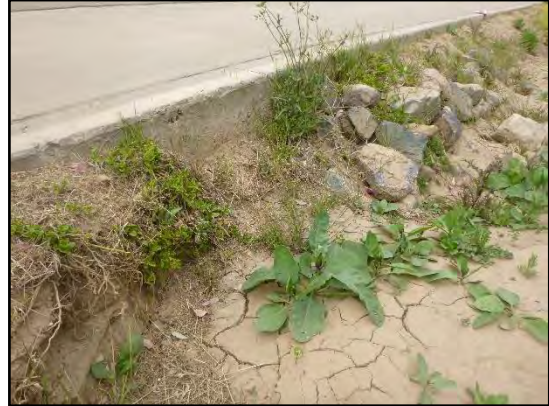
1b. Dunhill 1: Looking at bank erosion along Dunhill Street.

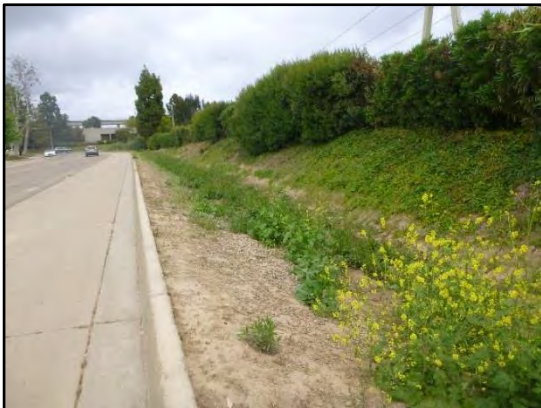
2. Dunhill 1: Looking downstream at vegetation and sediment in Dunhill segment.

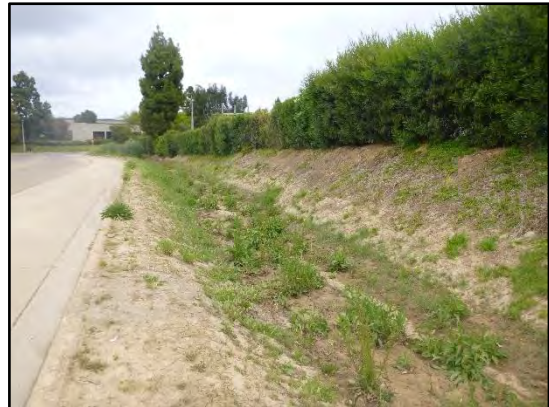
3. Dunhill 1: Looking downstream at vegetation and sediment in Dunhill segment.

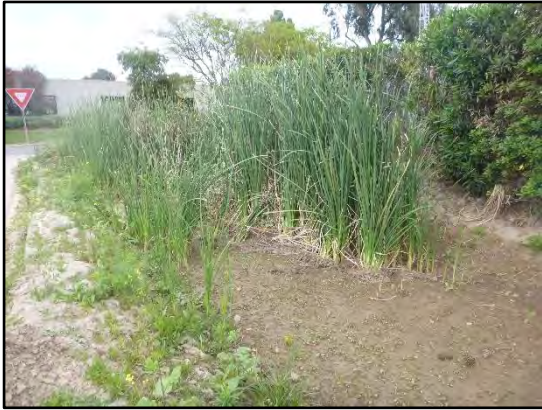
4. Dunhill 1: Looking downstream at vegetation and sediment/debris near downstream culvert inlet.

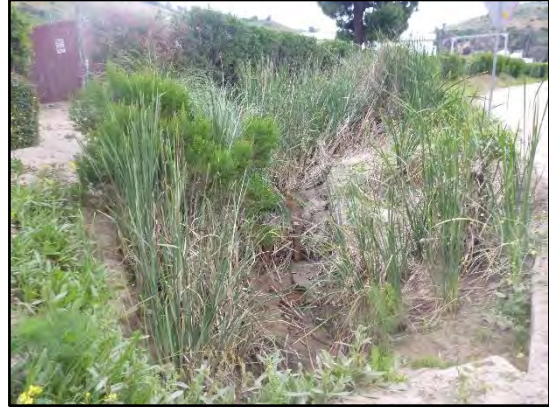
5. Dunhill 1: Looking upstream at debris fence, vegetation, and sediment/debris from downstream culvert inlet.

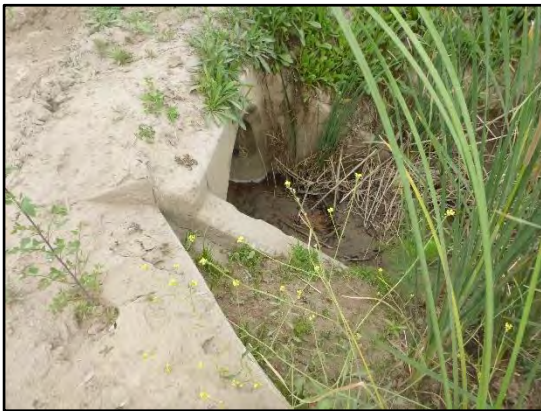
6. Dunhill 1: Looking downstream at entrance to 54-inch-diameter RCP culvert inlet.

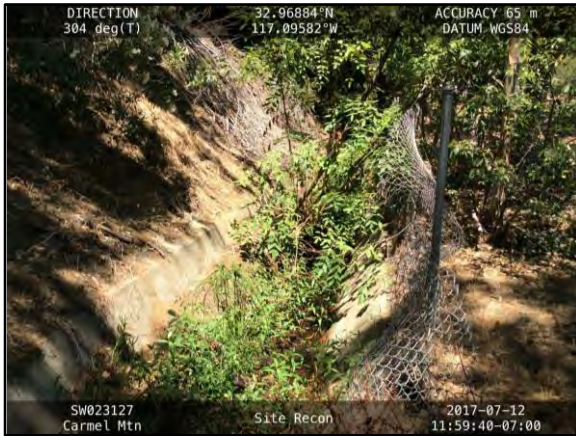
1. Via San Marco 1: Representative of segment with moderate vegetation, looking upstream.

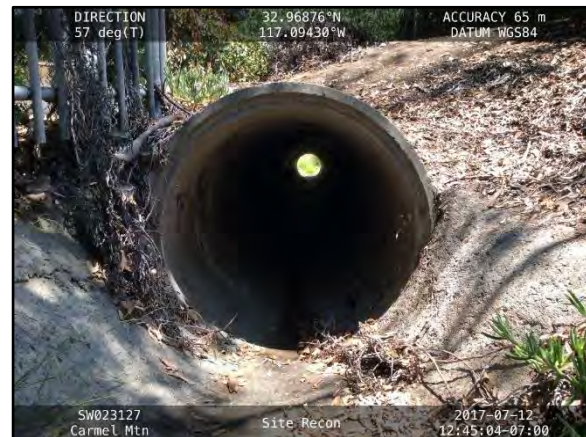
4. Via San Marco 1: Pipe culvert at downstream end of segment, looking northeast (Station 179).

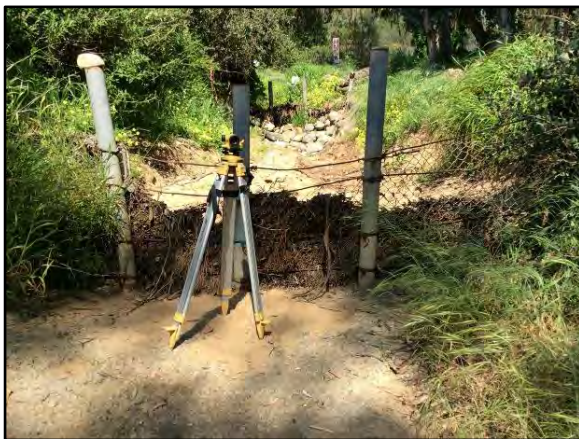
1. Torrey Pines 1: Looking upstream at check dams.

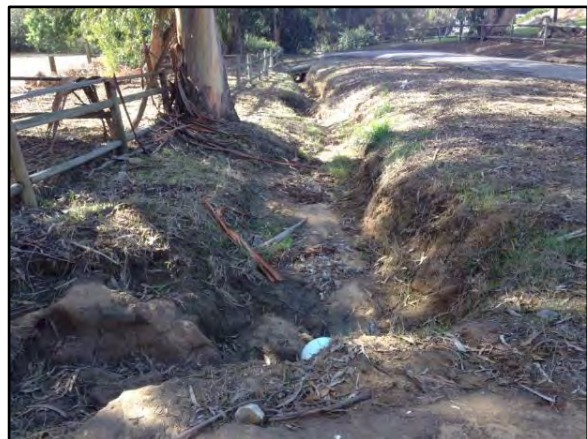
2. Torrey Pines 1: Representative of light weeds in the channel segment.

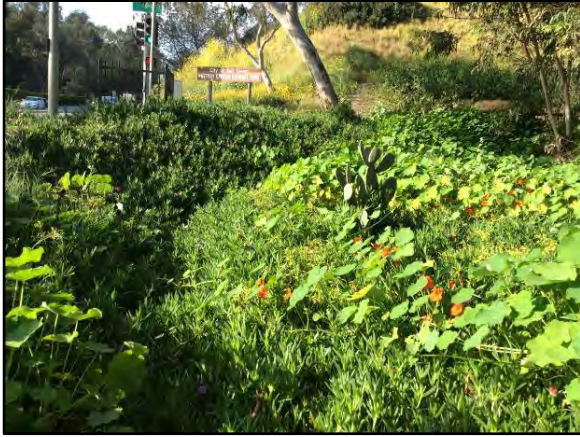
3. Torrey Pines 1: Looking upstream, representative of thick brush in the channel segment.

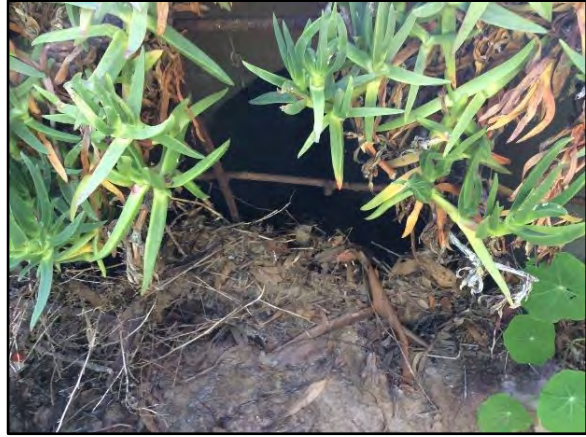
4. Torrey Pines 1: The drop inlet at the downstream end of the channel.

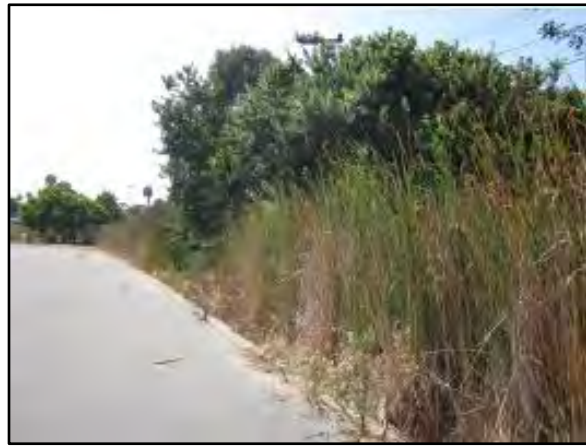
2. IHHA 30. MBHS 1: North edge of southern parking lot looking south. Existing vegetation is 8–10 feet high within the concrete channel.

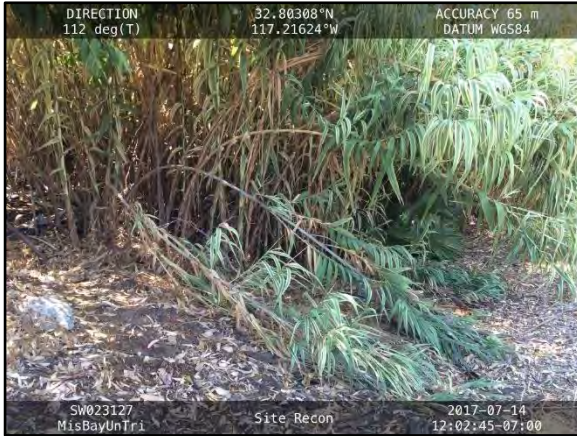
1. Mission Bay Drive 1: At upstream end of channel; culvert not visible.

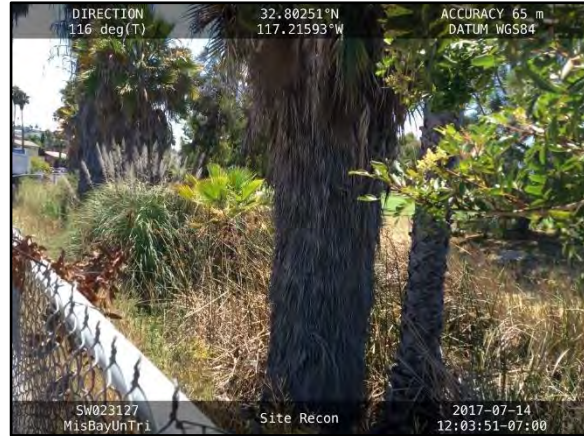
2. Mission Bay Drive 1: Representative upstream channel segment with dense vegetation.

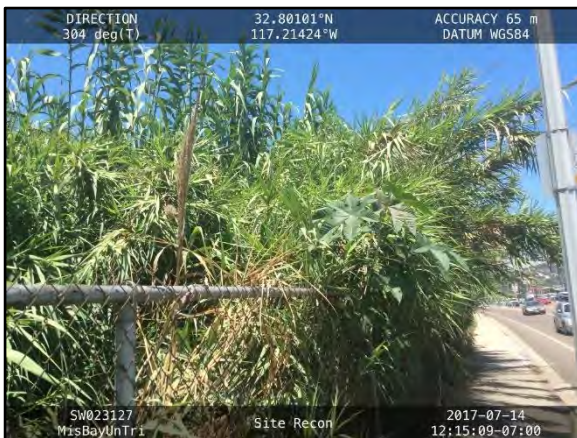
3. Mission Bay Drive 1: Representative downstream channel segment with dense vegetation.

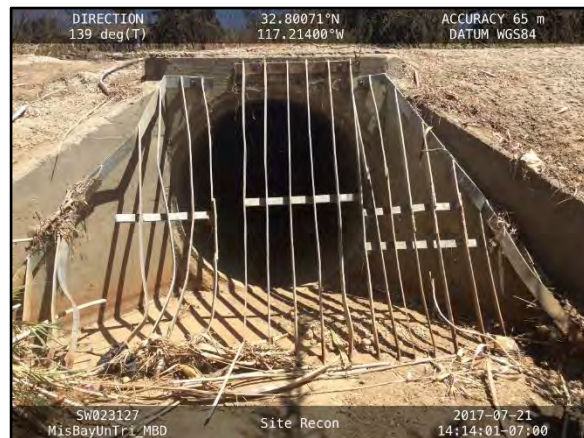
4. Mission Bay Drive 1: Recently maintained culvert inlet at downstream end of segment.

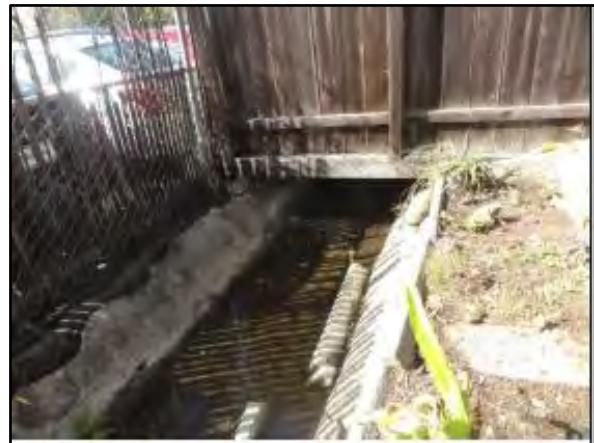
IHHA 6. Engineer 1 (Reach 2): Downstream portion of reach facing west (November 2015).

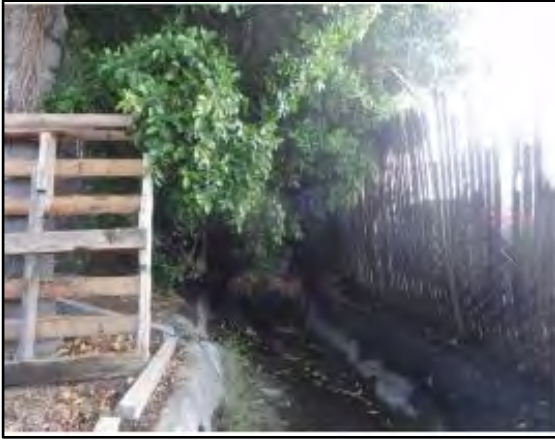
IHHA 8. Engineer 1 (Reach 2): Downstream portion of reach facing east at vegetation blocking the ditch (November 2015).

Facility Type	Bed: Concrete, Asphalt Banks: Concrete, Asphalt	Category 1
Is Maintenance Recommended?	Yes <sup>1</sup>	
Extent of Maintenance <sup>2</sup>	<ul style="list-style-type: none"> <li>Remove accumulated sediment/debris and vegetation from Station 12 to Station 1232.</li> <li>Remove accumulated sediment/debris and vegetation from culverts at Station 12 and Station 1232.</li> </ul>	
Benefit	<ul style="list-style-type: none"> <li>Increases conveyance capacity from 15 cfs to 45 cfs; level of service remains &lt;2-year storm event in Reach 1.</li> <li>Increases conveyance capacity from &lt;10 cfs to 25 cfs; level of service remains &lt;2-year storm event in Reach 2.</li> <li>Increases conveyance capacity from &lt;10 cfs to 40 cfs; level of service remains &lt;2-year storm event in Reach 3.</li> <li>Decreases water surface elevations, reducing the limits and frequency of flooding.</li> </ul>

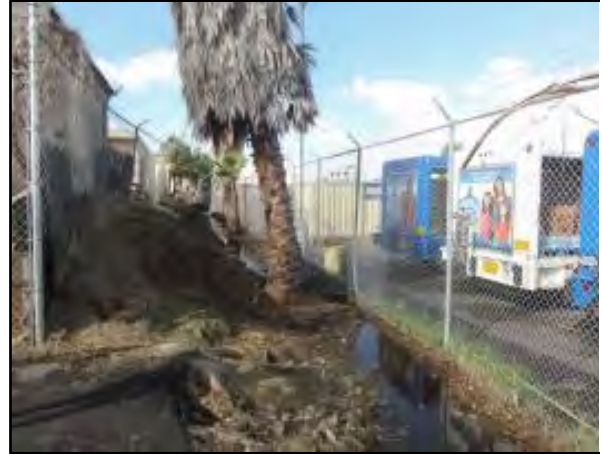
IHHA 15. Engineer 1 (Reach 2): Upstream portion of reach facing west, showing sediment and vegetation in ditch (November 2015).

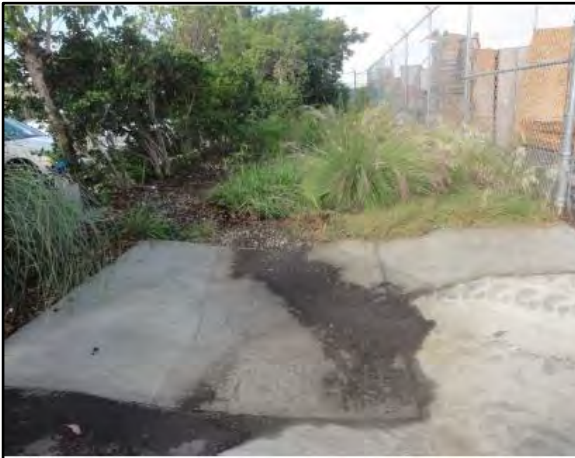
IHHA 20. Engineer 1 (Reach 3): Upstream end of facility group facing west.

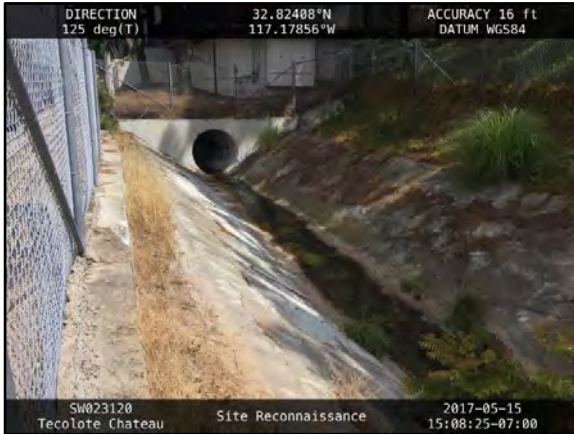
1. Chateau 1: Downstream of 72-inch-diameter CMP culvert beneath Chateau Drive at Paola Way.

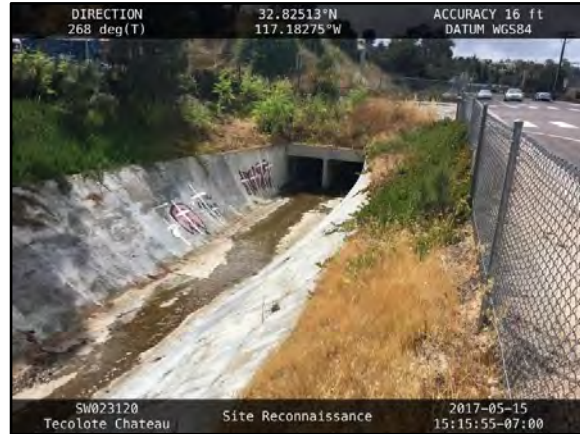
2. Chateau 1: Upstream of double 5-foot-wide by 4-foot-high RCB culvert beneath Derrick Drive.

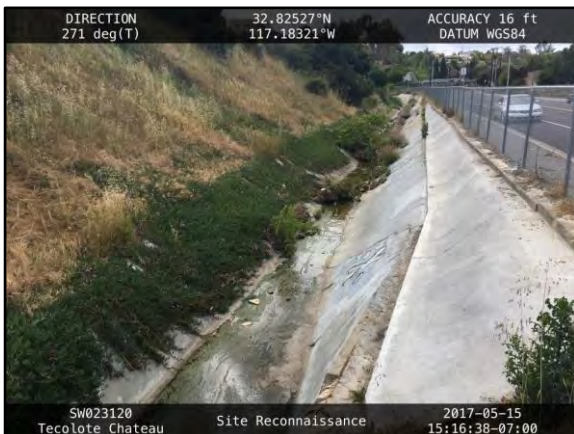
3. Chateau 1: Looking upstream from 10-foot-wide by 4-foot-high RCB culvert at Verley Court.

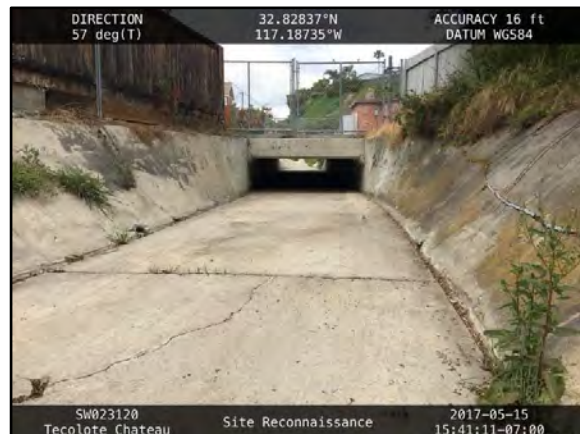
4. Chateau 2: Downstream of 10-foot-wide by 3-foot-high RCB culvert beneath Chateau Drive.

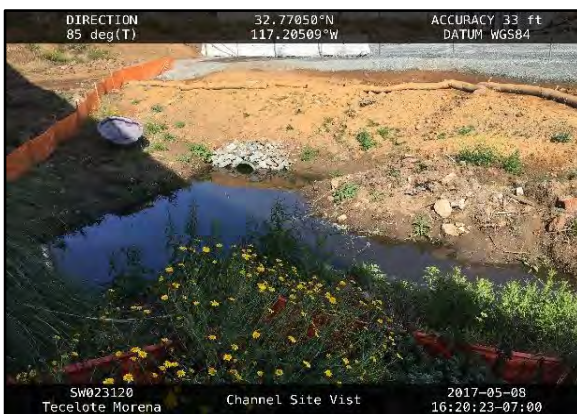
1. Morena 1: Looking upstream, culvert at upstream end of channel.

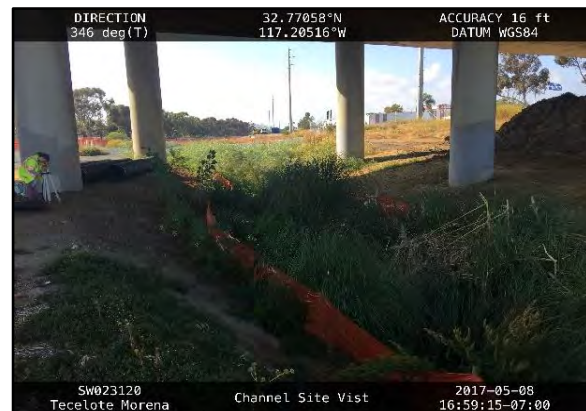
2. Morena 1: Looking downstream, representative of thick vegetation in the channel.

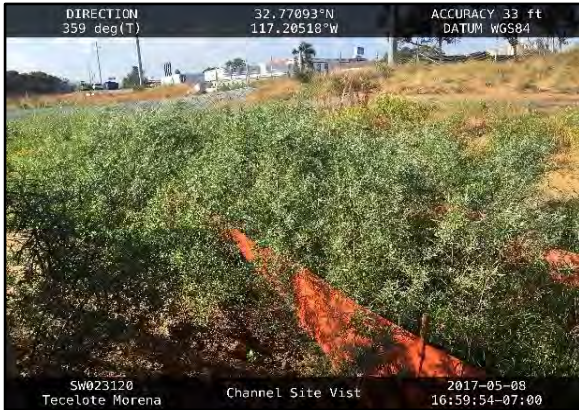
3. Morena 1: Looking downstream, culvert inlet at downstream end of channel covered in vegetation.

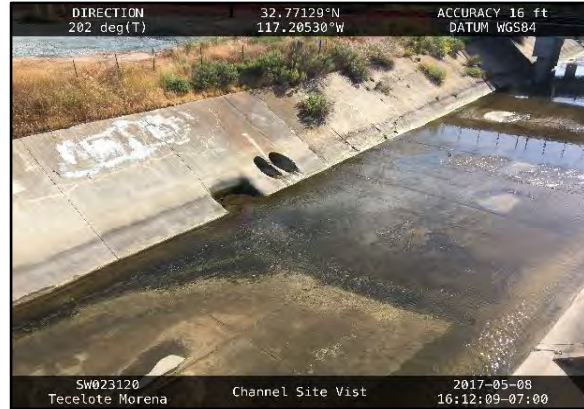
4. Morena 1: Downstream domain of analysis: Outfall into Tecolote Creek.

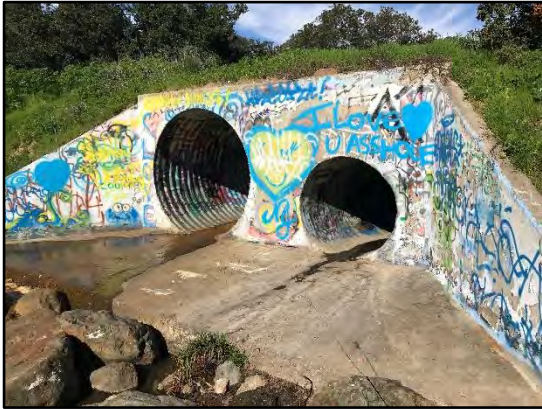
1. Genesee1: Looking upstream at dual 84-inch-diameter and 54-inch-diameter CMP culvert outlet.

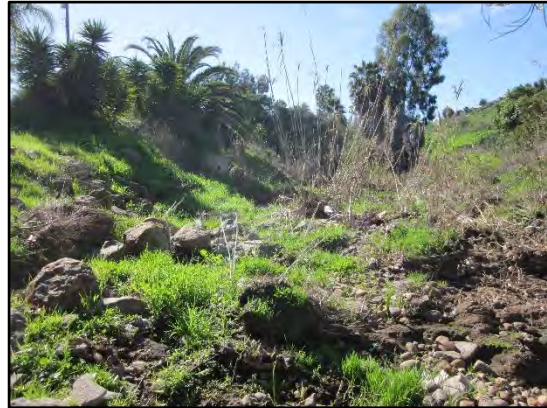
2. Genesee 1: Looking downstream at vegetation and sediment/debris.

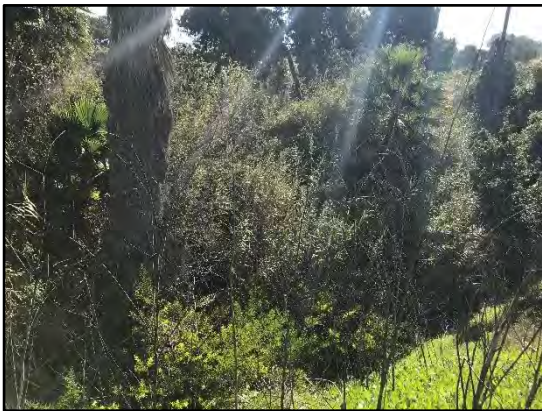
3. Genesee 1: Looking from the western bank (Genesee Avenue) at vegetation.

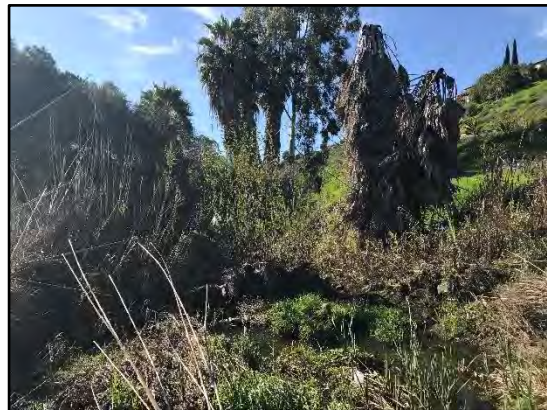
4. Genesee 1: Looking downstream at vegetation and sediment/debris.

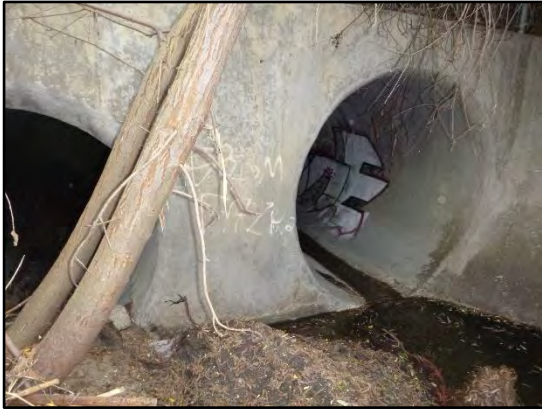
5. Genesee 1: Looking downstream at dual 84-inch-diameter and 72-inch-diameter RCP culvert inlet.

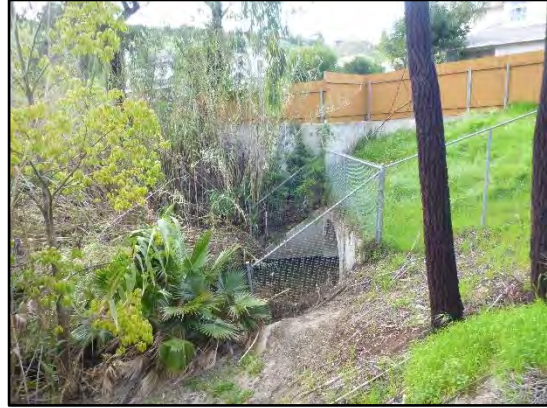
6. Downstream Domain of Analysis: Looking from east bank towards the culvert outlet.

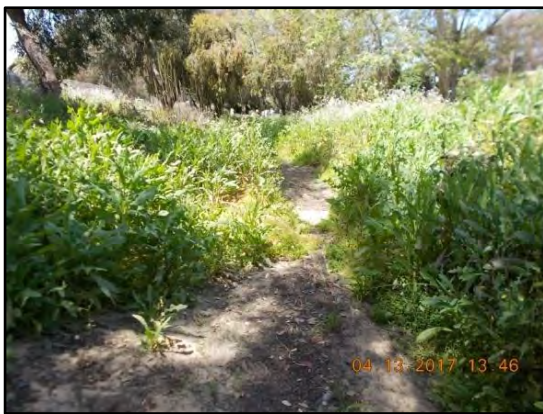
1. Nimitz 3: Looking downstream near upstream end of facility.

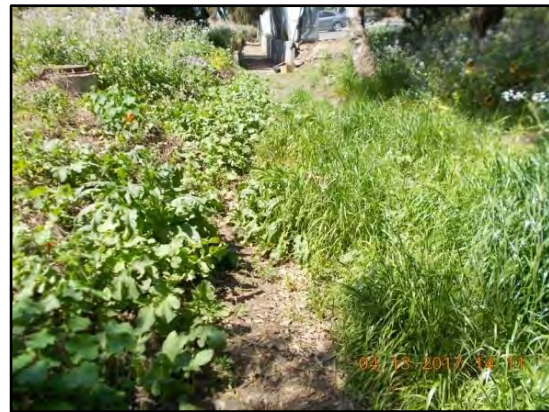
2. Nimitz 3: Looking downstream at vegetation, upstream of transition to Nimitz 2.
