# **APPENDIX I**

## ***Hydrology and Hydraulics Technical Report***

## A.1 Green Valley Creek – Pomerado

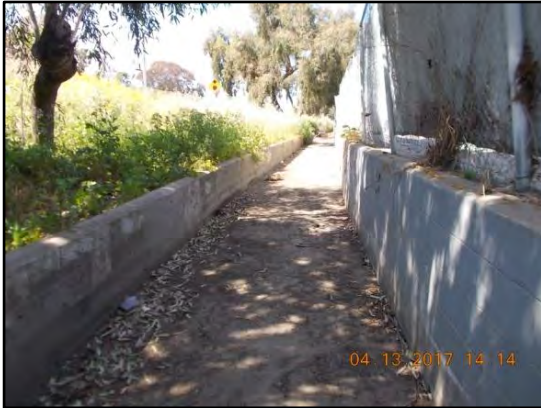
3. Nimitz 2: Looking downstream at debris/sediment at upstream end of concrete ditch.

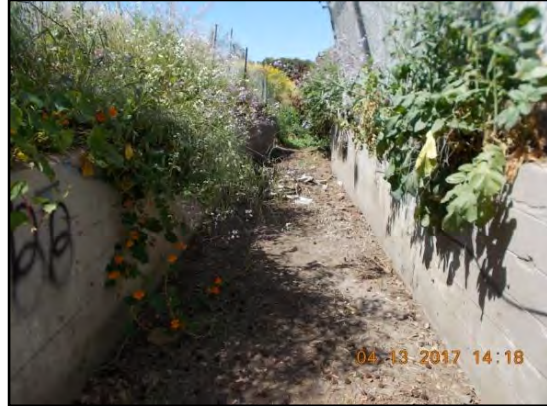
4. Nimitz 2: Looking downstream at sediment/debris near end of concrete ditch.

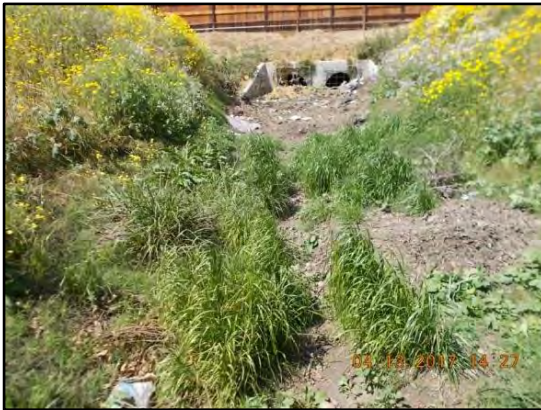
5. Nimitz 1: Looking downstream at sediment/debris in segment and at entrance to dual 54-inch diameter RCP culvert inlet.

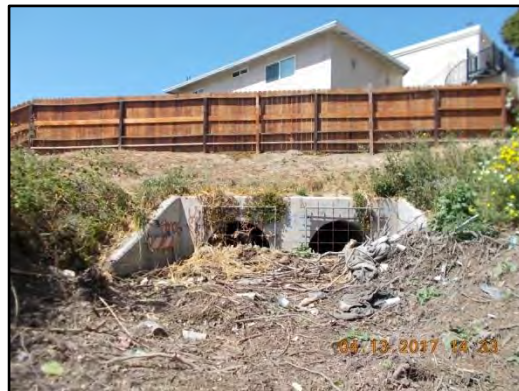
6. Nimitz 1: Looking downstream at dual 54-inch diameter RCP culvert inlet.

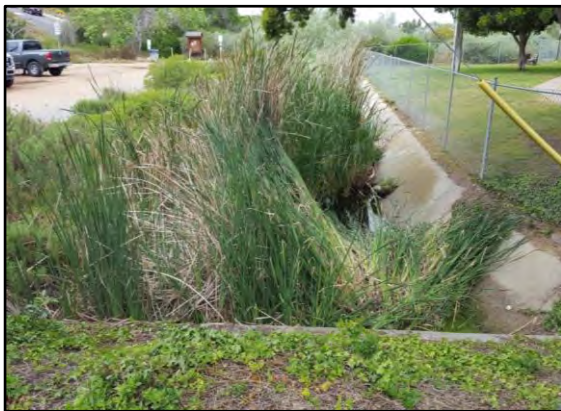
1. Valeta 1: Looking downstream over headwall and 48-inch-diameter and 30-inch-diameter RCP culvert outlet.

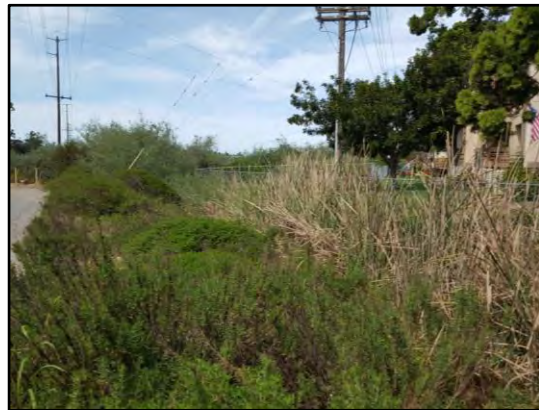
2. Valeta 1: Looking downstream at vegetation in the ditch from the parking lot to the west of the facility.

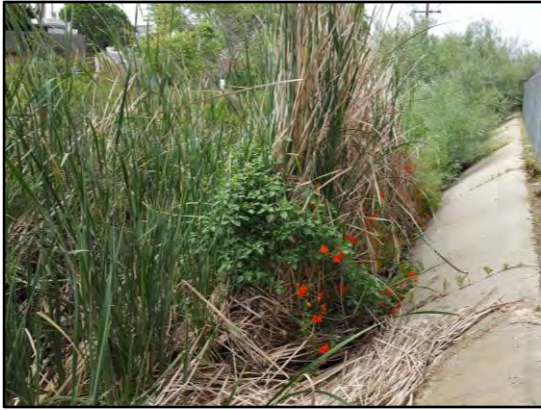
3. Valeta 1: Looking downstream at vegetation in concrete ditch.

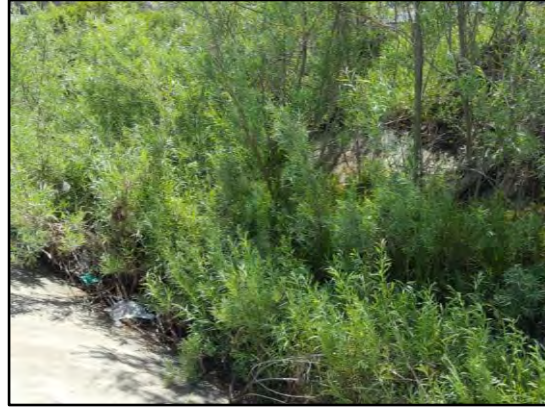
4. Valeta 1: Looking downstream at vegetation.

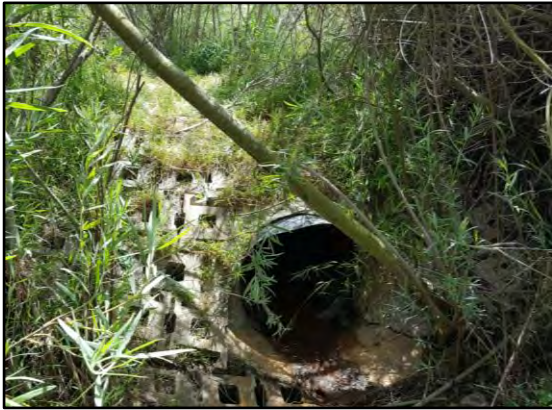
5. Downstream Domain of Analysis: Looking upstream at 24-inch-diameter PVC culvert through pedestrian trail.

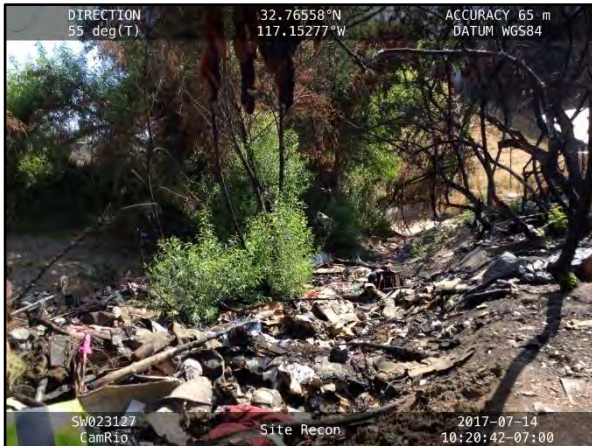
1. Camino del Rio 1: Looking upstream towards the 6.5-foot-wide by 6-foot-high RCB inlet of the Camino del Rio segment.

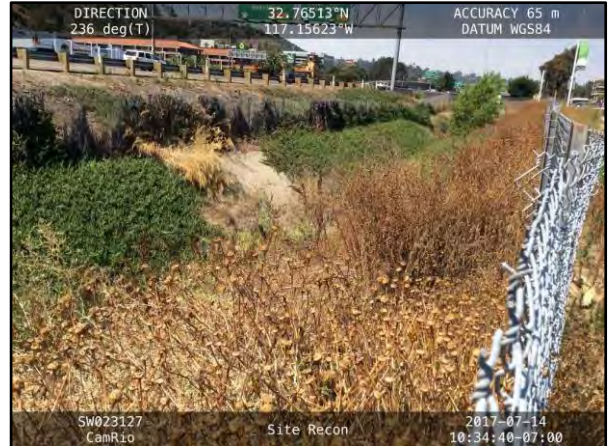
2. Camino del Rio 1: Representative of Camino del Rio segment, looking downstream.

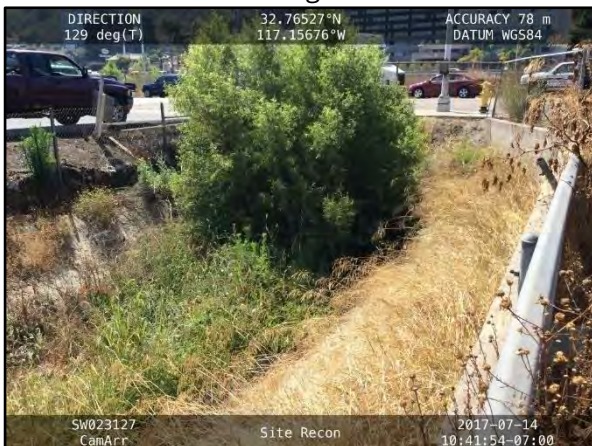
3. Camino del Arroyo 1: Looking upstream towards the 9-foot-wide by 6-foot-high RCB inlet of the Camino del Arroyo segment.

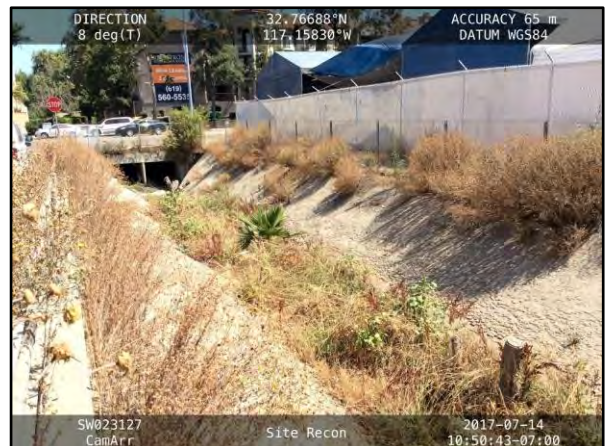
4. Camino del Arroyo 1: Representative of Camino del Arroyo segment, looking downstream.

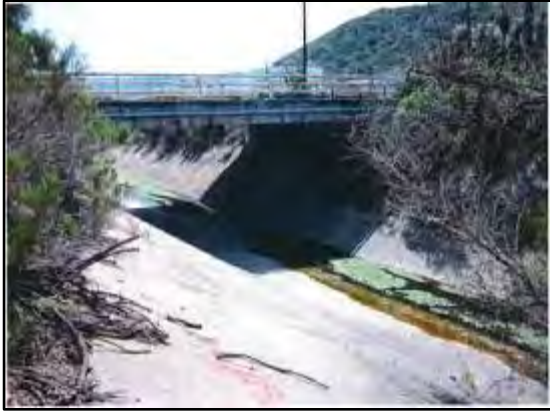
IHHA 20. Murphy Canyon 1, Map 1: Looking downstream towards access road bridge near the upstream limit of concrete channel lining (March 2013).

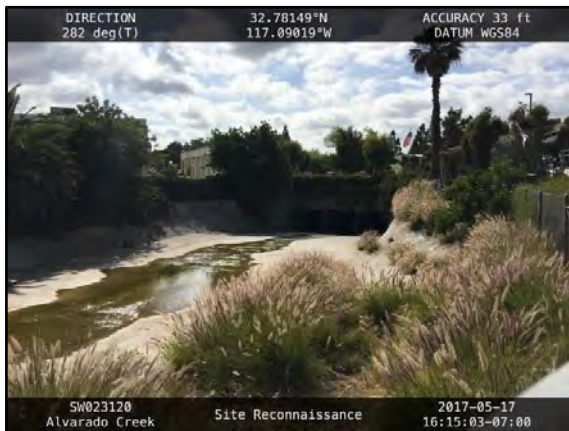
2. Mission Gorge 4, Map 1: Looking downstream at the triple 9-foot-wide by 8-foot-high RCB culvert beneath the I-8 off-ramp to Waring Road.

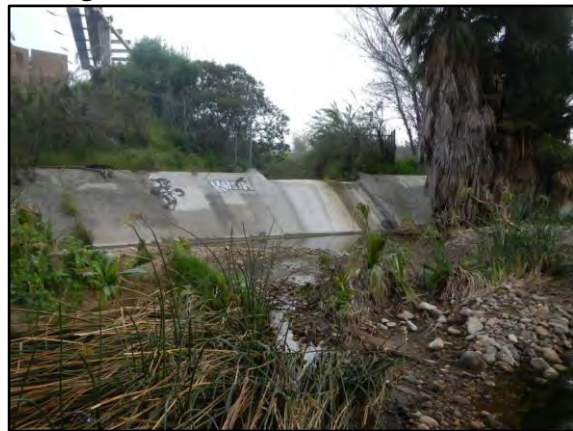
3. Mission Gorge 3, Map 1: Looking at downstream end of segment, towards the triple 11-foot-wide by 8-foot-high RCB culvert beneath Mission Gorge Place.

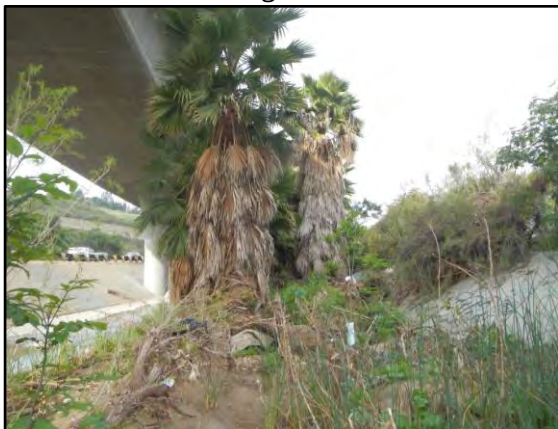
4. Mission Gorge 3, Map 1 (March 2019), Looking north at scour hole at outlet of tributary channel.

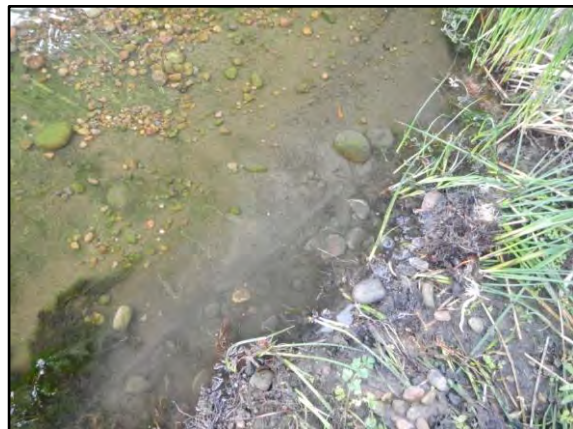
5. Mission Gorge 3, Map 1 (March 2019), Looking downstream adjacent to the overpass. Sediment accumulation, palms, and vegetation evident on right half of channel, left half (lined) is mostly clear.

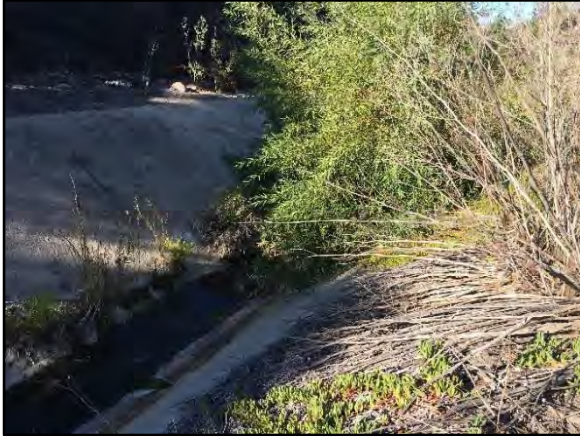
1. Cowles Mountain 1: Upstream of culvert near Station 780 (October 2018).

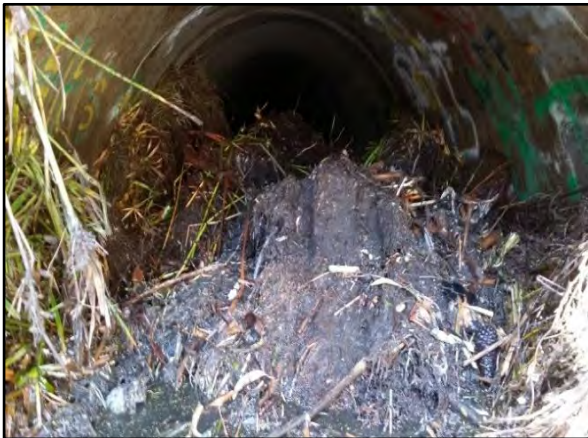
3. Cowles Mountain 2: Culvert under Lake Badin Avenue at Station 1855 (October 2014).

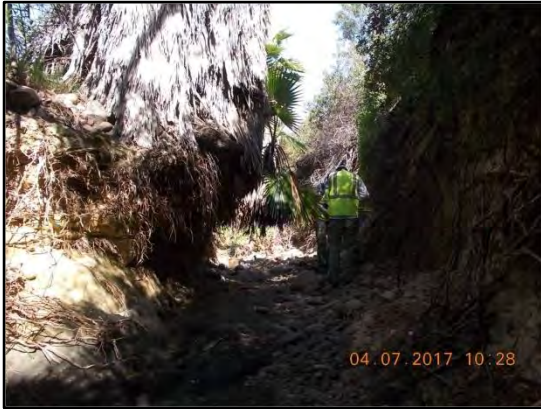
1. Aldine 1: Looking downstream at vegetation, erosion in facility.

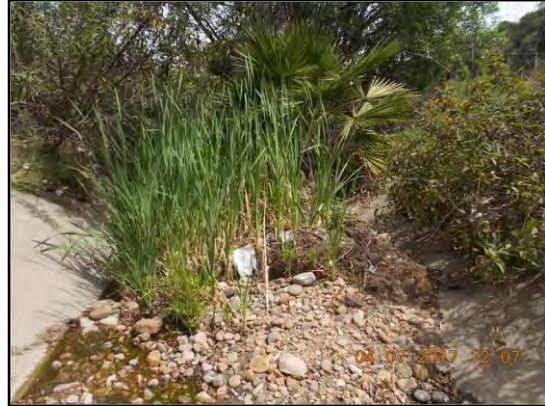
2. Fairmount 4: Looking downstream at sediment/debris and vegetation in concrete ditch.

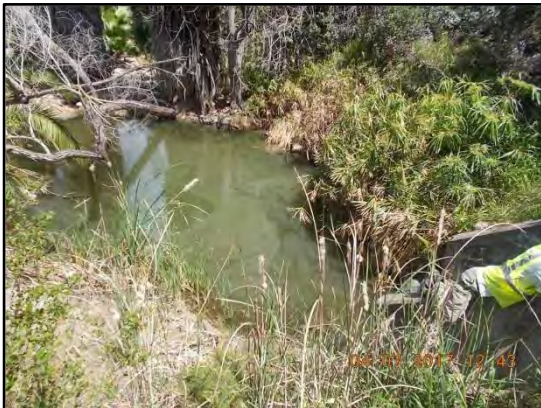
3. Fairmount 3: Looking downstream at scour pool at channel outfall.

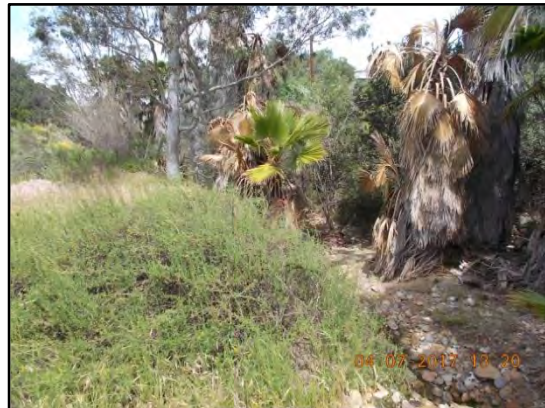
4. Fairmount 3: Looking downstream at vegetation in channel.

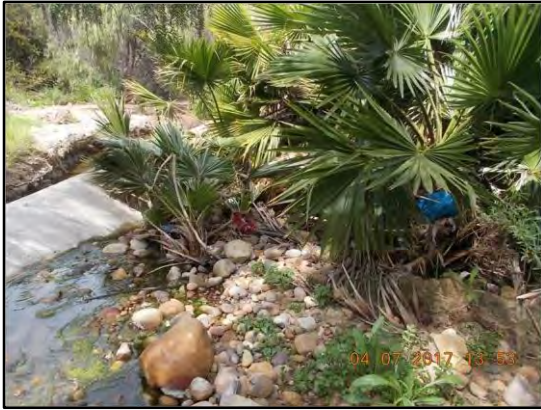
5. Fairmount 2: Looking downstream at sediment/debris and vegetation in concrete ditch.

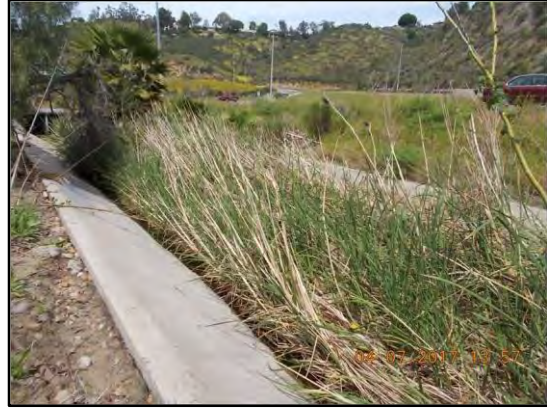
6. Fairmount 2: Looking downstream at vegetation concrete ditch.

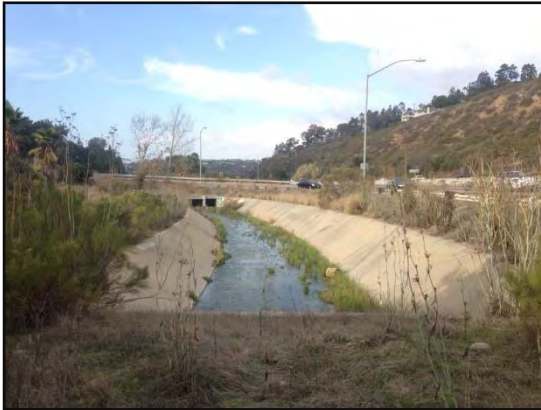
7. Fairmount 1: Looking downstream at concrete channel.

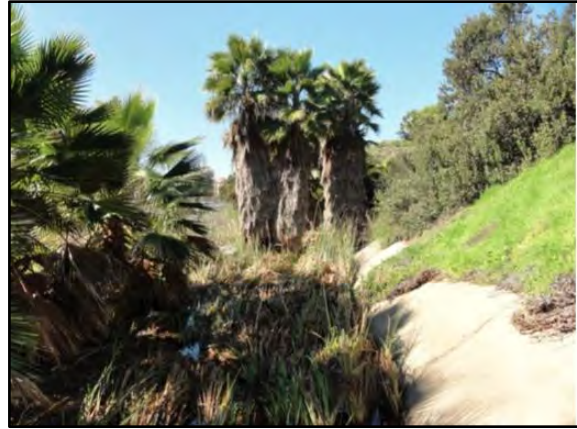
IHHA 7. Baja 1 (Reach 2): Facing downstream towards tulles and downstream palm tree stand.

increase velocities above the permissible velocities for unlined channels. To mitigate this, the recommended maintained condition was modified. The existing palm trees should be cut down, leaving 2-foot-tall stumps with root balls attached, in the ground. All fallen palm tree trunks and debris should be removed. All other existing vegetation, including freshwater marsh species, should be left in place. Vegetation maintenance performed in this manner will increase velocities for earthen bottomed portions of the channel (Stations 281.1765 to 588.967).

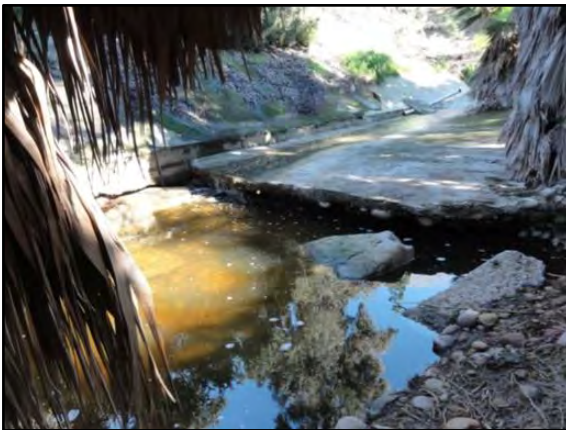
IHHA 9. Baja 1 (Reach 2): Facing the upstream end of Reach 2 towards transition from earthen bottomed to concrete lined immediately downstream of 60-inch-diameter RCP culvert beneath 54th Street.

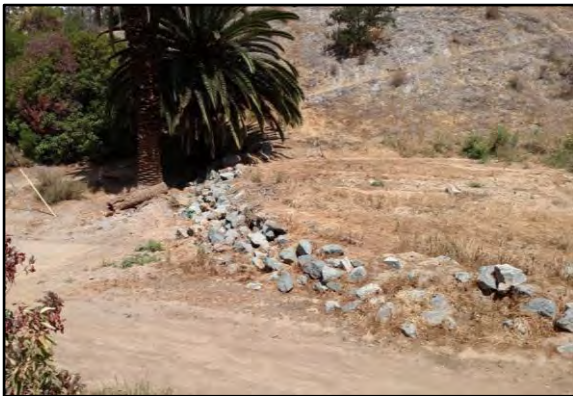
The baseline condition for the Maple Canyon facility group was determined to be the current condition as observed during a site visit in May 2018. The desilting basin is largely unvegetated and the sediment depth was estimated to be approximately 5 feet deep at the west end against the riprap embankment to less than 0.5 feet deep at the east (upstream) end of the basin. Ponded water was not observed within the basin area. The photos in the Representative Photos section below provide examples of the condition of the facility as observed during the May 2018 site visit.

3. Maple Canyon: Basin completely filled with sediment.

Facility Type	Desilting Basin: Earthen	Category 3
Is Maintenance Recommended?	Yes <sup>1</sup>	
Extent of Maintenance	<ul style="list-style-type: none"><li>Remove accumulated sediment/debris and vegetation from the desilting basin.</li></ul>	
Benefit	<ul style="list-style-type: none"><li>Reduces the amount of sediment that discharges from the canyon.</li></ul>

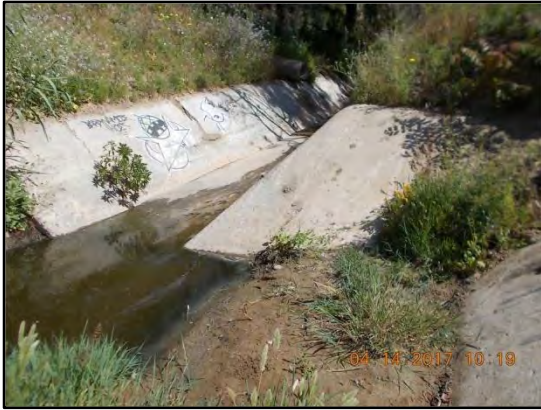
3. Washington 1: Looking upstream at transition from Washington 2 (April 2017).

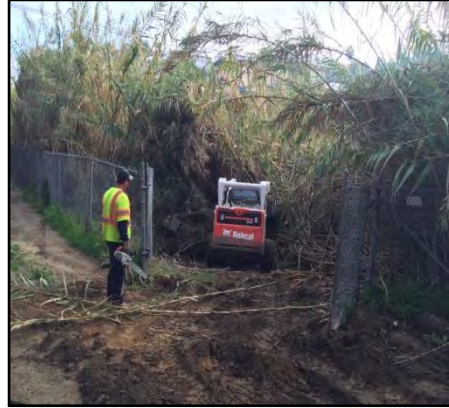
4. Washington 1: Looking downstream at vegetation during January 2016 maintenance.

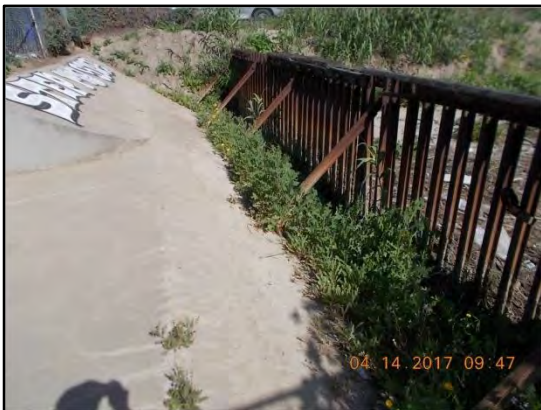
5. Washington 1: Looking northwest, across the facility at debris fence and elevated drop structure shown (April 2017).

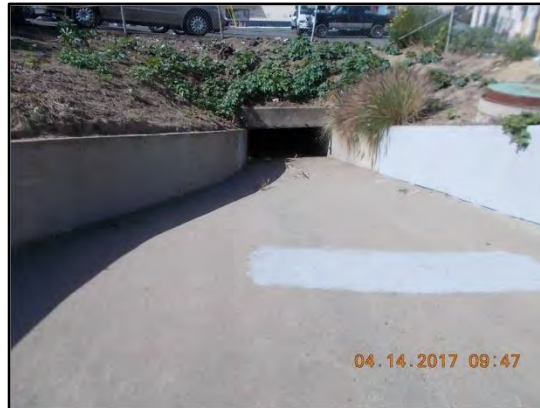
6. Downstream Domain of Analysis: Looking downstream at entrance to 2.5-foot by 6.5-foot RCB culvert inlet (April 2017).

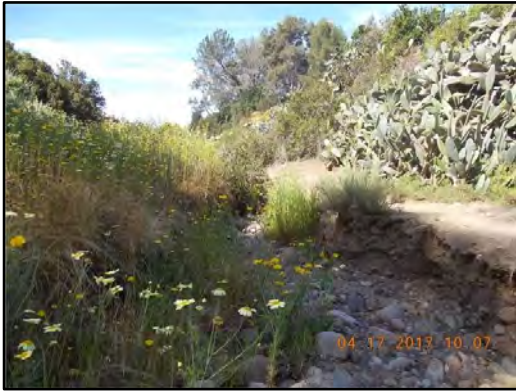
1. Titus 1: Upstream domain of analysis, Looking downstream at vegetation in canyon.

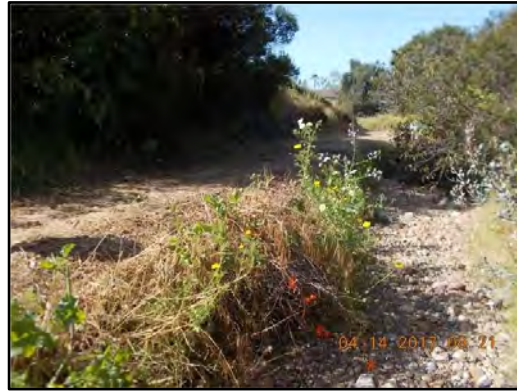
2. Titus 1: Looking downstream at vegetation

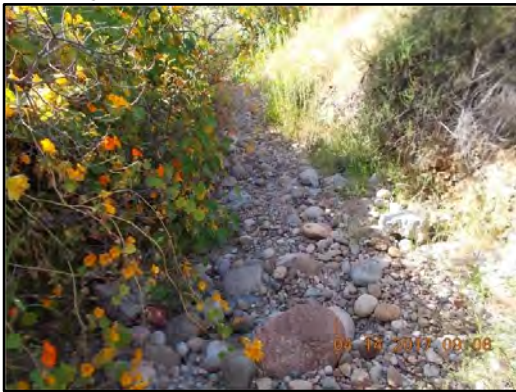
3. Titus 1: Looking downstream at vegetation and rock channel bottom.

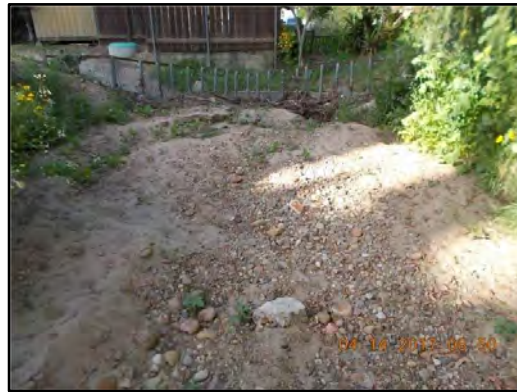
4. Titus 1: Looking downstream at sediment/debris accumulated at debris fence.

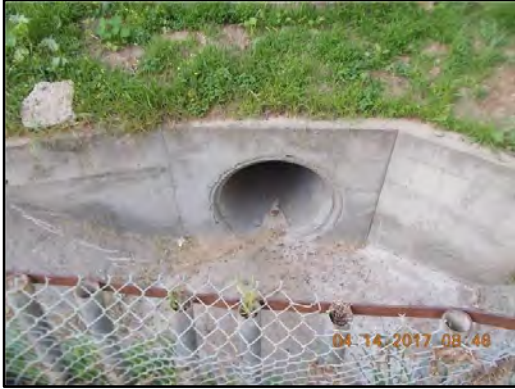
5. Titus 1: Looking downstream at 42-inch-diameter RCP culvert inlet.

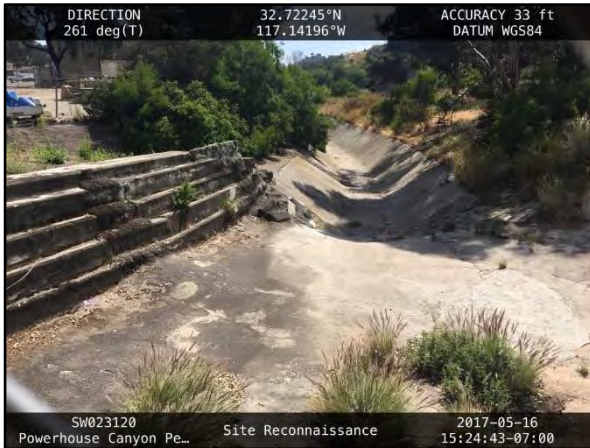
1. Pershing 1: Looking downstream from the upstream end of the segment at 26th Street.

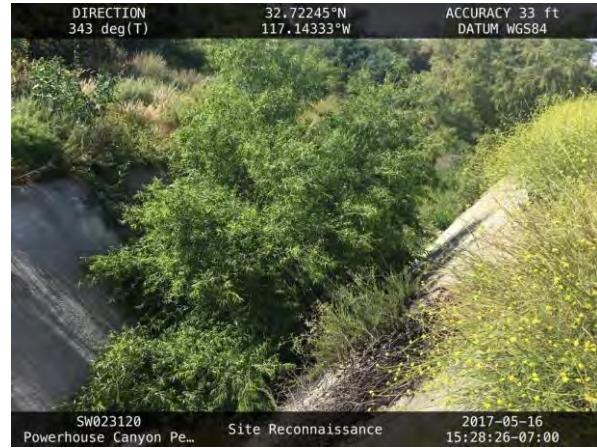
2. Pershing 2: Looking upstream from the Pershing Drive bridge.

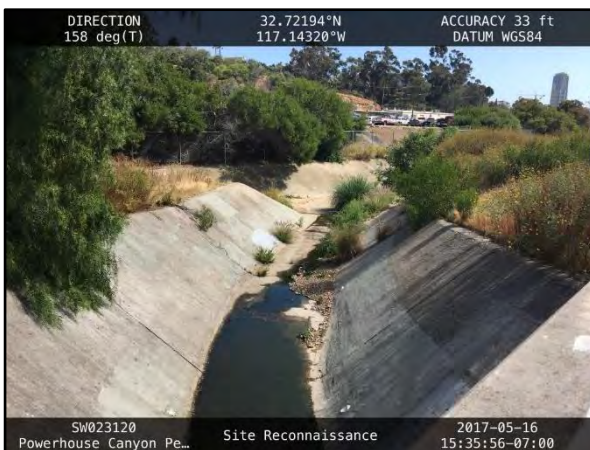
3. Pershing 2: Looking downstream at the confluence with Pershing 1 shown to the upper left.

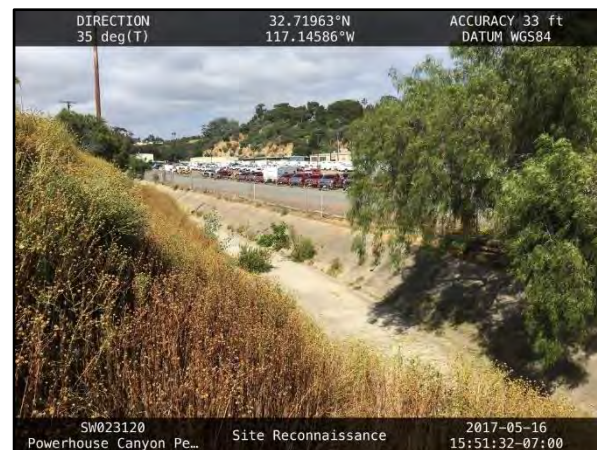
4. Pershing 1: Looking upstream near the downstream end of the segment.

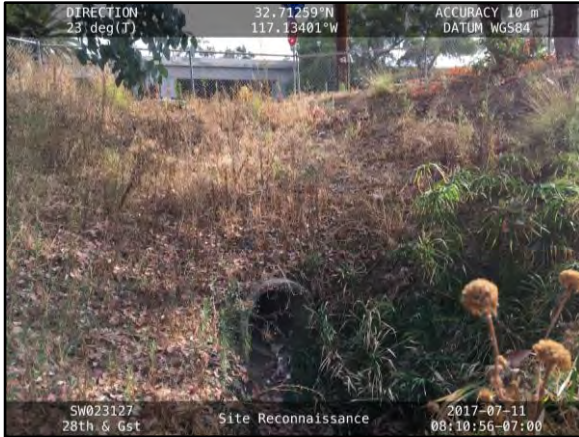
1. 28th St 1: RCP culvert outlet at upstream end of segment.

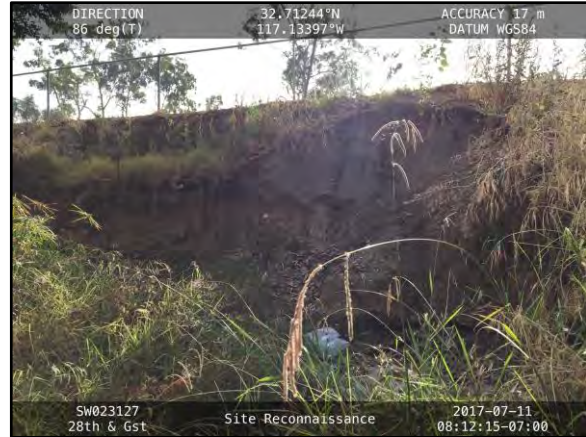
2. 28th St 1: Eroded eastern sidewall.

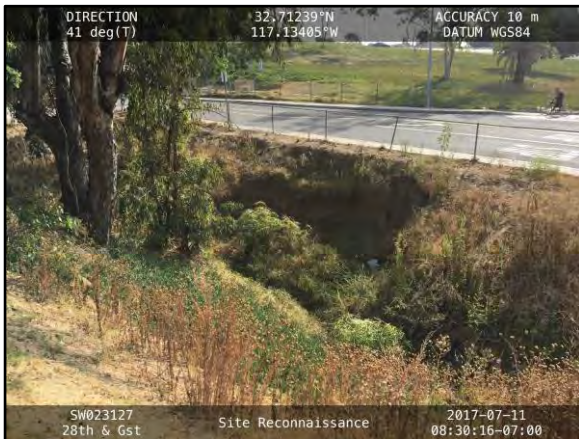
3. 28th St 1: Looking upstream towards the eroded eastern sidewall.

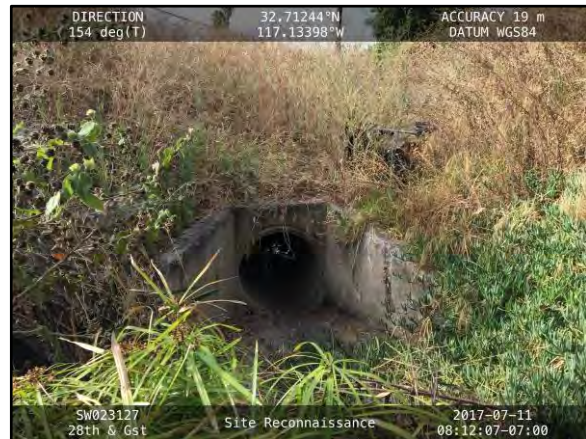
4. 28th St 1: 30-inch-diameter RCP culvert at downstream end of segment.

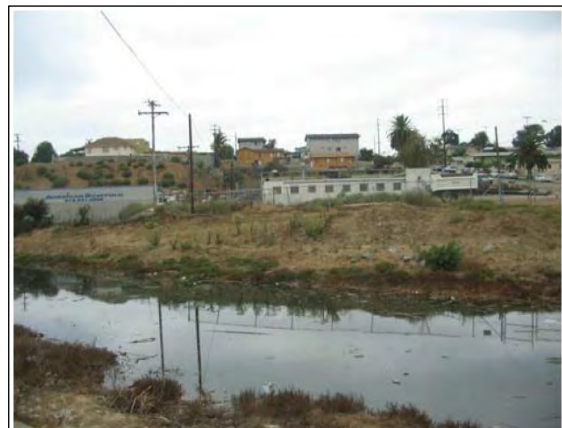
2. IHHA 4. National 1: Looking downstream, representative of low vegetation.

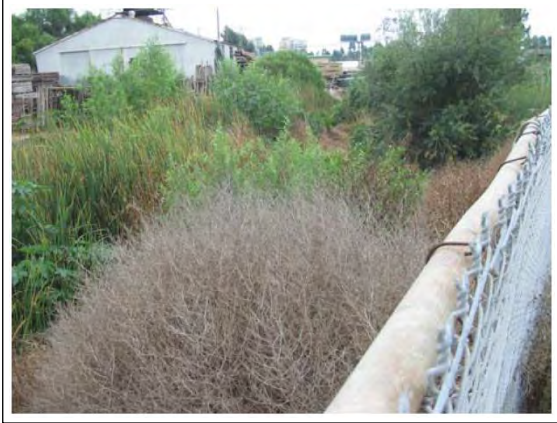
3. IHHA 5. National 2: Looking downstream, representative of dense vegetation.

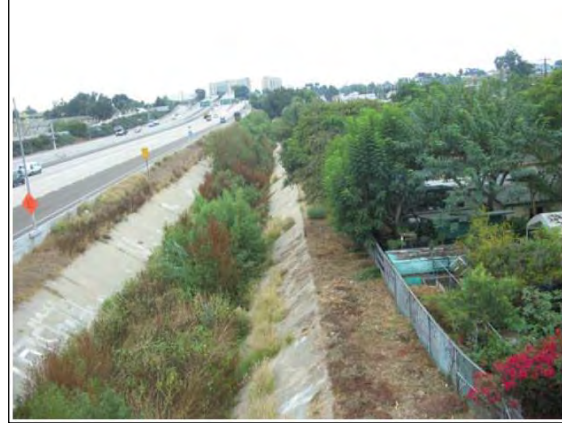
4. IHHA 6. National 2: Looking downstream, representative of medium to dense vegetation.

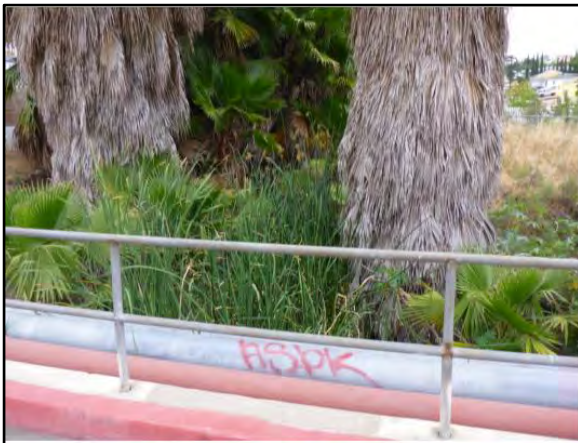
1. Rolando 2: Pre-maintenance; looking upstream from downstream end of segment.

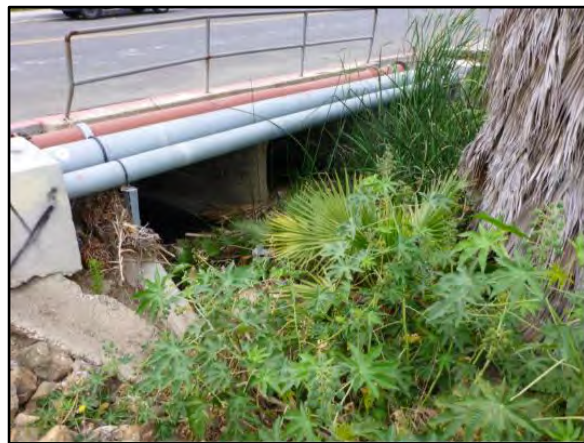
2. Rolando 2: Pre-maintenance; looking towards the double 8-foot wide by 5-foot, 2-inch tall RCB culvert at downstream end of segment.

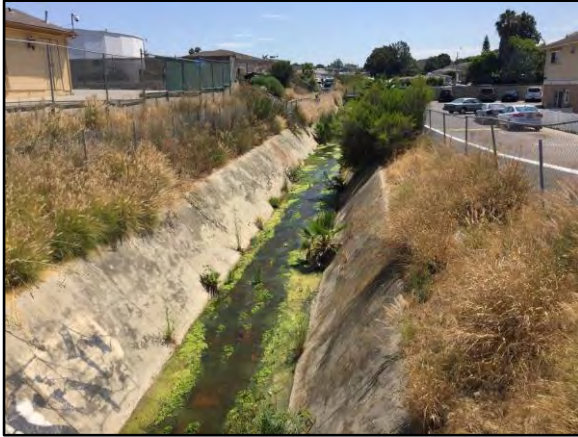
3. Rolando 1: Looking upstream from downstream end segment.

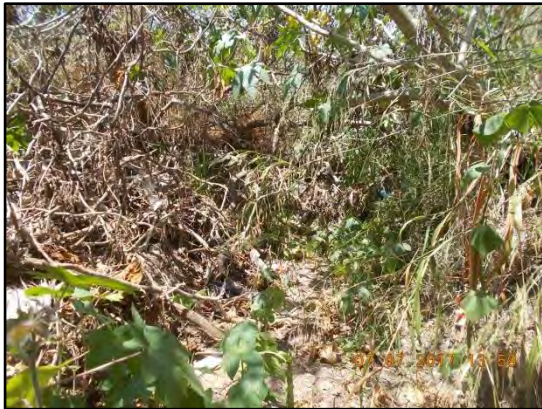
1. Martin 1: Looking upstream at vegetation density in upstream reach.

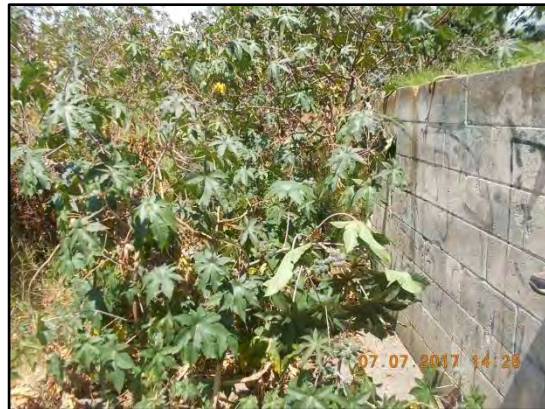
2. Martin 1: Looking upstream at retaining wall/walkway and vegetation in upstream reach.

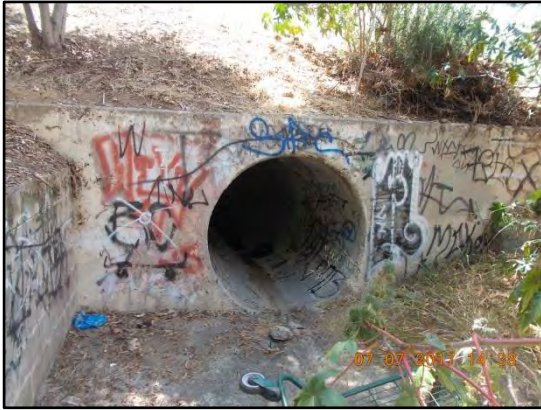
The HEC-RAS modeling results show that the conveyance capacity of the facility is restricted by the 60-inch-diameter RCP culvert under I-15, and the floodplain extends well within various private properties' open space areas. Therefore, additional analysis is recommended to evaluate potential increases in the level of service that could be achieved by capital improvements to address restrictions at the two 60-inch-diameter RCP culverts.

3. Martin 1: Looking downstream at 60-inch-diameter RCP culvert entrance under 35th Street.

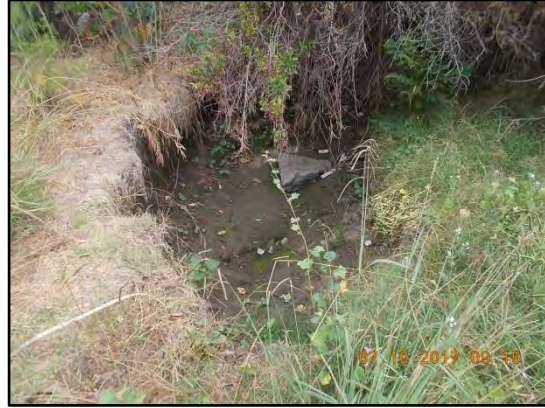
Because the baseline condition modeling showed velocities outside the permissible range for a vegetated channel and the evidence of scour in the downstream reach in the current condition, maintenance was scaled back. In addition, several hydraulic modeling scenarios were analyzed which showed maintenance activities such as vegetation removal, trimming, or grubbing/mowing do not improve the facility capacity.

4. Martin 1: Looking downstream at scoured channel bed.

The recommended maintenance consists of filling and compacting of the scoured area and contouring the filled area of the channel bed with a constant slope from Station 616 to Station 496. The level of service after these maintenance activities will remain unchanged at less than the 50-year storm, or 228 cfs, due to the limited capacity of the culvert at Station 233.

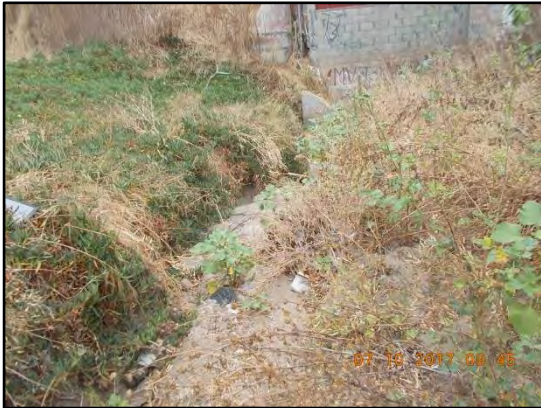
5. Martin 1: Looking downstream at 60-inch-diameter RCP culvert entrance (below concrete block wall).

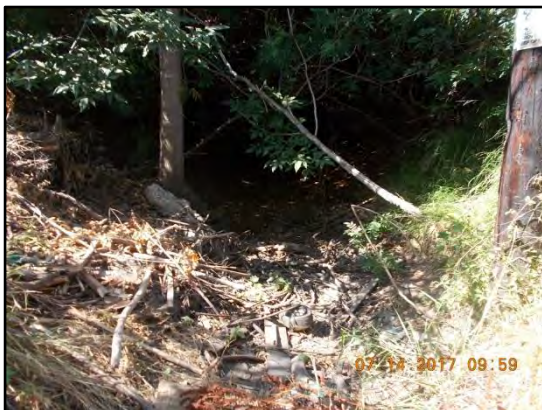
1. J St 1 (Reach 2): Looking downstream at vegetation in upstream reach

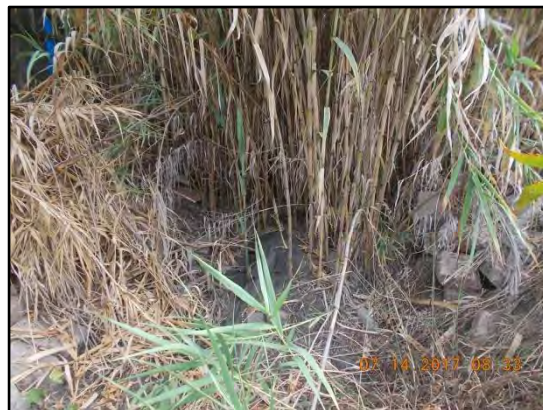
2. J St 1 (Reach 2): Looking upstream at invasive vegetation

The recommended maintained condition for the J Street facility group includes trimming vegetation and removal of invasive vegetation between Station 193 and Station 10. The Manning's coefficients in the recommended maintained condition vary from 0.018 for the concrete pad at the culvert entrance to 0.030 for the trimming/removal of invasive vegetation within the channel bottom. The Manning's coefficient values for Reach 2 upstream of Station 193 remained unchanged since no maintenance is proposed. Station 193 is the approximate end of the invasive vegetation that is recommended to be removed and the reach conveys the 100-year storm event in the current condition upstream of Station 220.

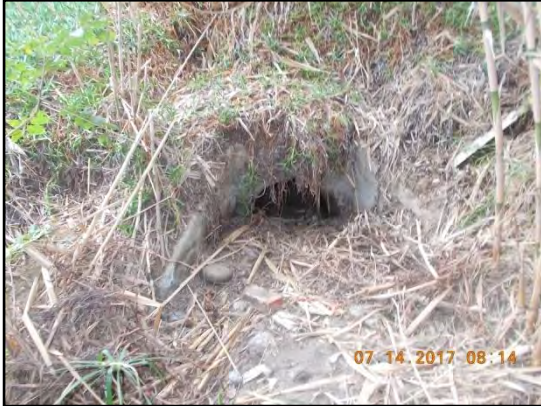
3. J St 1 (Reach 1): looking upstream at 24-inch-diameter culvert outlet

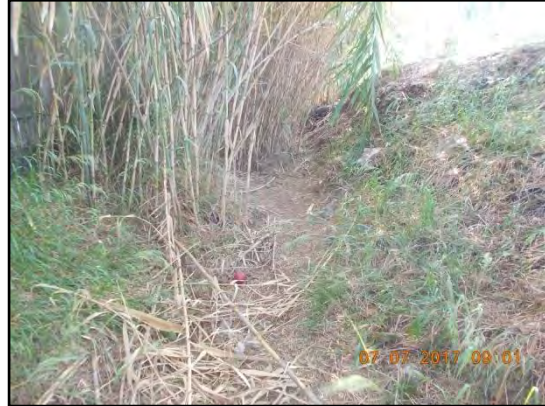
4. J St 1 (Reach 1): Looking upstream at invasive vegetation

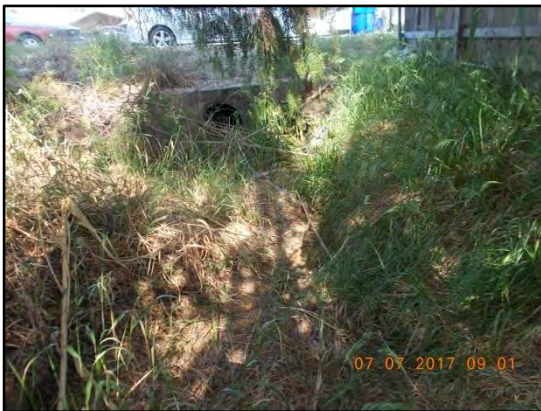
5. J St 1 (Reach 1): Looking downstream at 30-inch-diameter RCP culvert inlet on east side of Toyne Street

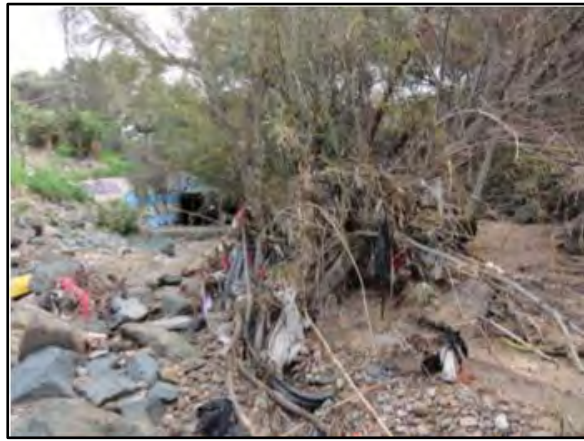
IHHA 4. Home 2, Map 1: Looking upstream at the vegetation and displaced riprap downstream of the double 7-foot wide by 6-foot tall RCB culvert.

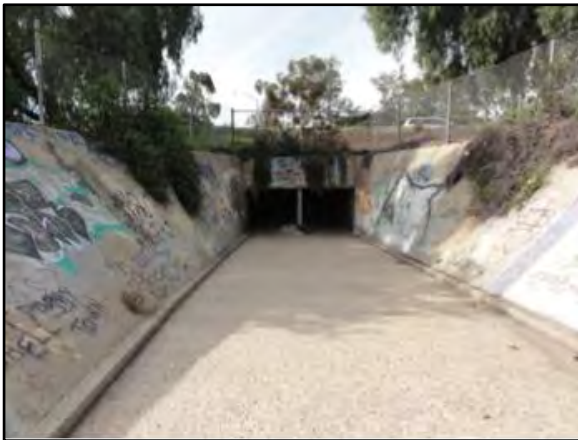
IHHA 6. Home 3, Map 1: Looking downstream towards 7-foot wide by 6-foot tall double RCB culvert. Note clean channel.

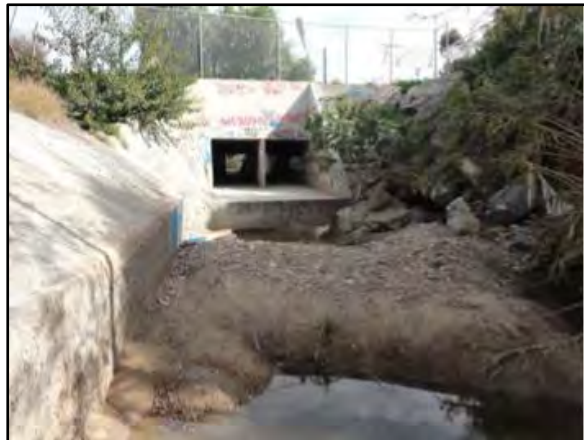
IHHA 10. Home 4, Map 1: Looking upstream at the double 6-foot wide by 6-foot tall RCB culvert. Note the standing water and erosion at culvert outlet.

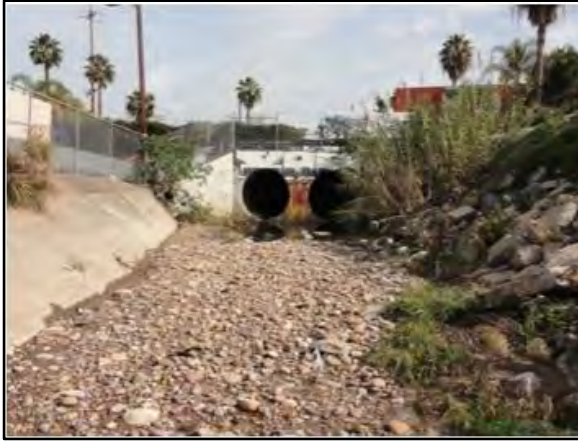
IHHA 13. Home 5, Map 1: Looking upstream at the double-barrel 74-inch-diameter RCP culvert.

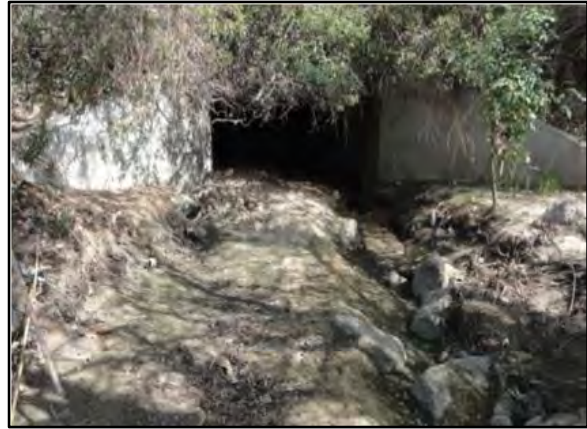
1. Home 1, Map 2: Looking the upstream end of the segment towards the 12-foot wide by 6-foot tall RCB culvert under Terrace View Villas.

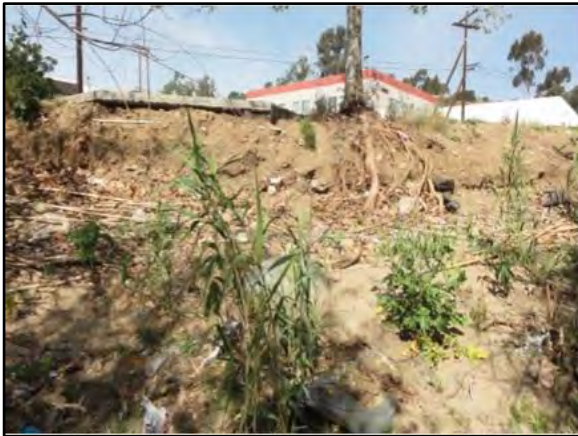
2. Home 1, Map 2: Standing at the upstream end the segment, looking west where erosion occurs along Home Avenue.

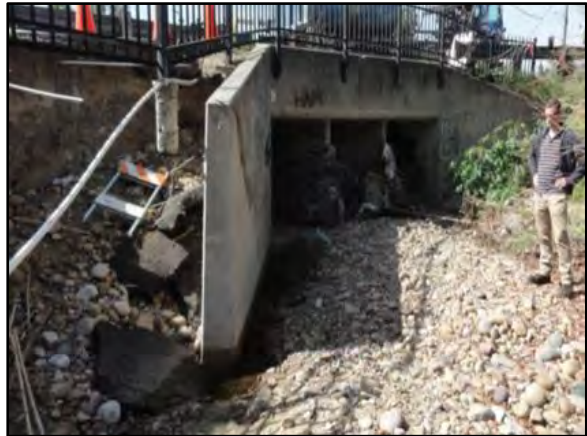
3. Home 1, Map 2: Standing along east bank of segment, looking southwest at erosion behind east wing wall at downstream end.

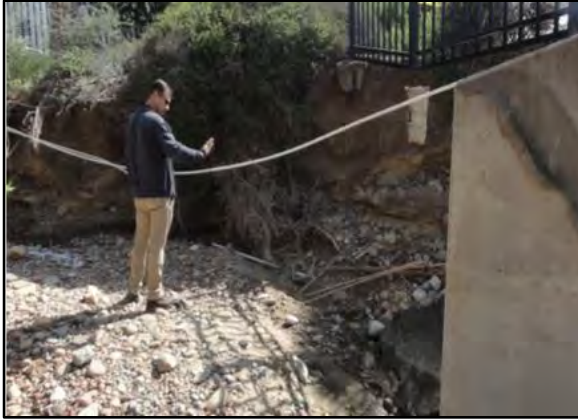
4. Home 1, Map 2: Standing at downstream end of segment, looking northeast at erosion along the east bank of the channel.

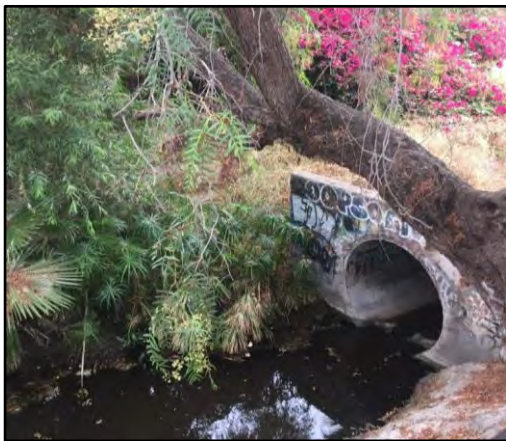
1. Oakcrest 1: Looking upstream at RCP storm drain system outlet.

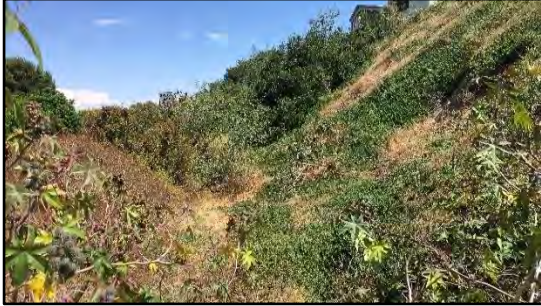
1. Megan 2: looking upstream near upstream end at vegetation.

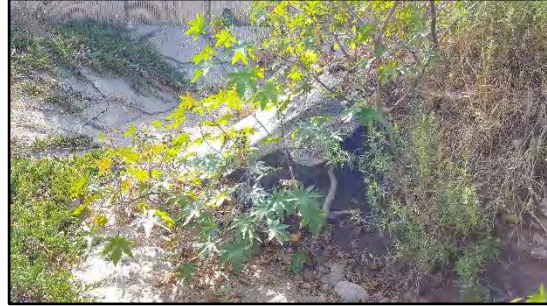
2. Transition between Megan 1 and 2: Looking downstream at eroded area behind right concrete bank.

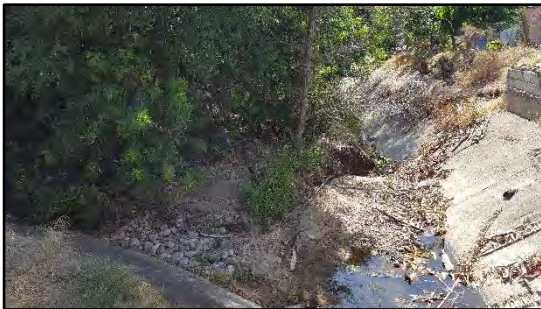
5. Megan 1, Reach 1: Looking downstream from 90-degree bend.

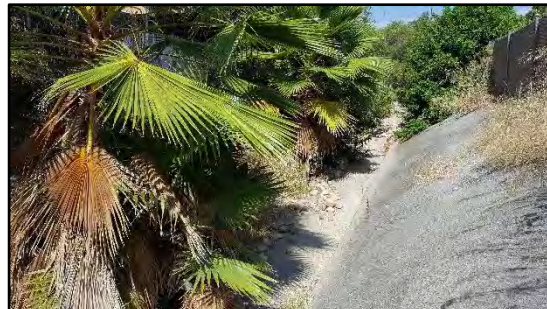
6. Megan 1, Reach 1: Looking upstream at concrete bank and vegetation.

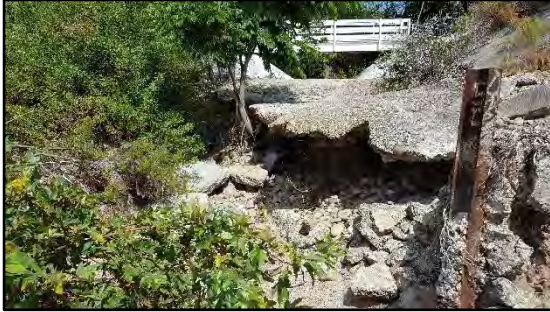
7. Megan 1, Reach 1: Looking upstream at erosion under concrete bottom at ditch outfall to Chollas Creek.
