## A.44 Chollas Creek – 54th Street (No. 5-04-280)

### Summary of Recommended Maintenance

## Attachment A: Hydrology and Hydraulics Fact Sheets

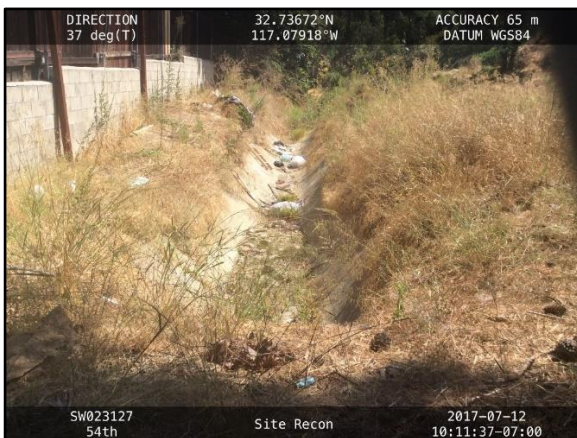
1. 54th St 1: Looking upstream.

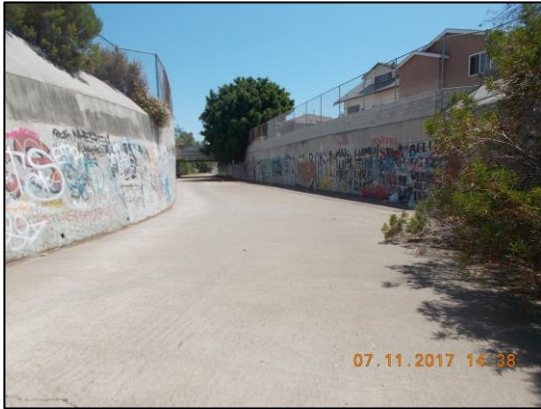
1. Ocean View 1 (Reach 10): looking downstream toward the Ocean View Boulevard bridge.

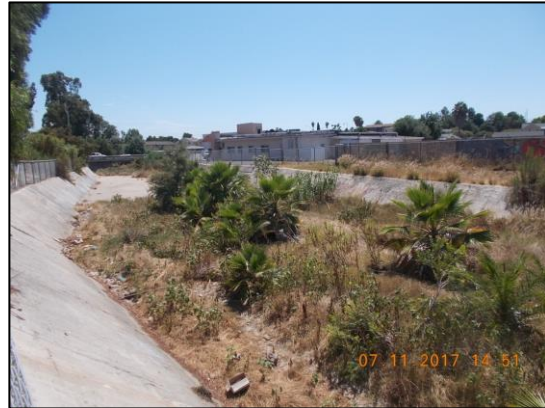
2. Ocean View 1 (Reach 8): looking downstream toward the start of the Reach 7 concrete bottom channel.

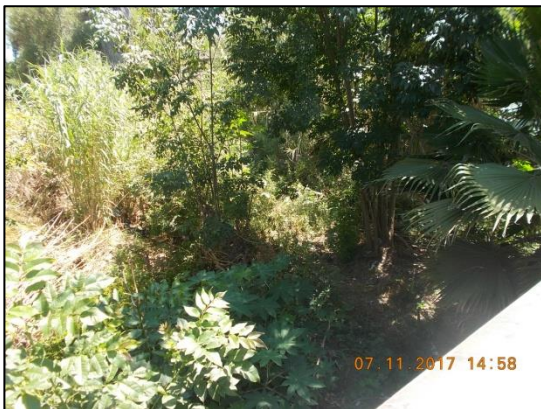
3. Alpha 1 (Reach 6): looking downstream from the National Avenue bridge.

Removing deposited sediment/debris and vegetation from Alpha Reach 6 improves the conveyance capacity to 2,000 cfs, with the level of service increasing to the 10-year storm event. Maintaining Reach 6 also improves the conveyance capacity of Reach 7 to 2,000 cfs, with the level of service increasing to the 10-year storm event. In addition, maintaining Reach 6 reduces the water surface elevation in Reach 8 during the 100-year storm event by approximately 0.2 feet, which decreases the overall limits of flooding in Reach 8. As noted earlier, the 2018 RICK IHHA reports that maintenance within Reach 6 is the responsibility of private parties, not the City.

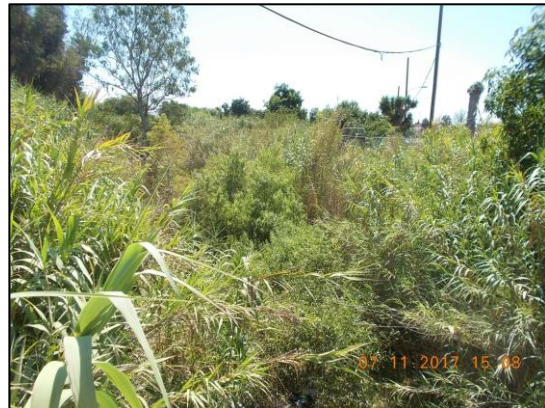
4. Alpha 1 (Reach 5): looking downstream from the pedestrian bridge at Southcrest Park. Dense vegetation is present in the channel.

Removing deposited sediment/debris and vegetation from the bottom of Alpha Reach 5 improves the conveyance capacity to 2,000 cfs, with the level of service increasing to the 10-year storm event from Station 6437 to 6398. The recommended maintenance from Station 6398 to 5627 improves the conveyance to 1,300 cfs, with the level of service increasing to the 5-year storm event.

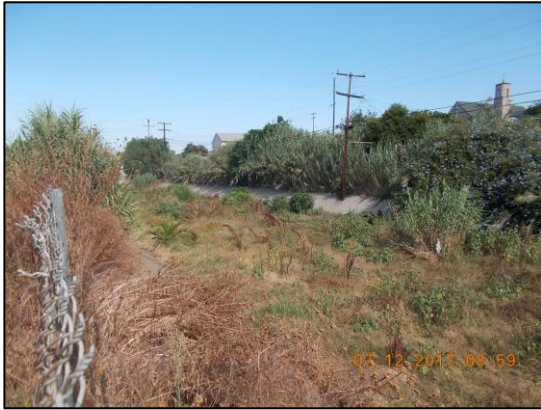
5. Alpha 1 (Reach 2): looking downstream, showing concrete banks and vegetation in earthen bottom.

- Alpha, Reach 2: The Manning's coefficient values for the recommended maintained condition were set at 0.030 for the earthen bottom and 0.018 for the concrete banks.

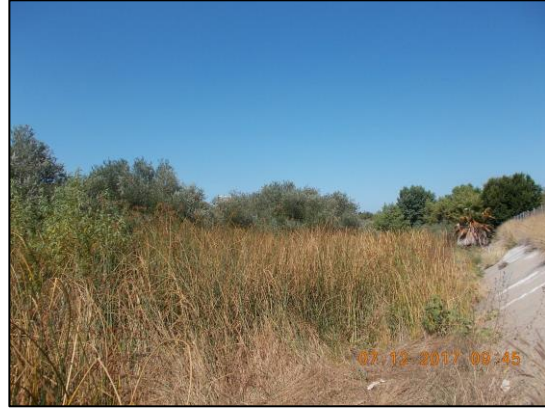
6. Alpha 1 (Reach 1): looking downstream, showing vegetation in the earthen channel bottom and the concrete right bank.

For Reach 1 of the Alpha segment, the analysis indicated that the increase in level of service following maintenance activities is negligible. A portion of the segment is located within a restoration area and maintenance activities are limited in scope to primarily the removal of any invasive vegetation. Additionally, low bank elevations along a portion of the southerly bank limited the potential capacity improvements provided by the maintenance. Therefore, maintenance activities were not recommended for Reach 1 of the Alpha segment. The Manning's coefficients and sediment/debris depths in segments for which no maintenance is proposed and for the domain of analysis segments were kept the same as in the baseline condition.

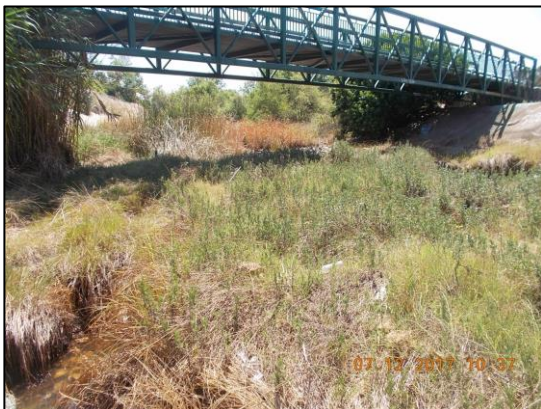
7. Alpha 1 (Reach 1): looking downstream under the pedestrian bridge located just east of I-5.

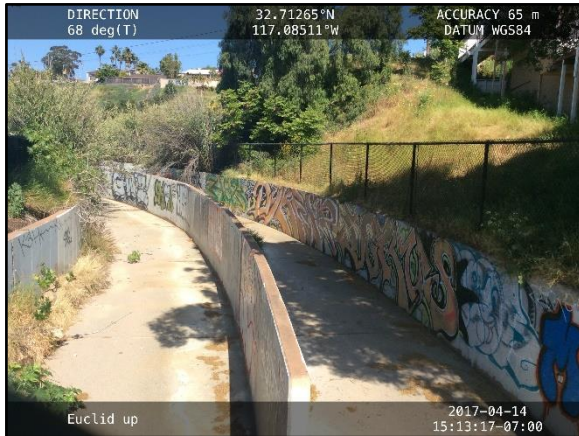
1. Euclid 2: Representative of concrete portion of channel.

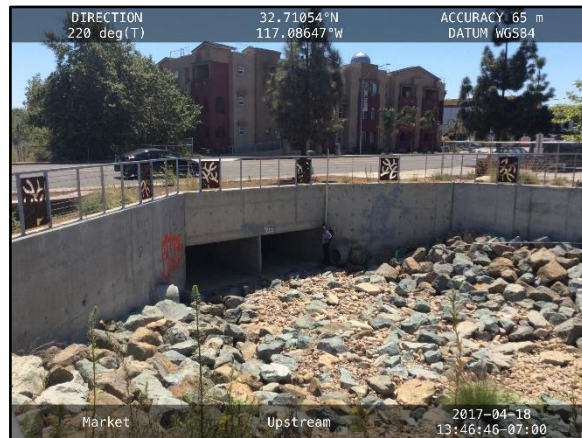
4. Euclid 1: Double box culvert inlet at Market Street.

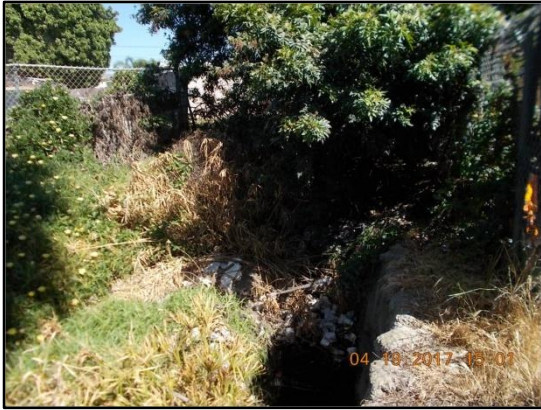
1. Castana 1: Looking upstream at vegetation near 24-inch-diameter RCP outfall.

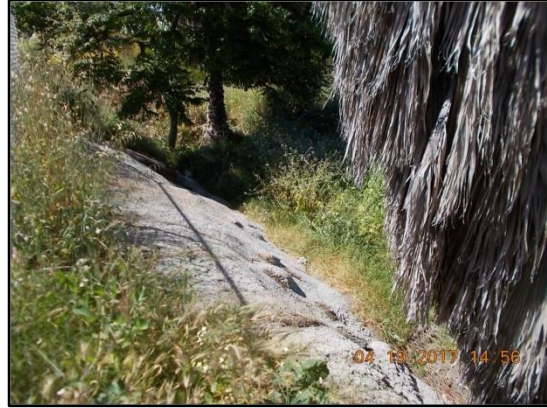
2. Castana 1: Looking downstream at vegetation and gunite lining on left bank.

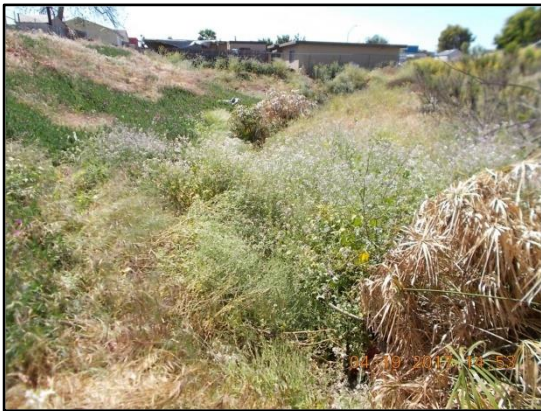
3. Castana 1: Looking downstream at vegetation.

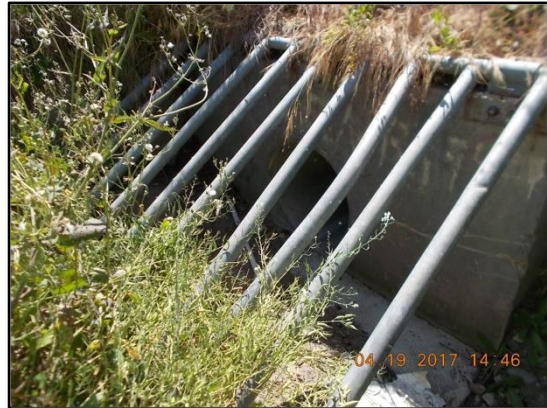
4. Castana 1: Looking downstream at 24-inch-diameter RCP culvert inlet.

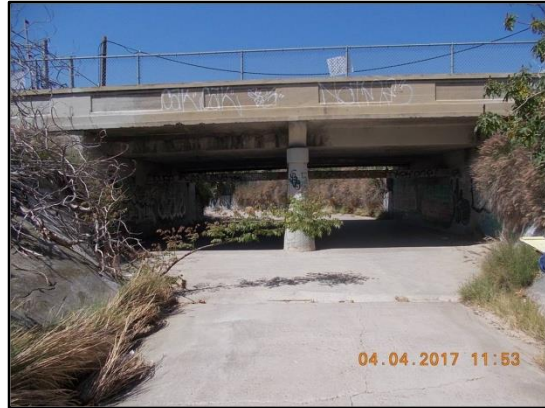
2. Imperial 2: Looking downstream at Merlin Drive Bridge.

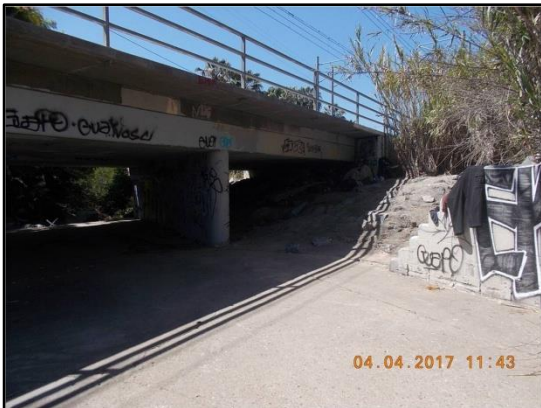
3. Imperial 2: Looking upstream at MTS Orange Line Bridge

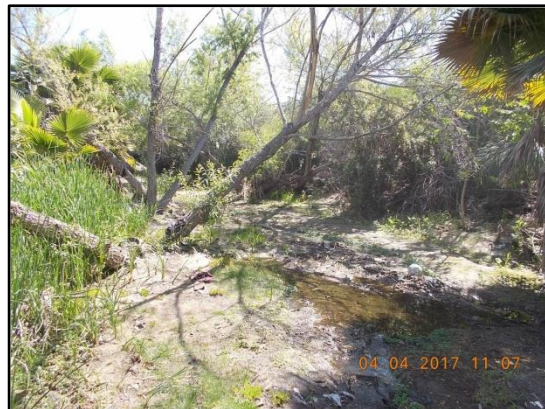
4. Imperial 1: Looking downstream of Orange Line bridge at vegetation.

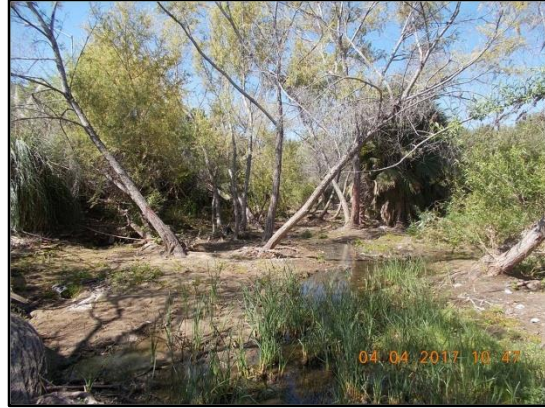
6. Imperial 1: Looking downstream at vegetation in channel.

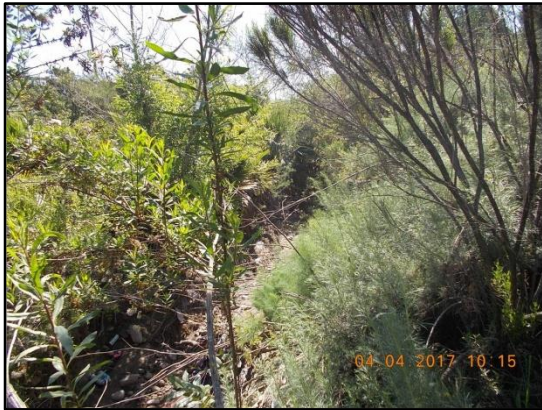
7. Imperial 1: Looking downstream at vegetation in channel

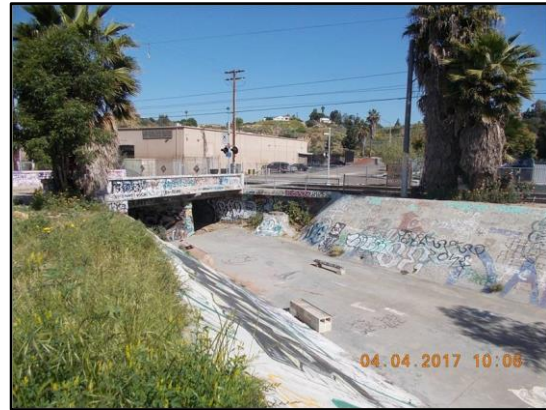
8. Imperial 1: looking downstream at transition to concrete channel at the 54<sup>th</sup> Street bridge.

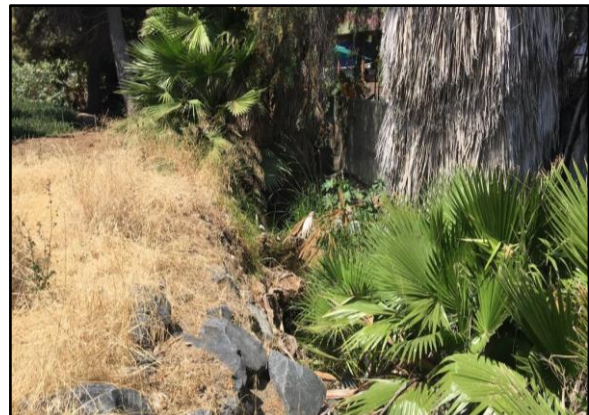
2. Jamacha 2: Downstream of Beacon Drive culvert (36-inch-diameter RCP), looking west. Riprap apron and dense vegetation present.

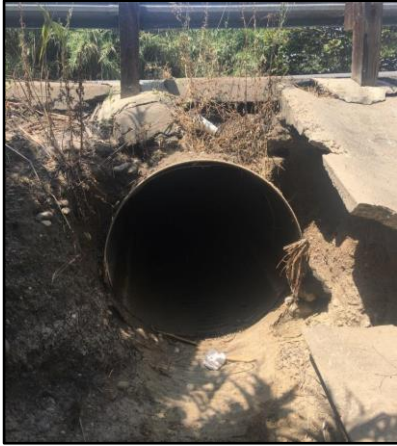
3. Jamacha 2: Upstream of the Cadman Street culvert (54-inch-diameter corrugated metal pipe), facing west.

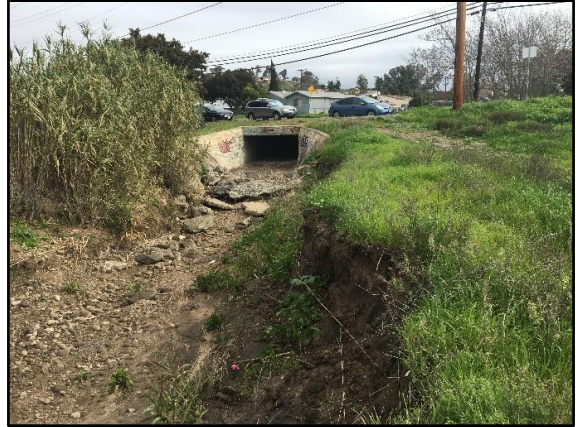
4. Jamacha 1: Upstream of 10-foot-wide by 5-foot-high RCB culvert beneath 69th Street facing west.

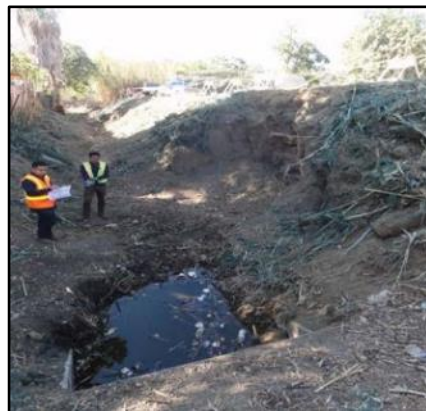
2. Lobrico 1, Reach 2: Beginning of Lobrico 1 at outlet of 48-inch RCP beneath Lisbon Street, looking south (November 2016).

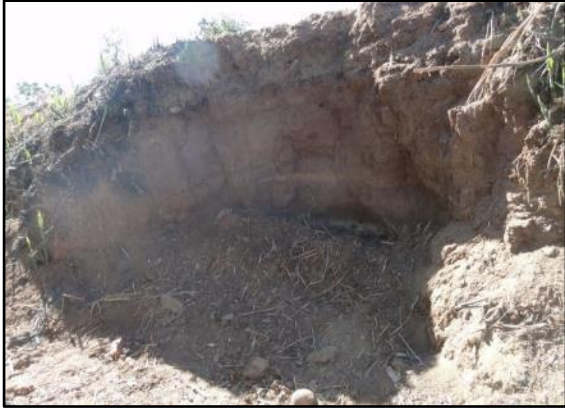
3. Lobrico 1, Reach 2: Erosion along right bank, at outlet of 48-inch RCP beneath Lisbon Street, looking southwest (November 2016).

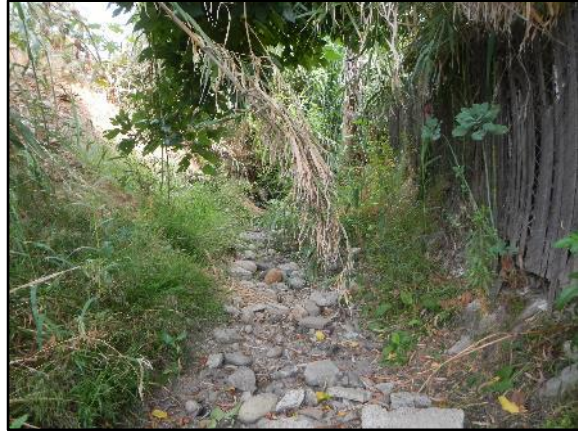
4. Lobrico 1, Reach 2: Typical section of downstream portion of Reach 2 with short left bank height, looking north (July 2019).

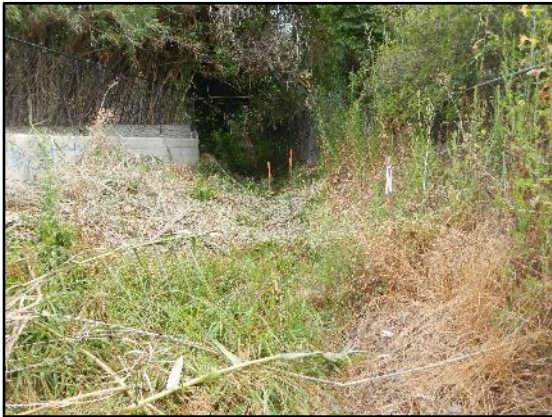
5. Lobrico 1, Reach 1: Dense vegetation present in channel and start of the 3-foot high private masonry wall along right bank, looking north (July 2019).

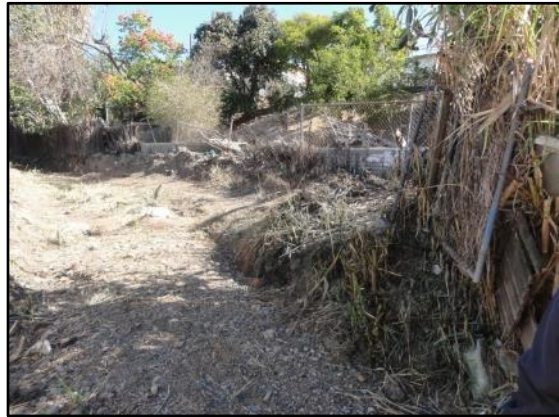
6. Lobrico 1, Reach 1: Middle portion of Lobrico 1 channel viewing the 3-foot high private wall along left bank, looking northeast (November 2016).

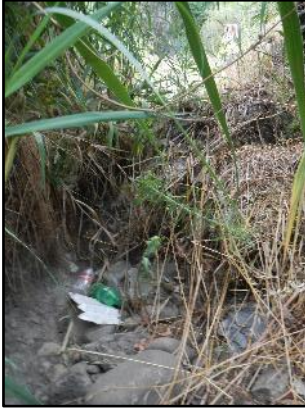
7. Lobrico 1, Reach 1: First head cut erosion along bottom of channel, measuring 3 feet in height, looking northeast (July 2019).

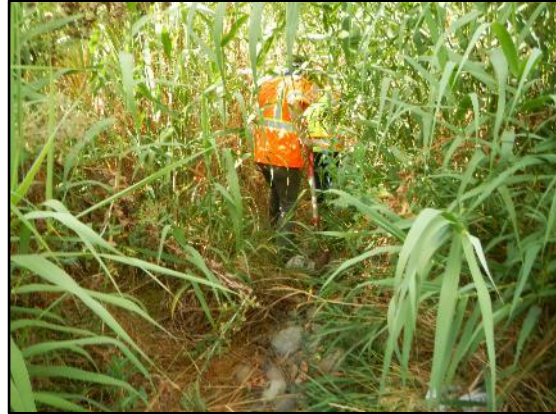
8. Lobrico 1, Reach 1: Dense vegetation present in typical section of middle portion of Reach 1, looking southwest (July 2019).

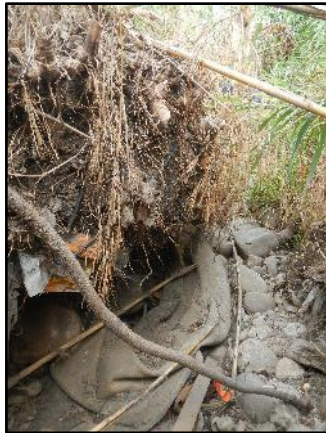
9. Lobrico 1, Reach 1: Second head cut erosion along bottom of channel, measuring 2 feet in height, looking southwest (July 2019).

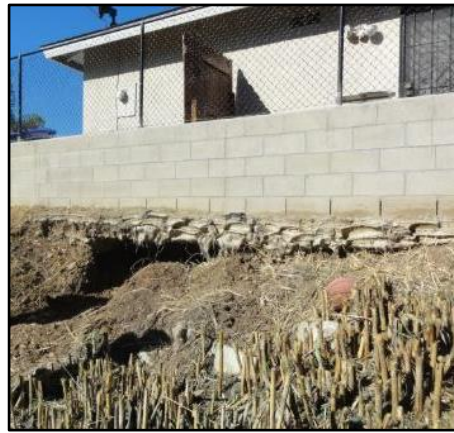
10. Lobrico 1, Reach 1: Scour hole underneath the private masonry wall on right channel bank, looking southwest (November 2016).

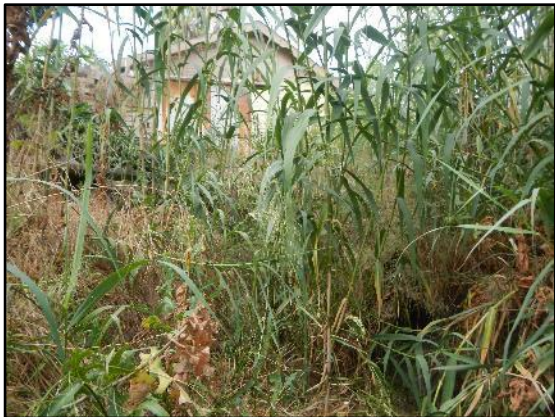
11. Lobrico 1, Reach 1: Dense vegetation present in typical section of downstream portion of Reach 1, looking southwest (July 2019).

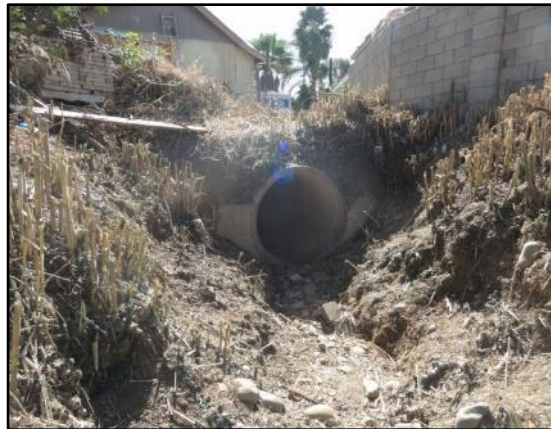
12. Lobrico 1, Reach 1: End of Lobrico 1 at inlet of 48-inch RCP beneath Jamacha Road, looking southwest (November 2016).

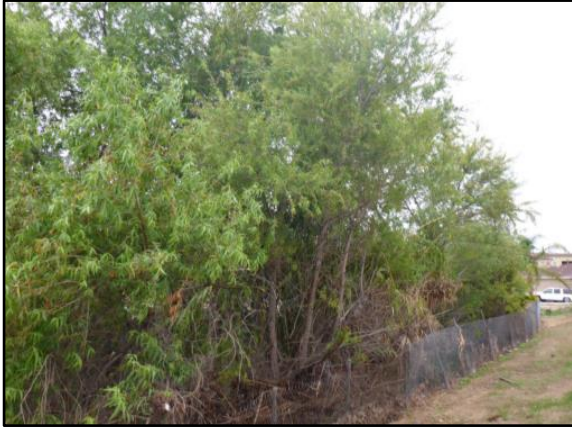
1. Cottonwood 2: Looking downstream of triple 72-inch-diameter RCP culvert beneath Highland Avenue at start of channel.

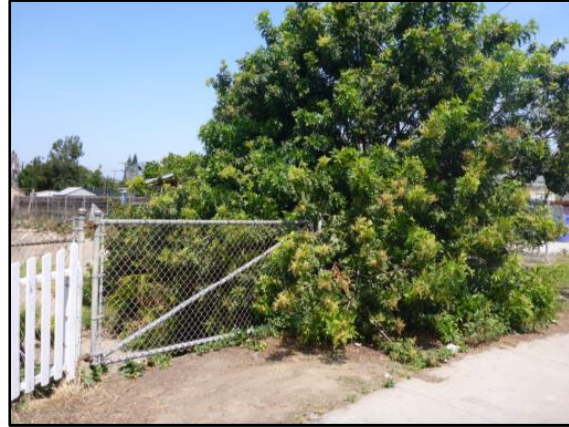
2. Cottonwood 2: Looking downstream from double 9-foot-wide by 5-foot-tall RCB culvert at 42nd Street; heavy vegetation and trees visible in segment.

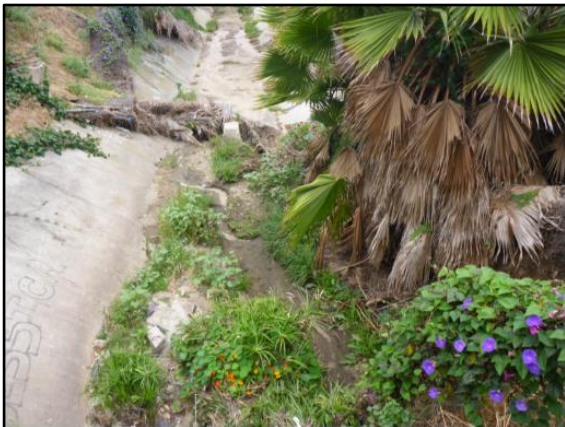
3. Cottonwood 2: Looking downstream at segment; vegetation and palm trees visible.

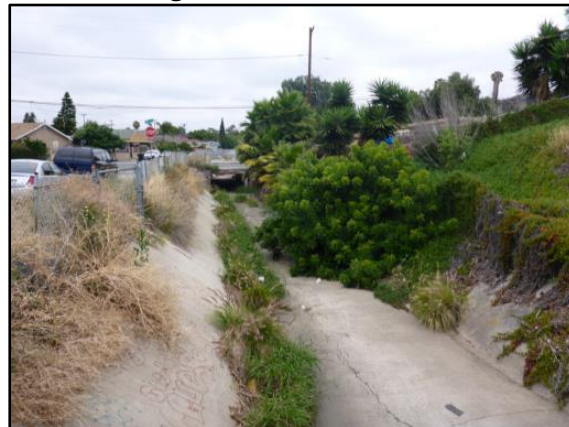
4. Cottonwood 2: Looking upstream from double 9-foot-wide by 5-foot-tall RCB culvert at 40th Street.

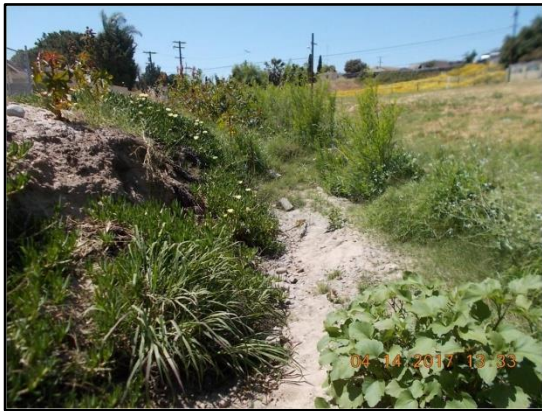
1. Cervantes 1: Looking downstream at vegetation.

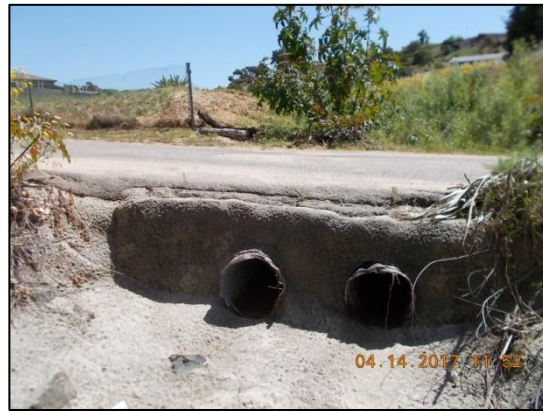
2. Cervantes 1: Looking upstream at double 18-inch-diameter CMP culvert and Arizona crossing at Cervantes Road.

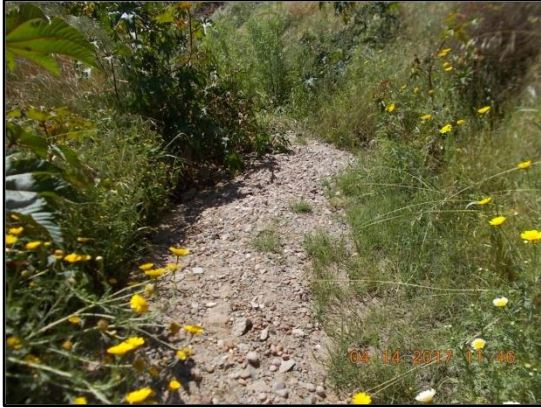
3. Cervantes 1: Looking downstream at vegetation.

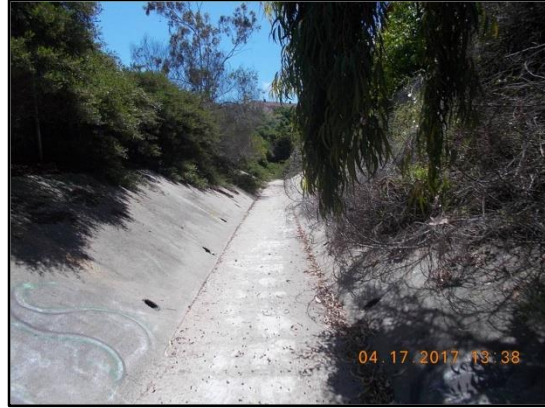
4. Solola 2 (Reach 2): Looking downstream at concrete ditch.

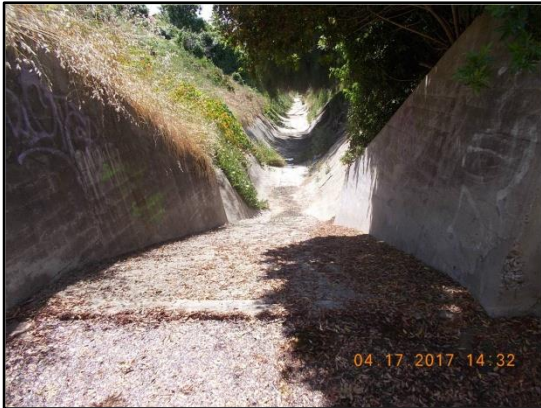
5. Solola 2 (Reach 2): Looking downstream at first drop structure.

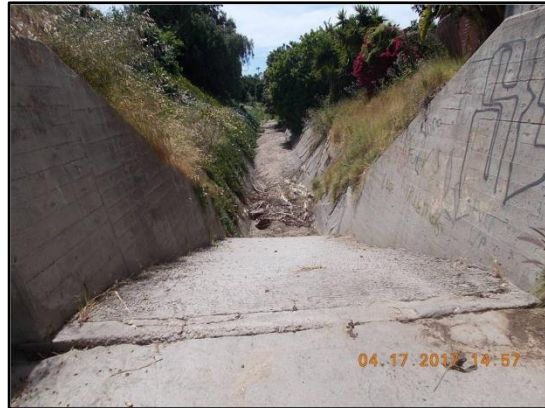
6. Solola 2 (Reach 1): Looking downstream at second drop structure and sediment accumulated at bottom of structure.

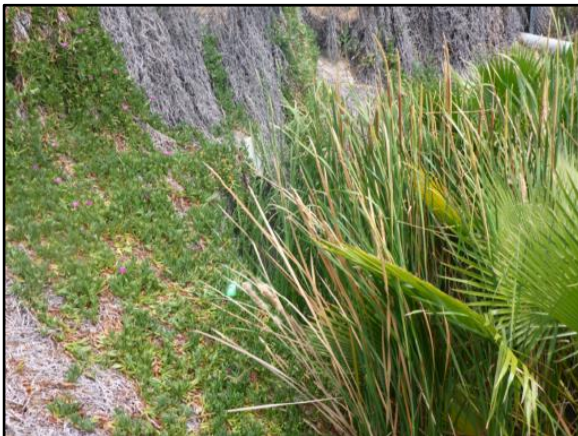
1. Parkside 1: Looking downstream from the inlet of the channel.

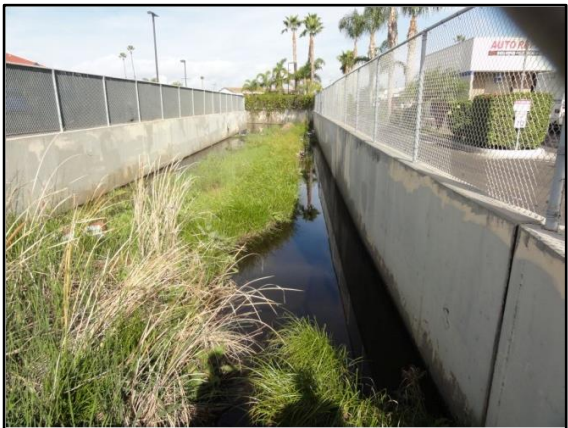
IHHA 5. Cedar 2: Looking downstream from the upstream end of the segment (November 2016).

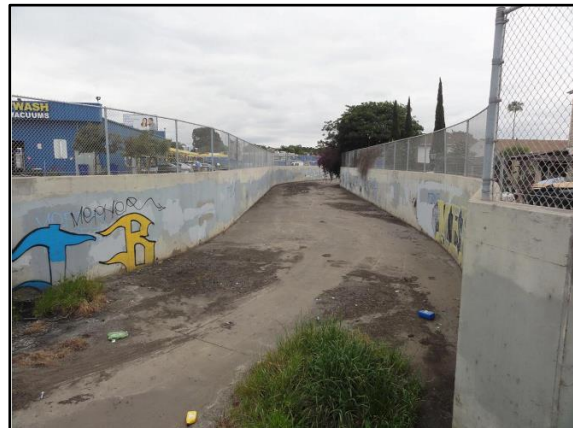
IHHA 6. Dahlia 1: Looking upstream (April 2015).

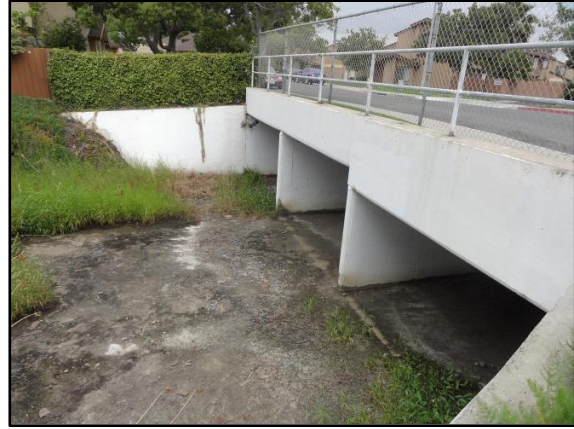
IHHA 8. Cerrissa 1: Looking downstream at the Cerrissa Court triple RCB culvert (April 2015).

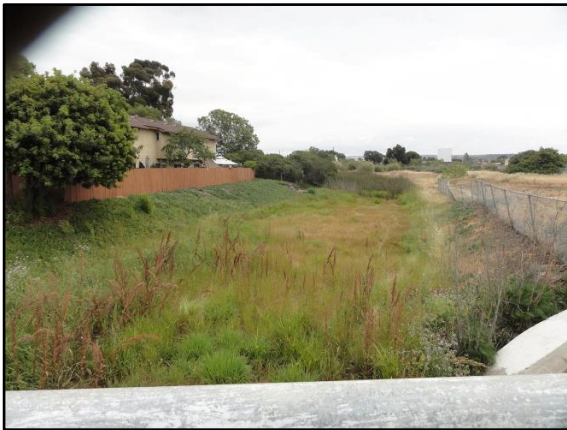
IHHA 9. Cerrissa 1: Looking upstream at the downstream end of the segment (April 2015).

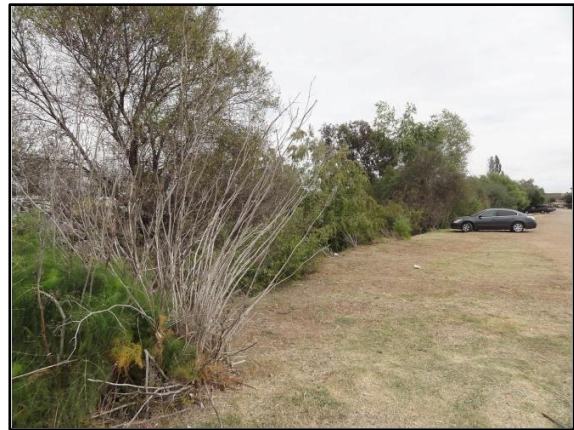
IHHA 11. Cerrissa 1: Looking upstream (April 2015).

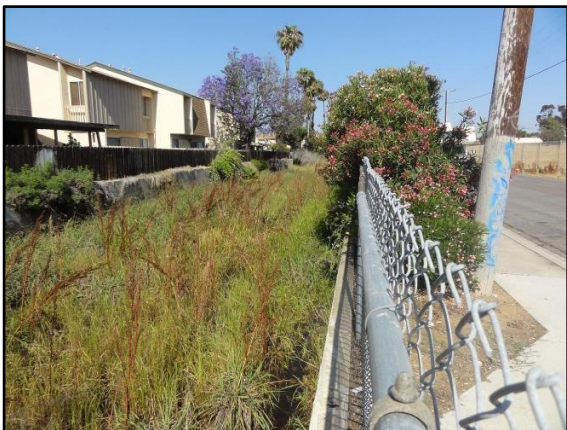
IHHA 21. Grove 1: Looking upstream at the downstream portion of the segment (May 2015).

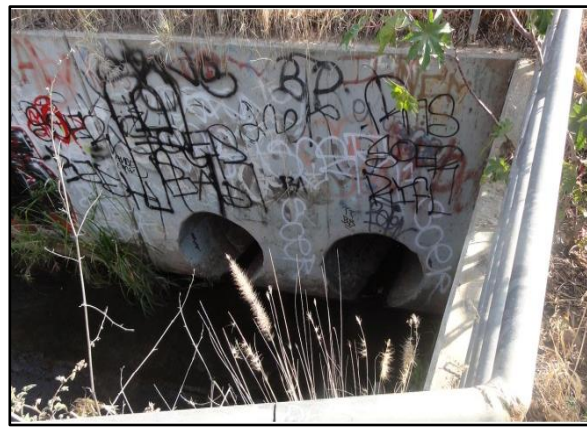
IHHA 24. 30<sup>th</sup> St 1: Looking downstream at the double-barrel 36-inch-diameter RCP culvert at the San Diego Railroad crossing (May 2015).

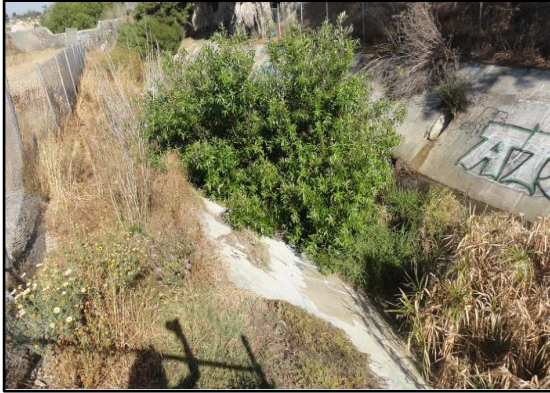
IHHA 25. 30<sup>th</sup> St 1: Looking upstream from a location further downstream of the 42-inch-diameter RCP culvert (May 2015).

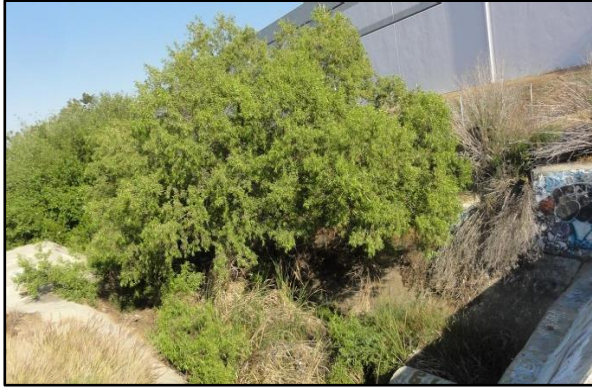
IHHA 28. 30<sup>th</sup> St 1: Looking upstream from the 42-inch-diameter RCP culvert at the middle of the segment (May 2015).

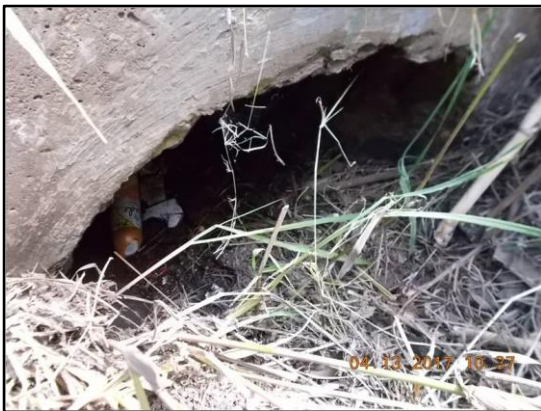
1. Outer 1, Reach 2: Looking upstream at 21-inch CMP outfall.

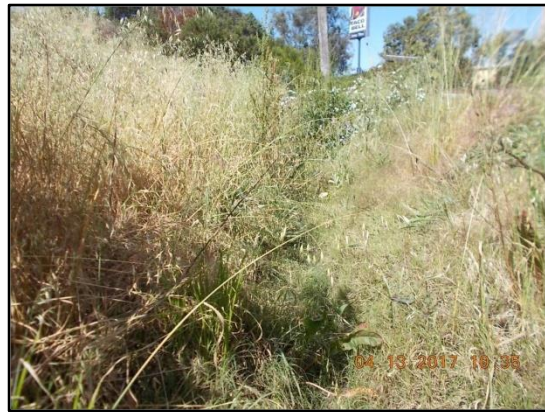
2. Outer 1, Reach 2: Looking downstream at vegetation.

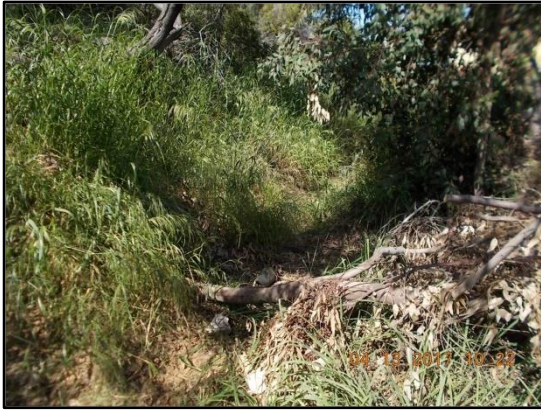
3. Outer 1, Reach 2: Looking downstream at vegetation upstream of Outer 1 and Outer 2 junction.

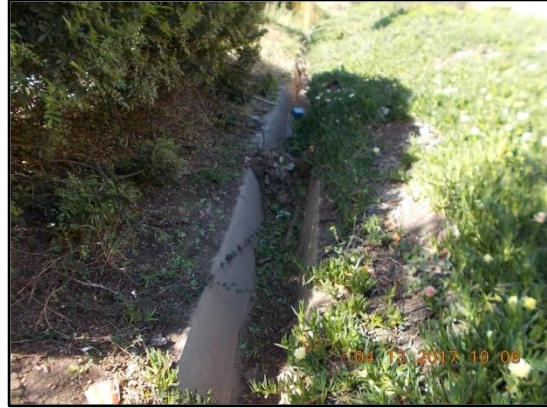
4. Outer 2: Looking downstream at debris/sediment and overhanging vegetation upstream of Outer 1 and Outer 2 junction.

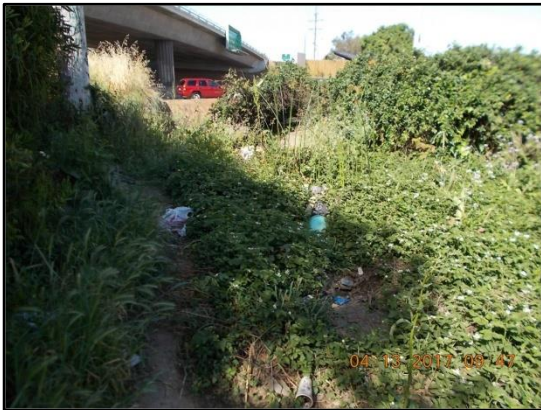
5. Outer 1, Reach 1: Looking downstream at vegetation downstream of Outer 1 and Outer 2 junction.

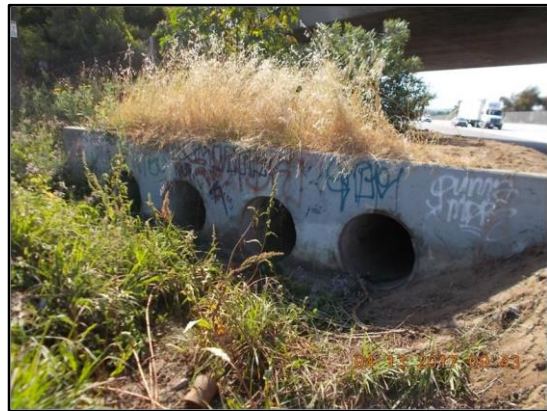
6. Outer 1, Reach 1: Looking downstream at entrance to quadruple 30-inch-diameter RCP culvert inlet.

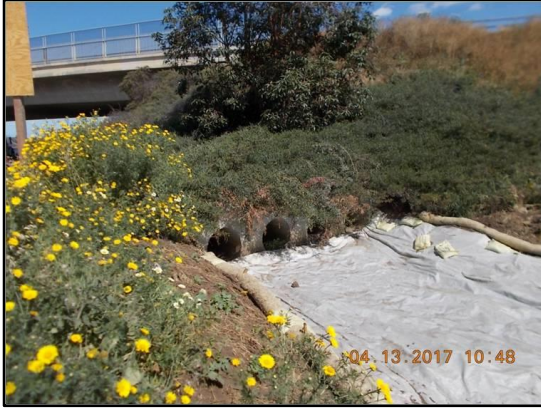
7. Downstream domain of analysis: Looking upstream at quadruple 30-inch-diameter culvert outlet.

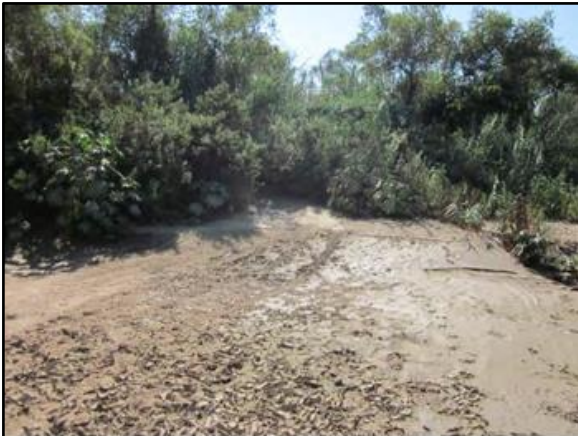
11. Pilot Channel 1: Looking south at the confluence point with the Smuggler's Gulch.

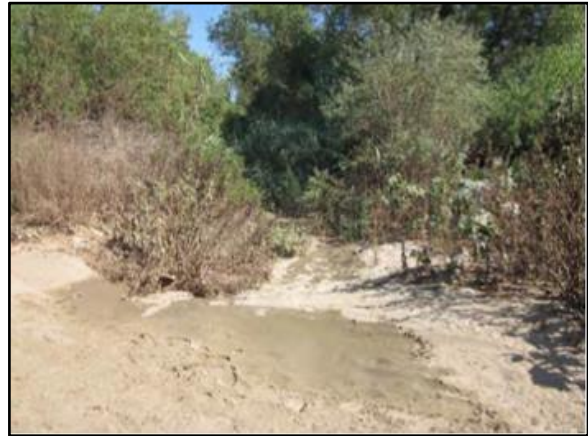
13. Pilot Channel 1: Looking east at the confluence point with the Smuggler's Gulch.

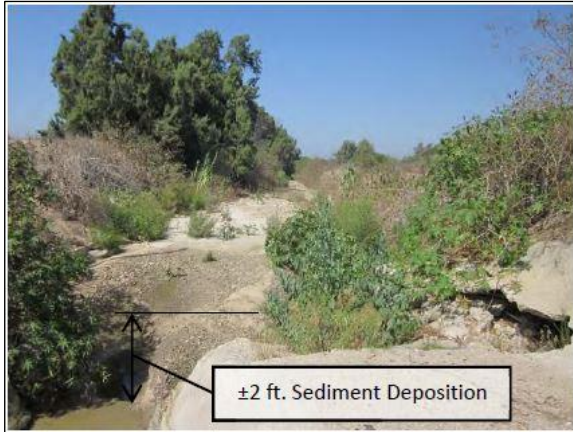
16. Smuggler's Gulch 1: Looking downstream (north) at culvert outlet near Monument Road.

Removing deposited sediment/debris and vegetation from the channel bottom increases the level of service to a >2-year event, with the conveyance capacity increasing to 900 cfs. Repair/replacement of the concrete grout near the outlet of the 52-inch-diameter CMP culvert (Station 4046) is also recommended to prevent flows from undermining structure.

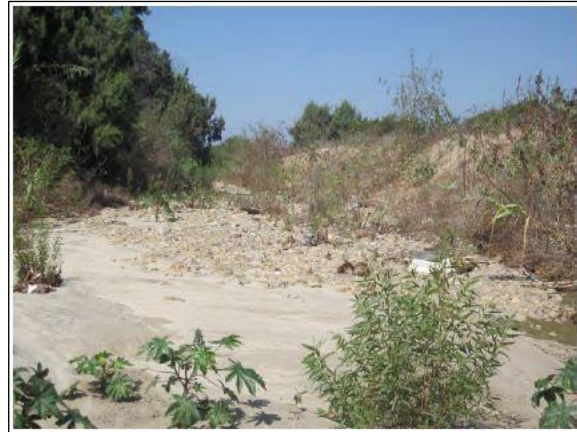
18. Smuggler's Gulch 1: Looking downstream (north) from Monument Road.

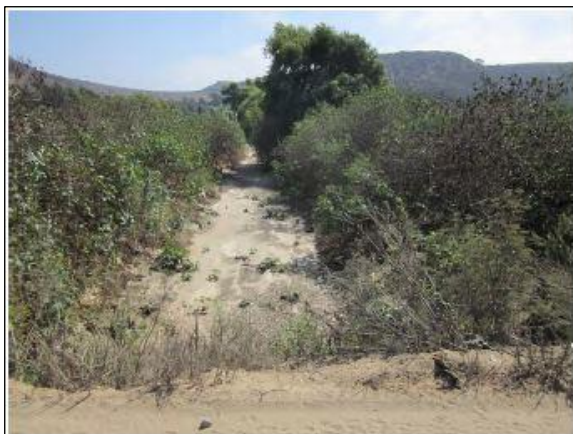
19. Smuggler's Gulch 1: Looking south (upstream) from atop the Disney Crossing.

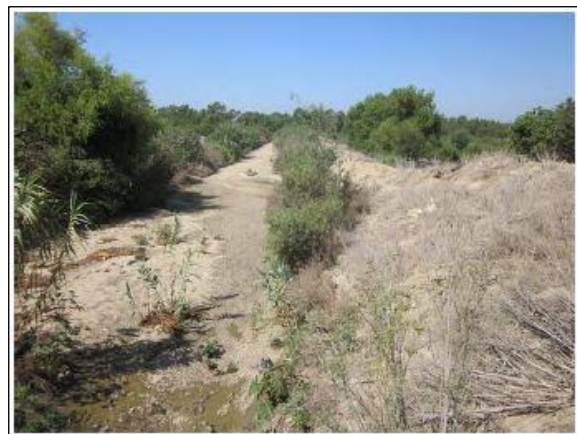
21. Smuggler's Gulch 1: Looking north (downstream) from atop the Disney Crossing.

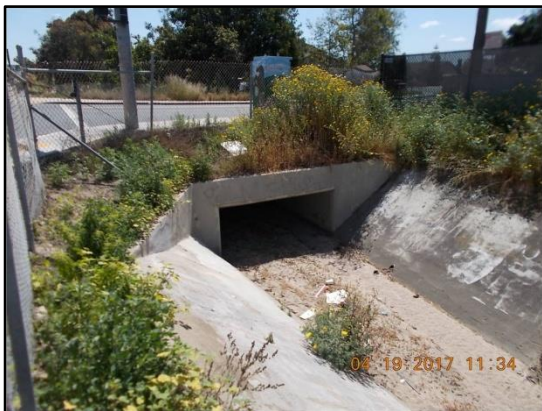
1. Tocayo 2: Looking downstream at inlet to Oro Vista Road culvert.

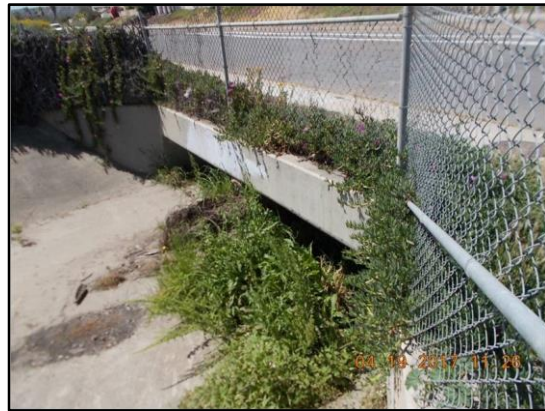
2. Tocayo 2: Looking downstream at inlet to Hollister Street bridge.

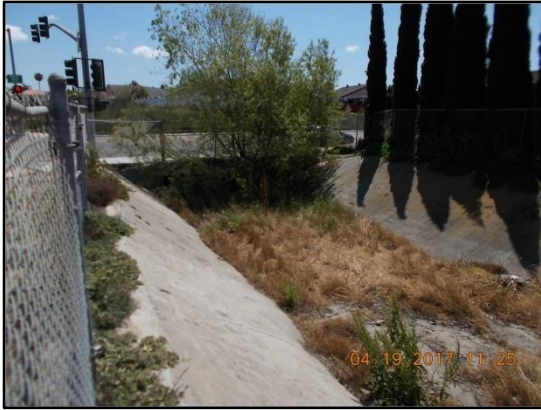
3. Tocayo 2: Looking upstream at vegetation on downstream side of Hollister Street Bridge.

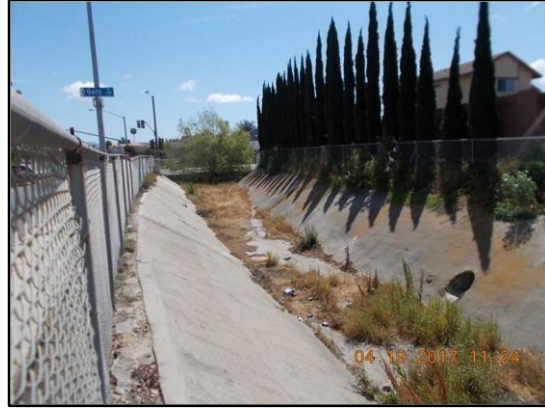
4. Tocayo 2: Looking upstream at vegetation.

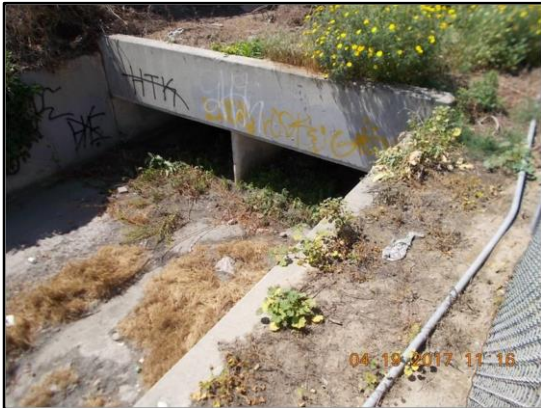
5. Tocayo 2: Looking downstream at inlet to double 10-foot by 4-foot RCB culvert.

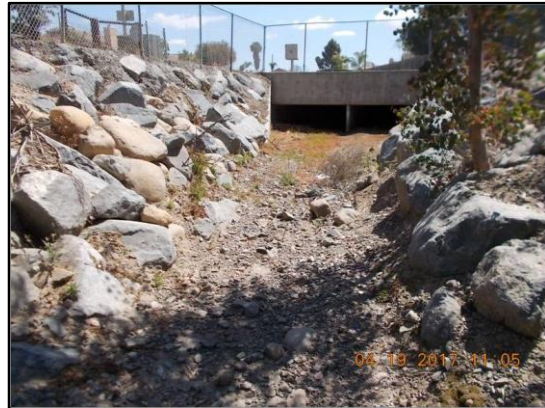
6. Tocayo 1: Looking upstream vegetation and outlet of double 10-foot by 4-foot RCB culvert.

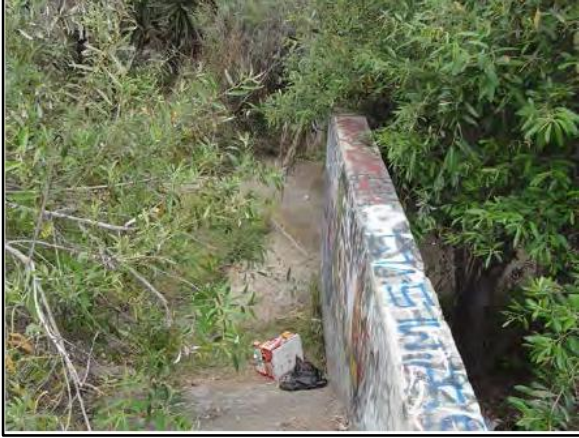
IHHA 4. Smythe 1, Map 2 (Reach 3): Upstream side of concrete check dam from northern bank.

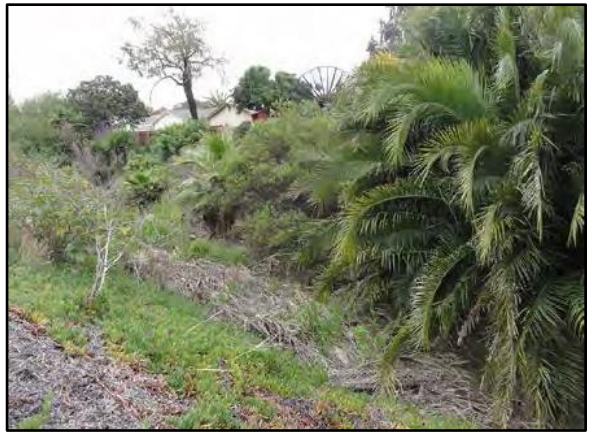
IHHA 5. Smythe 1, Map 2 (Reach 3): Looking upstream near HEC-RAS cross-section 4313.02.

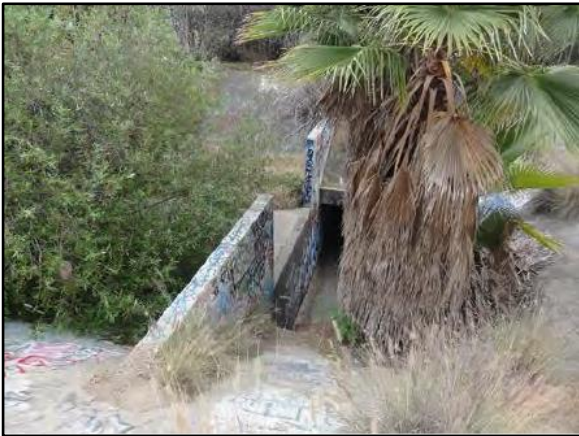
IHHA 6. Smythe 1, Map 2 (Reach 3): Downstream side of drop inlet structure.

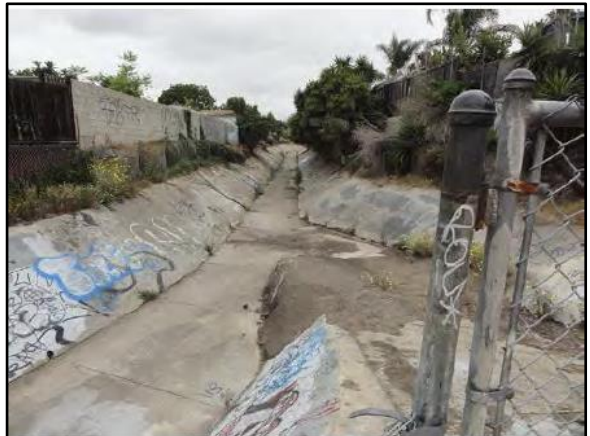
IHHA 8. Via Encantadoras 3, Map 2 (Reach 2): Looking upstream from double 72-inch-diameter RCP culvert.

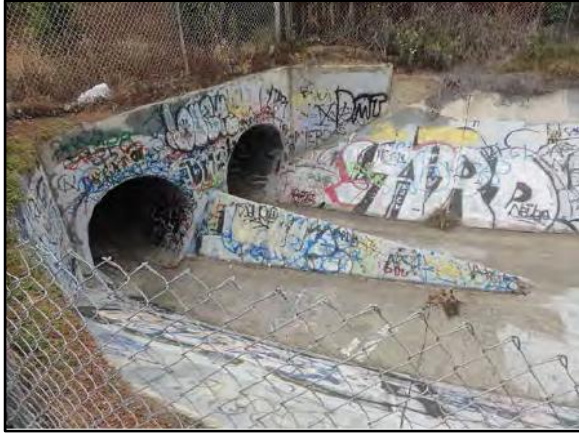
IHHA 9. Via Encantadoras 3, Map 2 (Reach 2): Entrance to double-barrel 72-inch-diameter RCP culvert under Vista Lane.

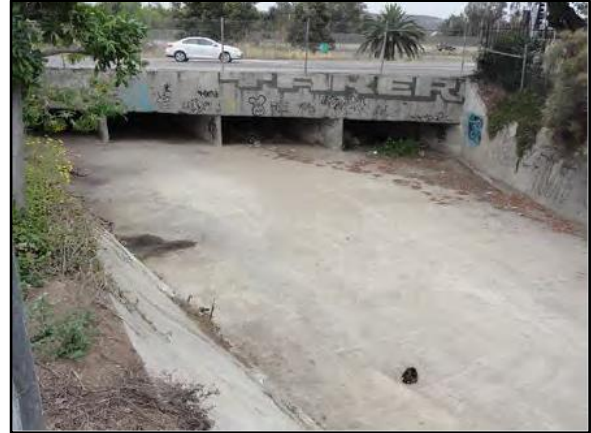
IHHA 11. Via Encantadoras 2, Map 2 (Reach 1): Looking downstream at entrance to quadruple 12-foot-wide by 4-foot-high RCB culvert beneath West San Ysidro Boulevard.

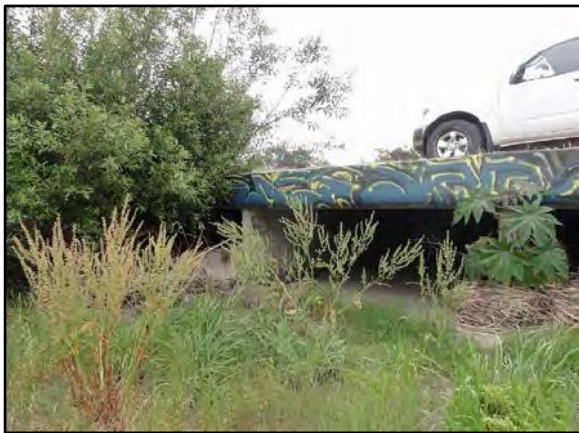
IHHA 14. Via Encantadoras 1, Map 2 (Reach 1): Looking downstream at entrance to quadruple 12-foot-wide by 4-foot-high RCB culvert beneath Interstate 5.

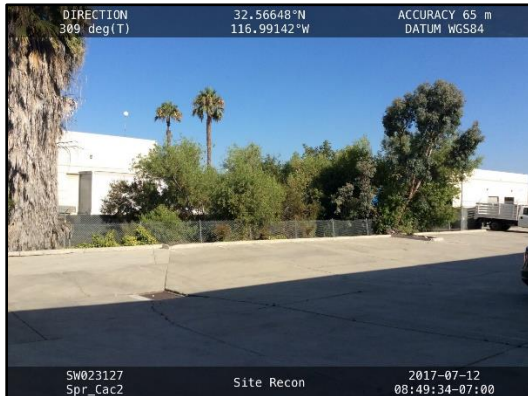
1. Cactus 1: Tree growth in basin.

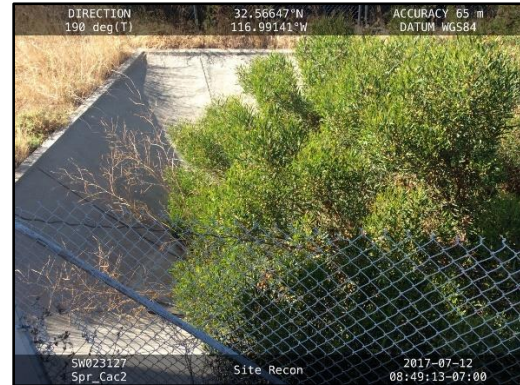
2. Cactus 1: Dense vegetation in basin.

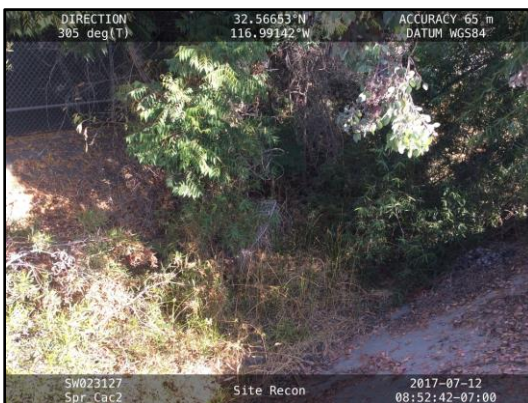
3. Cactus 1: Sediment/debris deposition and vegetation growth in basin.

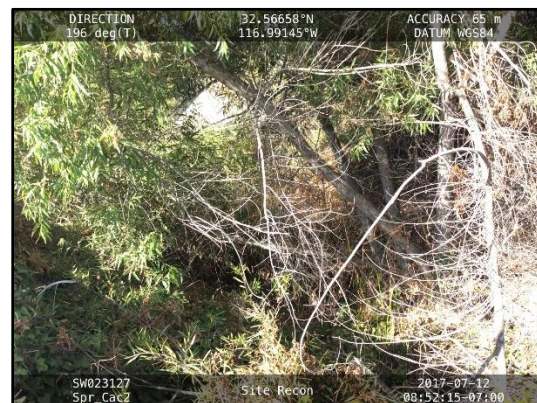
4. Cactus 1: Vegetation growth at outflow structure.

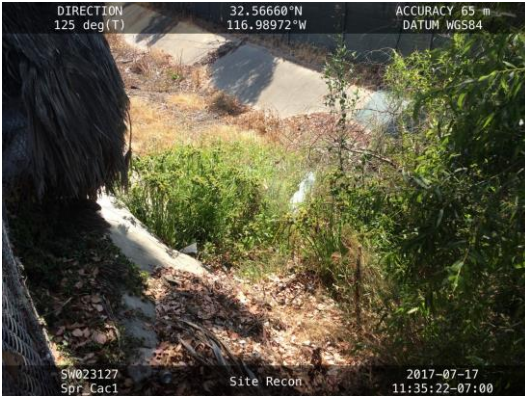
1. Cactus 2: Sediment deposition and vegetation growth at inlet.

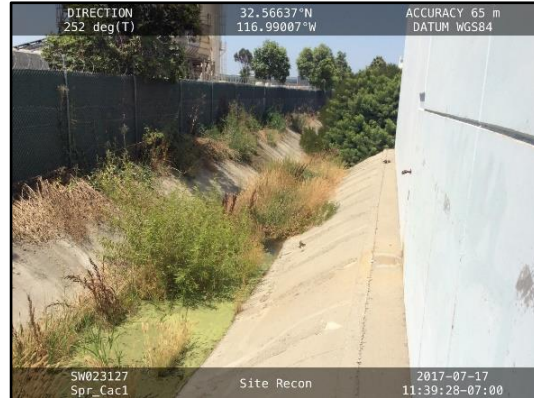
2. Cactus 2: Standing water and vegetation growth in the basin.

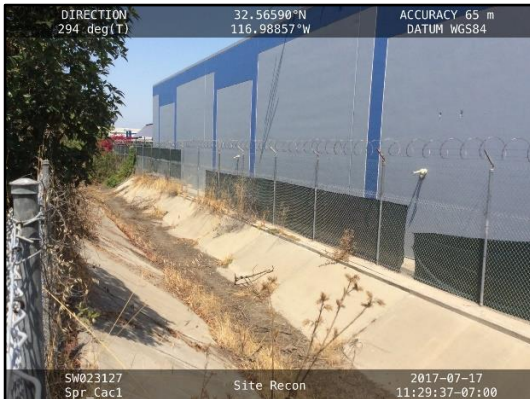
3. Cactus 2: Sediment deposition in basin.

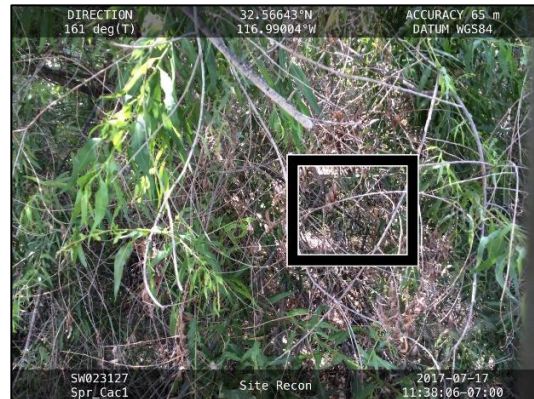
4. Cactus 2: Vegetation growth at outlet.
