## A.44 Chollas Creek – 54th Street (No. 5-04-280)

### Summary of Recommended Maintenance

## Attachment A: Hydrology and Hydraulics Fact Sheets

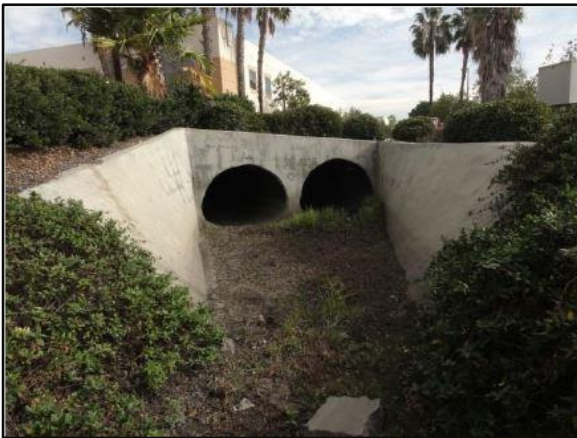
IHHA 5. Siempre Viva 1, Reach 2 (Bristow Channel): Looking west towards the inlet of the downstream pair of culverts.

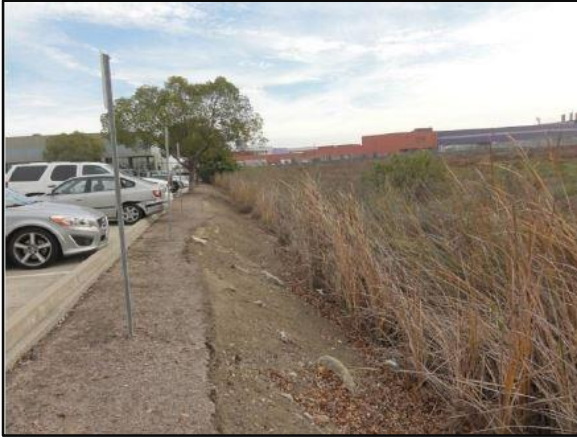
IHHA 15. Siempre Viva 1, Reach 3 (Siempre Viva Channel): Looking east along a typical section of vegetated channel.

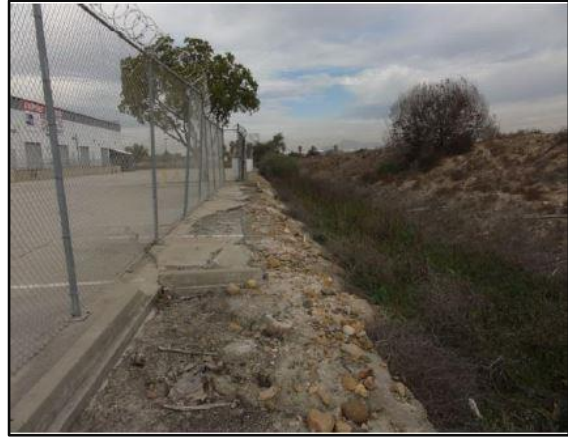
IHHA 18. Siempre Viva 1, Reach 3 (Siempre Viva Channel): Middle portion of Reach 3 looking north towards the lightly vegetated section in the middle of the reach.

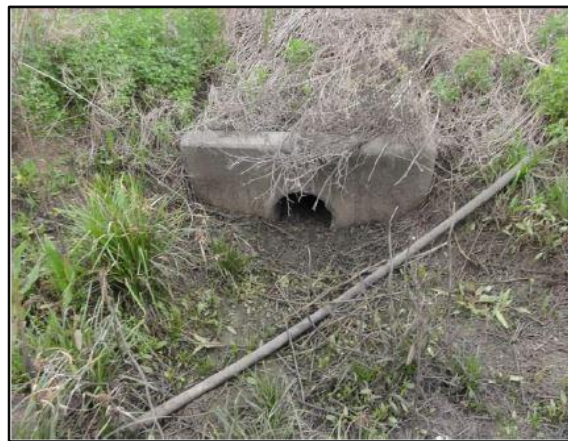
IHHA 22. Detention Basins: 18-inch-diameter RCP connecting the two detentions basins in the shared detention facility.

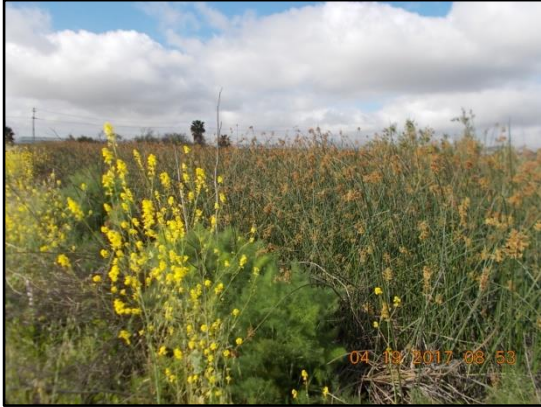
1. La Media 1: Looking downstream at vegetation in the ditch from La Media Road.

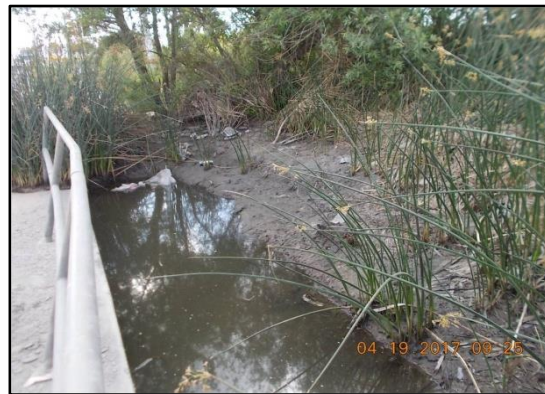
4. Downstream Domain of Analysis: Looking east at sediment and vegetation.

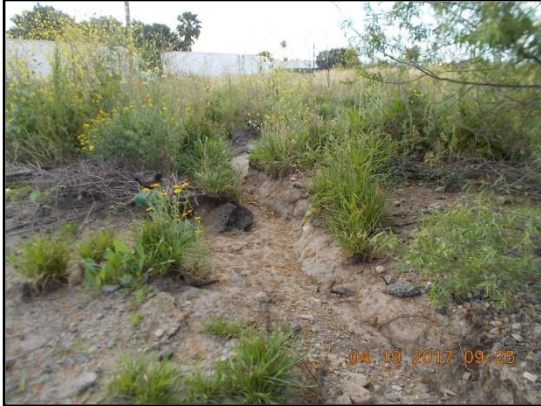
5. Downstream Domain of Analysis: Looking downstream at naturally occurring bypass of sediment obstruction.
