A.44 Chollas Creek – 54th Street (No. 5-04-280)

A.45 South Chollas Creek – Southcrest

A.46 South Chollas Creek - Euclid

A.47 South Chollas Creek – Federal

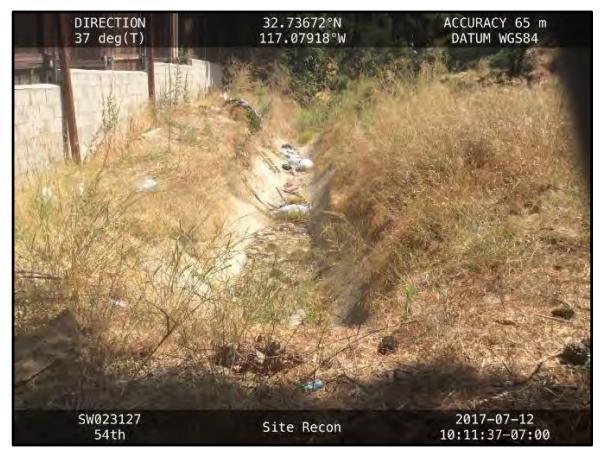
1. 54th St 1: Looking upstream.

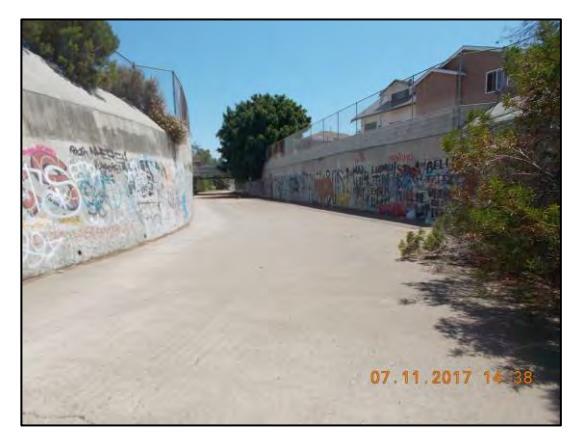
1. Ocean View 1 (Reach 10): looking downstream toward the Ocean View Boulevard bridge.

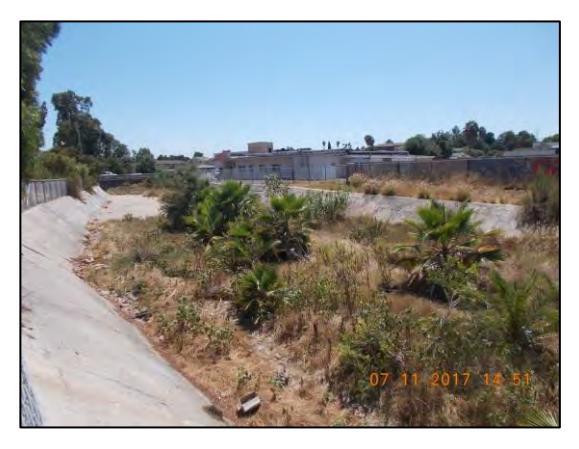
2. Ocean View 1 (Reach 8): looking downstream toward the start of the Reach 7 concrete bottom channel.

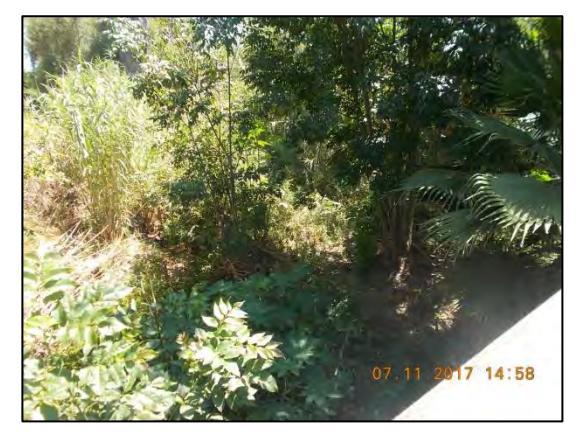
3. Alpha 1 (Reach 6): looking downstream from the National Avenue bridge.

- Alpha, Reach 6: The Manning's coefficient values for the recommended maintained condition were set at 0.030 for the earthen bottom and 0.045 for the riprap banks. The 2018 IHHA reports that maintenance within Reach 6 is entirely the responsibility of private parties.

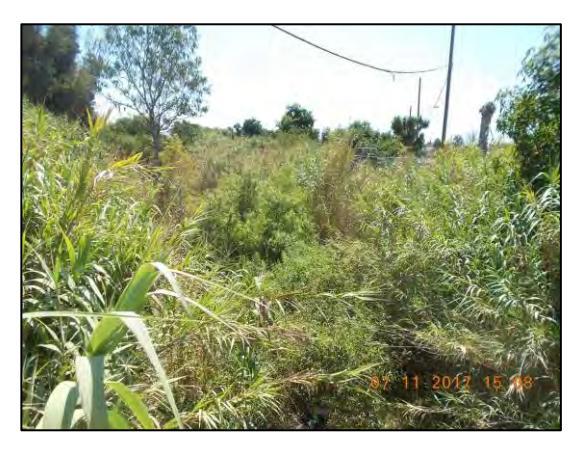
4. Alpha 1 (Reach 5): looking downstream from the pedestrian bridge at Southcrest Park. Dense vegetation is present in the channel.

- Alpha, Reach 5: From Station 6437 to Station 5627 the Manning's coefficient value of 0.035 was assigned to reflect channel conditions after removing accumulated sediment and vegetation. The 2018 IHHA reports that maintenance within Reach 5 is primarily the responsibility of private parties. The City is responsible for maintenance of the channel in the area where the Newton Avenue right-of-way crosses the channel from Station 6277 to 6195, and for the portion of the channel within an easement from Station 5734 to 5627.

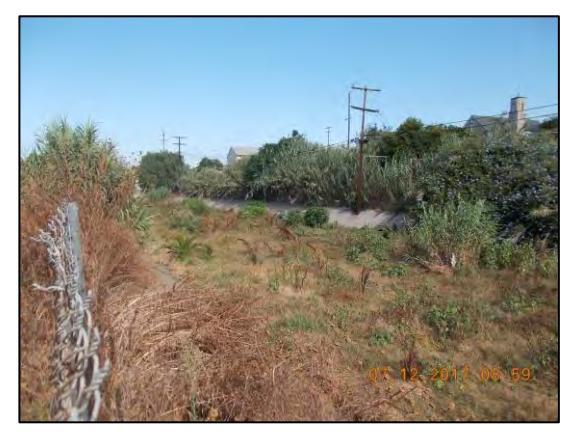
5. Alpha 1 (Reach 2): looking downstream, showing concrete banks and vegetation in earthen bottom.

- Alpha, Reach 2: The Manning's coefficient values for the recommended maintained condition were set at 0.030 for the earthen bottom and 0.018 for the concrete banks.

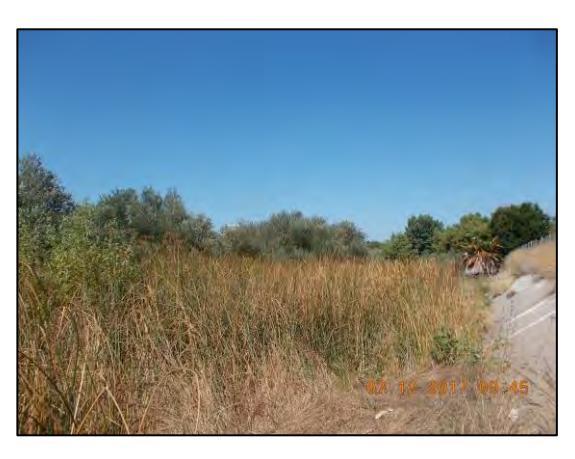
6. Alpha 1 (Reach 1): looking downstream, showing vegetation in the earthen channel bottom and the concrete right bank.

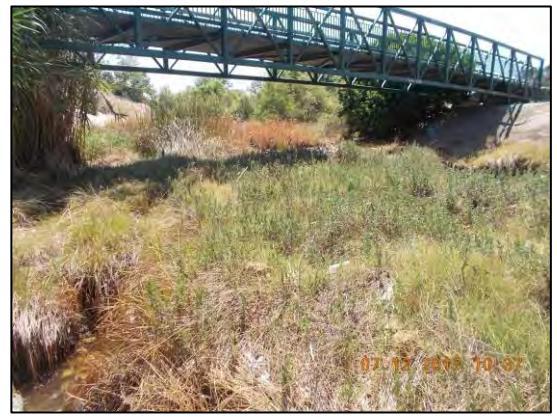
7. Alpha 1 (Reach 1): looking downstream under the pedestrian bridge located just east of I-5.

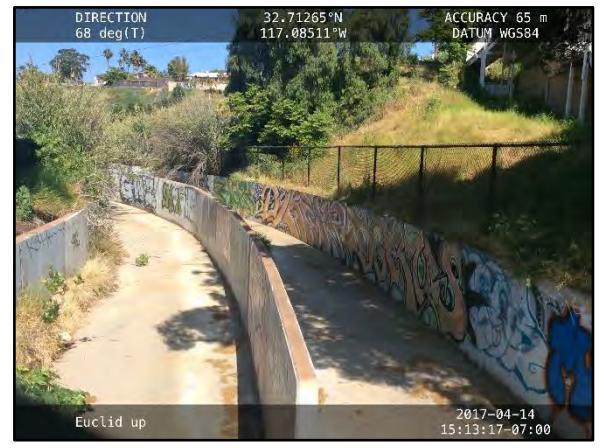
1. Euclid 2: Representative of concrete portion of channel.

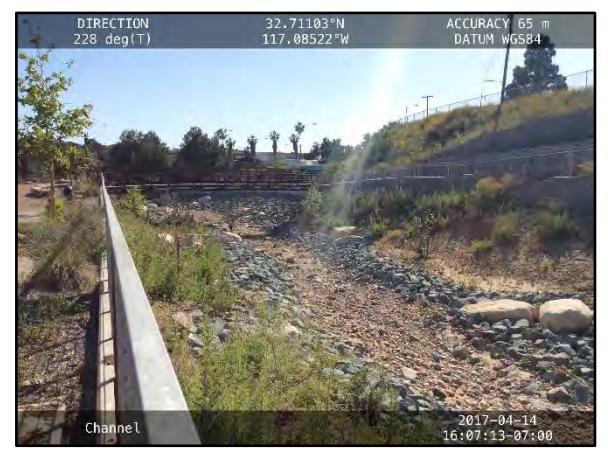
3. Euclid 1: Representative of earthen with cobble portion of channel.

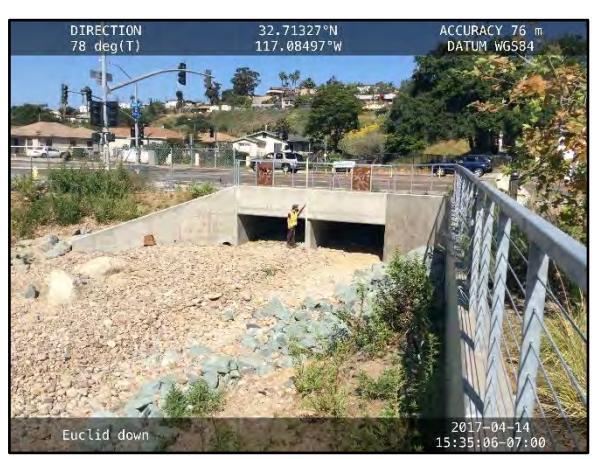
2. Euclid 1: Double box culvert outlet at Euclid Avenue.

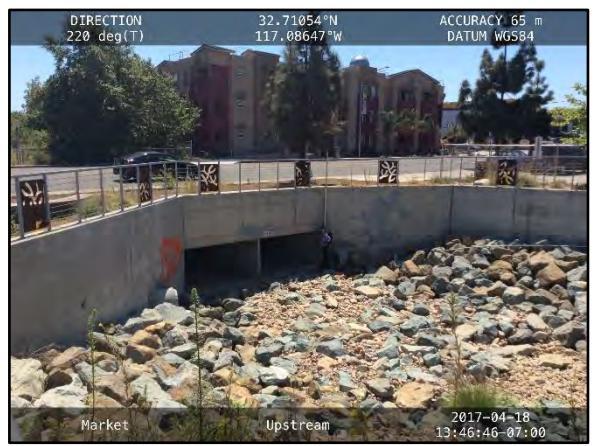
4. Euclid 1: Double box culvert inlet at Market Street.

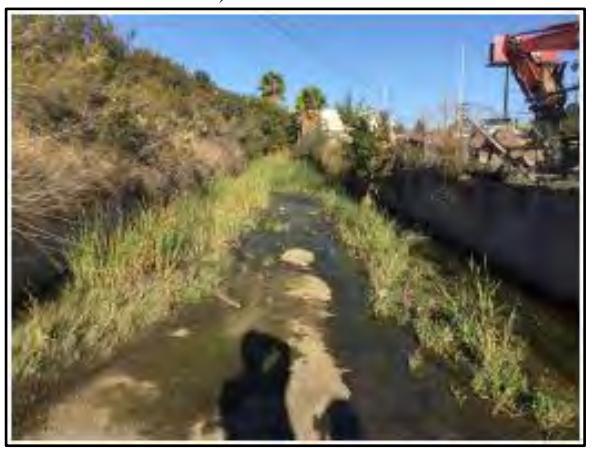
IHHA 19. Federal 2: Upstream portion of Reach 3 looking northeast at the rectangular concrete channel. Note the minimal vegetation established in channel.

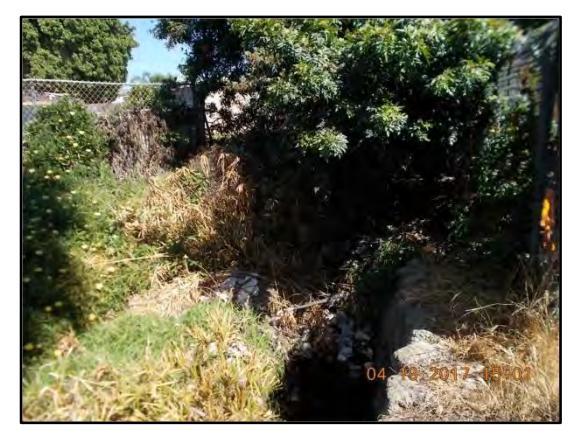
1. Castana 1: Looking upstream at vegetation near 24-inch-diameter RCP outfall.

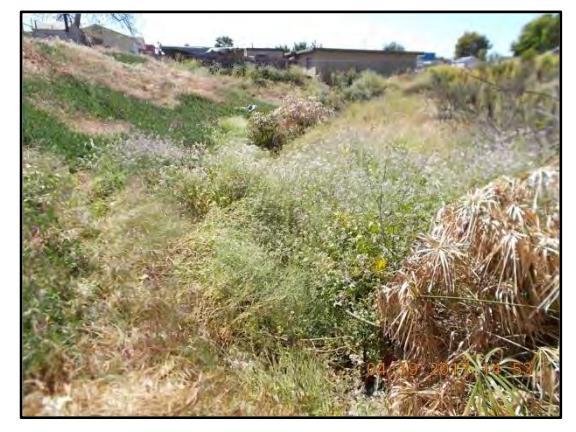
3. Castana 1: Looking downstream at vegetation.

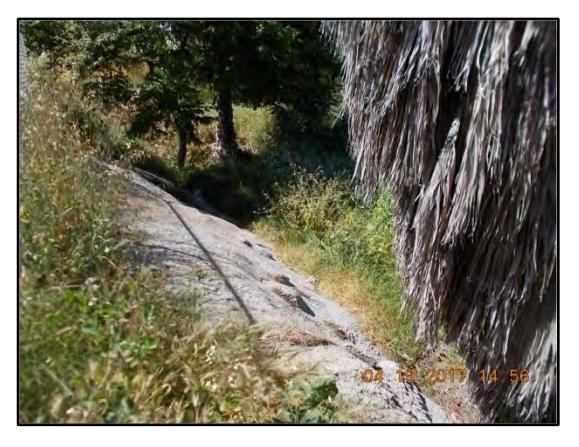
2. Castana 1: Looking downstream at vegetation and gunite lining on left bank.

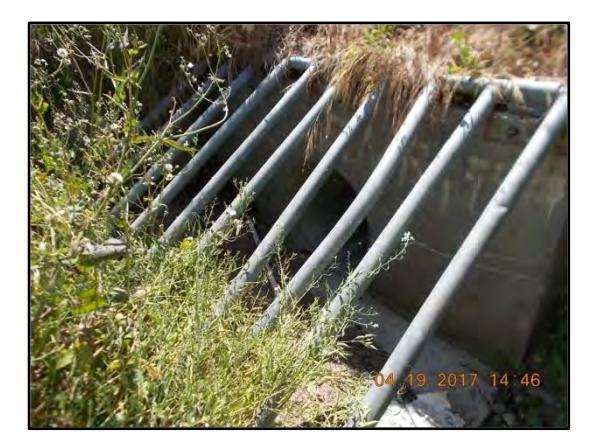
4. Castana 1: Looking downstream at 24inch-diameter RCP culvert inlet.

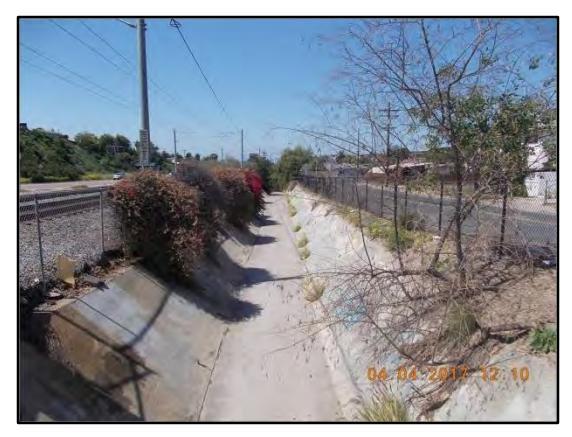
1. Imperial 2: Looking downstream at concrete channel near 60th street.

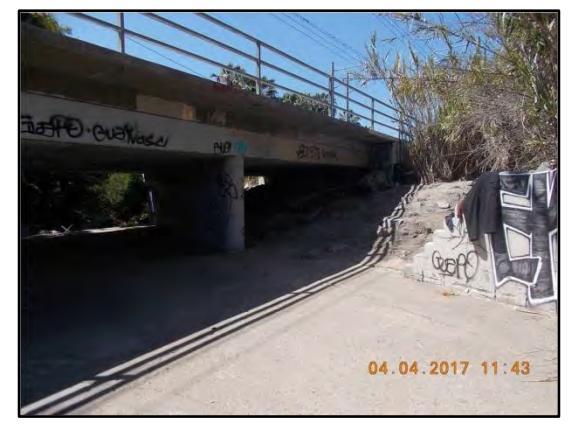
3. Imperial 2: Looking upstream at MTS Orange Line Bridge

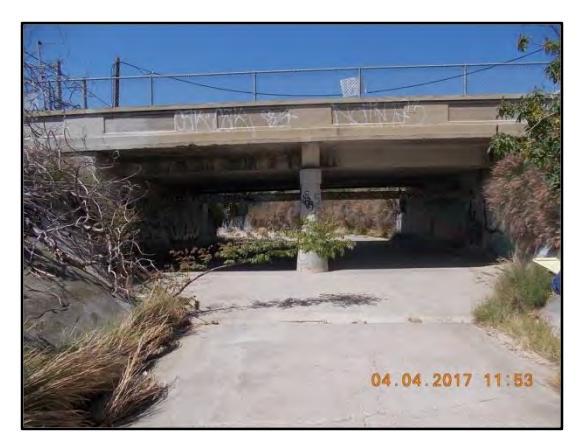
2. Imperial 2: Looking downstream at Merlin Drive Bridge.

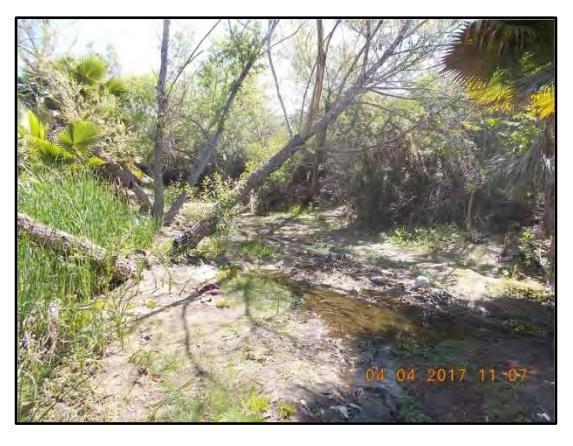
4. Imperial 1: Looking downstream of Orange Line bridge at vegetation.

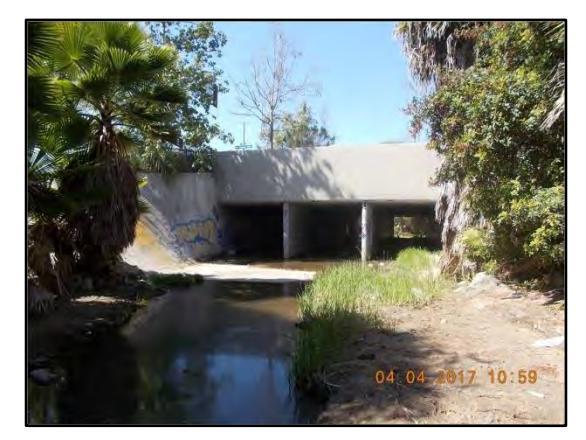
5. Imperial 1: Looking downstream at Stevens Way Culvert.

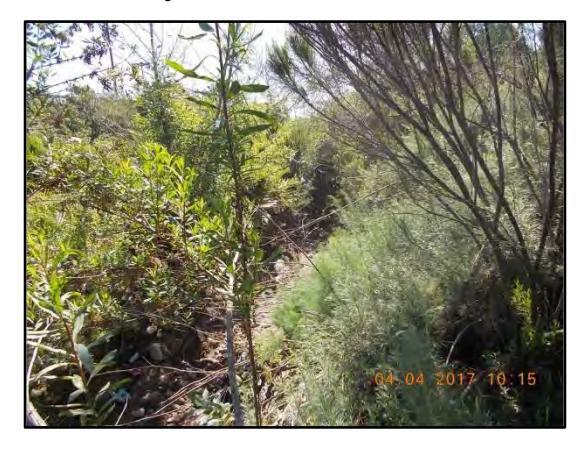
7. Imperial 1: Looking downstream at vegetation in channel

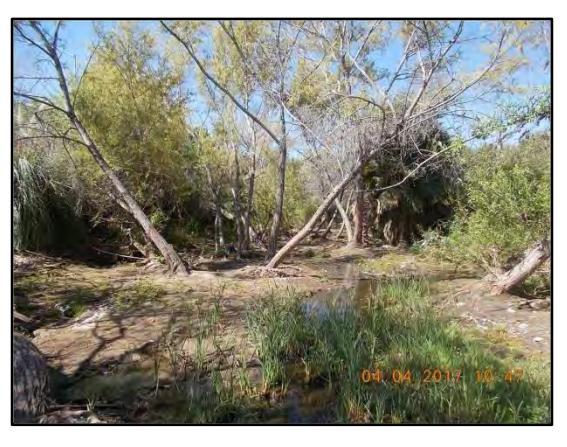
6. Imperial 1: Looking downstream at vegetation in channel.

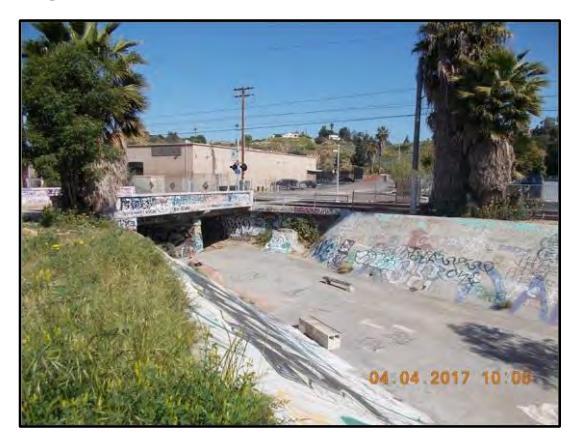
8. Imperial 1: looking downstream at transition to concrete channel at the 54th Street bridge.

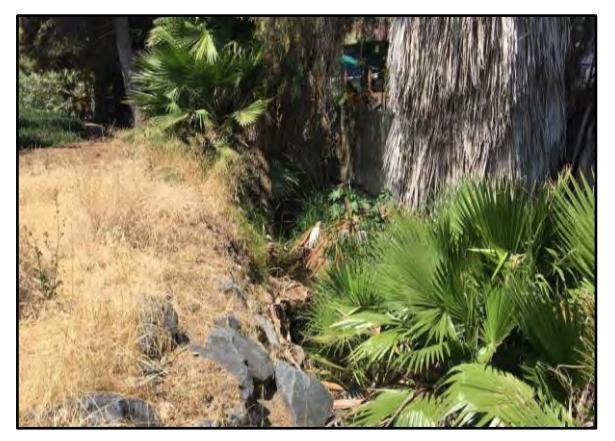
2. Jamacha 2: Downstream of Beacon Drive culvert (36-inch-diameter RCP), looking west. Riprap apron and dense vegetation present.

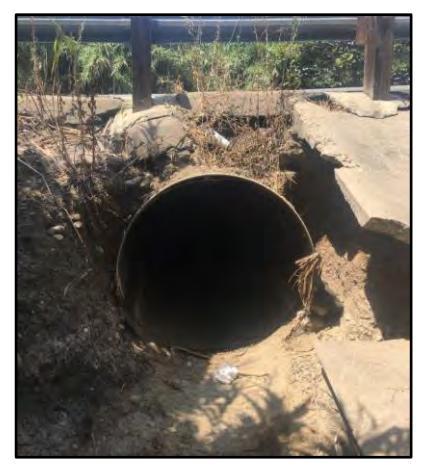
3. Jamacha 2: Upstream of the Cadman Street culvert (54-inch-diameter corrugated metal pipe), facing west.

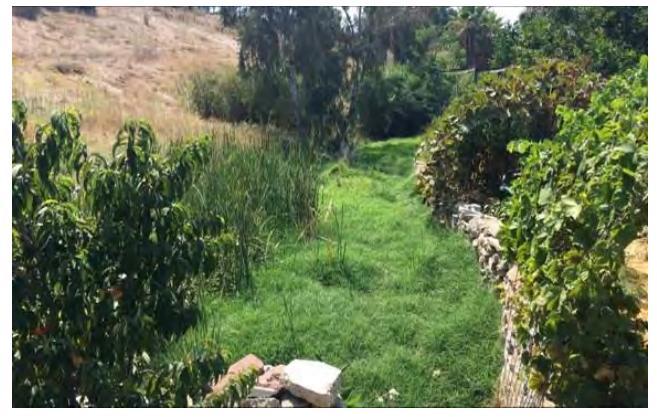
5. Cadman 1: Looking downstream at the dense vegetation present in the channel, facing northwest.

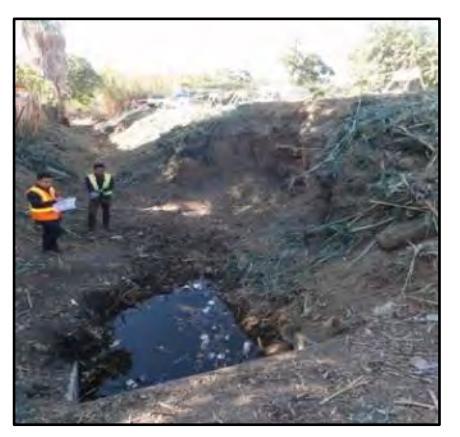
2. Lobrico 1, Reach 2: Beginning of Lobrico 1 at outlet of 48-inch RCP beneath Lisbon Street, looking south (November 2016).

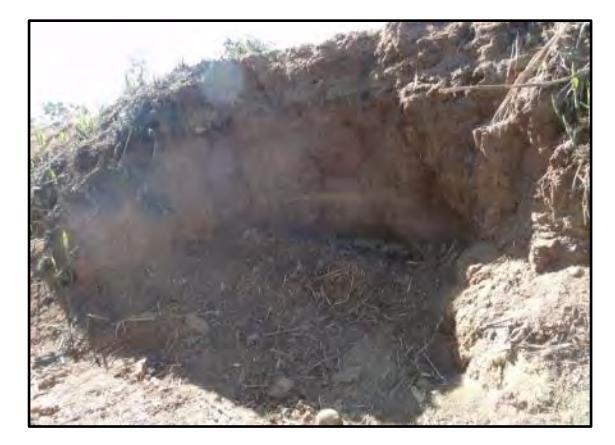
3. Lobrico 1, Reach 2: Erosion along right bank, at outlet of 48-inch RCP beneath Lisbon Street, looking southwest (November 2016).

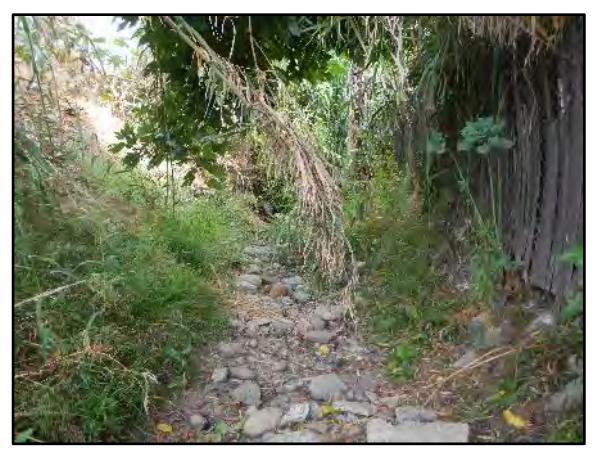
4. Lobrico 1, Reach 2: Typical section of downstream portion of Reach 2 with short left bank height, looking north (July 2019).

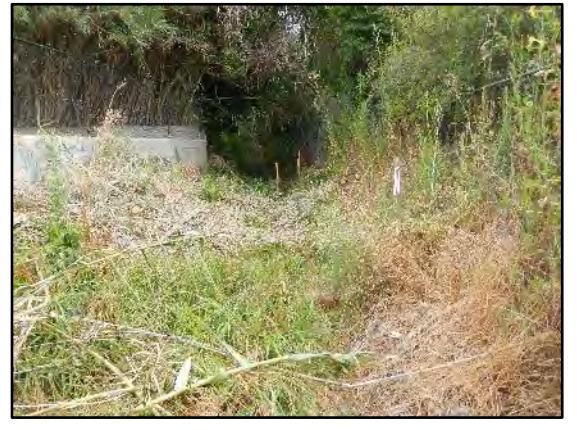
5. Lobrico 1, Reach 1: Dense vegetation present in channel and start of the 3-foot high private masonry wall along right bank, looking north (July 2019).

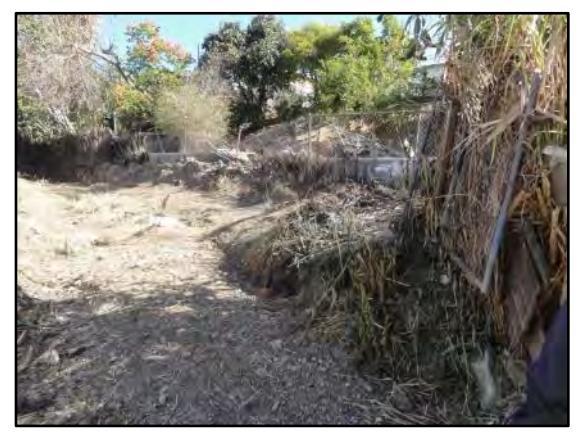
6. Lobrico 1, Reach 1: Middle portion of Lobrico 1 channel viewing the 3-foot high private wall along left bank, looking northeast (November 2016).

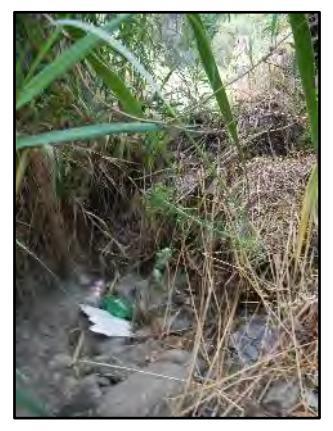
7. Lobrico 1, Reach 1: First head cut erosion along bottom of channel, measuring 3 feet in height, looking northeast (July 2019).

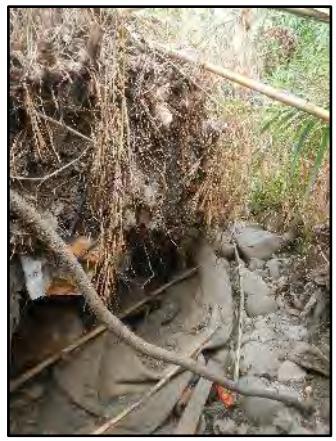
9. Lobrico 1, Reach 1: Second head cut erosion along bottom of channel, measuring 2 feet in height, looking southwest (July 2019).

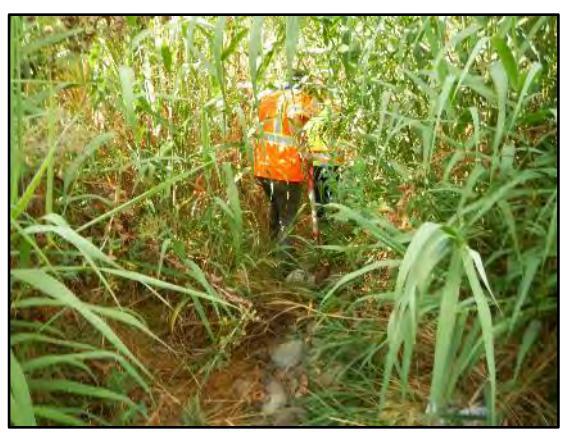
8. Lobrico 1, Reach 1: Dense vegetation present in typical section of middle portion of Reach 1, looking southwest (July 2019).

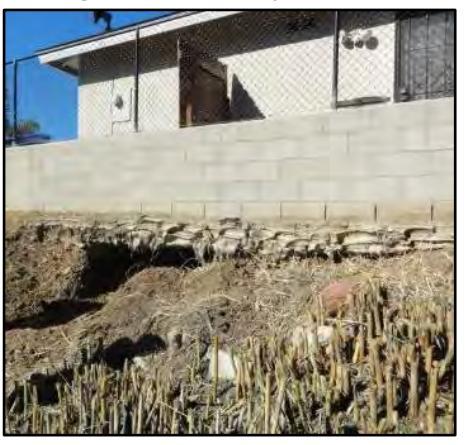
10. Lobrico 1, Reach 1: Scour hole underneath the private masonry wall on right channel bank, looking southwest (November 2016).

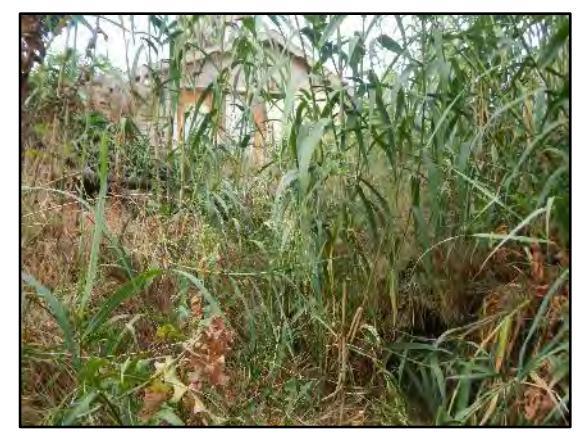
11. Lobrico 1, Reach 1: Dense vegetation present in typical section of downstream portion of Reach 1, looking southwest (July 2019).

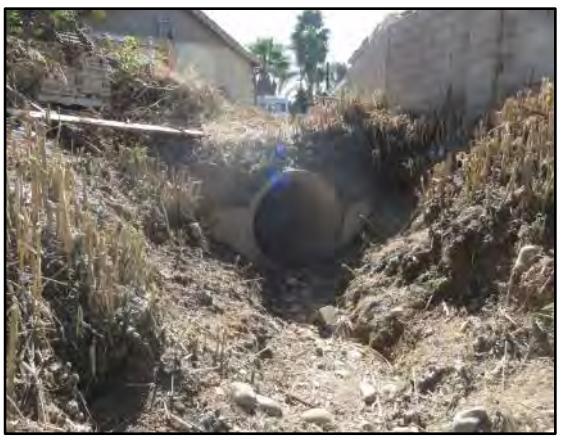
12. Lobrico 1, Reach 1: End of Lobrico 1 at inlet of 48-inch RCP beneath Jamacha Road, looking southwest (November 2016).

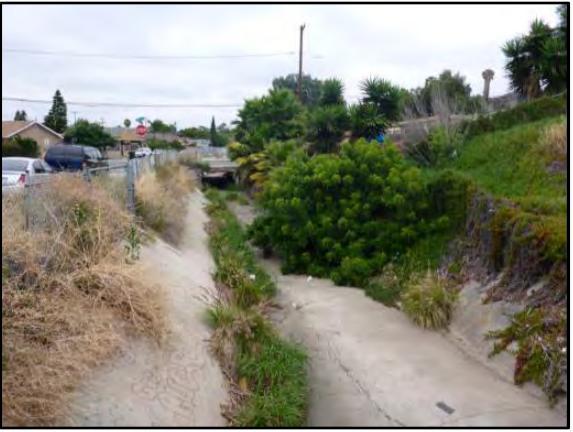
4. Cottonwood 2: Looking upstream from double 9-foot-wide by 5-foot-tall RCB culvert at 40th Street.

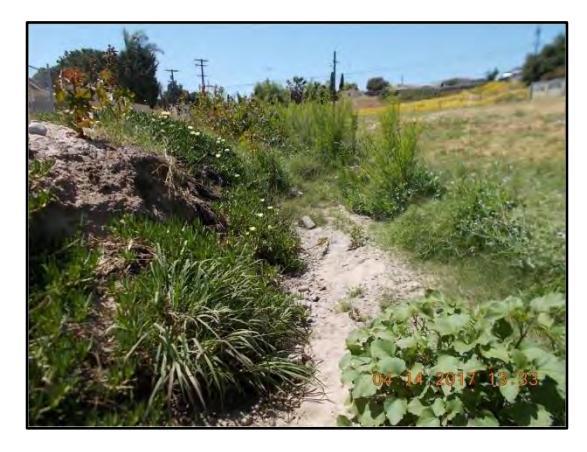
1. Cervantes 1: Looking downstream at vegetation.

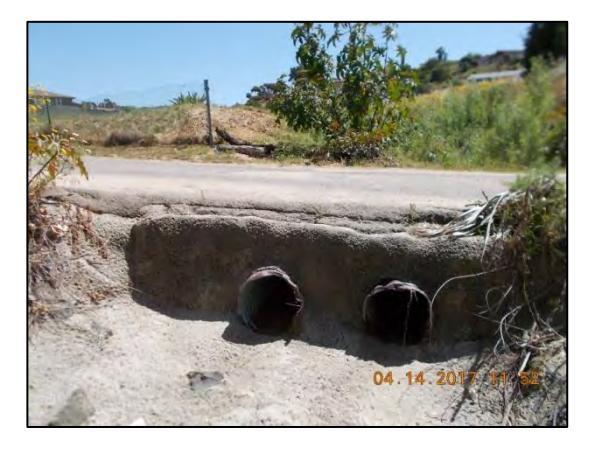
2. Cervantes 1: Looking upstream at double 18-inch-diameter CMP culvert and Arizona crossing at Cervantes Road.

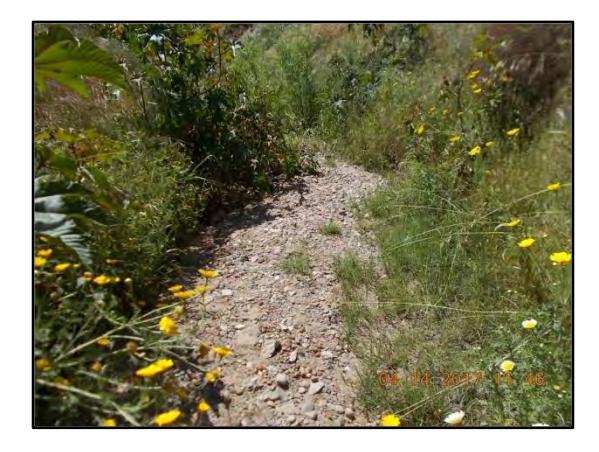
3. Cervantes 1: Looking downstream at vegetation.

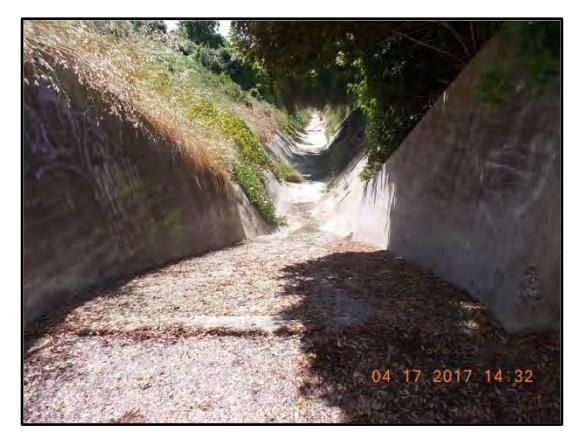
5. Solola 2 (Reach 2): Looking downstream at first drop structure.

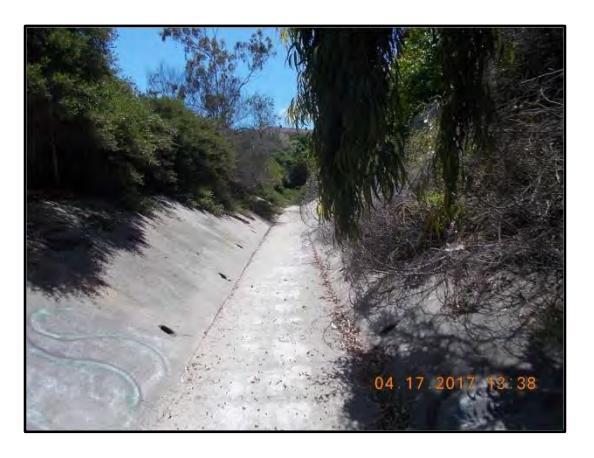
4. Solola 2 (Reach 2): Looking downstream at concrete ditch.

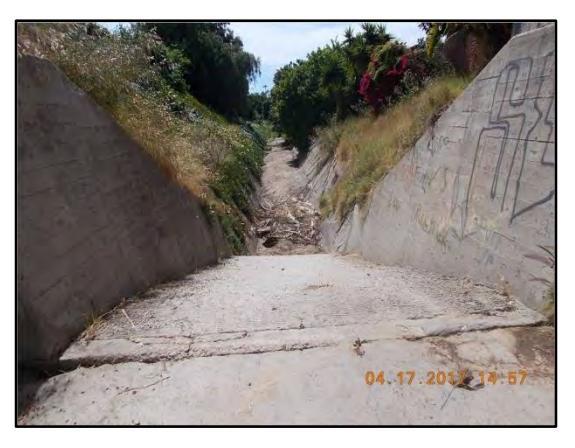
6. Solola 2 (Reach 1): Looking downstream at second drop structure and sediment accumulated at bottom of structure.

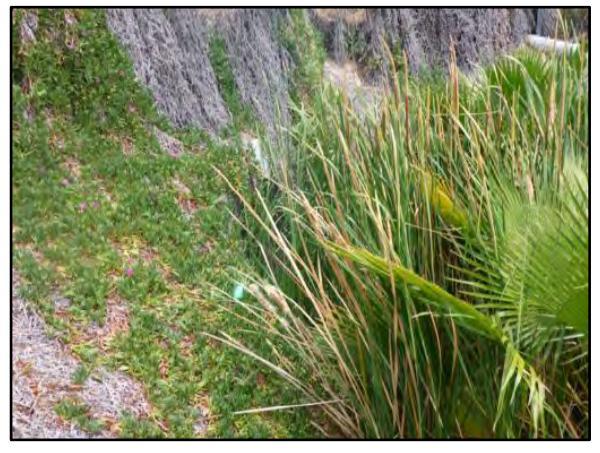
1. Parkside 1: Looking downstream from the inlet of the channel.

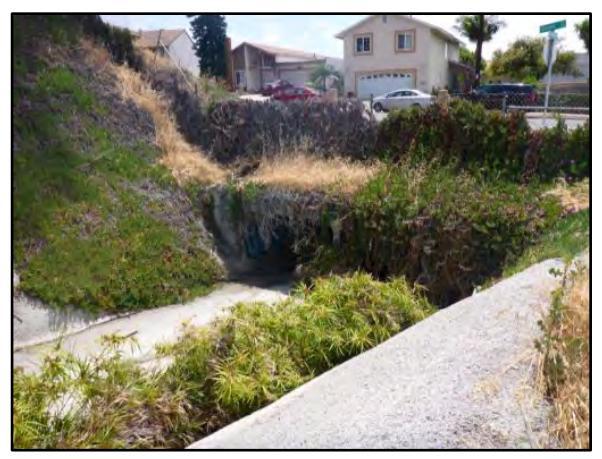
4. Parkside 1: Double box culvert at downstream end of channel, looking southwest.

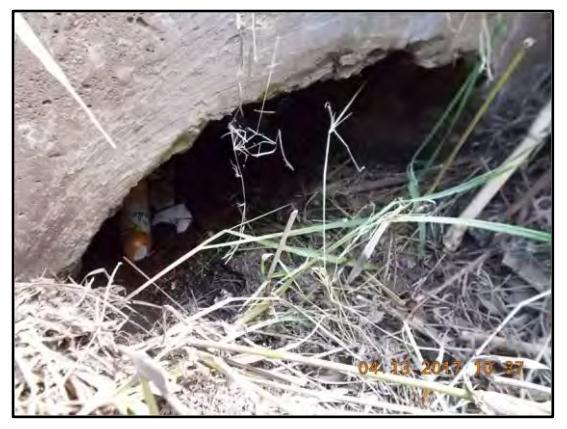
1. Outer 1, Reach 2: Looking upstream at 21-inch CMP outfall.

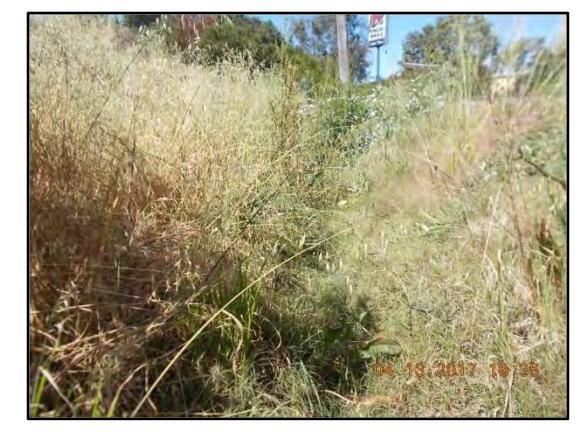
2. Outer 1, Reach 2: Looking downstream at vegetation.

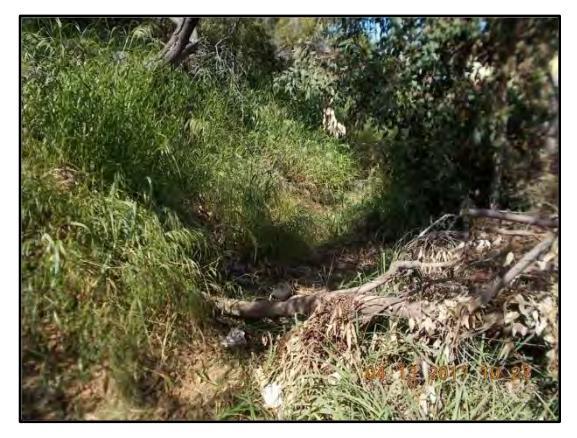
3. Outer 1, Reach 2: Looking downstream at vegetation upstream of Outer 1 and Outer 2 junction.

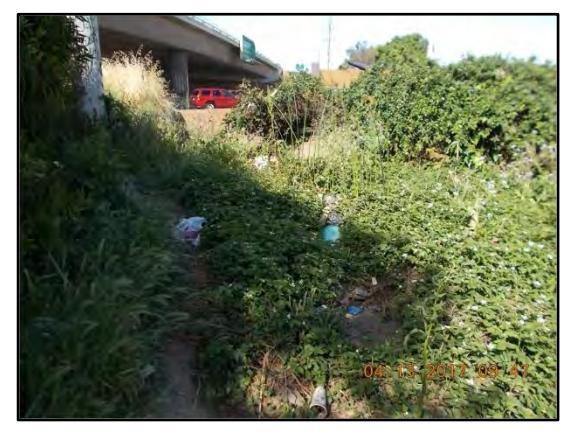
5. Outer 1, Reach 1: Looking downstream at vegetation downstream of Outer 1 and Outer 2 junction.

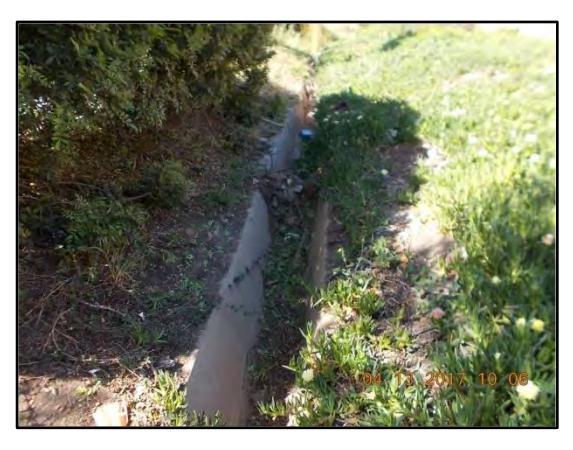
4. Outer 2: Looking downstream at debris/sediment and overhanging vegetation upstream of Outer 1 and Outer 2 junction.

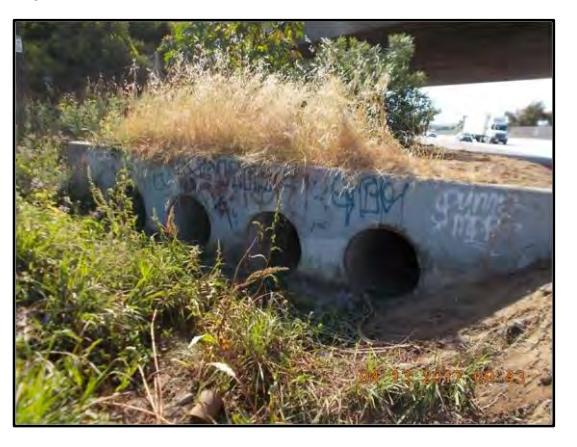
6. Outer 1, Reach 1: Looking downstream at entrance to quadruple 30-inch-diameter RCP culvert inlet.

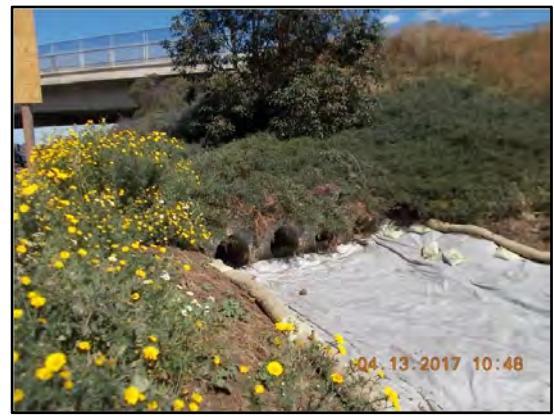
7. Downstream domain of analysis: Looking upstream at quadruple 30-inch-diameter culvert outlet.

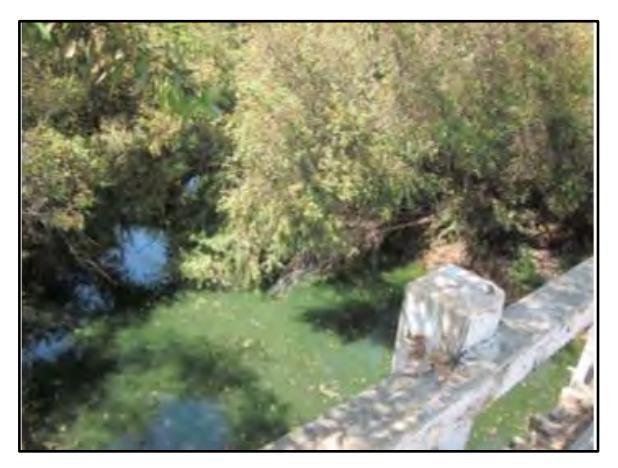
6. Pilot Channel 1: Immediately downstream of the Hollister Street Bridge.

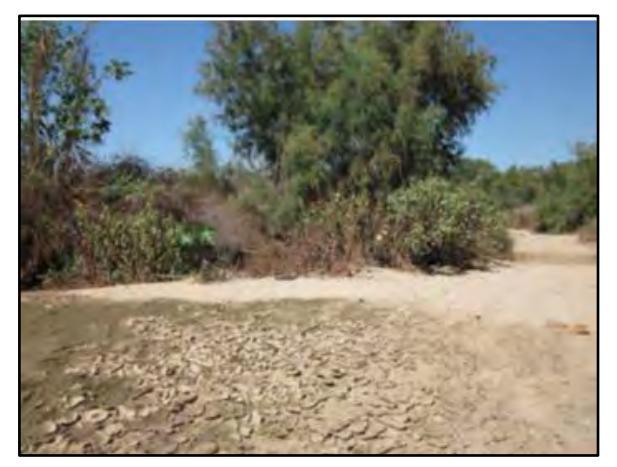
8. Pilot Channel 1: Looking north at the confluence point with the Smuggler's Gulch.

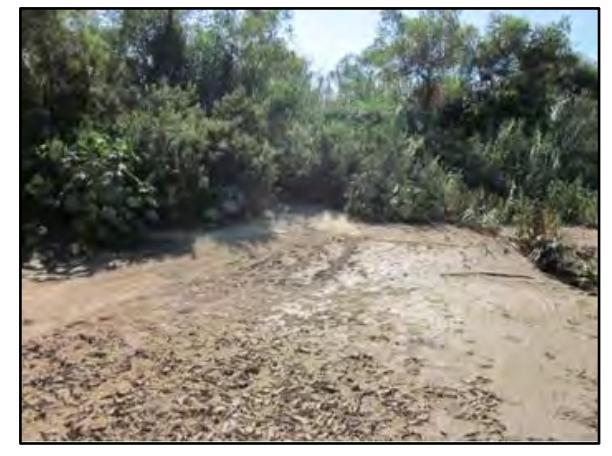
11. Pilot Channel 1: Looking south at the confluence point with the Smuggler's Gulch.

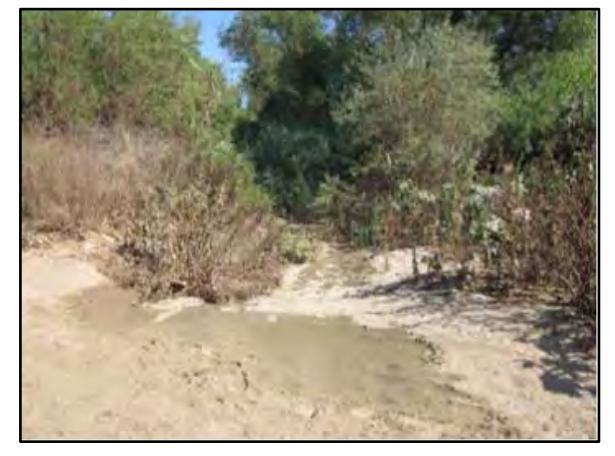
13. Pilot Channel 1: Looking east at the confluence point with the Smuggler's Gulch.

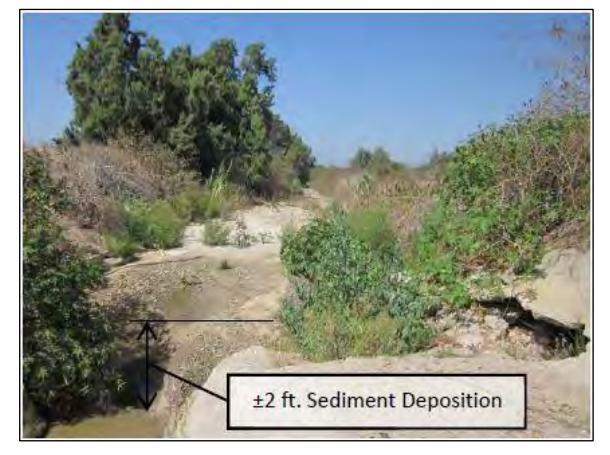
16. Smuggler's Gulch 1: Looking downstream (north) at culvert outlet near Monument Road.

Removing deposited sediment/debris and vegetation from the channel bottom increases the level of service to a >2-year event, with the conveyance capacity increasing to 900 cfs. Repair/replacement of the concrete grout near the outlet of the 52-inch-diameter CMP culvert (Station 4046) is also recommended to prevent flows from undermining structure.

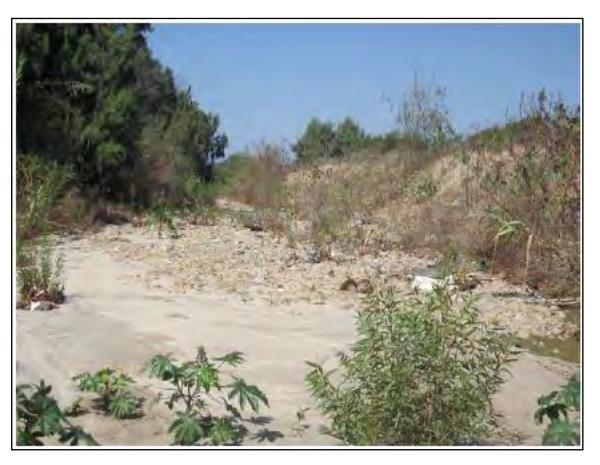
18. Smuggler's Gulch 1: Looking downstream (north) from Monument Road.

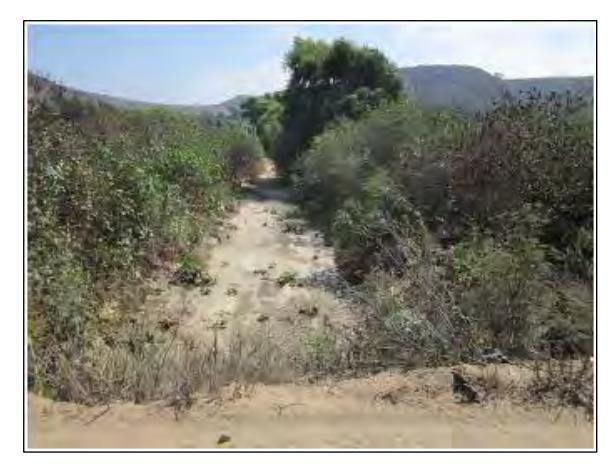
19. Smuggler's Gulch 1: Looking south (upstream) from atop the Disney Crossing.

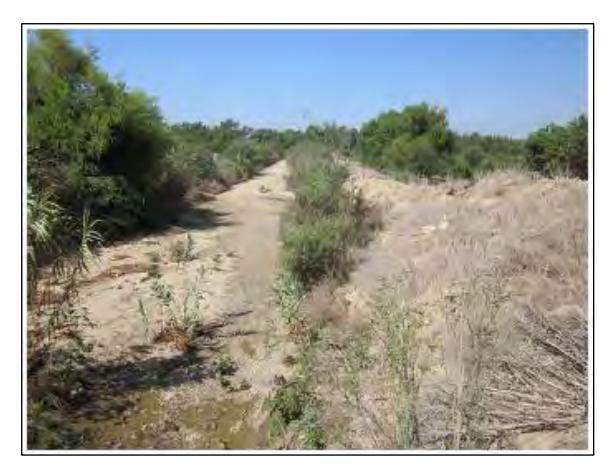
21. Smuggler's Gulch 1: Looking north (downstream) from atop the Disney Crossing.

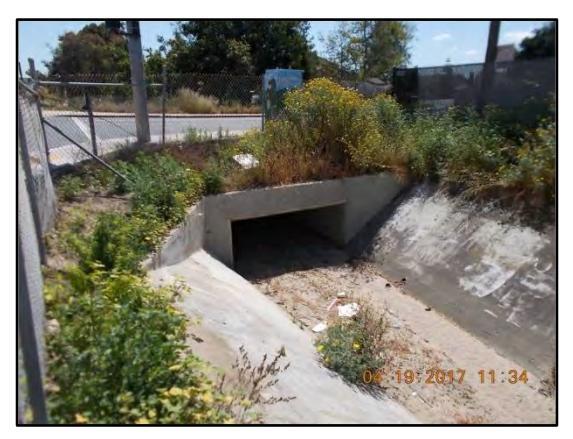
1. Tocayo 2: Looking downstream at inlet to Oro Vista Road culvert.

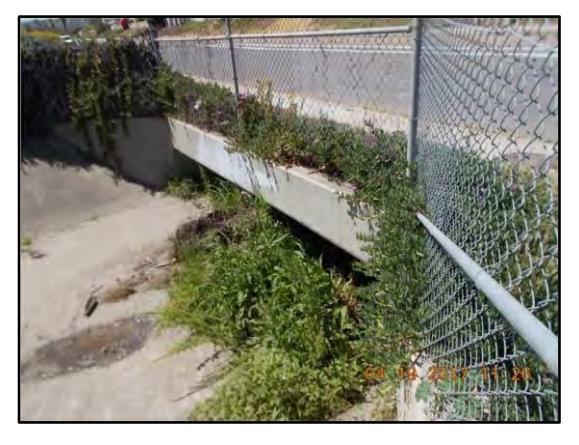
2. Tocayo 2: Looking downstream at inlet to Hollister Street bridge.

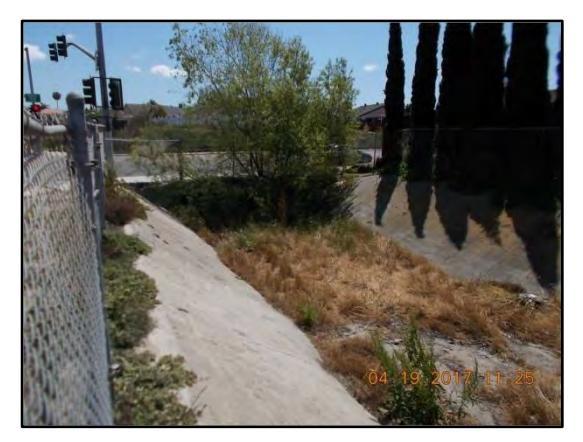
3. Tocayo 2: Looking upstream at vegetation on downstream side of Hollister Street Bridge.

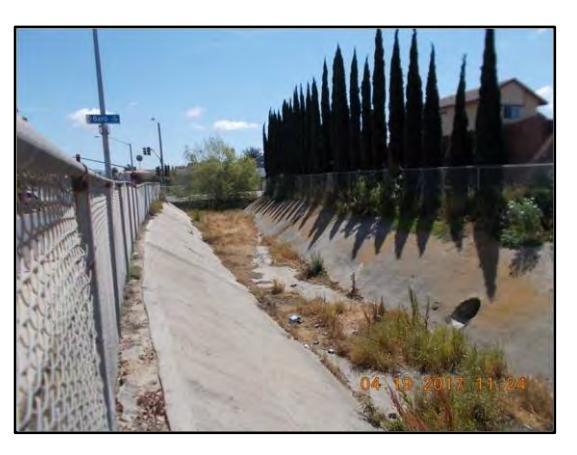
4. Tocayo 2: Looking upstream at vegetation.

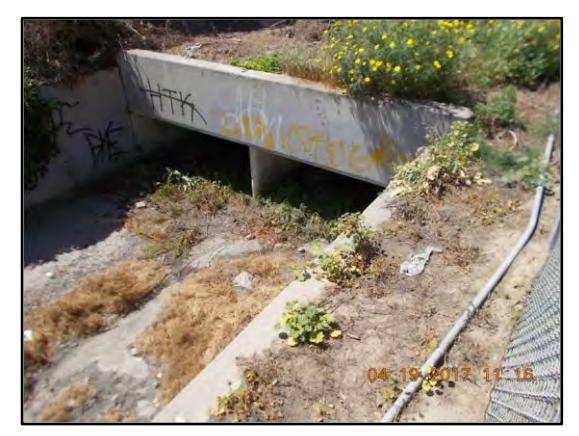
5. Tocayo 2: Looking downstream at inlet to double 10-foot by 4-foot RCB culvert.

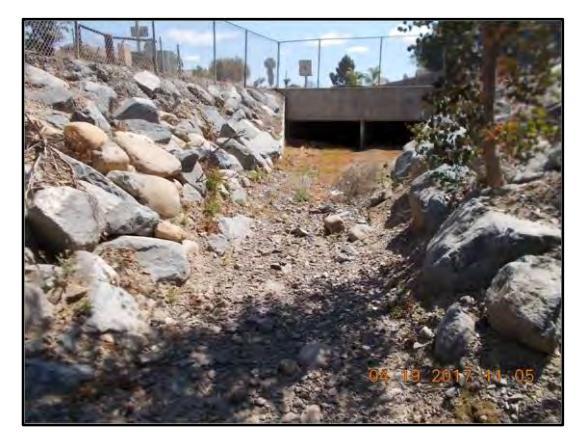
6. Tocayo 1: Looking upstream vegetation and outlet of double 10-foot by 4-foot RCB culvert.

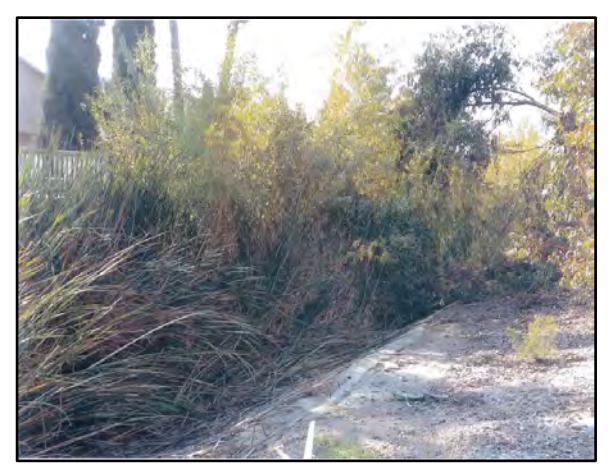
2. Via de La Bandola 1, Map 1: Looking downstream at dense vegetation throughout channel.

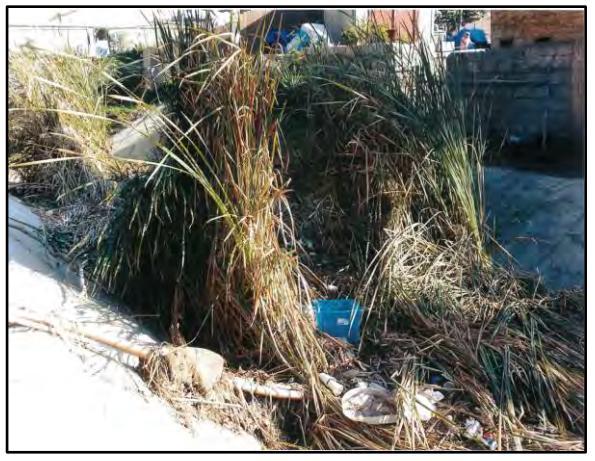
3. Via de La Bandola 1, Map 1: Looking upstream at dense vegetation and sediment/debris within channel.

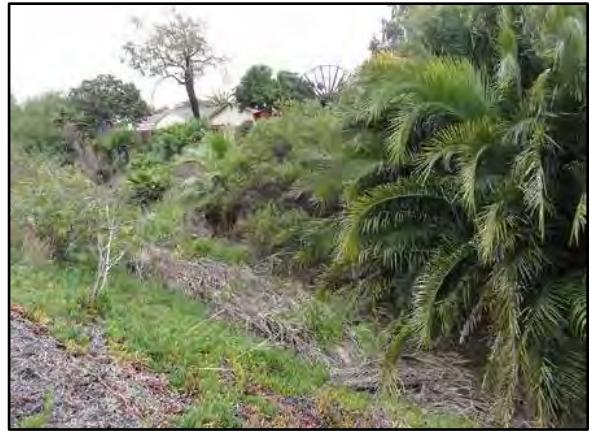
IHHA 5. Smythe 1, Map 2 (Reach 3): Looking upstream near HEC-RAS cross-section 4313.02.

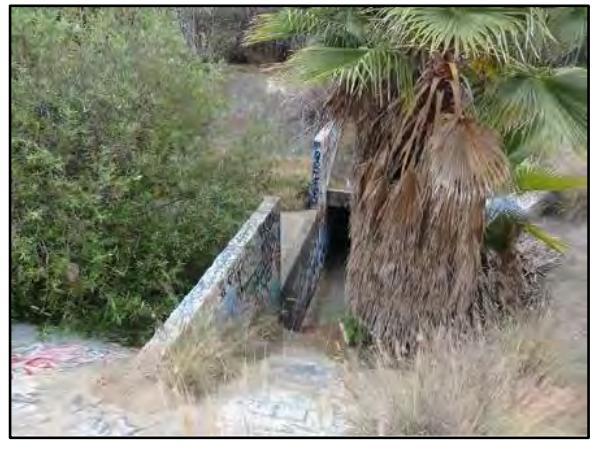
IHHA 6. Smythe 1, Map 2 (Reach 3): Downstream side of drop inlet structure.

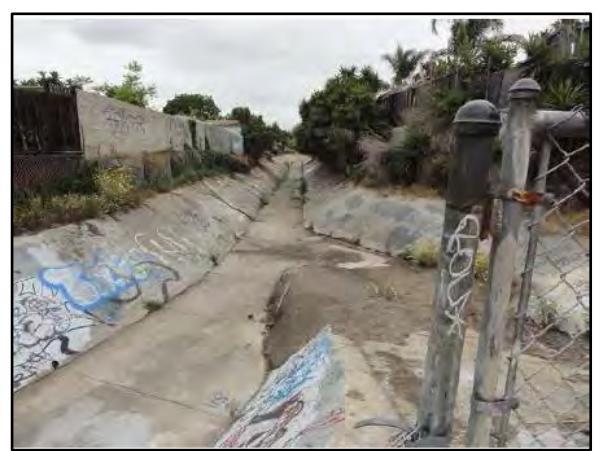
IHHA 8. Via Encantadoras 3, Map 2 (Reach 2): Looking upstream from double 72-inchdiameter RCP culvert.

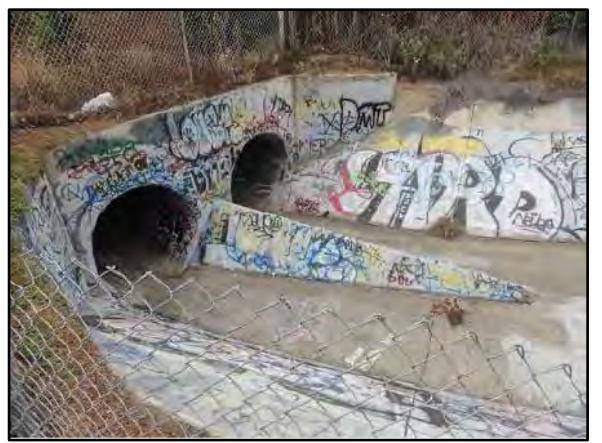
IHHA 9. Via Encantadoras 3, Map 2 (Reach 2): Entrance to double-barrel 72-inch-diameter RCP culvert under Vista Lane.

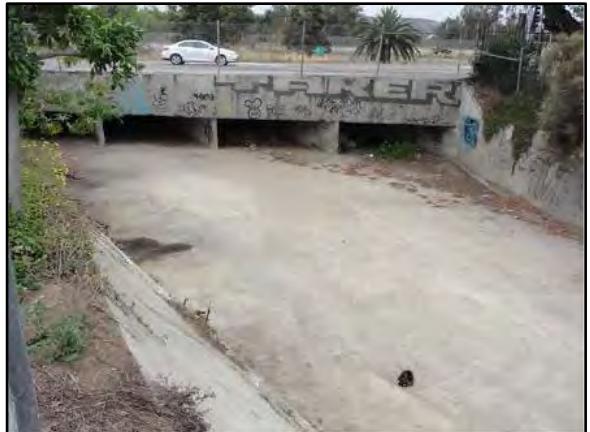
IHHA 11. Via Encantadoras 2, Map 2 (Reach 1): Looking downstream at entrance to quadruple 12-foot-wide by 4-foot-high RCB culvert beneath West San Ysidro Boulevard.

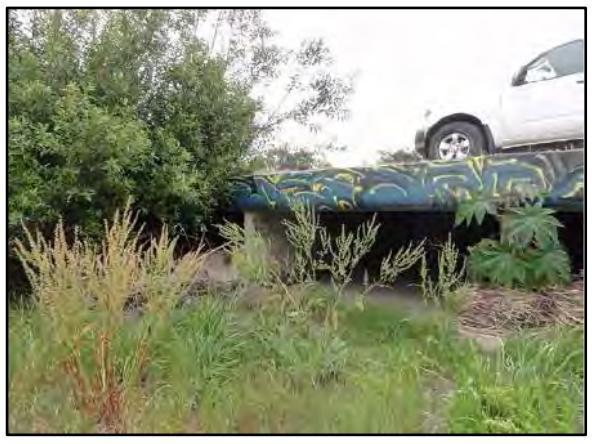
IHHA 14. Via Encantadoras 1, Map 2 (Reach 1): Looking downstream at entrance to quadruple 12-foot-wide by 4-foot-high RCB culvert beneath Interstate 5.

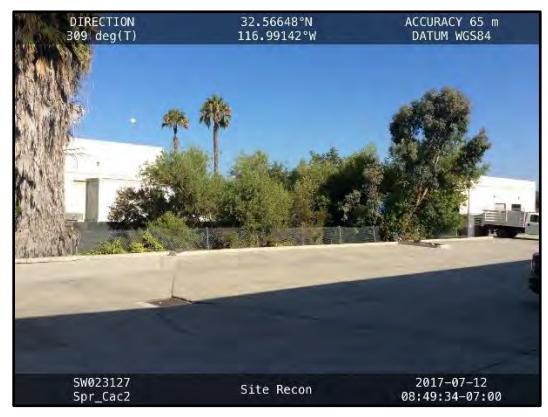
1. Cactus 1: Tree growth in basin.

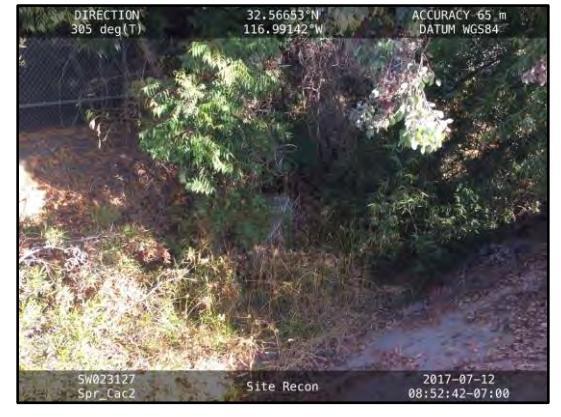
3. Cactus 1: Sediment/debris deposition and vegetation growth in basin.

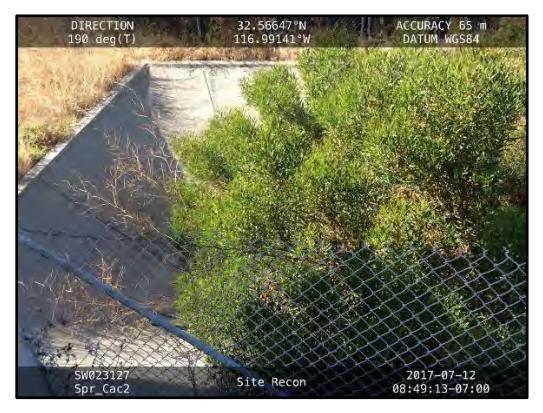
2. Cactus 1: Dense vegetation in basin.
