A.44 Chollas Creek – 54th Street (No. 5-04-280)

A.45 South Chollas Creek – Southcrest

A.46 South Chollas Creek - Euclid

A.47 South Chollas Creek – Federal

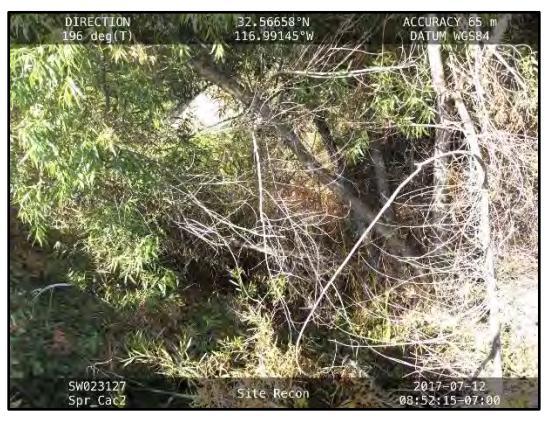
4. Cactus 1: Vegetation growth at outflow structure.

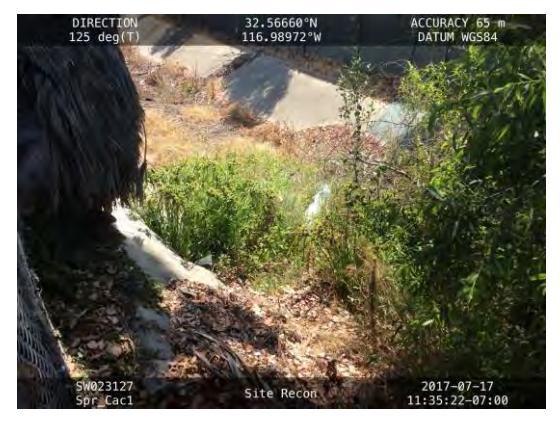
1. Cactus 2: Sediment deposition and vegetation growth at inlet.

Facility Type	Detention Basin: Concrete	Category 1
Is Maintenance Recommended?	Yes ¹	
Extent of Maintenance	• Remove accumulated sedimen the basin to restore the as-bui	t/debris and vegetation throughout lt condition.
Benefits	 Reduces flood risk associated v Restores capacity of the basin benefits. 	with outlet structure clogging. and potential water quality

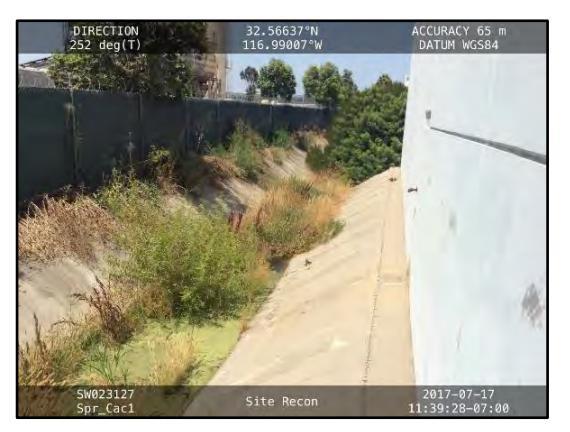
2. Cactus 2: Standing water and vegetation growth in the basin.

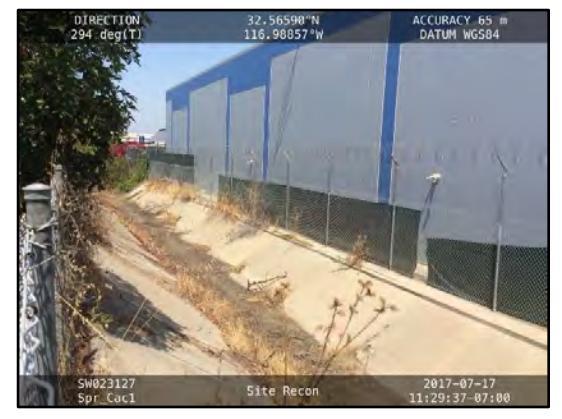
When applying the 10% maintenance threshold described in Section 4.2.3 of the *Hydrology and Hydraulics Technical Report*, maintenance is necessary. Sediment deposition is approximately 0.5 feet deep in the baseline condition, and when compared to the overflow weir height of 2.8 feet, approximately 18% of the sediment storage is occupied by sediment, which meets the detention basin maintenance threshold. Therefore, removal of deposited vegetation and sediment/debris from the bottom of the basin is recommended to restore the capacity of the detention basin. The frequency will be established based on annual inspection of the basin and outlet works.

3. Cactus 2: Sediment deposition in basin.

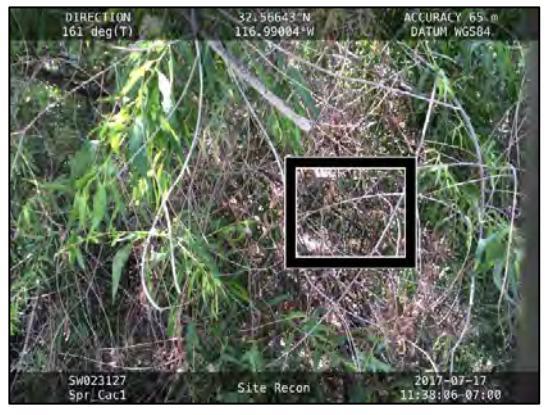
4. Cactus 2: Vegetation growth at outlet.

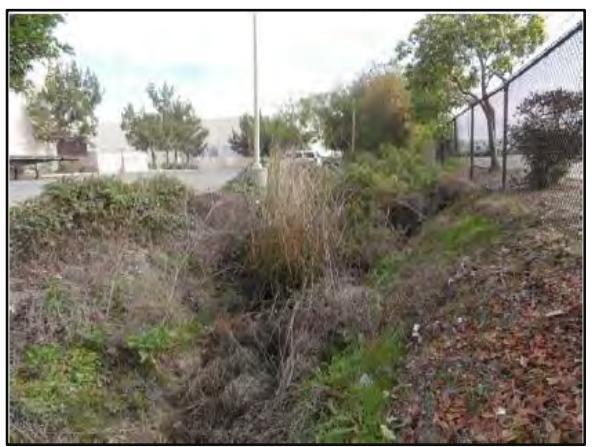
IHHA 3. Siempre Viva 1, Reach 1 (Bristow Channel): looking east towards upstream end of dense vegetation.

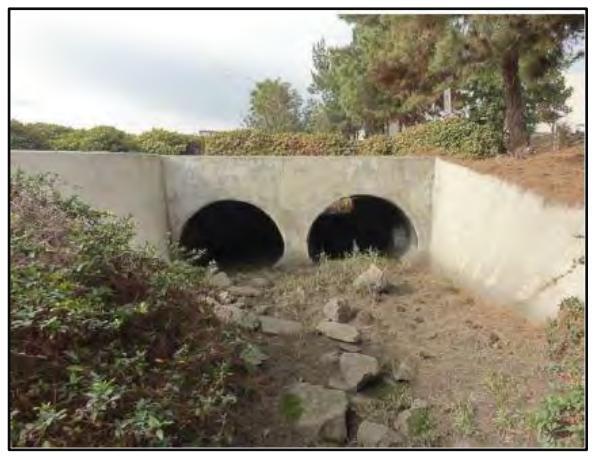
IHHA 8. Siempre Viva 1, Reach 2 (Bristow Channel): Looking west towards the outlet of the upstream pair of culverts.

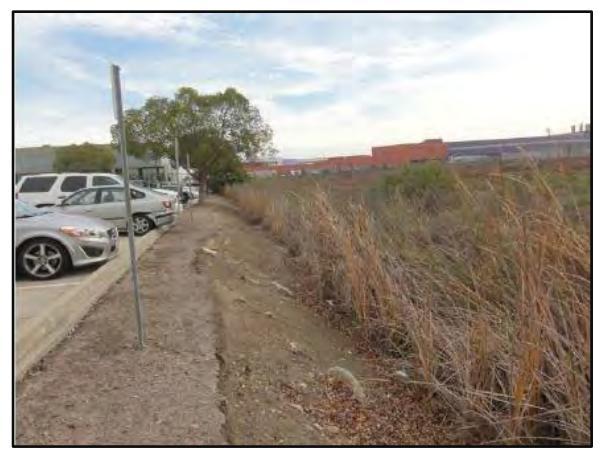
IHHA 15. Siempre Viva 1, Reach 3 (Siempre Viva Channel): Looking east along a typical section of vegetated channel.

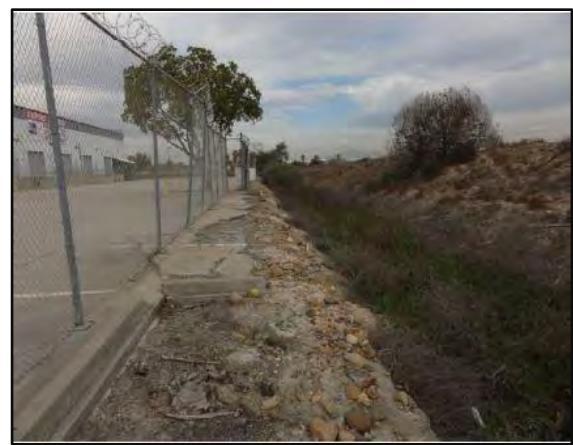
IHHA 18. Siempre Viva 1, Reach 3 (Siempre Viva Channel): Middle portion of Reach 3 looking north towards the lightly vegetated section in the middle of the reach.

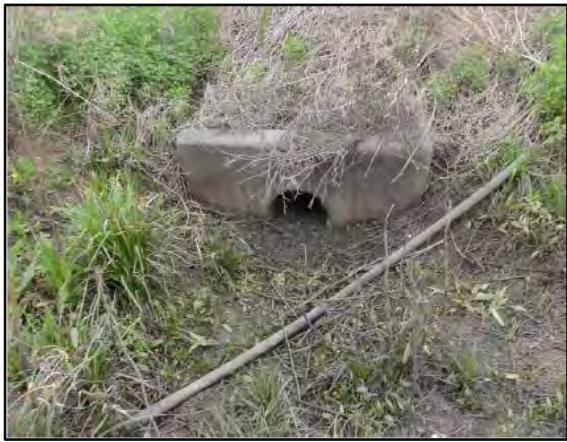
IHHA 21. Siempre Viva 1, Reach 3 (Siempre Viva Channel): Downstream portion of Reach 3 looking south towards the shared detention facility.

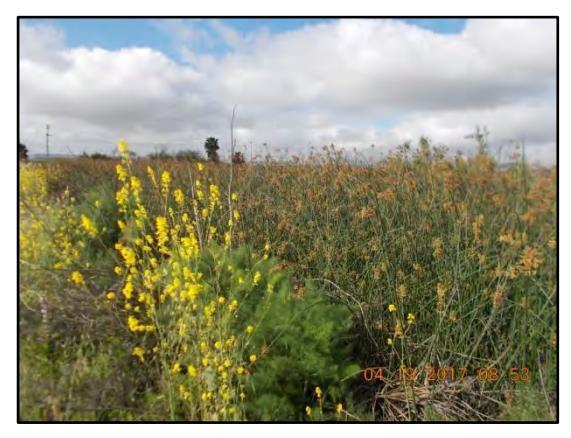
1. La Media 1: Looking downstream at vegetation in the ditch from La Media Road.

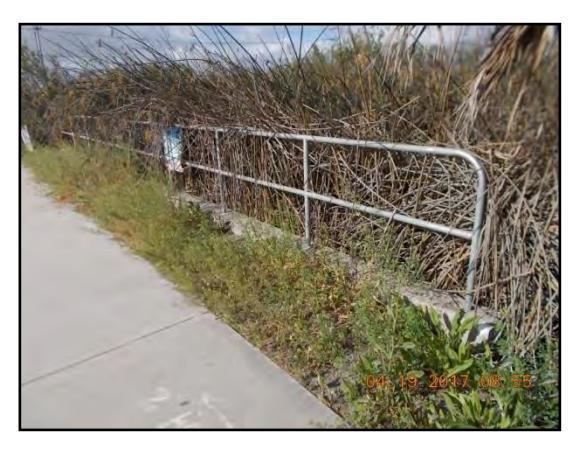
2. La Media 1: Looking downstream over headwall and three 24-inch-diameter RCP culvert outlet.

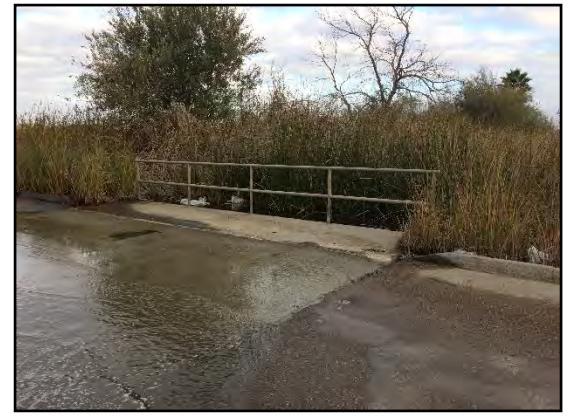
3. La Media 1: Looking upstream at conservation area from Airway Road.

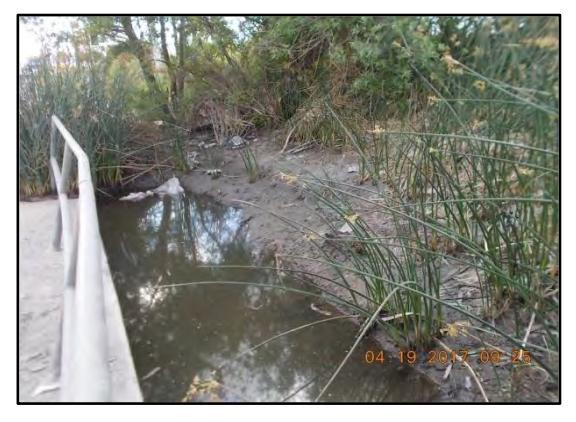
4. Downstream Domain of Analysis: Looking east at sediment and vegetation.

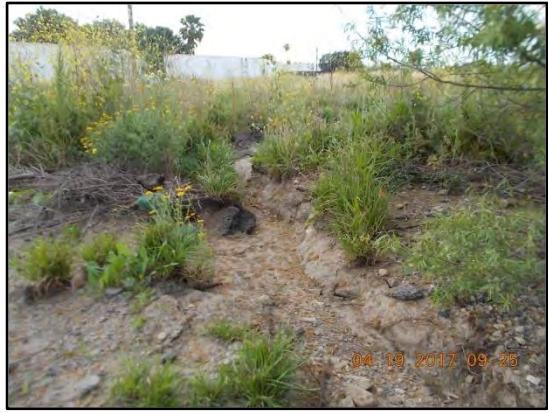
5. Downstream Domain of Analysis: Looking downstream at naturally occurring bypass of sediment obstruction.
