Mission Trails Regional Park Master Plan Update
Hazardous Materials/
Unexploded Ordnance (UXO) Review

GHD Inc.

May 2016

Client: U.S. Army Corps of Engineers
Location: Tierrasanta Project Area, San Diego, California
Photograph Dates: November 16 - 20, 2006

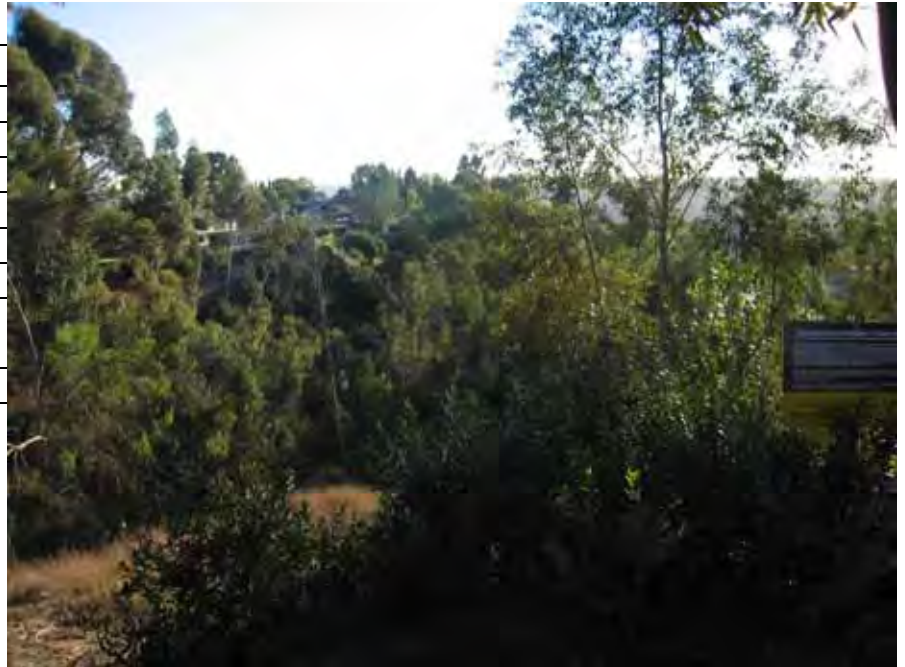
Photograph No. 3

Heavily vegetated; within portion of area F-5N that did not burn during the Cedar Fire.

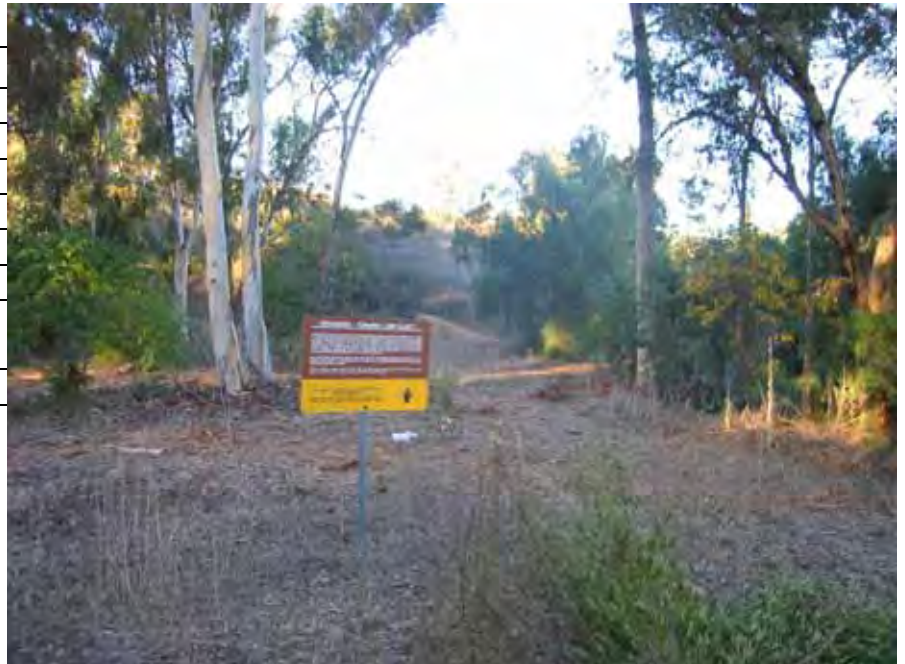
**Photograph No. 4**

MEC warning sign at F-3 and Tierrasanta Road.

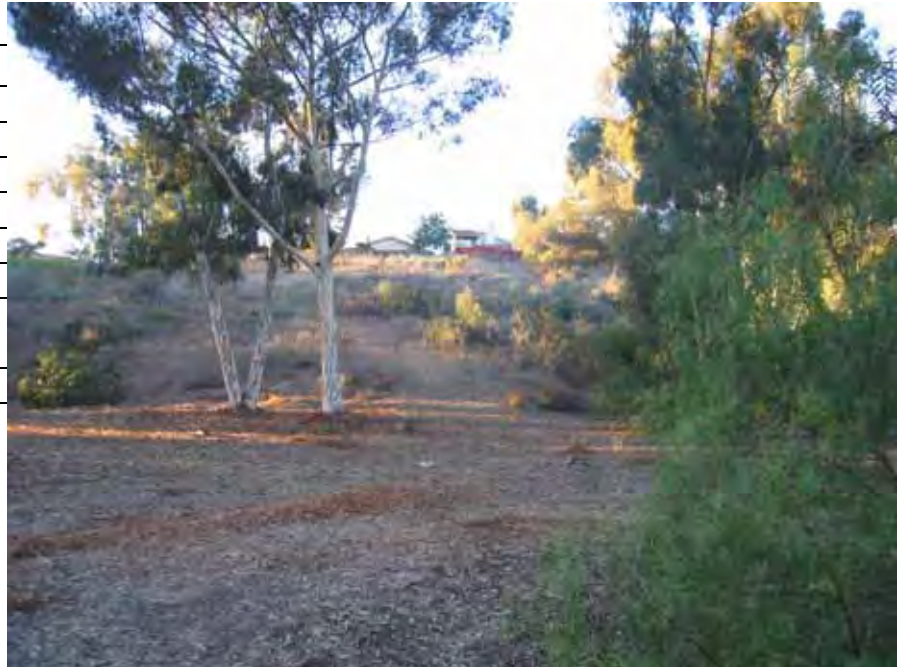
Good vegetation at F-3 and
Tierrasanta Road. Area did not burn
in the Cedar Fire

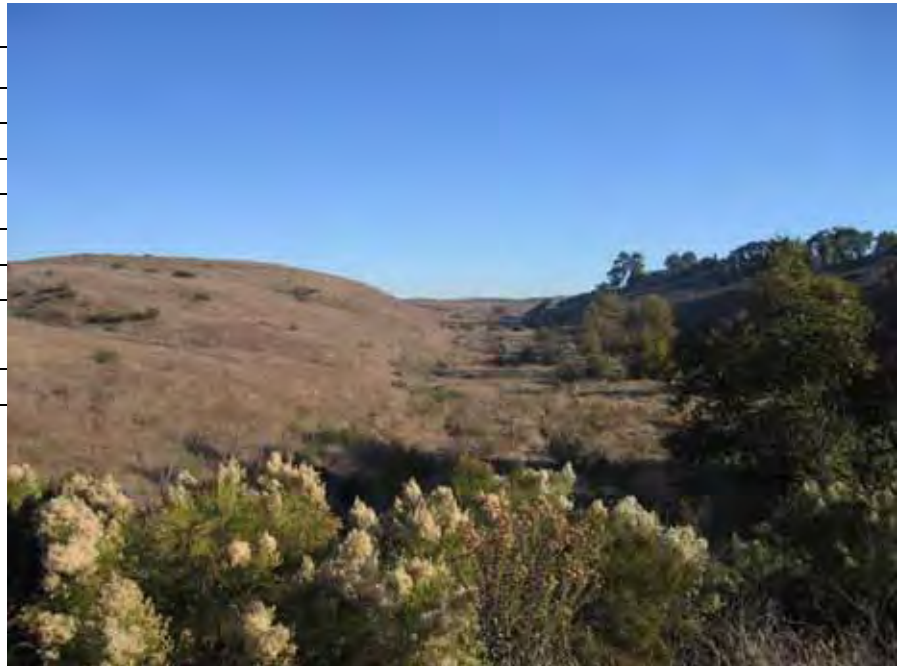
**Photograph No. 6**

F-8/F-9; fully recovered from the
Cedar Fire.

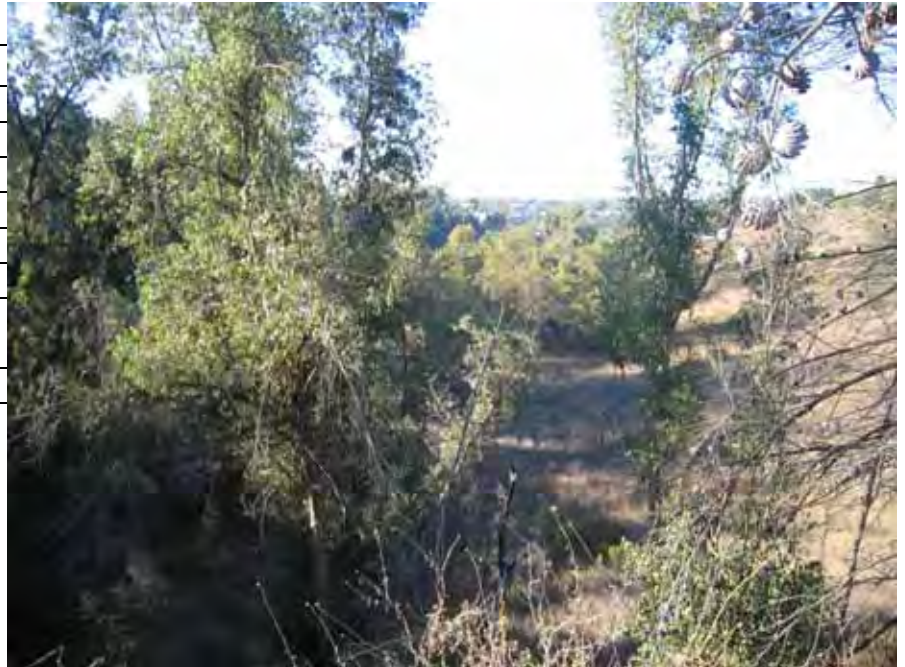
F-8E fully recovered from the Cedar Fire; heavily vegetated, no erosion.

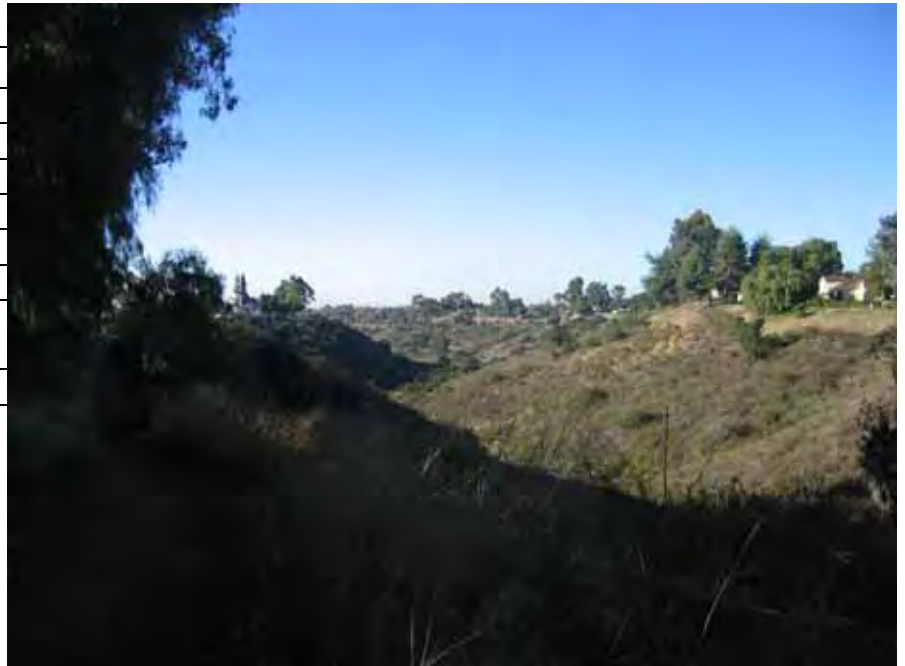
**Photograph No. 8**

F-2W; heavily vegetated. This area did not burn in the Cedar Fire.

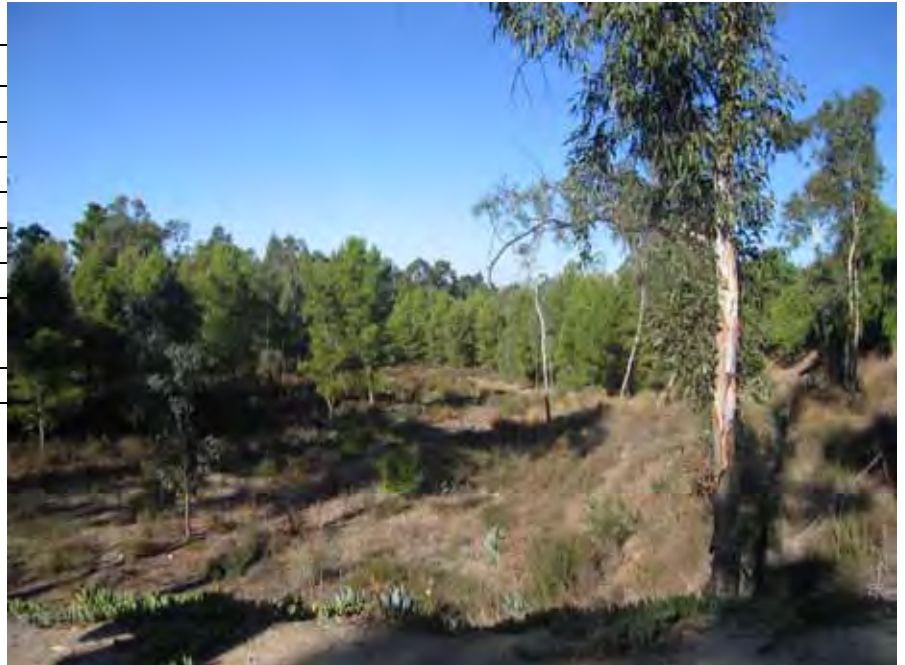
F-2W; heavily vegetated. This area did not burn in the Cedar Fire.

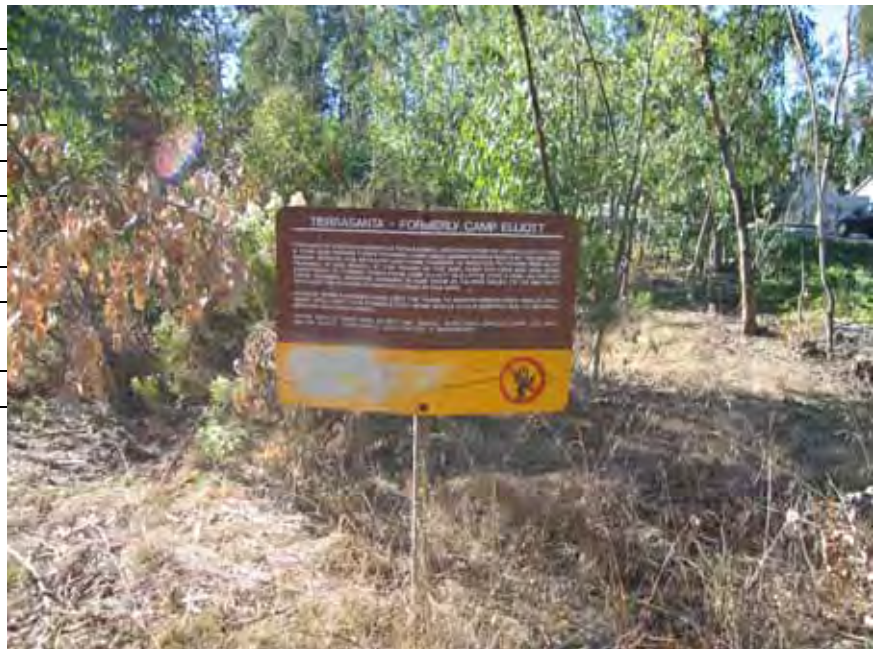
Photograph No. 10

F-2W, same location as Photograph 10. Minor vandalism to the MEC sign.

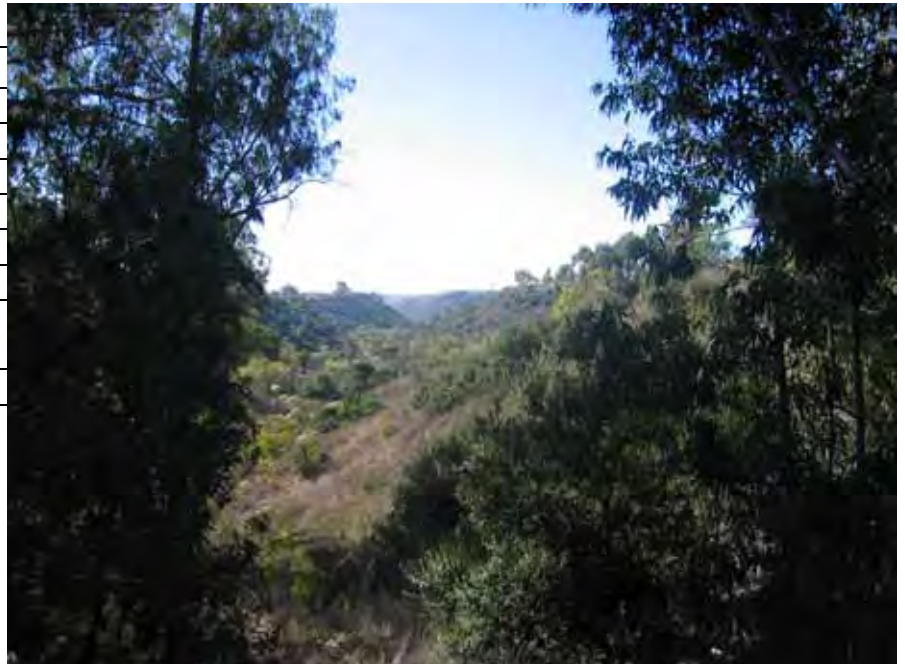
F-1 from Tierrasanta. Heavily vegetated. This area did not burn in the Cedar Fire.

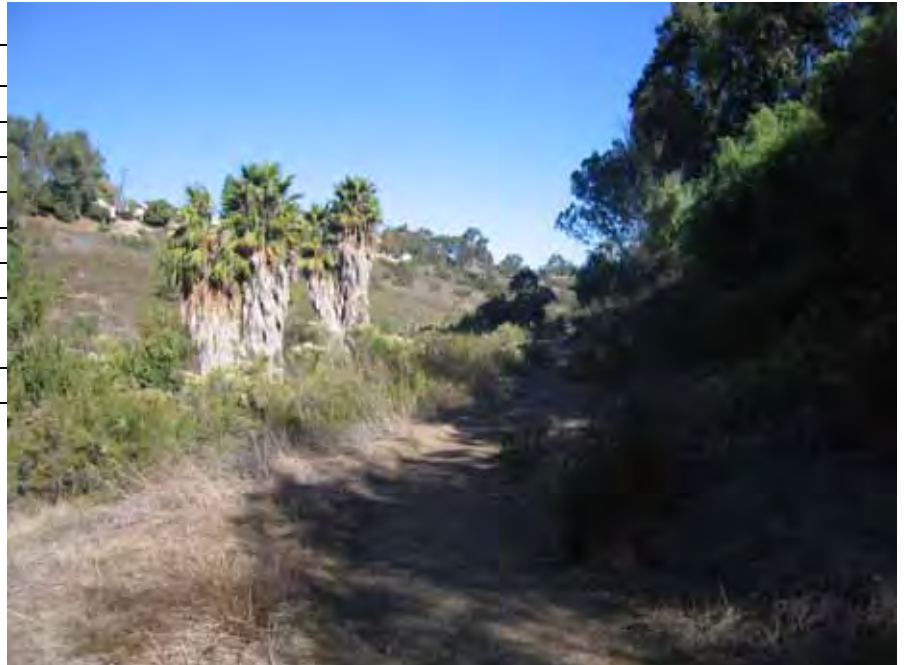
F-2W at southern end. Good vegetation; no evidence of burning.

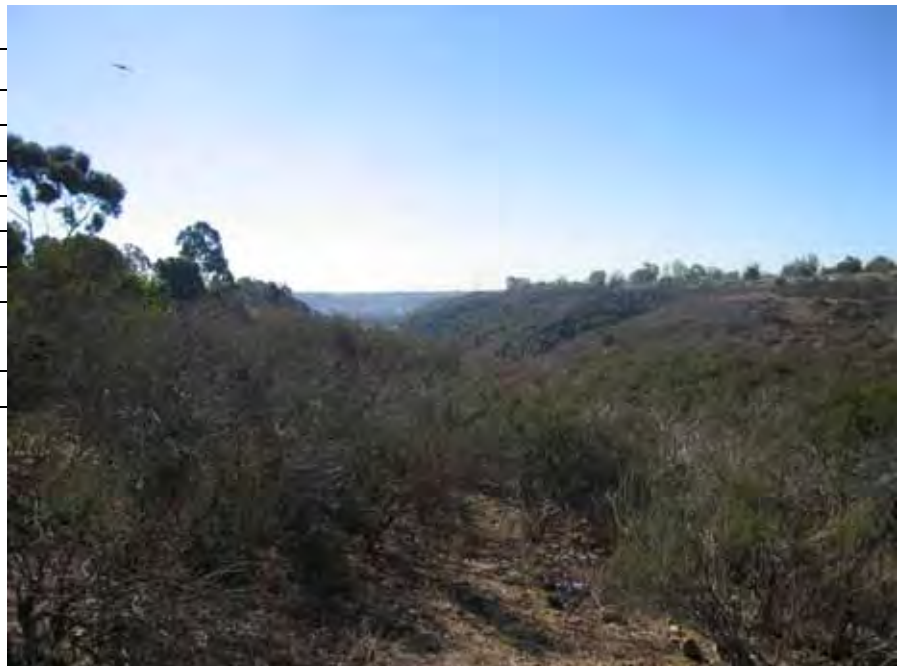
Photograph No. 14

F-1 from below Roadrunner Park. Heavily vegetated. This area did not burn in the Cedar Fire.

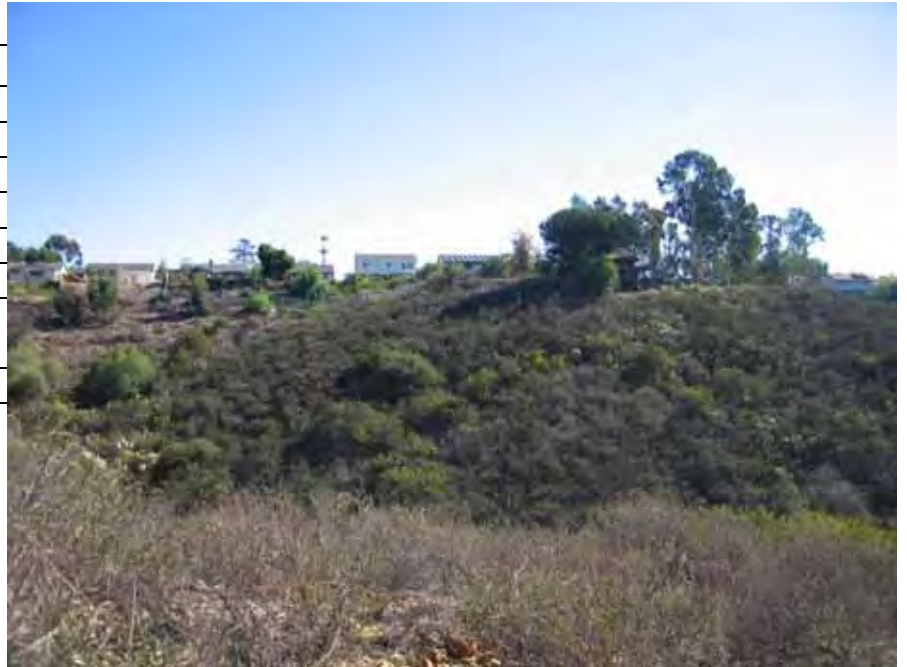
Photograph No. 15

F-1. Heavily vegetated, this area did not burn in the Cedar Fire.

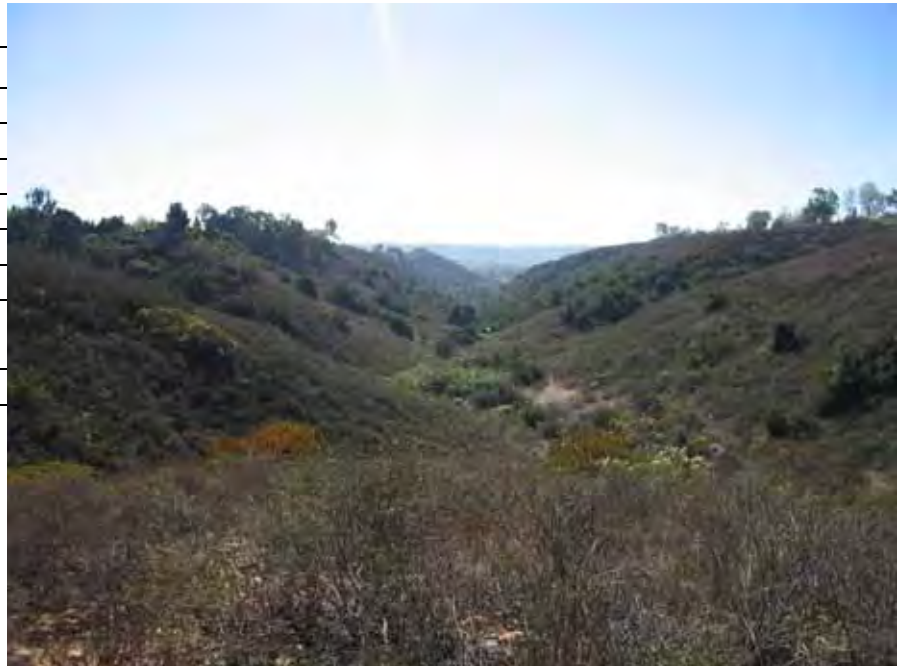
Photograph No. 16

F-1, same location as Photograph 15 above. Heavily vegetated; this area did not burn.

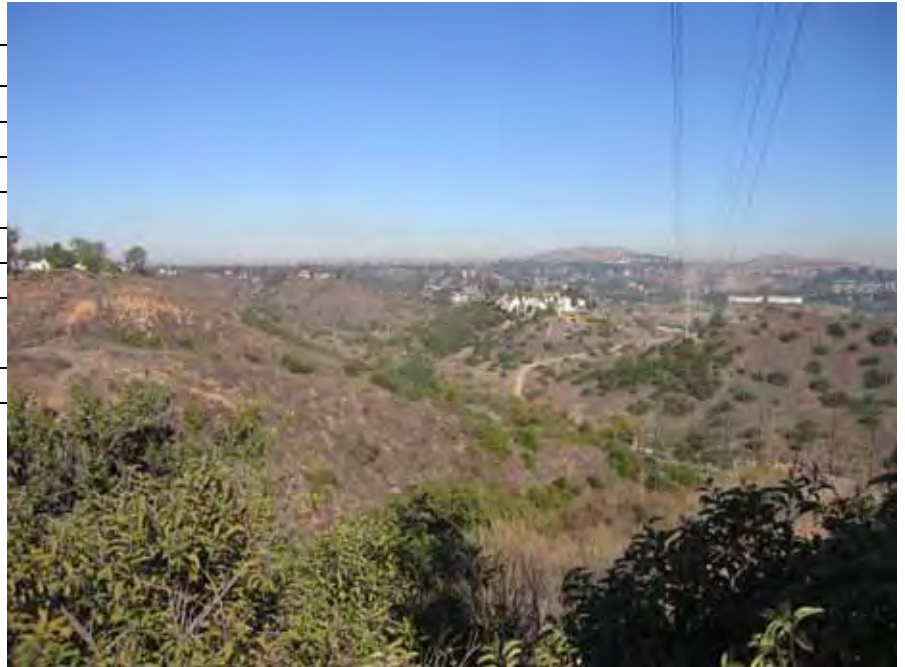
Photograph No. 17

F-1. Heavily vegetated; this area did not burn.

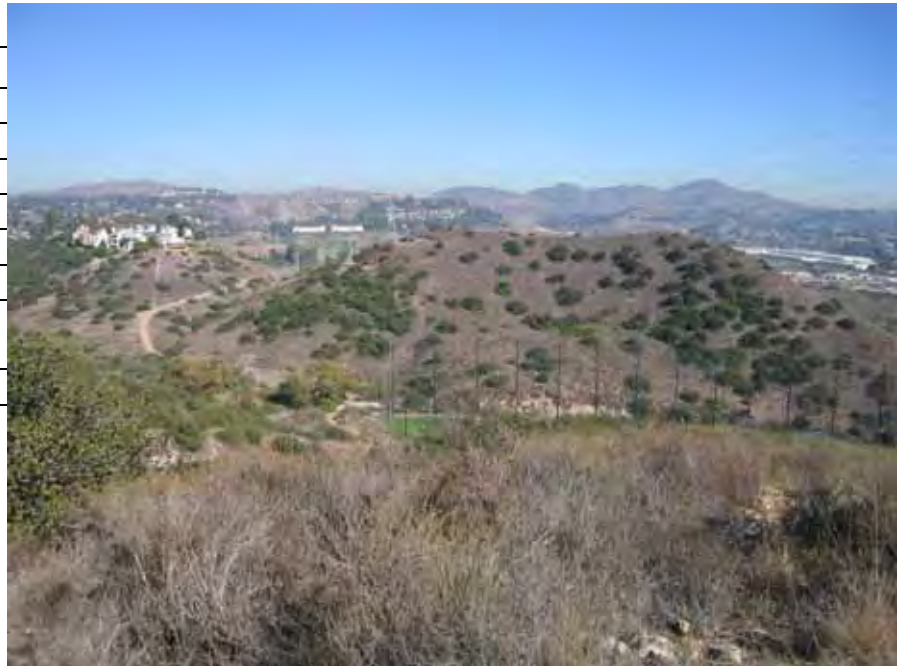
Photograph No. 18

F-11N, same location as Photograph 18 above. Heavily vegetated; this area did not burn.

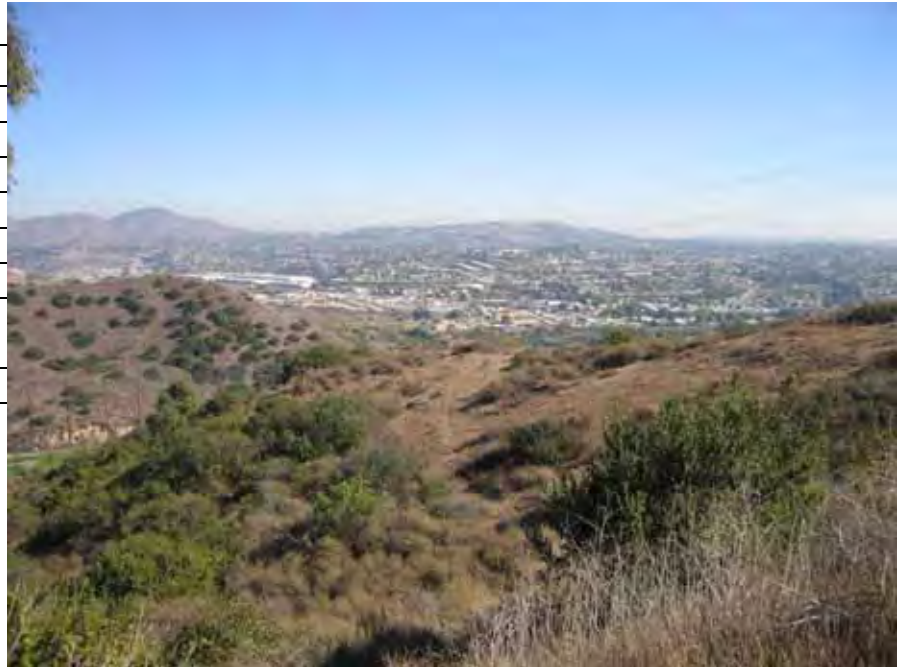
OA-1; F-11N and driving range in background heavily vegetated. Area did not burn.

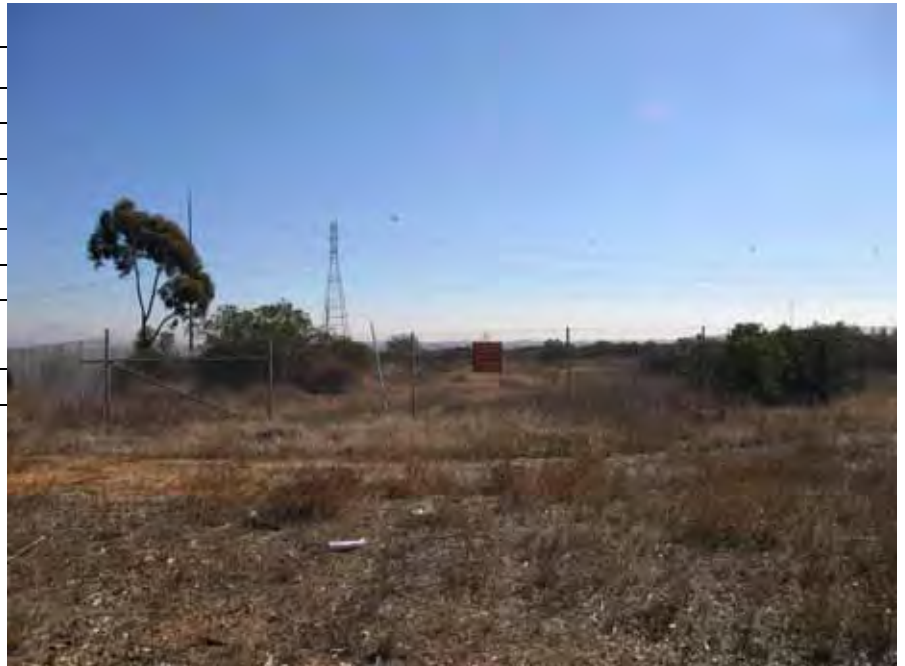
Photograph No. 20

OA-1, most of area is fenced to protect vernal pools.

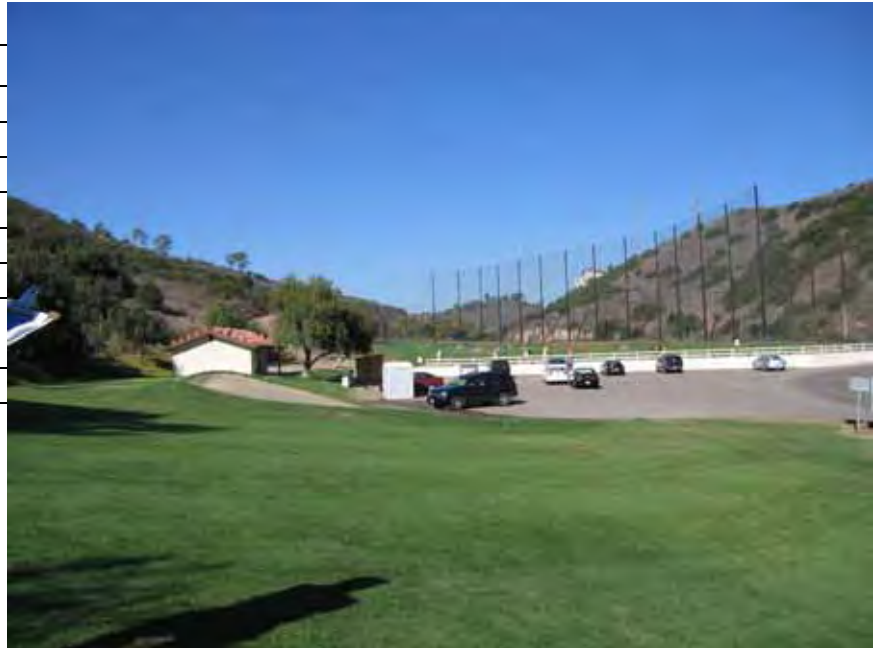
F-1 and driving range in background heavily vegetated.
Area did not burn.

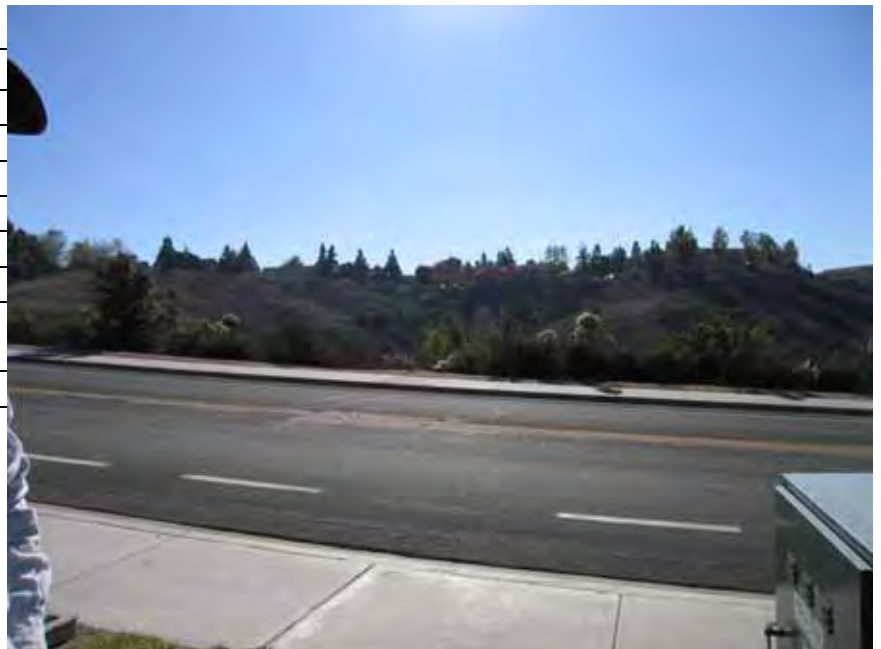
Photograph No. 22

C-3 good vegetation, no evidence of burn left.

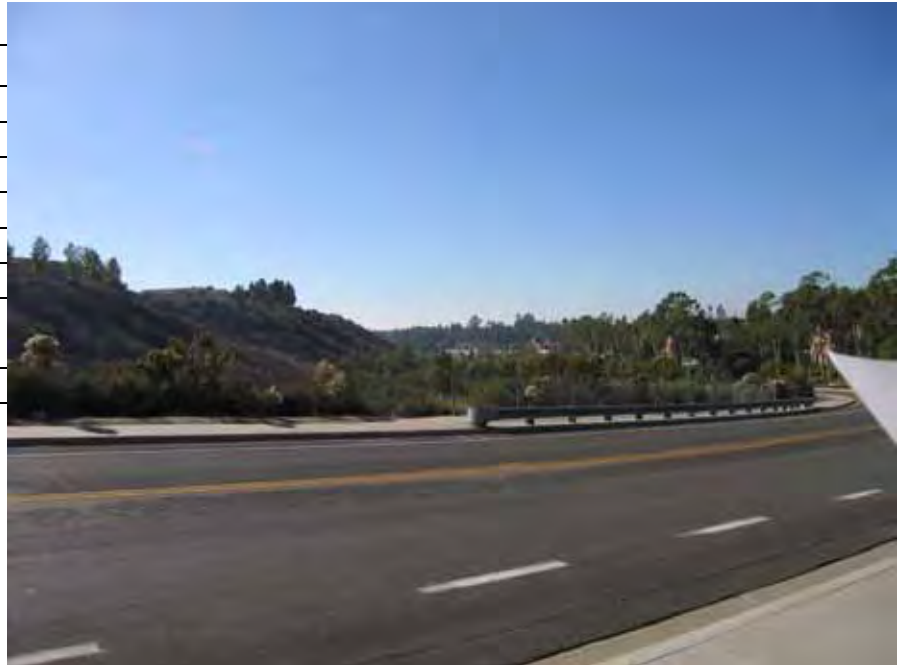
North end of C-3 at Portobello Dr.
Area burned in fire, fully recovered,
heavily vegetated. Same location as
22.

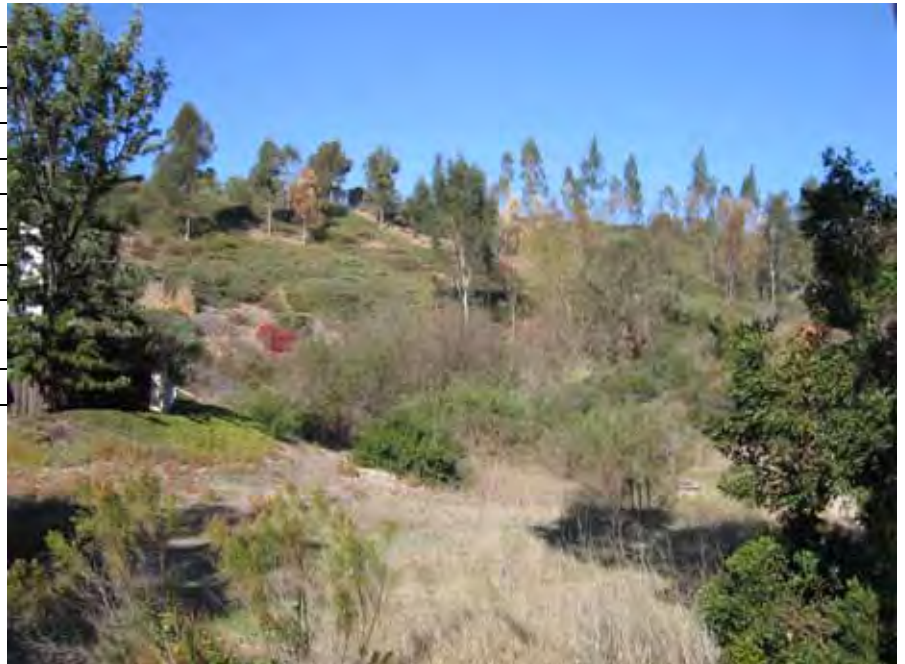
**Photograph No. 24**

C-1 at Portobello Dr. Area did not
burn in fire, heavily vegetated.

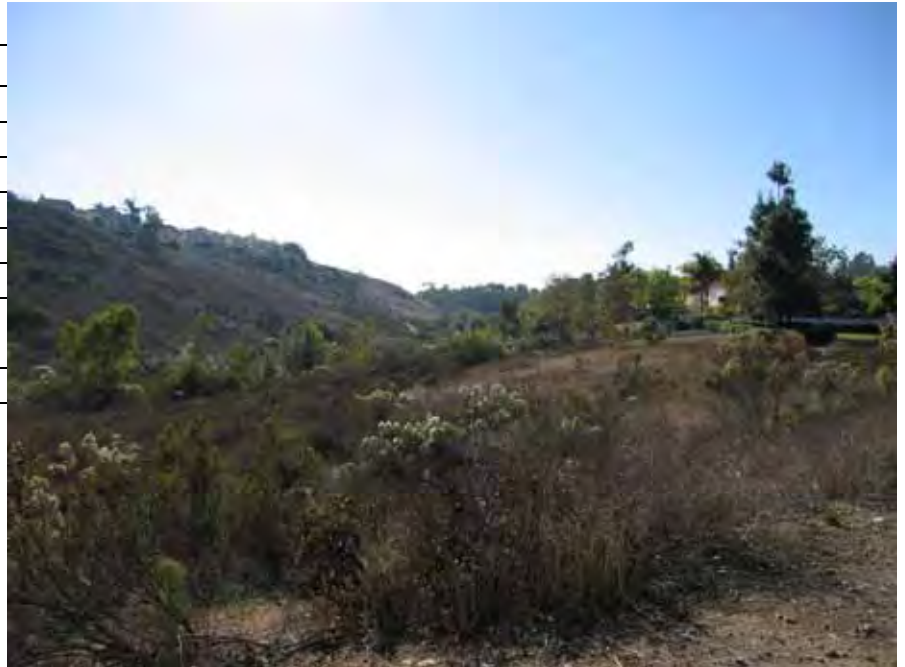
C-3 at Portobello Dr. Area burned in fire, fully recovered, heavily vegetated.

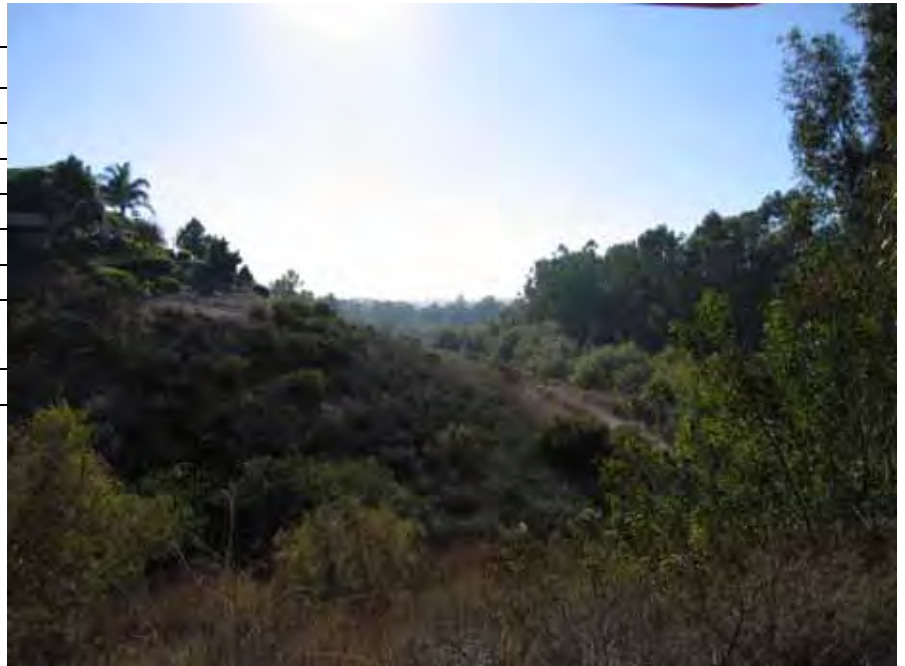
Photograph No. 26

F-10N. Area did not burn in fire, heavily vegetated.

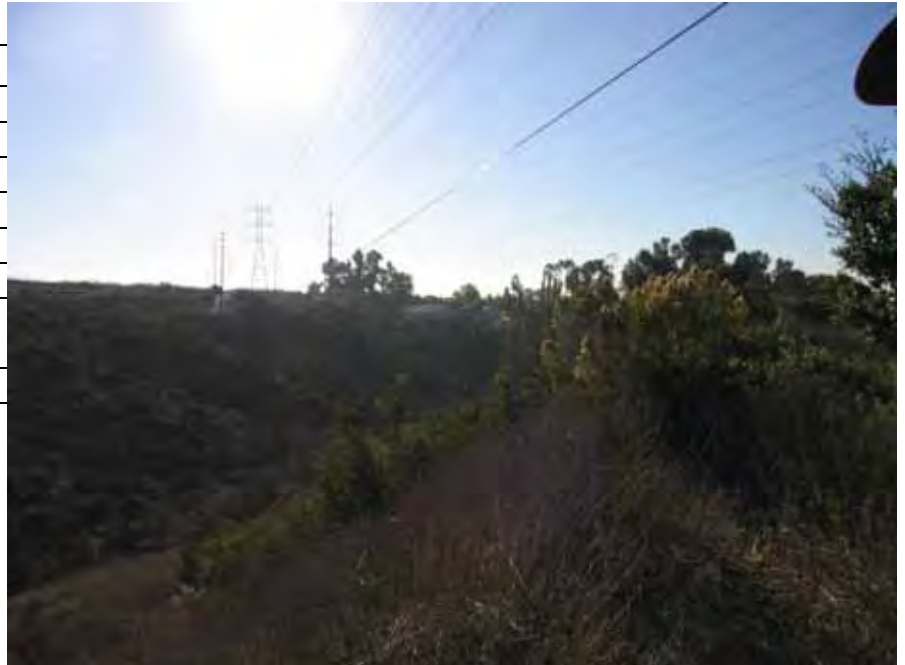
E-2 at park entrance end of Clairmonte Mesa Blvd. Area burned in fire, fully recovered, good vegetation.

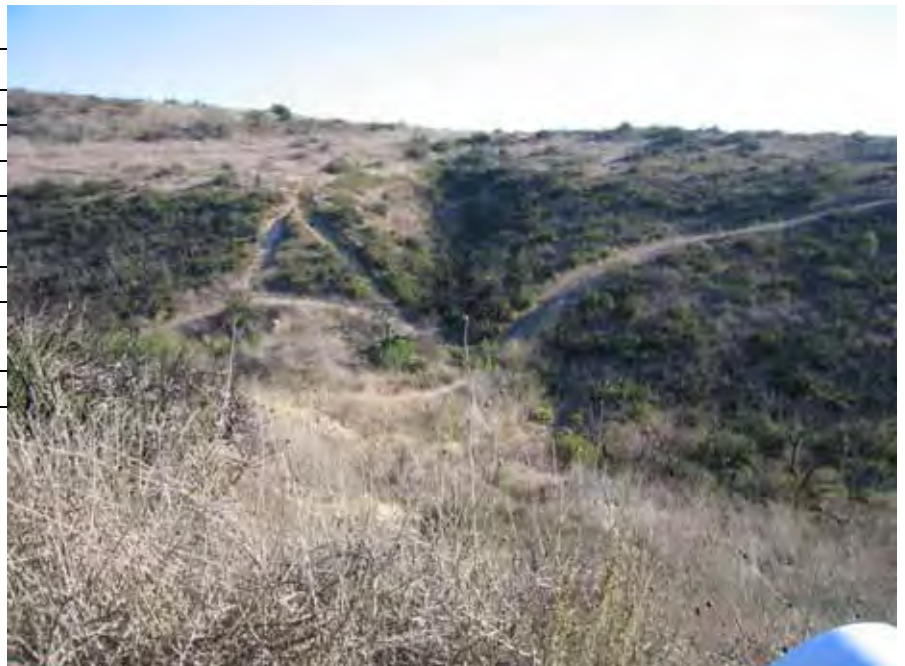
Photograph No. 28

E-2. Same area as above, trails/roads shown.

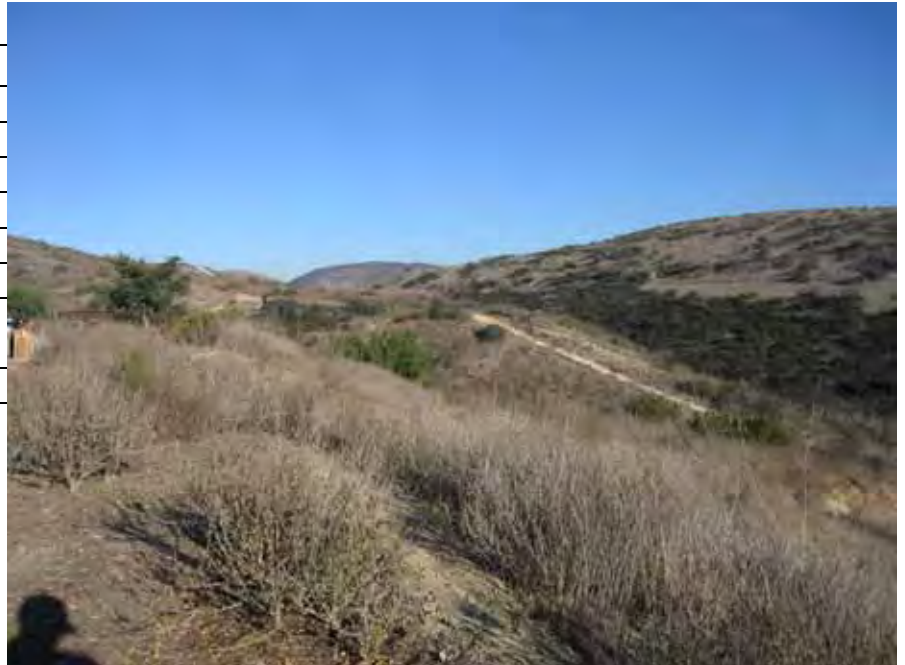
E-1 at park entrance end of Clairmonte Mesa Blvd. Area burned in fire, fully recovered, good vegetation.

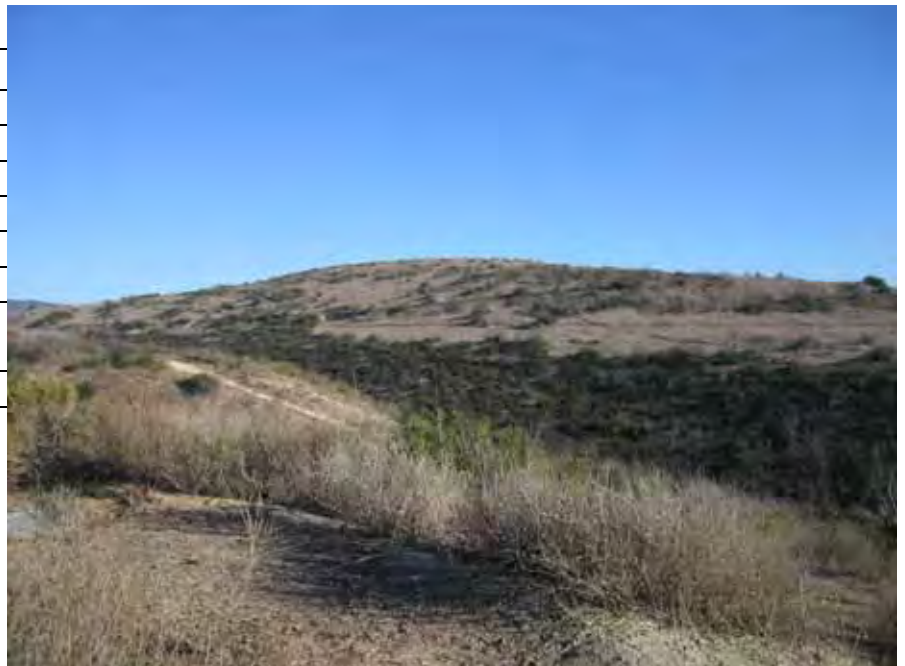
Photograph No. 30

E-2CB, hill in background. Same area as above.

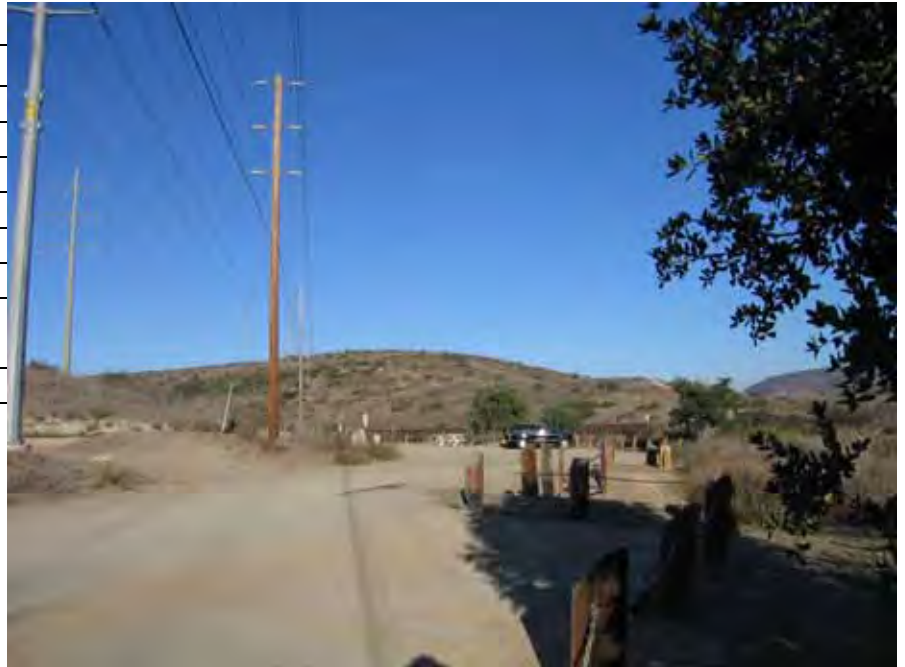
Park entrance end of Clairmonte
Mesa Blvd. Area burned in fire, fully
recovered, good vegetation.

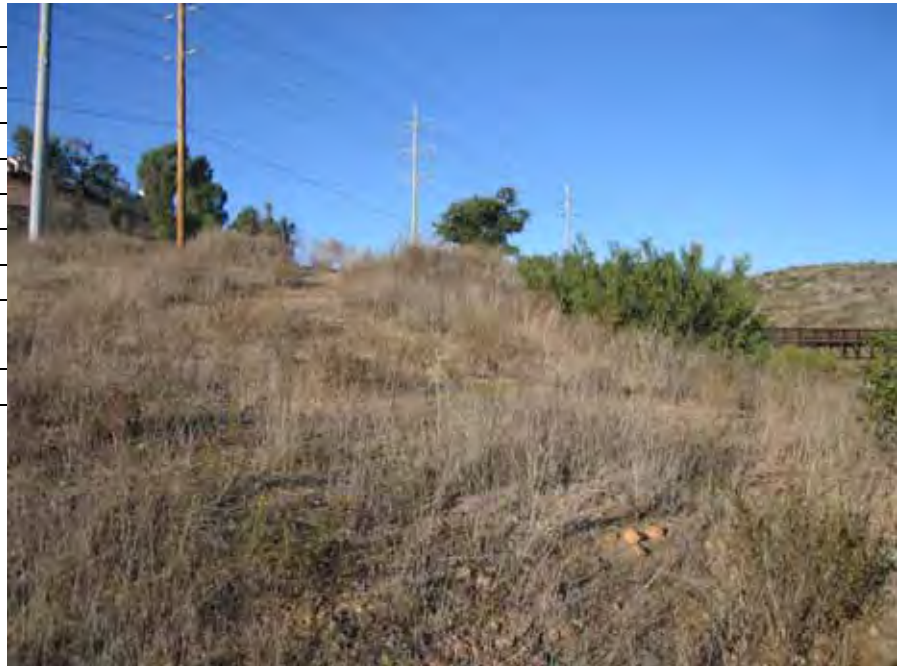
**Photograph No. 32**

Park entrance end of Clairmonte
Mesa Blvd. Area burned in fire, fully
recovered, good vegetation.

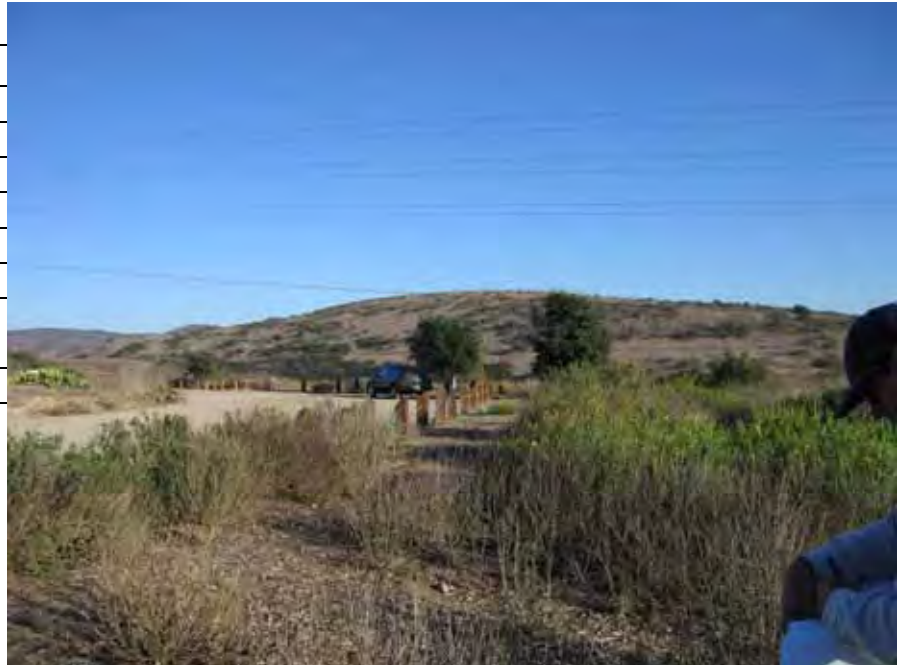
Photograph No. 33

Park entrance end of Clairmonte Mesa Blvd. Area burned in fire, fully recovered, good vegetation.

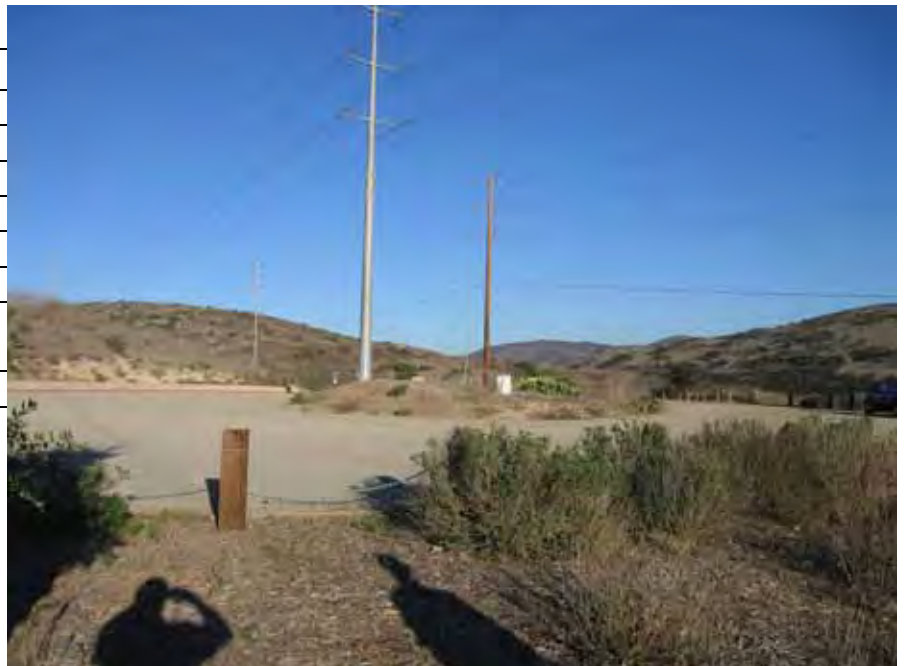
Photograph No. 34

Park entrance end of Clairmonte Mesa Blvd. Area burned in fire, fully recovered, good vegetation.

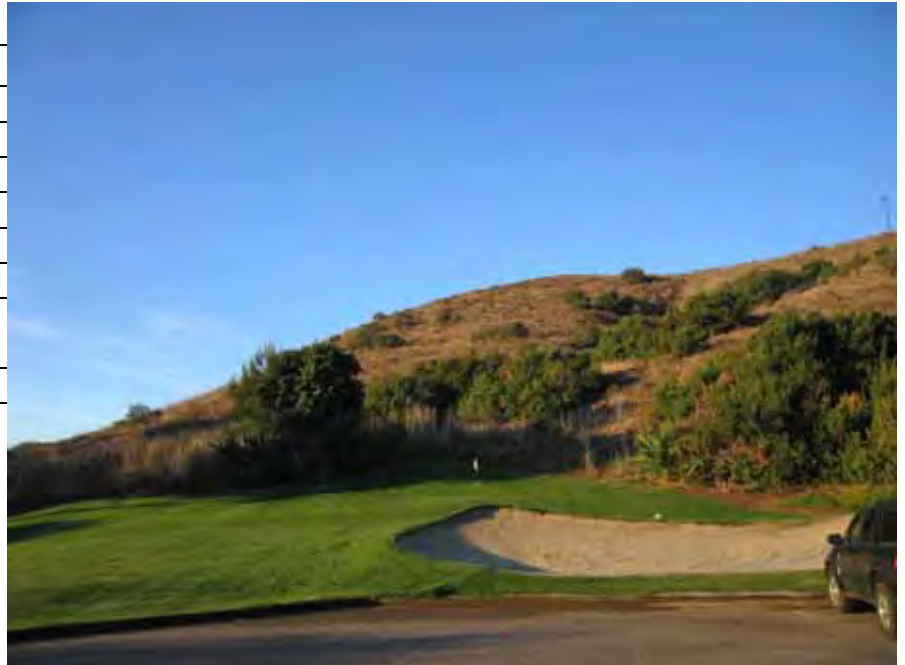
Photograph No. 35

F-11N at driving range, area did not burn, good vegetation, no erosion.

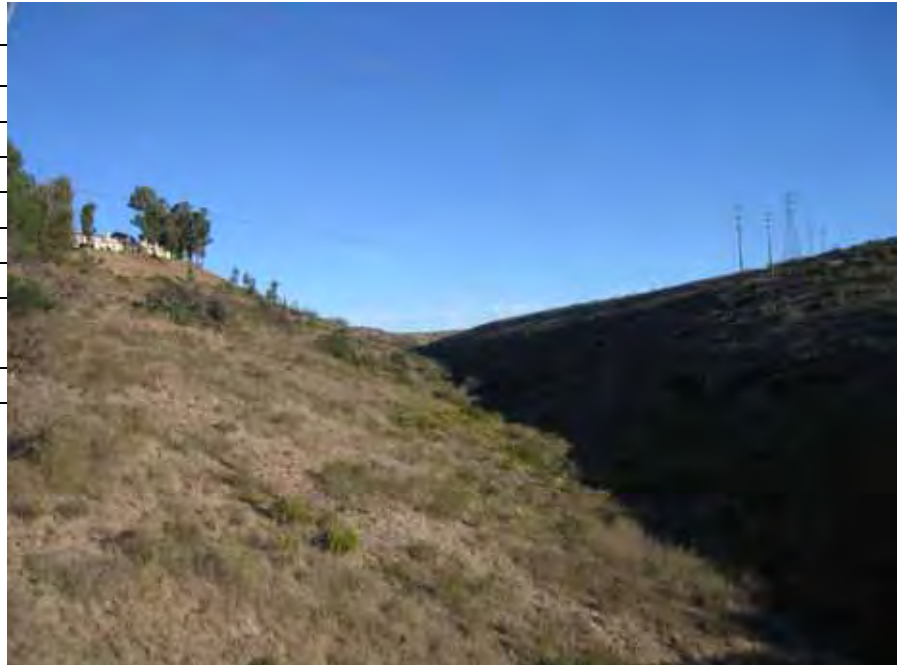
Photograph No. 37

F-10A, Area burned in fire, fully recovered, good vegetation. No erosion.

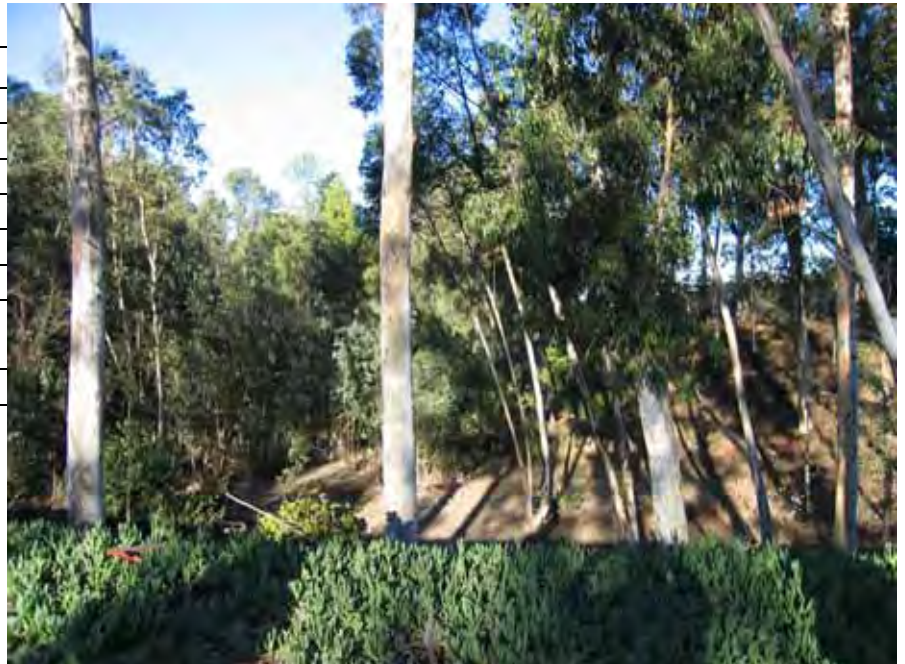
Photograph No. 38

F-2M entrance at Rueda Dr. Area did not burn, good vegetation.

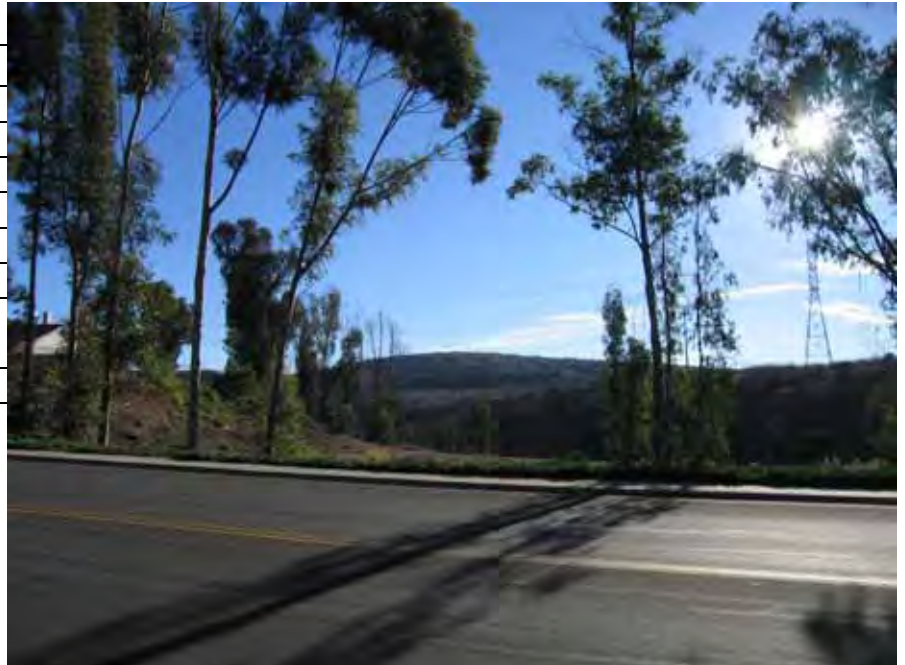
F-2E, Area burned in fire, fully recovered, decent vegetation. No erosion.

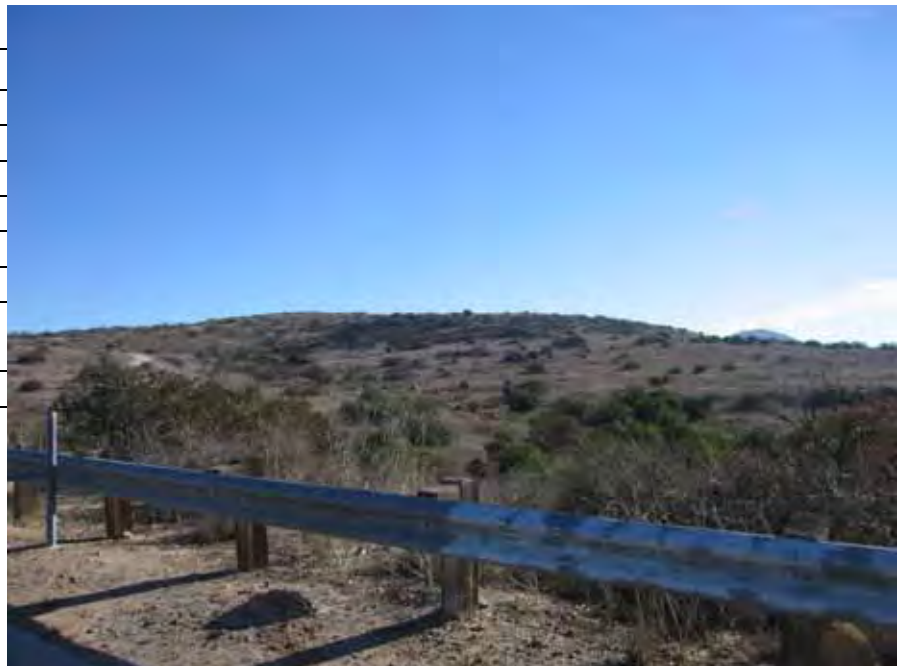
Photograph No. 40

F-2CB. Area burned in fire, fully recovered, decent vegetation. No erosion.

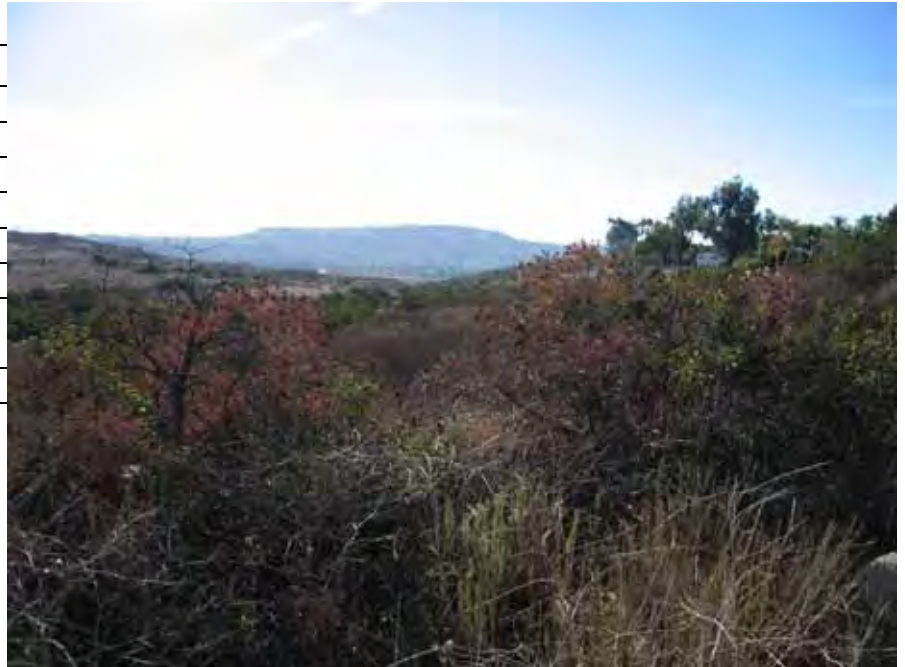
E-2, Area burned in fire, fully recovered, good vegetation. No erosion.
