Mission Trails Regional Park Master Plan Update
Hazardous Materials/
Unexploded Ordnance (UXO) Review

GHD Inc.

May 2016

Client: U.S. Army Corps of Engineers
Location: Tierrasanta Project Area, San Diego, California
Photograph Dates: November 16 - 20, 2006

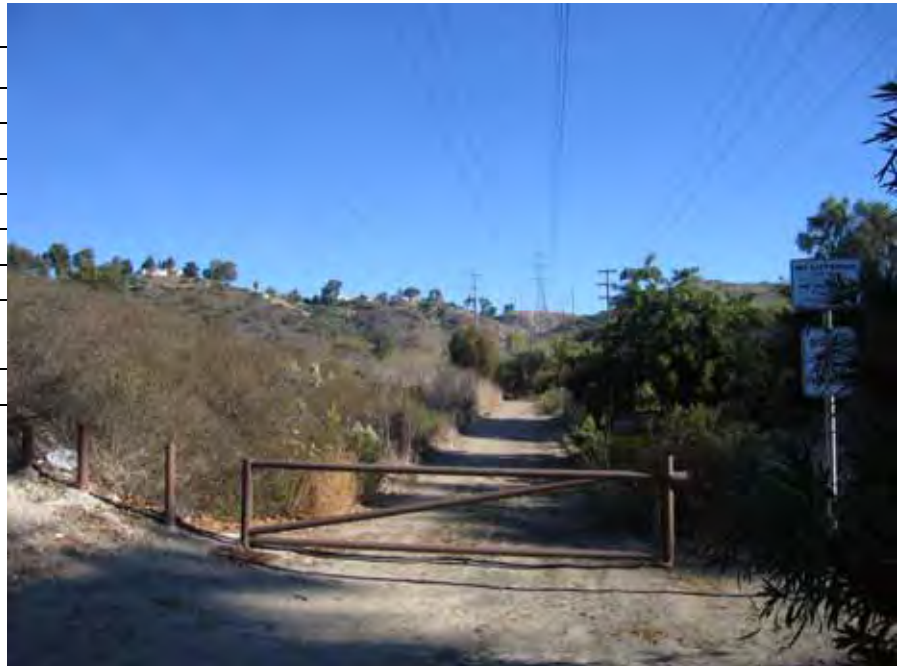
Photograph No. 42

F-5N at Tierrasanta Blvd.. Area burned in fire, fully recovered, good vegetation. No erosion.

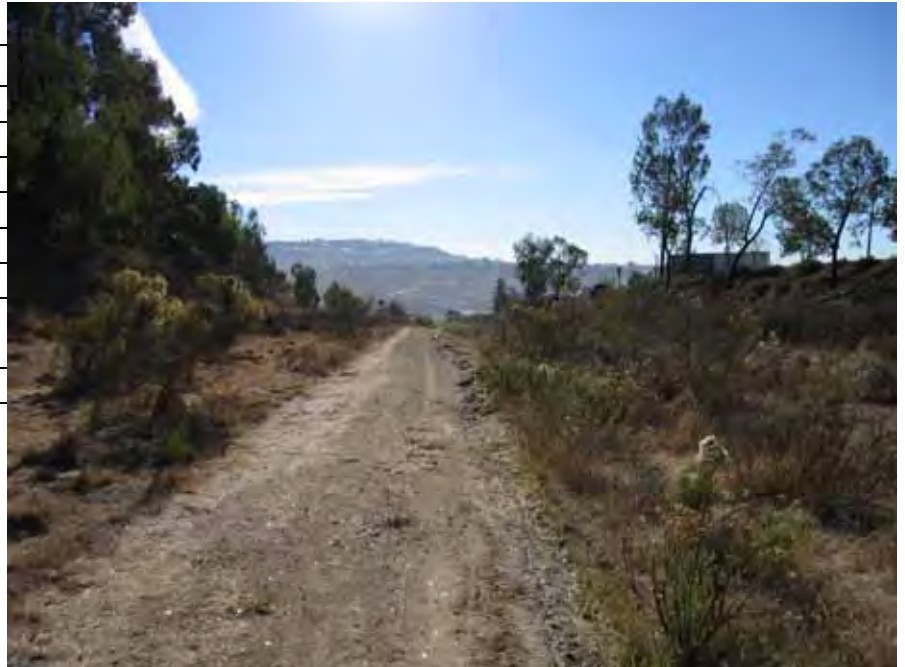
F-5S, Area burned in fire, fully recovered, good vegetation. No erosion.

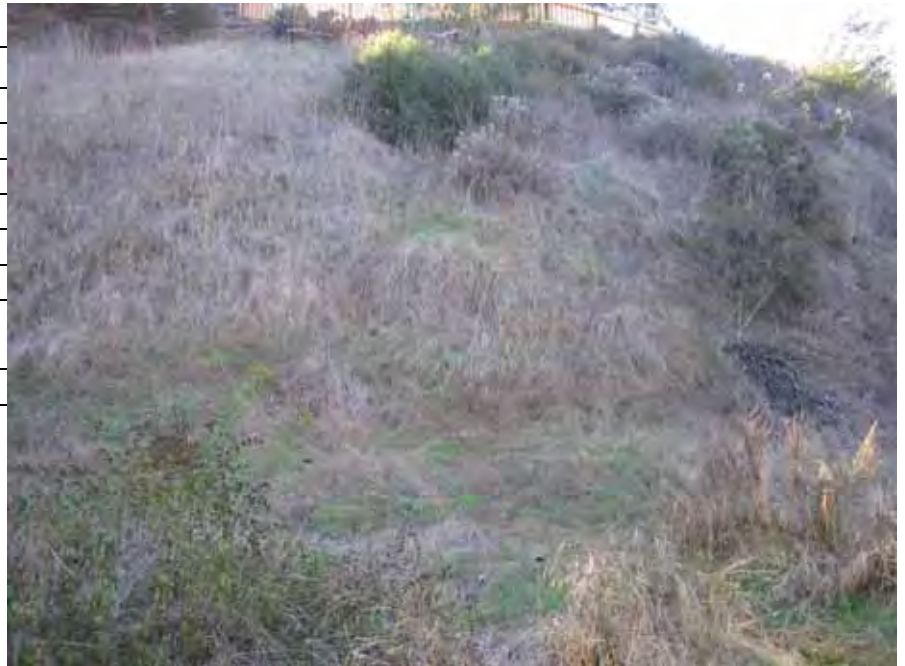
Photograph No. 44

F-10E at Tierrasanta Blvd.. Area burned in fire, fully recovered, good vegetation. No erosion.

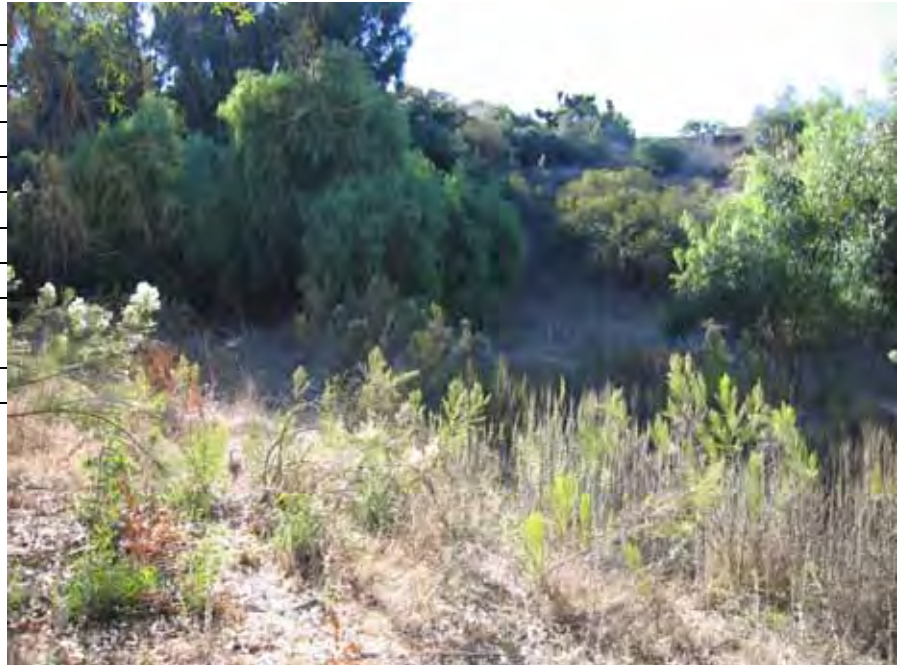
F-10E. Area burned in fire, fully recovered, good vegetation. No erosion, prior location of Bike Track, no evidence left of track.

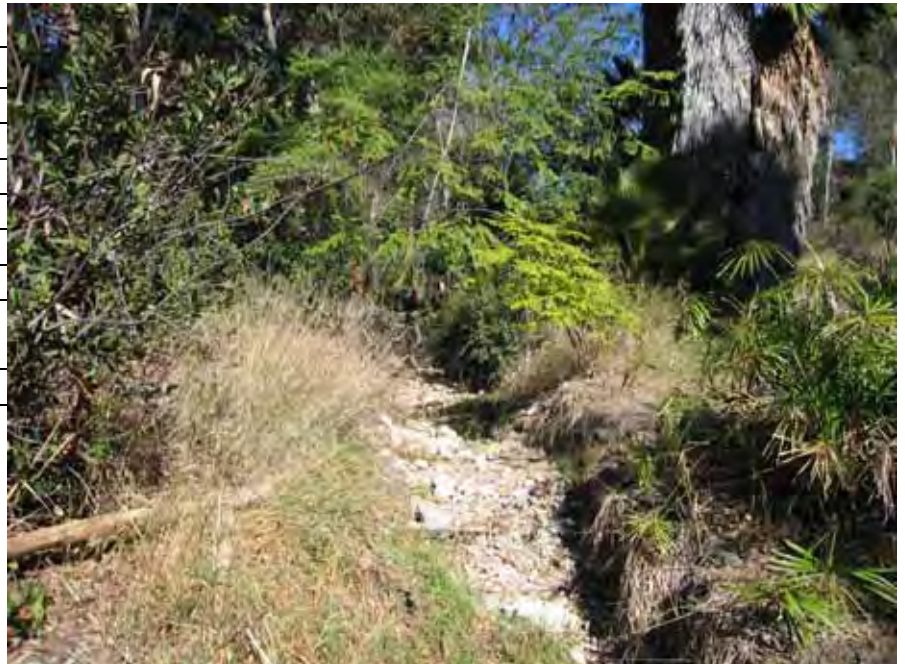
Photograph No. 46

F-7. Location did not burn, heavy vegetation. No increase in erosion from last review.

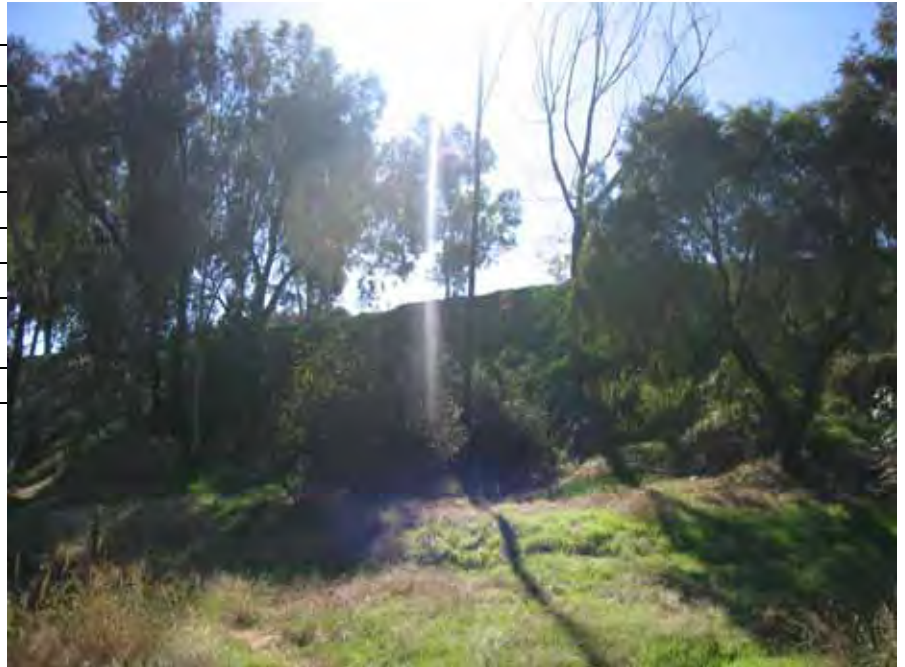
F-7. Area burned in fire, fully recovered, good vegetation. No erosion.

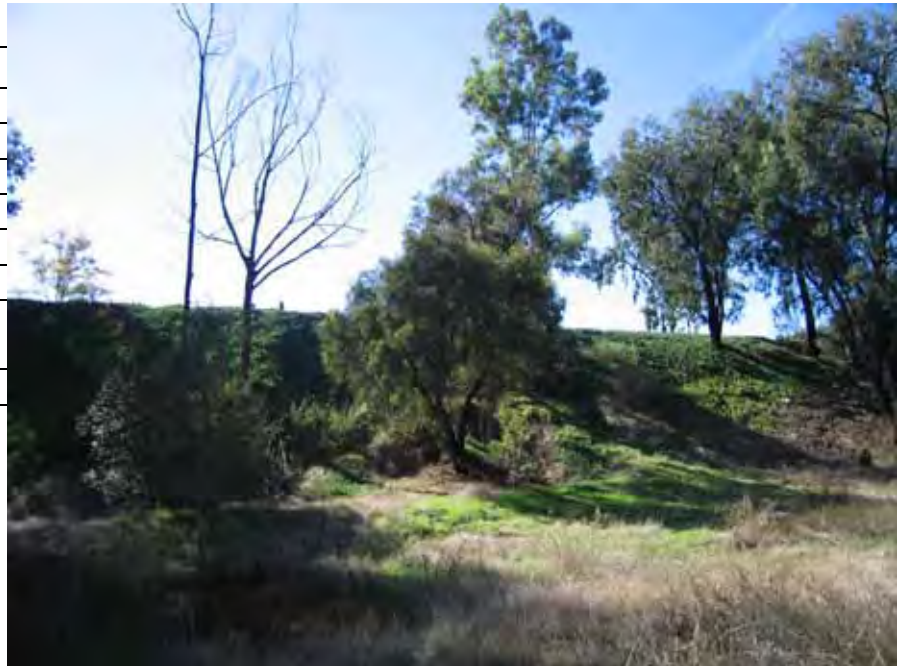
Photograph No. 48

F-7. Area burned in fire, fully recovered, good vegetation. No erosion.

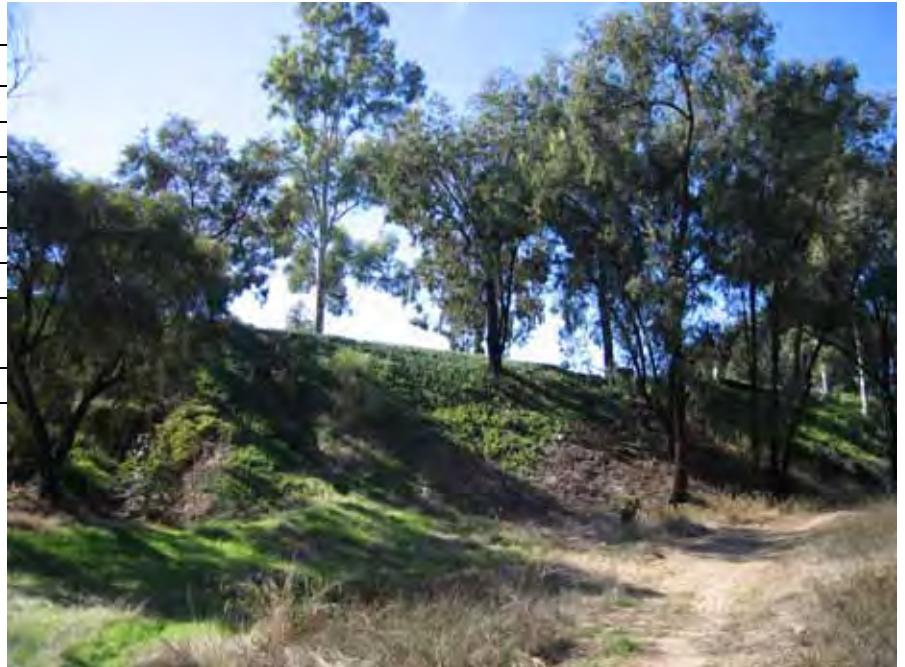
F-7. Area burned in fire, fully recovered, good vegetation. No erosion.

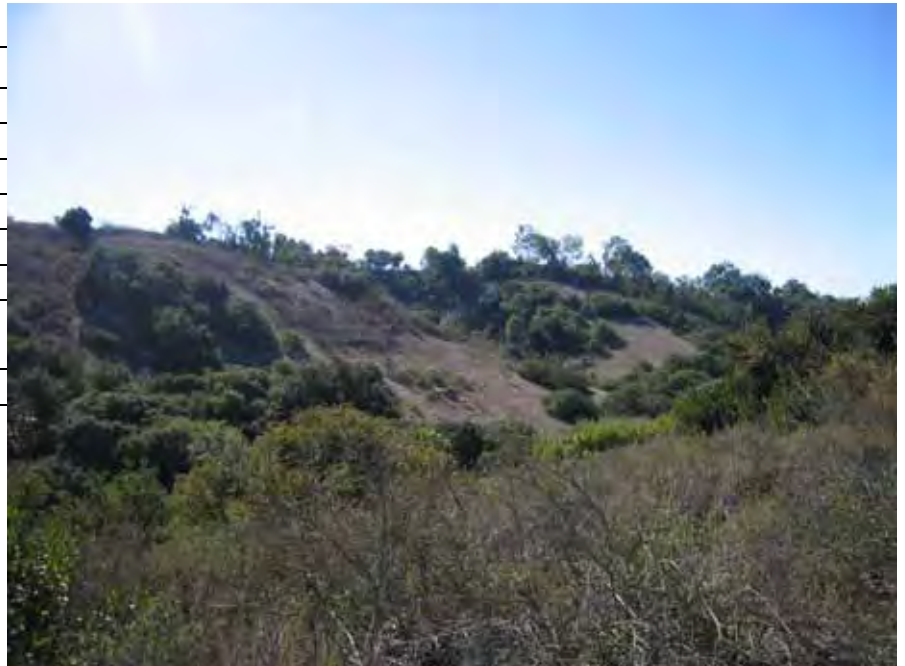
Photograph No. 50

F-6. Area not burned in fire, heavy vegetation. No erosion.

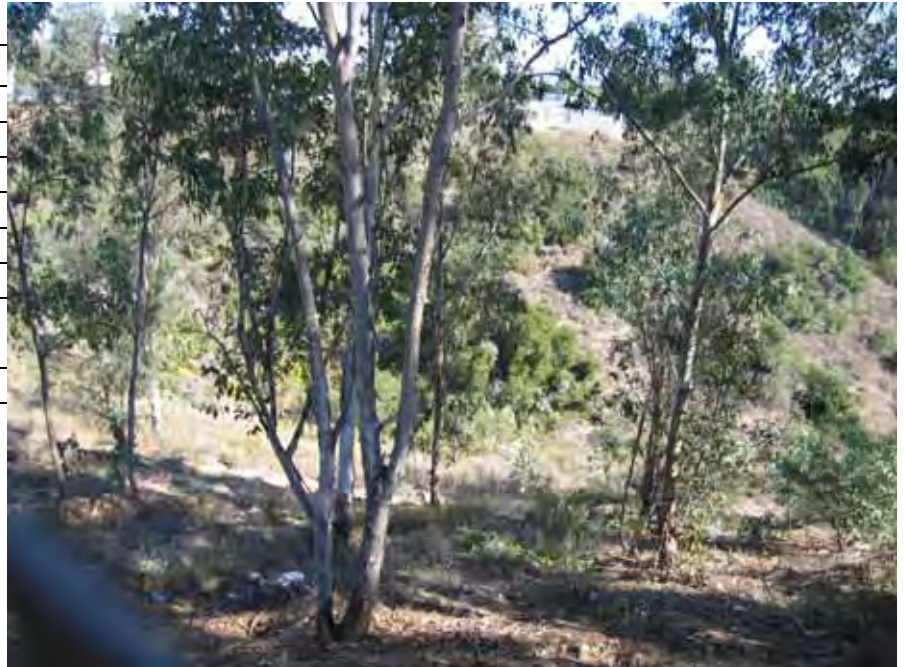
F-1. Area did not burn in fire, better vegetation. Erosion improved.

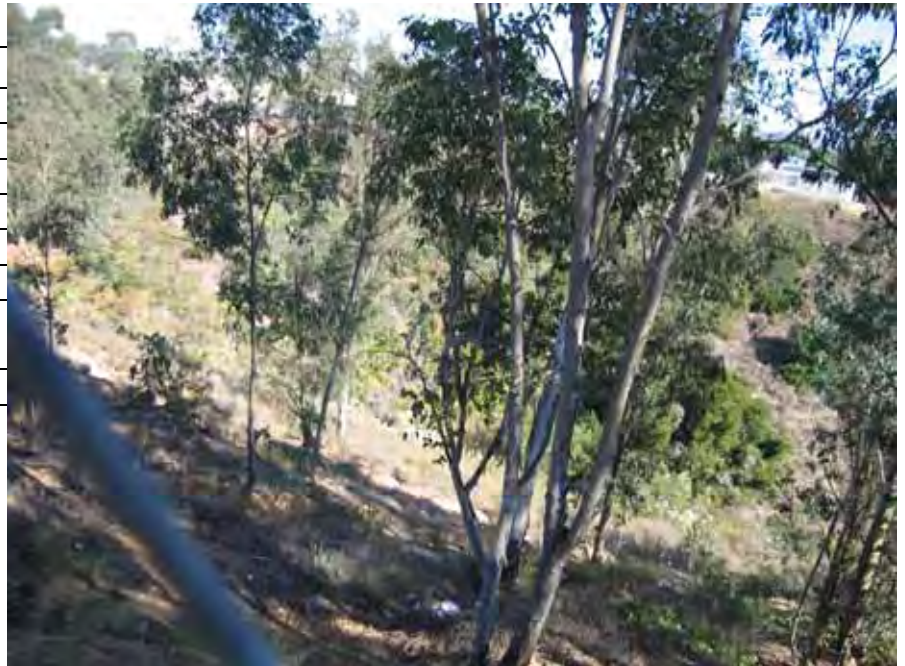
**Photograph No. 54**

F-1. Area did not burn in fire, better vegetation. Erosion improved. Same area as above.

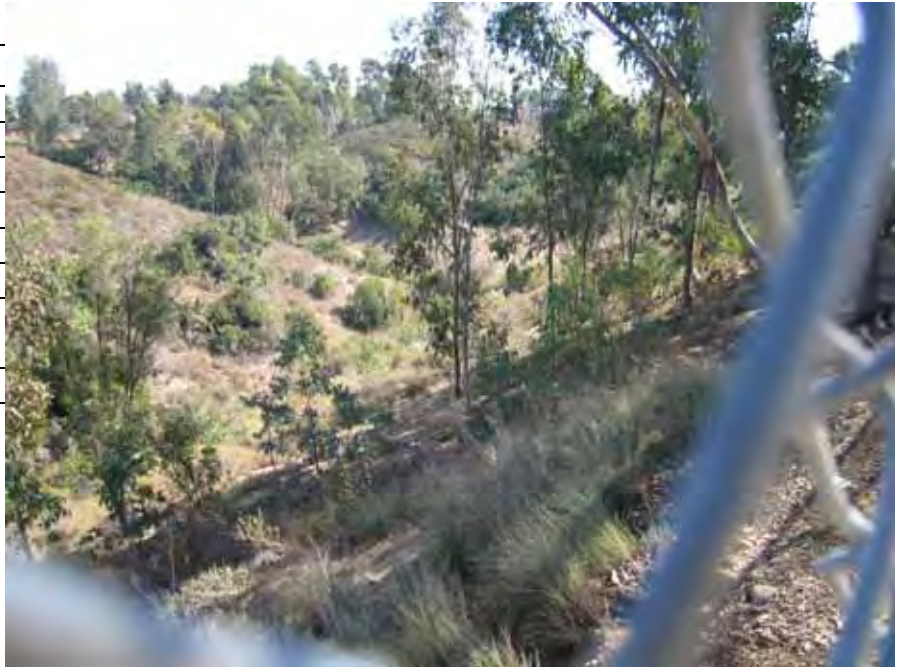
F-1. Area did not burn in fire, better vegetation. Erosion improved.

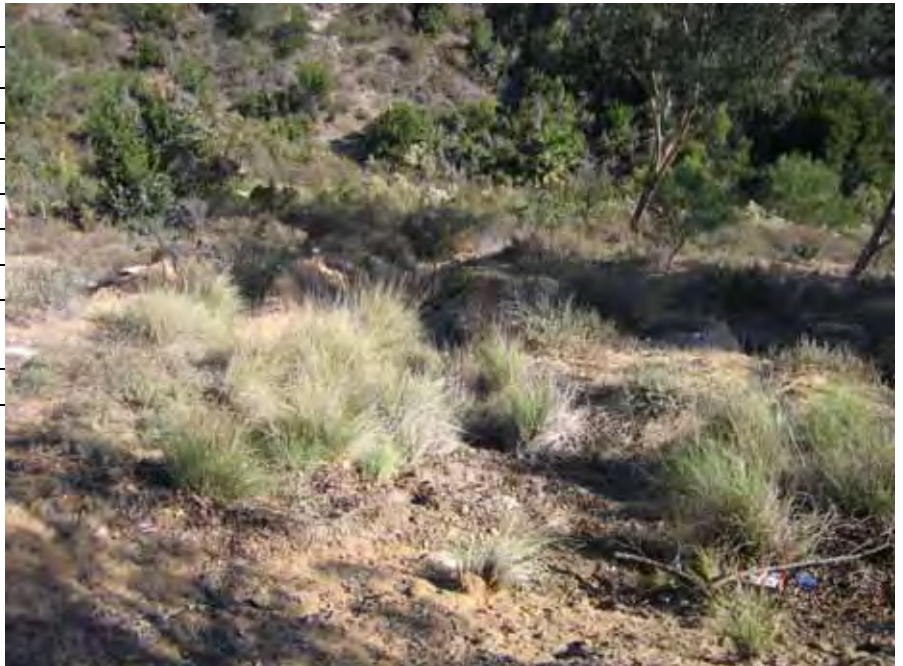
**Photograph No. 56**

F-1. Area did not burn in fire, better vegetation. Erosion improved. Same area as above.

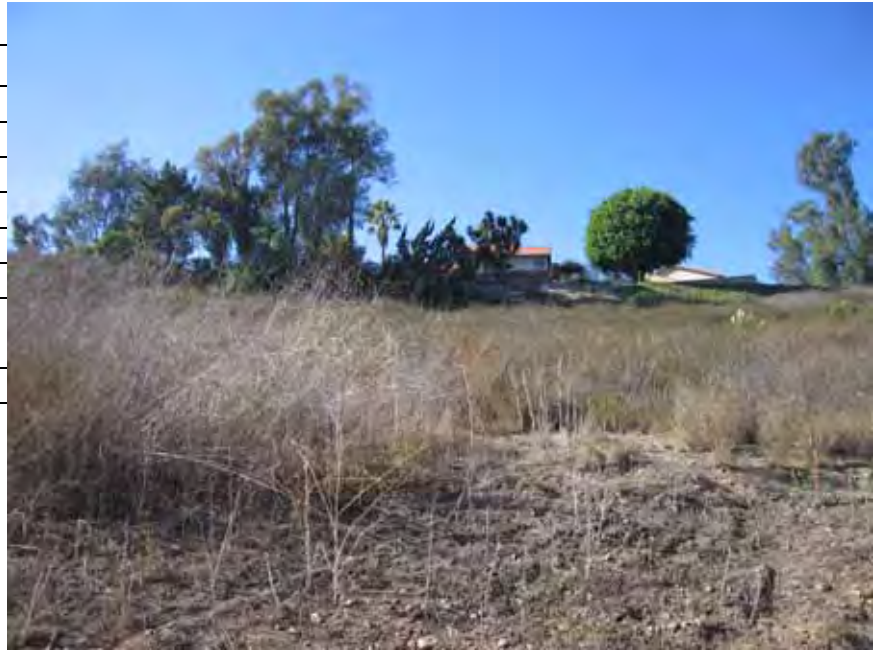
F-5N. Area burned in fire, vegetation recovered. Road in foreground.

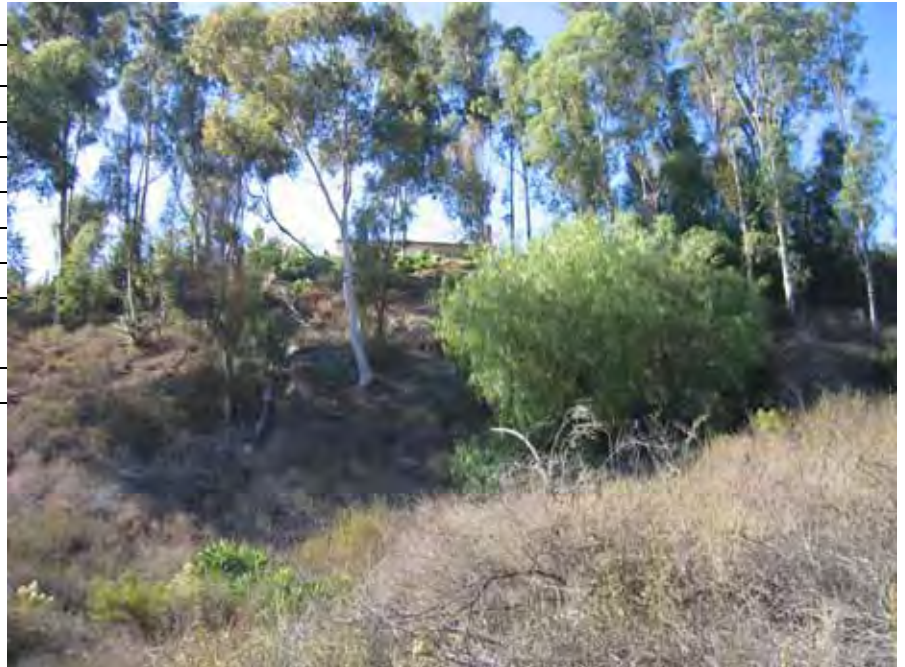
F-5N. Area burned in fire, vegetation recovered. Former minor erosion no longer present.

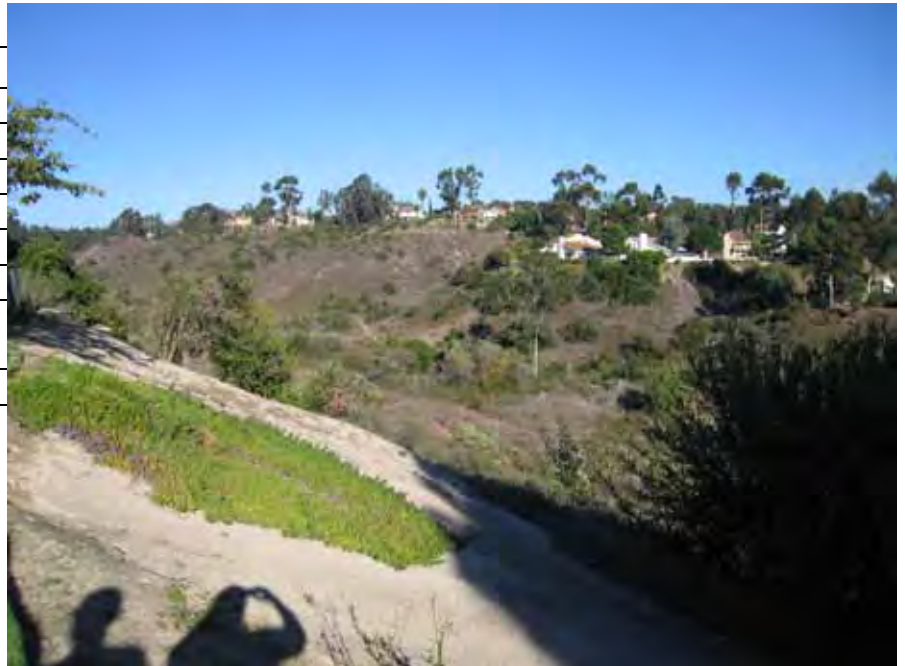
Photograph No. 60

F-2W. Previous minor erosion on slope below house unchanged.

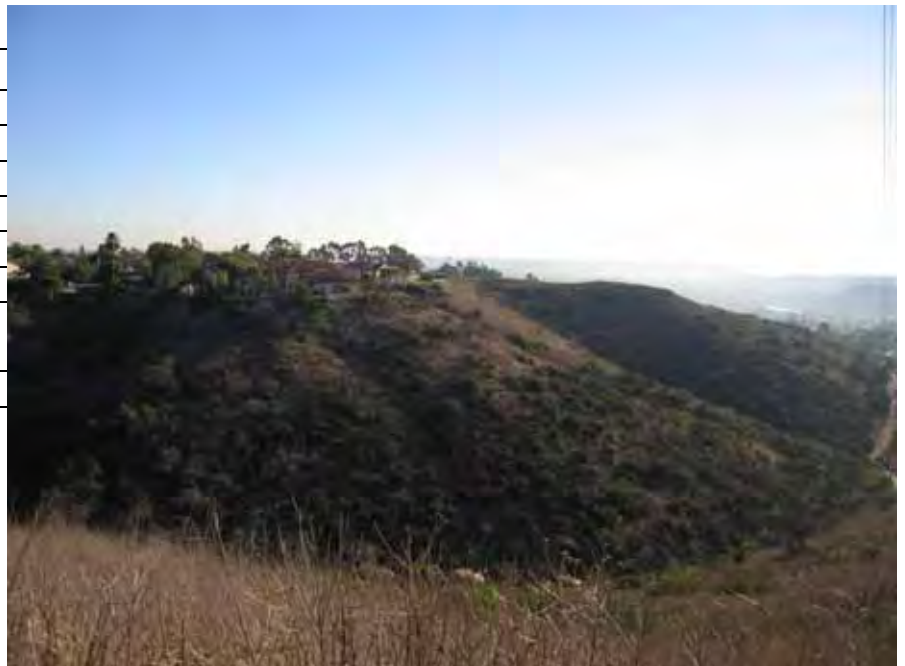
F-5N. Previous minor erosion on slope below houses has more vegetation, no visible erosion.

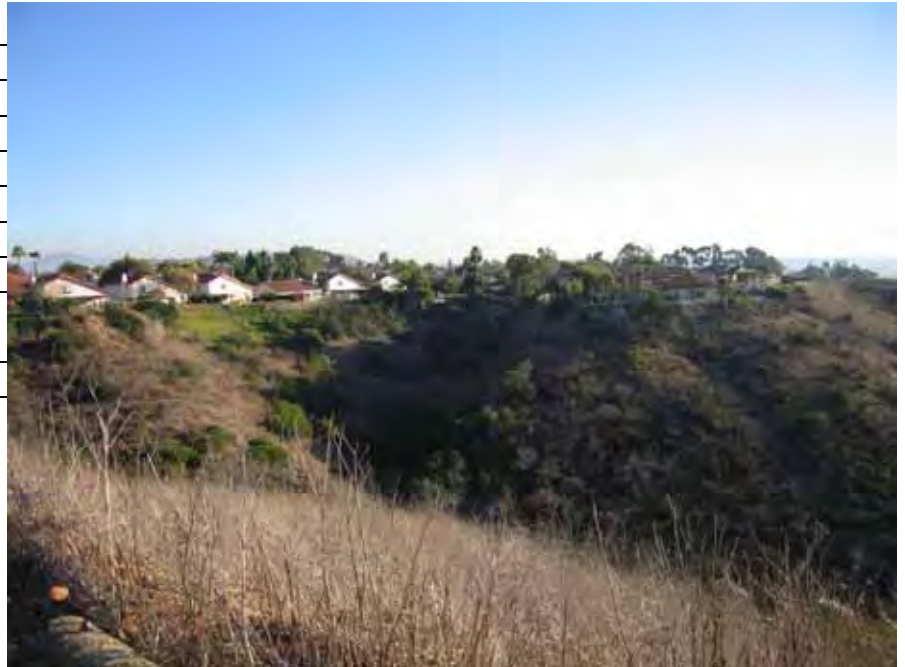
F-5N. Previous minor erosion on slope below houses not visible.

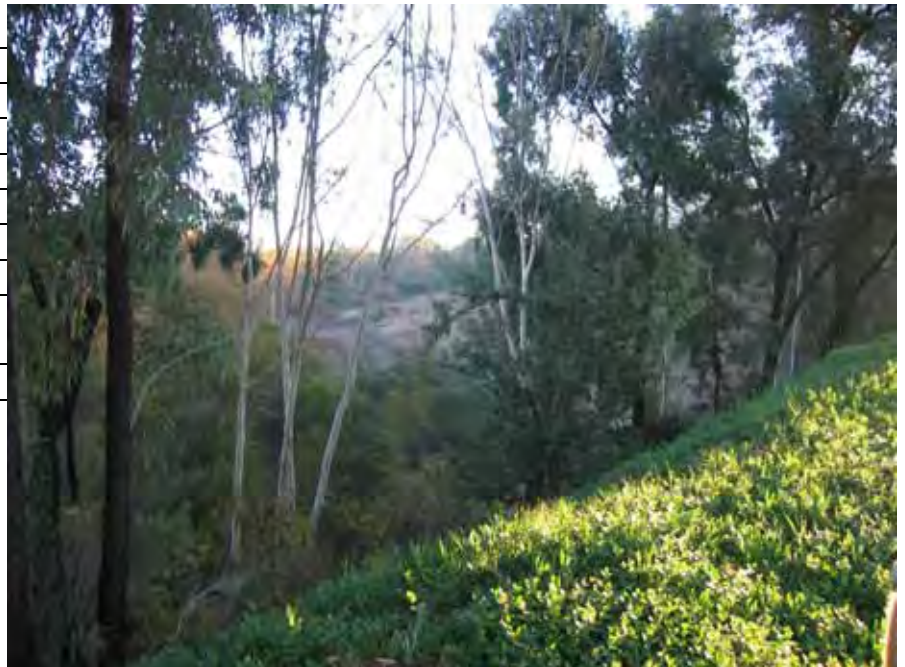
Photograph No. 64

F-7. Previous minor erosion on slope has more vegetation, not visible erosion.

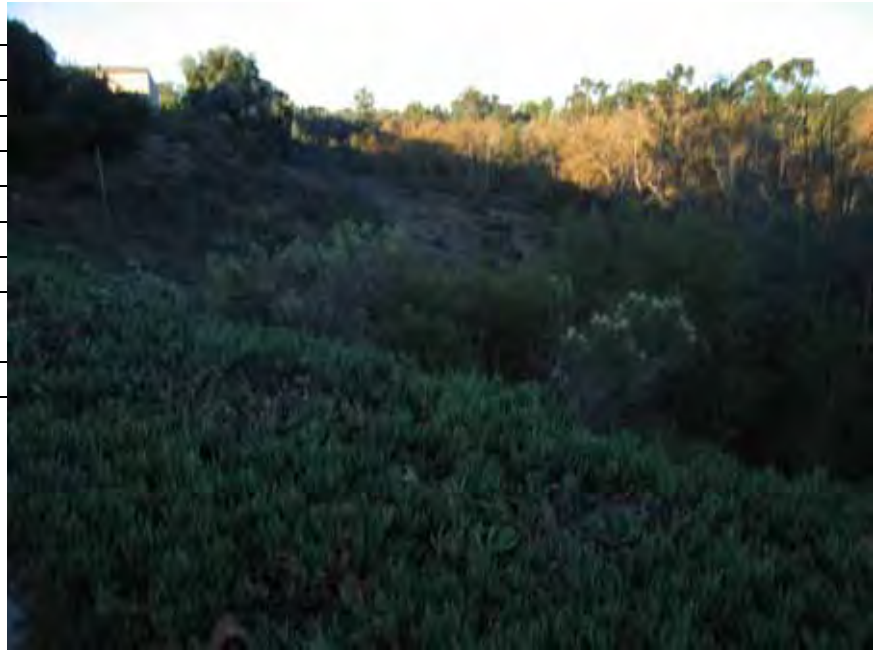
F-7. Previous minor erosion on slope below houses not visible.

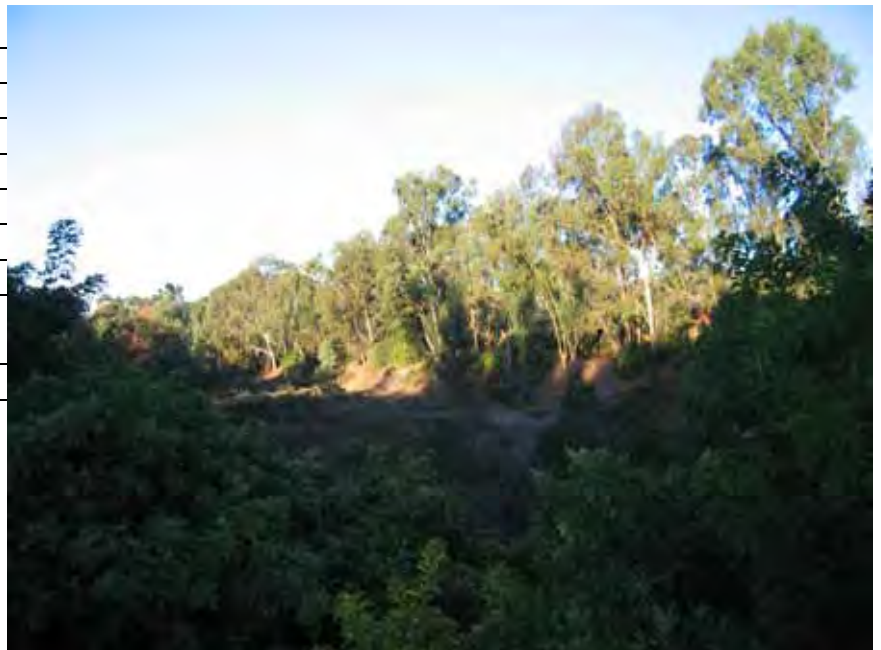
**Photograph No. 66**

F-7. Previous minor erosion on slope has more vegetation, no great change.

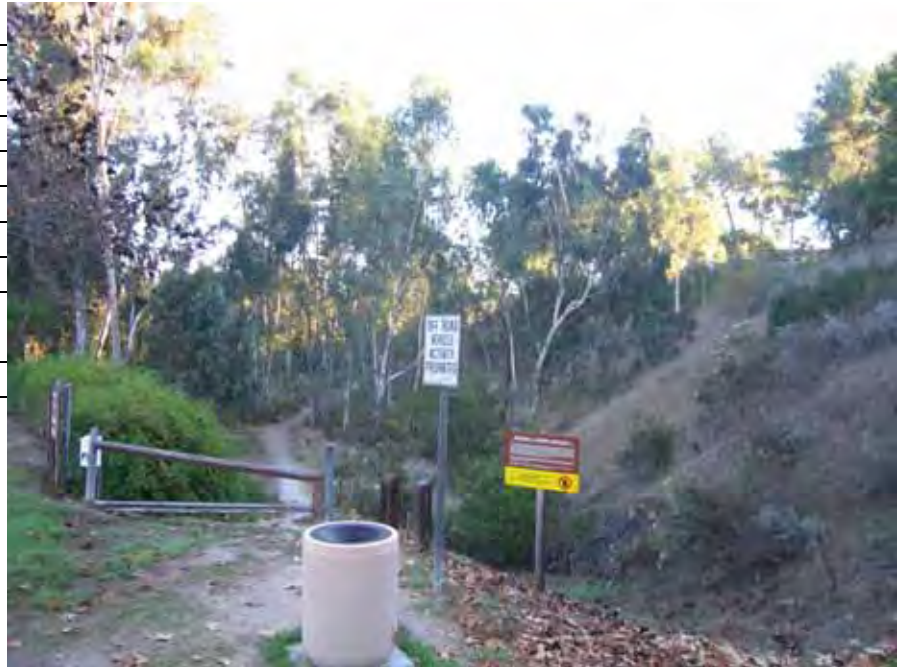
Photograph No. 67

F-10E. Vegetation improved, no erosion.

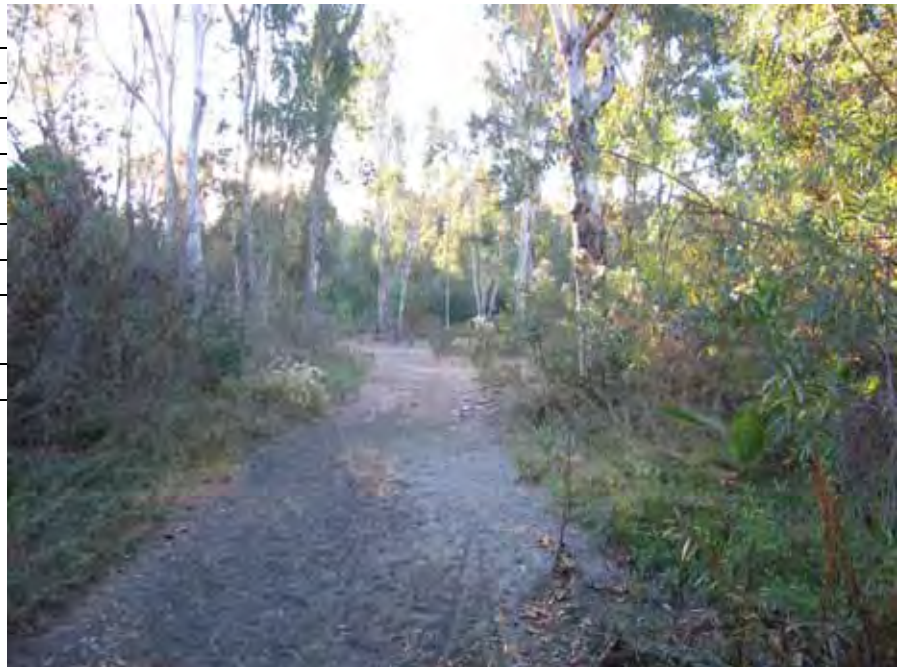
Photograph No. 68

F-10E. Vegetation improved, no erosion.

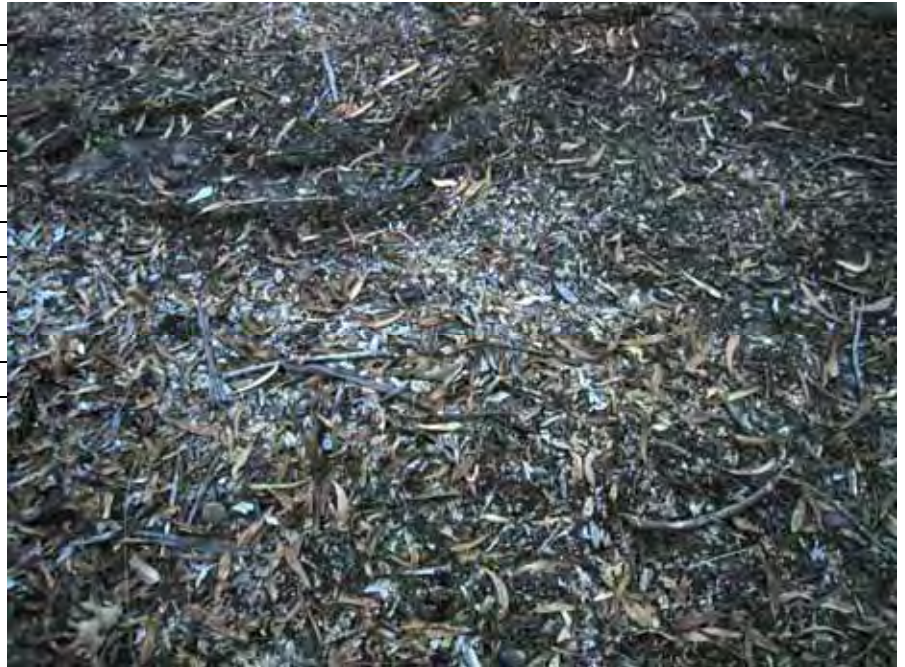
Photograph No. 69

F-10N. Mulch put down on trail.

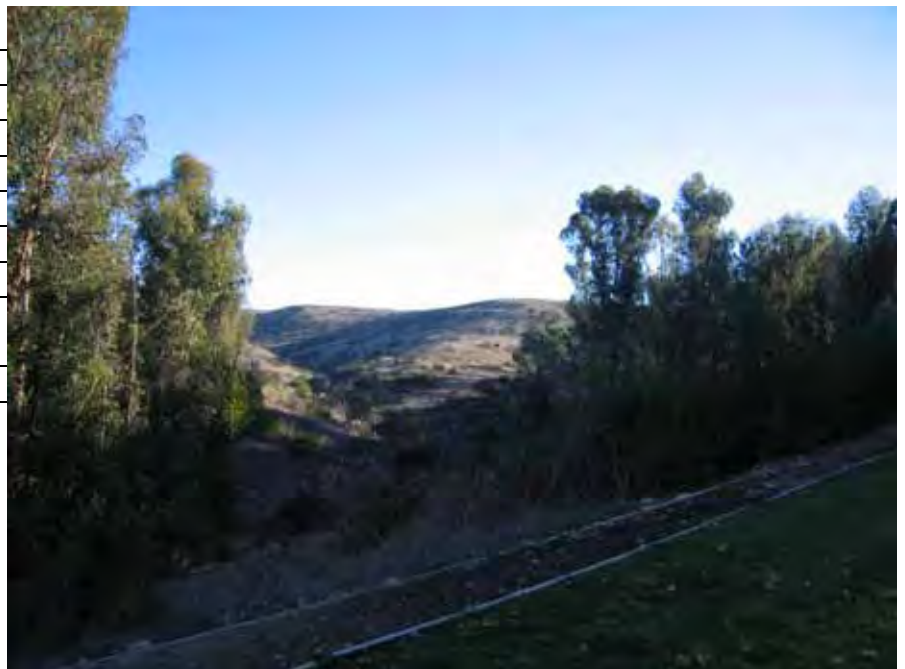
Photograph No. 70

F-10E. Vegetation improved since fire, no erosion found.

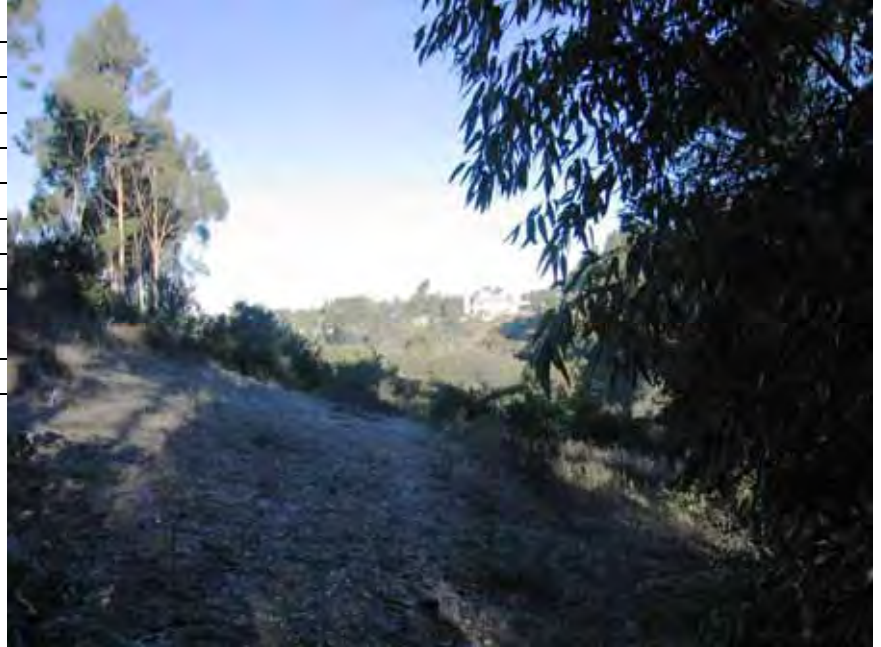
Photograph No. 71

F-10E. Area recovered from fire, good vegetation.

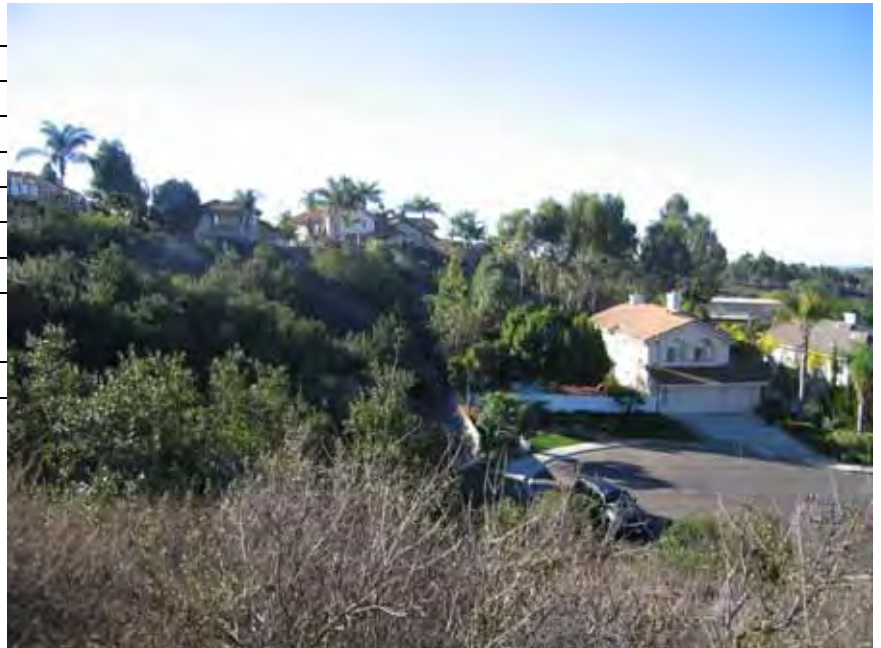
Photograph No. 72

C-5. Vegetation improved, no erosion found.

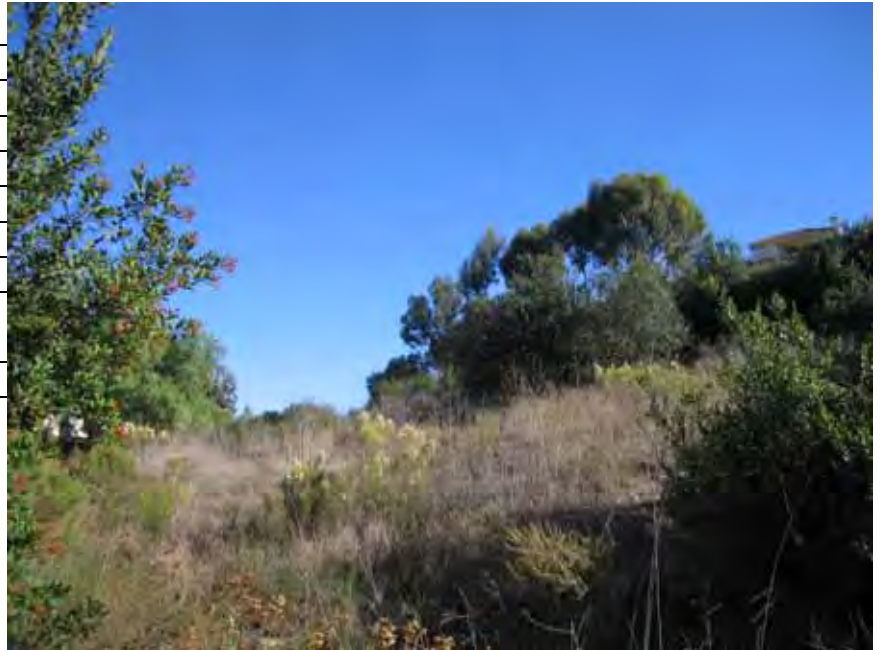
Photograph No. 73

C-5. Area recovered from fire, good vegetation.

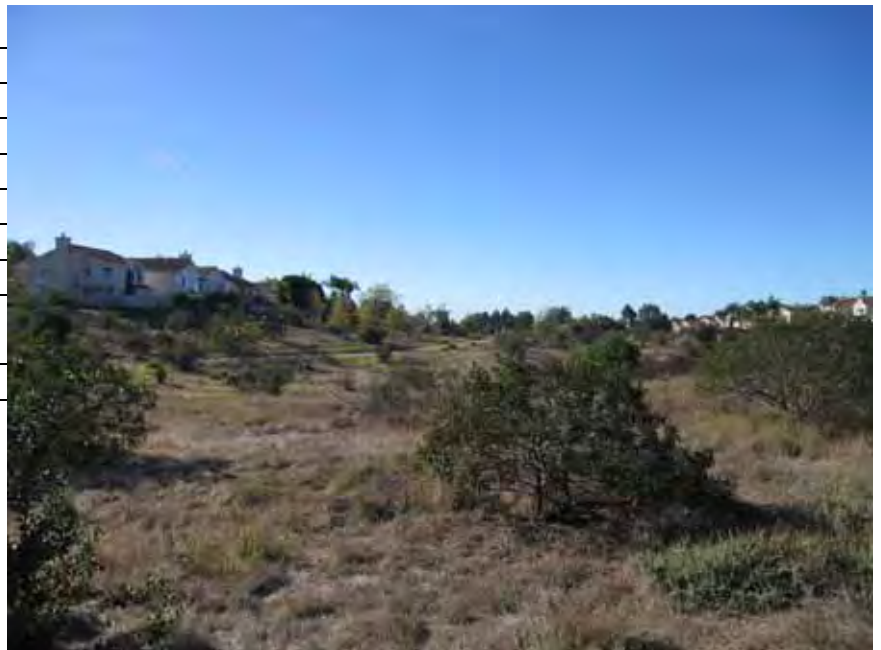
Photograph No. 74

C-4. Area recovered from fire, good vegetation.

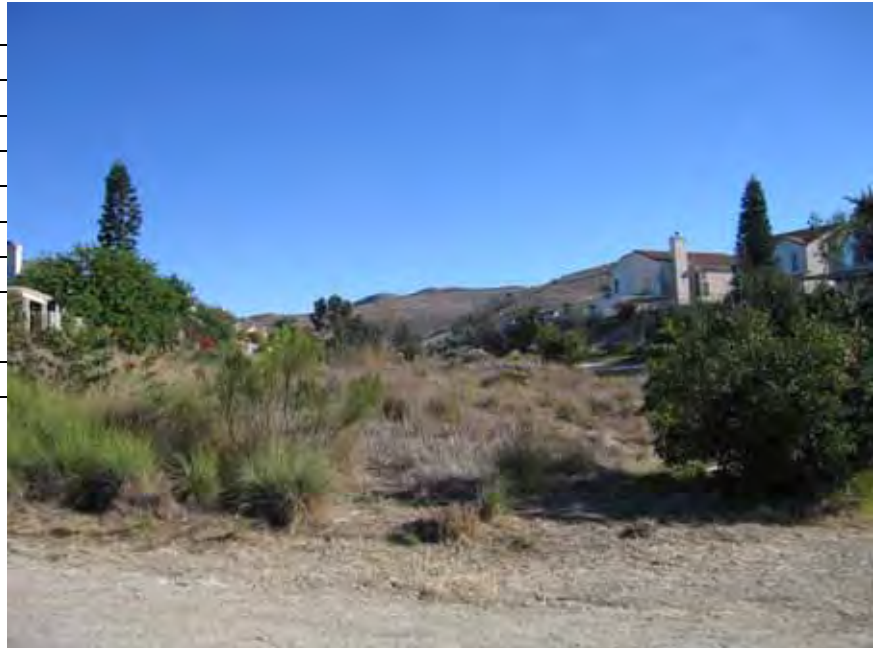
Photograph No. 75

C-4. Area recovered from fire, good vegetation.

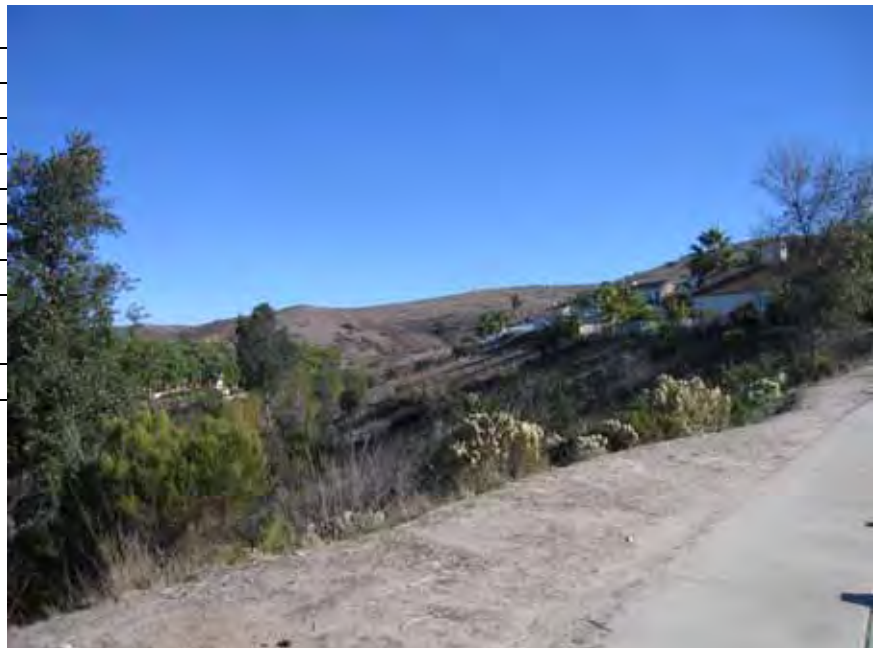
Photograph No. 76

C-4. Area recovered from fire, good vegetation.

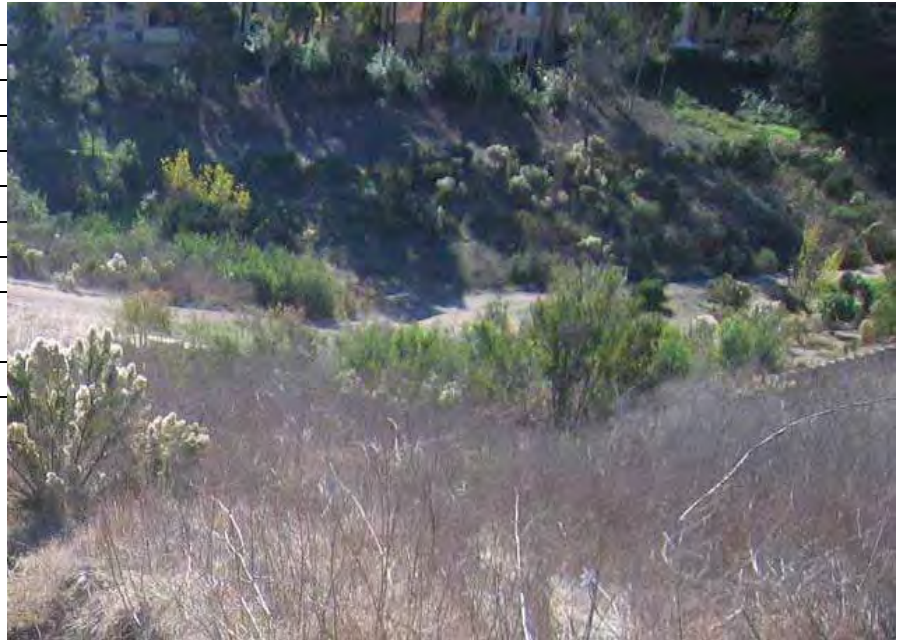
Photograph No. 77

C-2. Area recovered from fire, good vegetation. (This photo is closeup of Photograph No. 48 from 2008 MTRP Recurring Review)

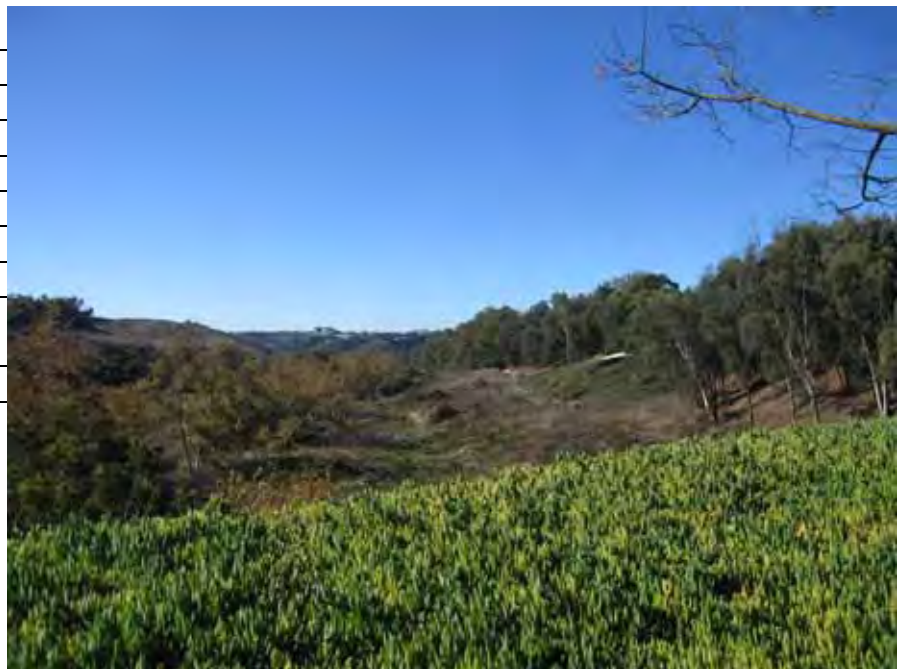
Photograph No. 78

F-6. Area recovered from fire, good vegetation.

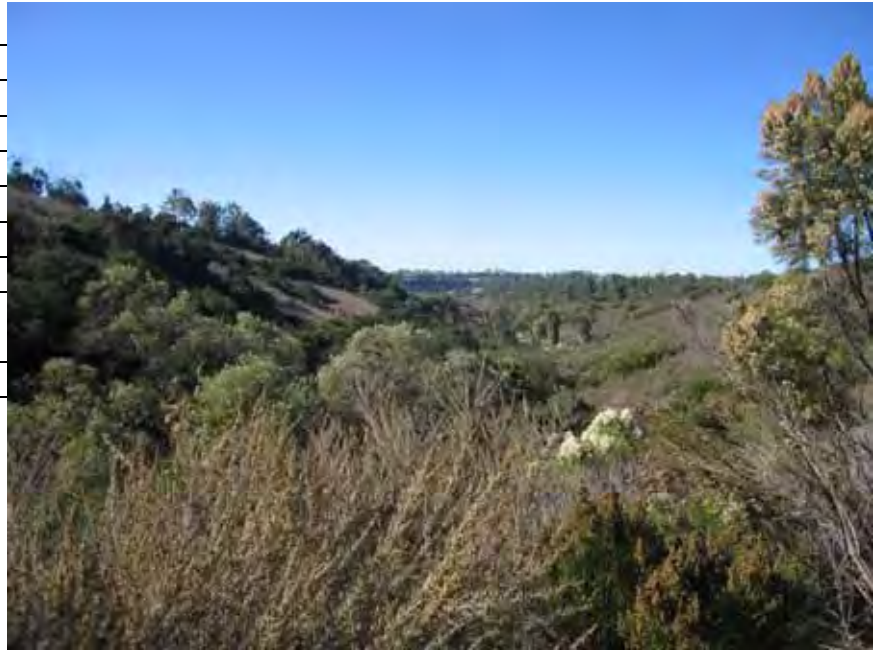
Photograph No. 79

F-6. Area recovered from fire, good vegetation, no erosion.

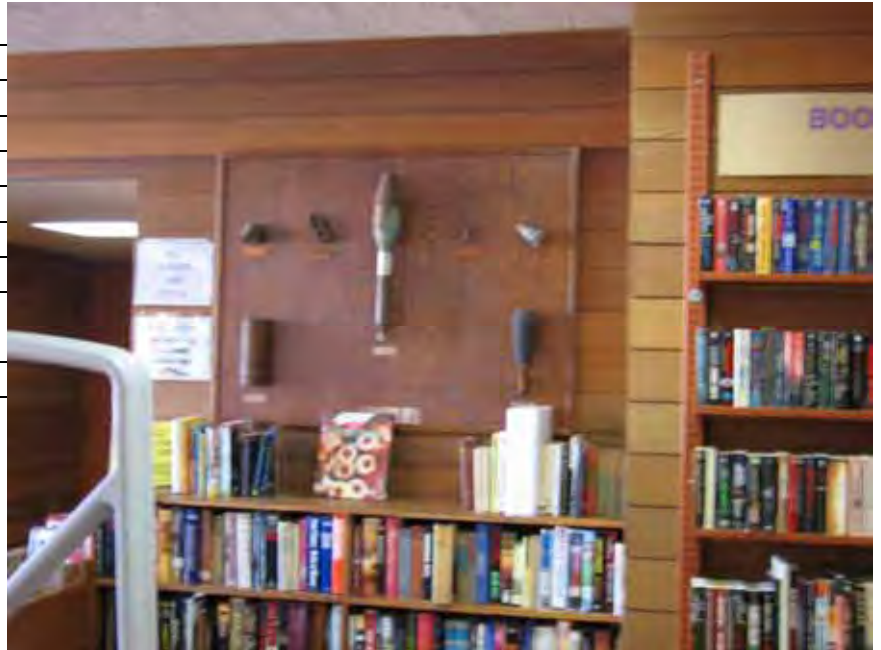
Description:
MEC Display at Tierrasanta Library.

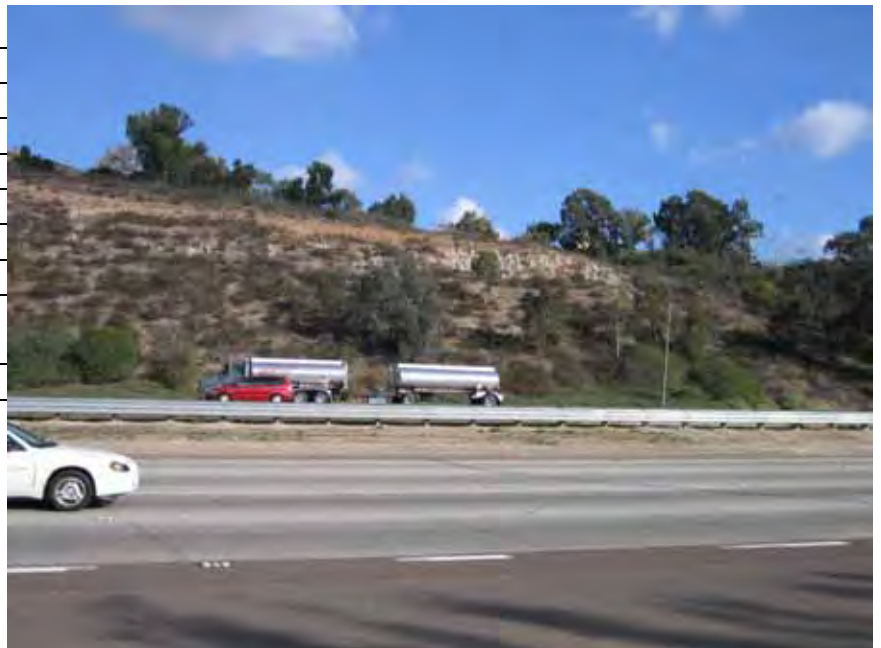
Photograph No. 84

Description:
OA-4. Only erosional area in OA-4.
