CALIFORNIA TREE SERVICE, INC.

July 17, 2015

Subject: Bonita Pump Station Project: Tree Risk Evaluation

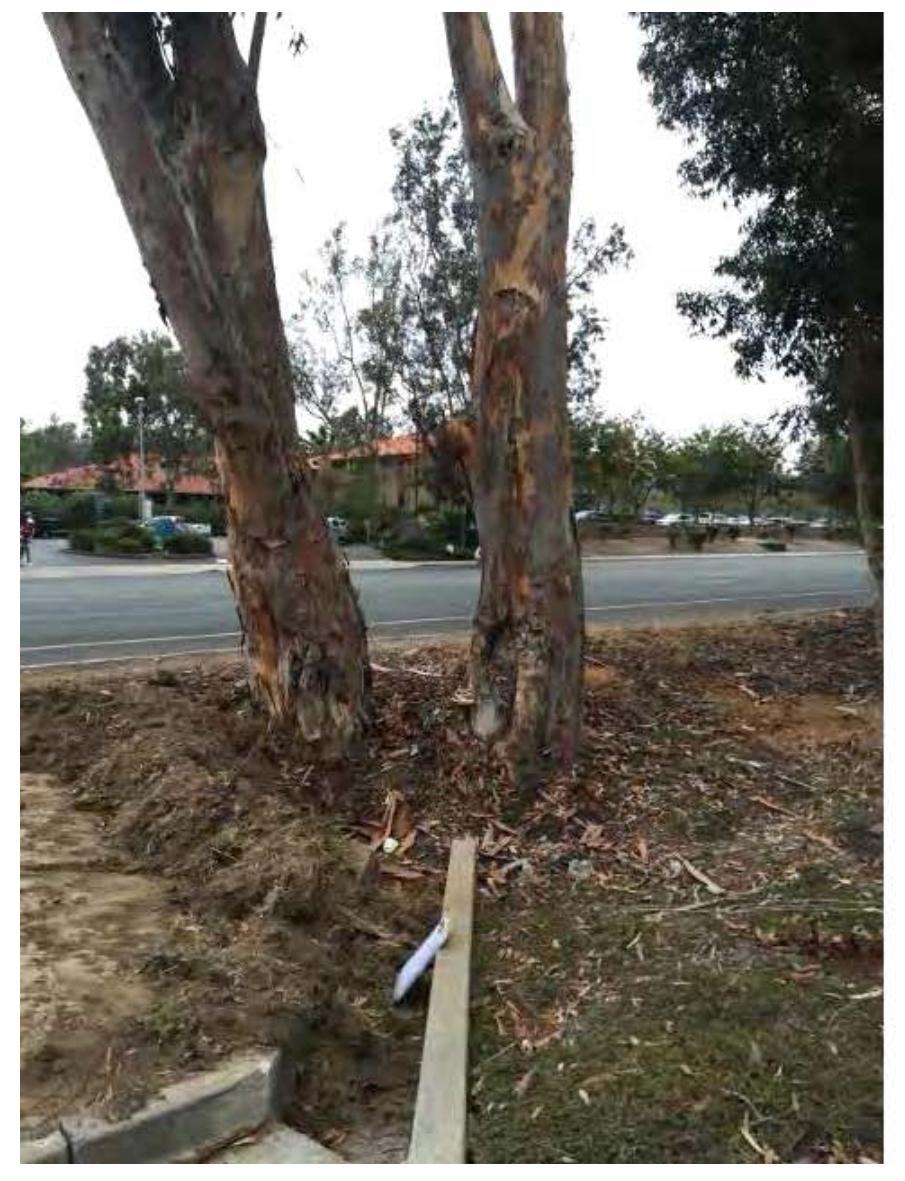
Photograph 5 – View of main stem (Tree #'s 1 and 2)

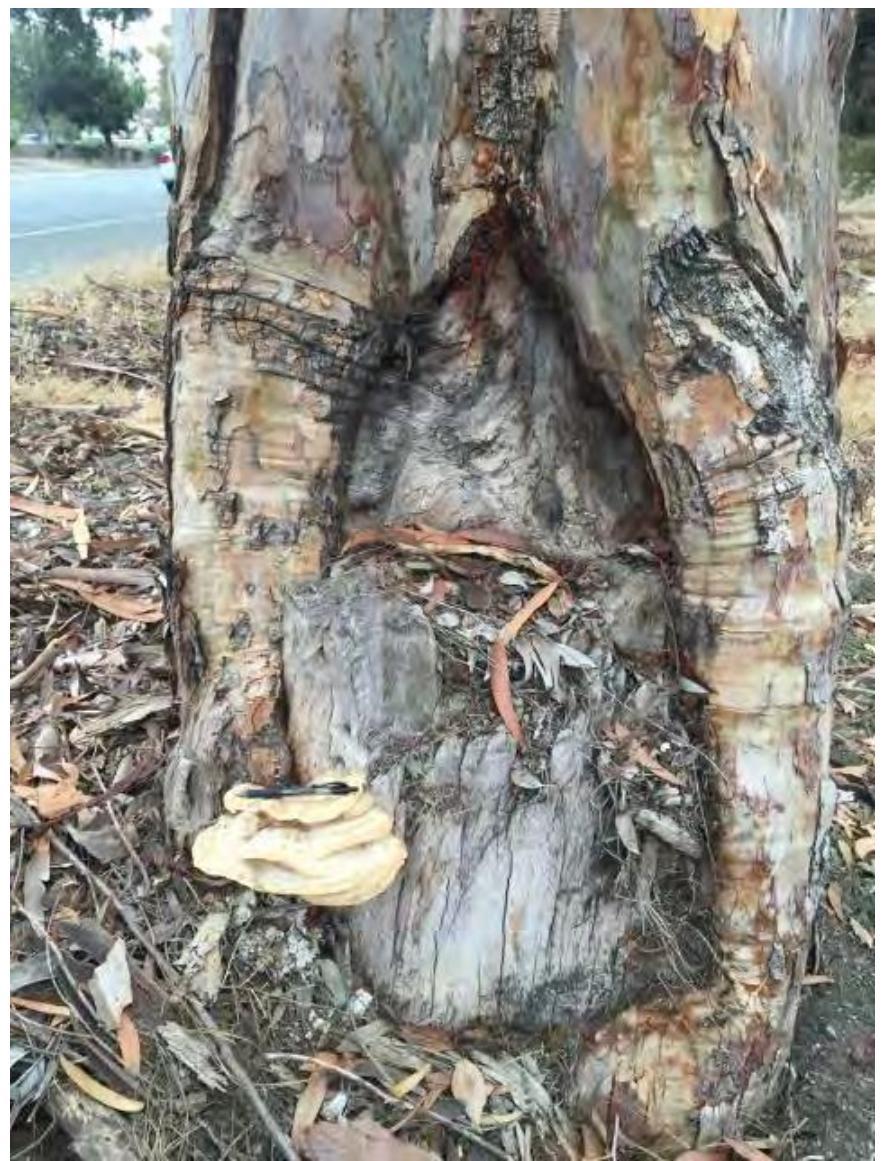
Photograph 8 – Close up view of trunk wound with conk (tree #2)

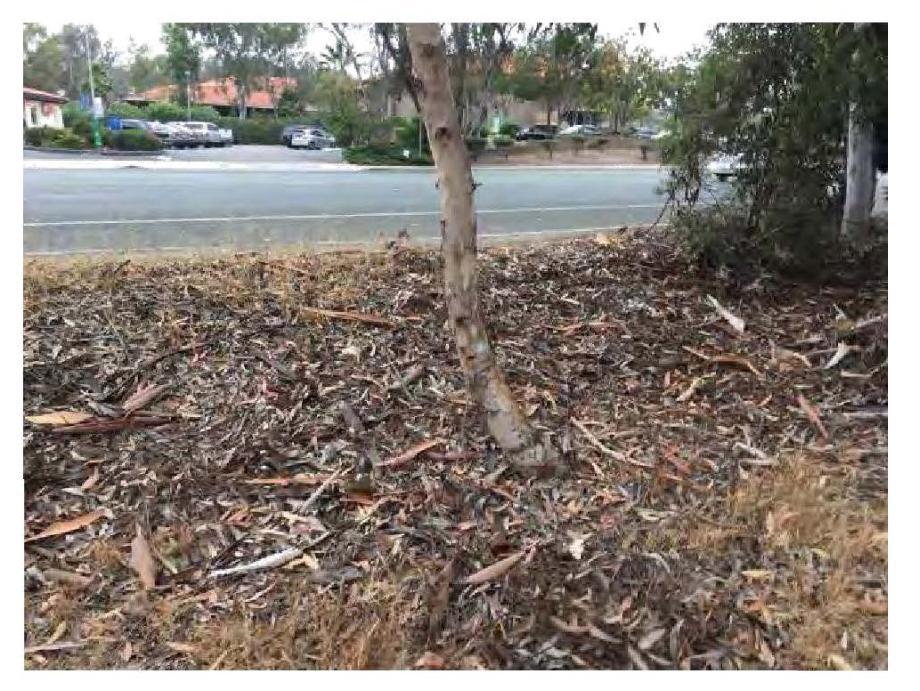
Photograph 10 – Close up view of trunk (tree #3)

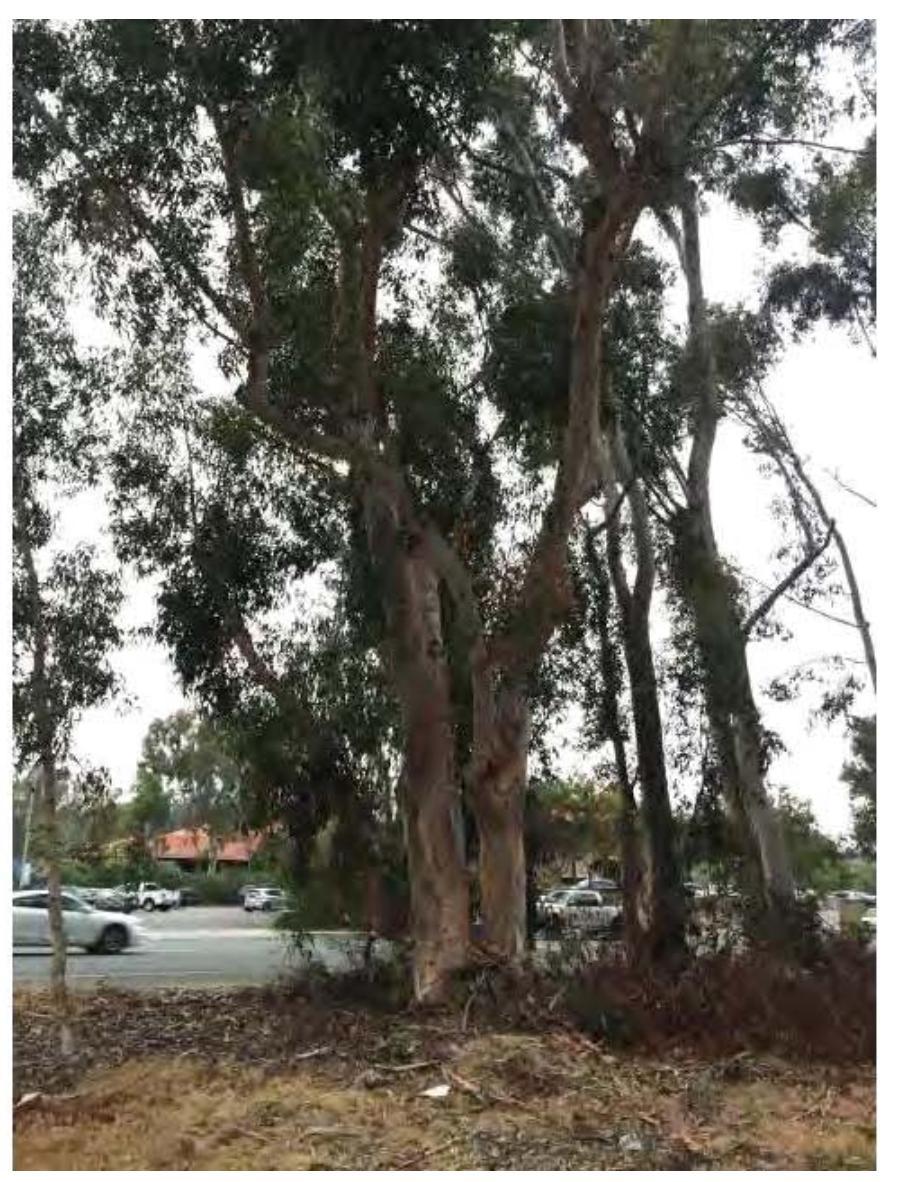
Photograph 12 – View of two main stems (tree # 4)

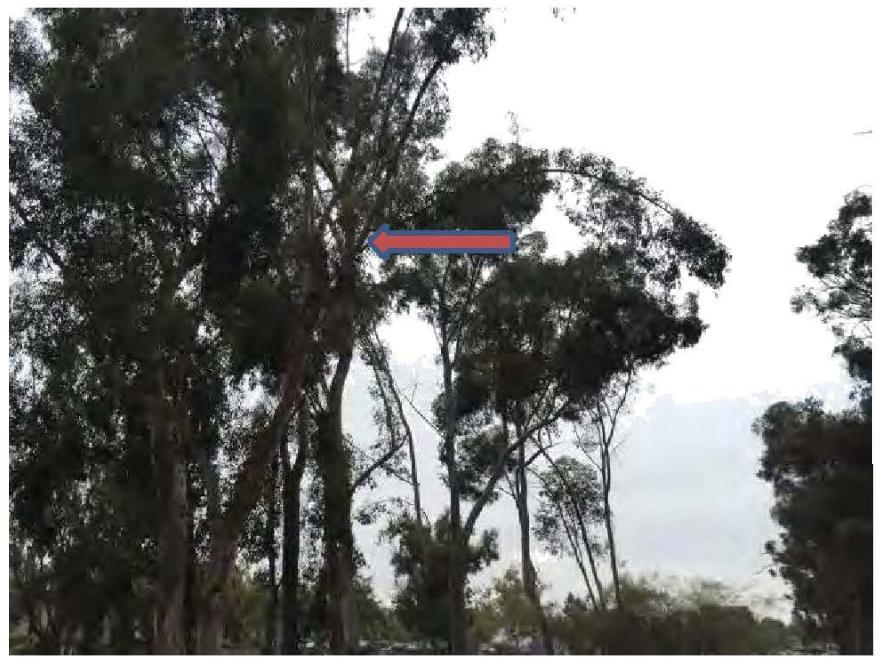
Photograph 13 – View of poor branch structure (tree # 4)

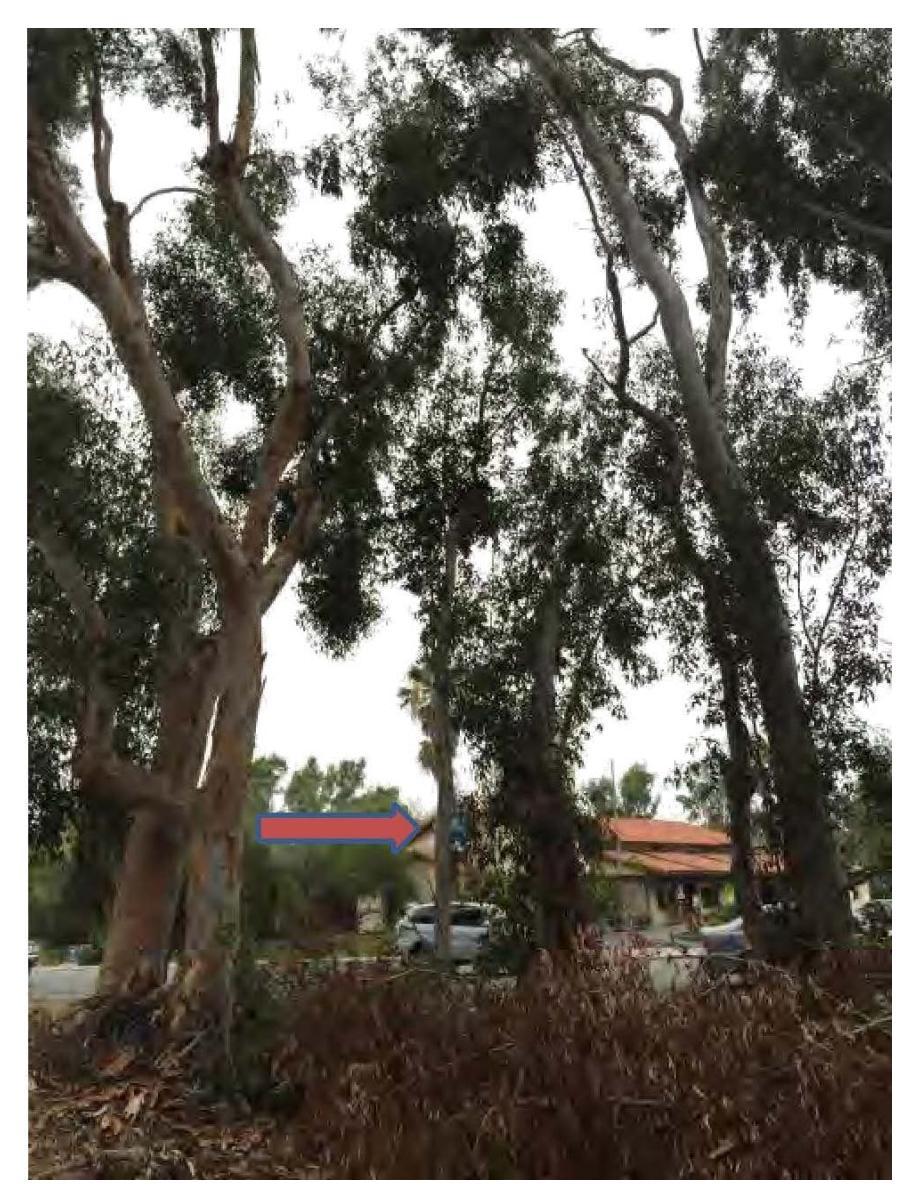
Photograph 14 – View of tree # 5

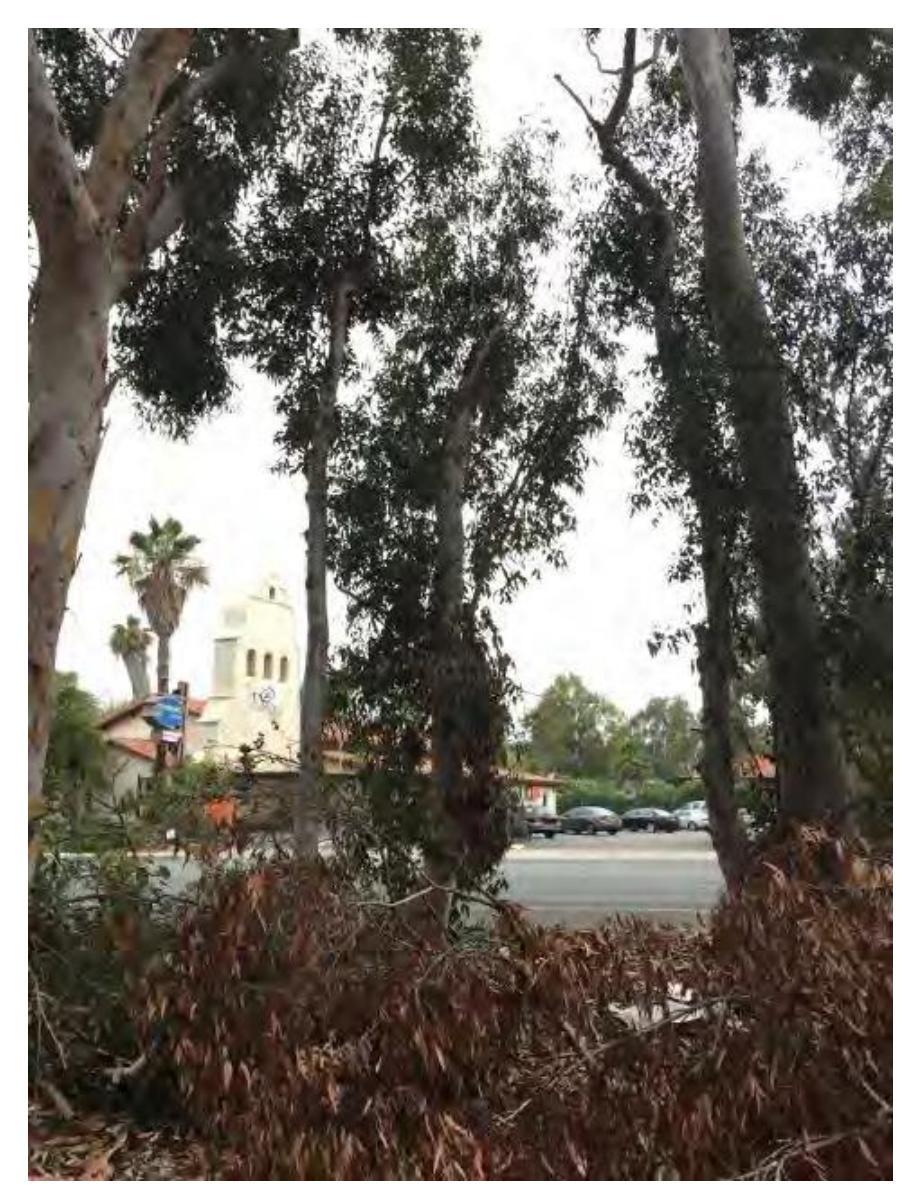
Photograph 16 – View of tree #6

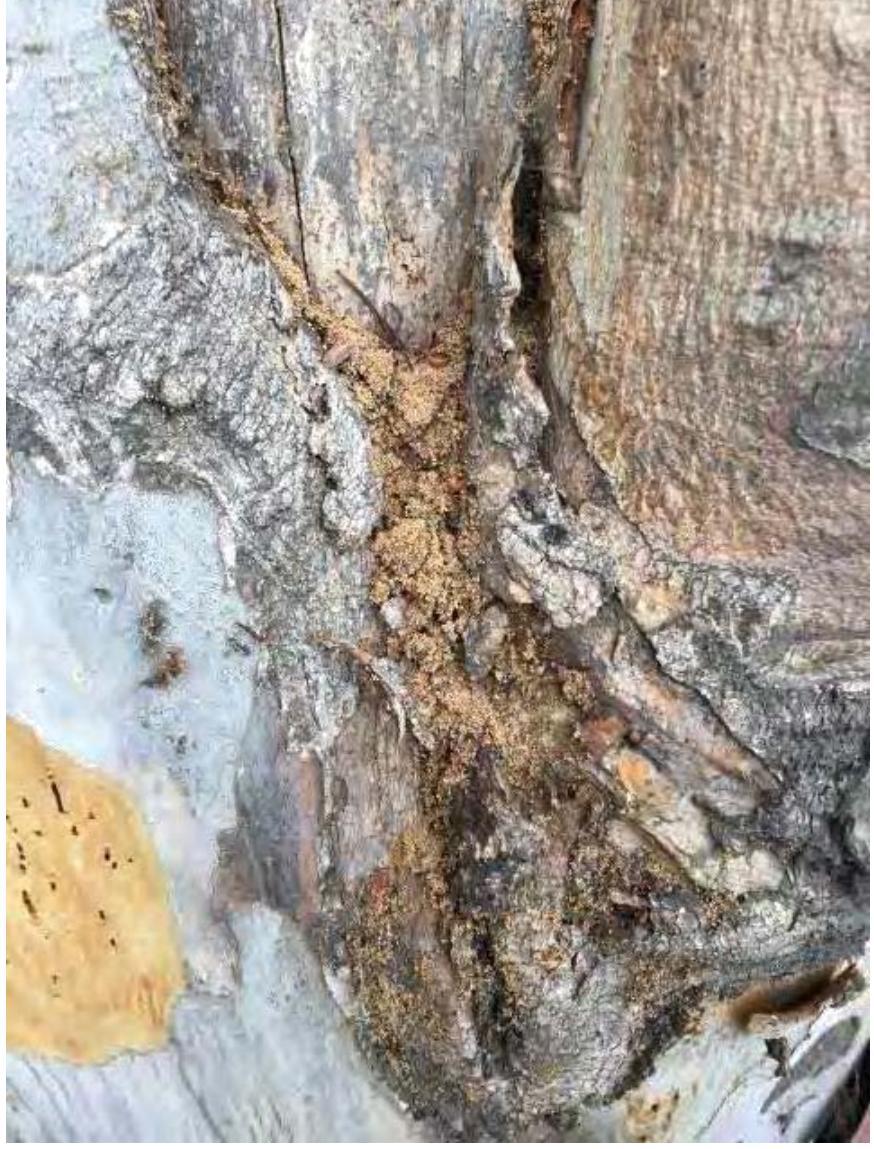
Photograph 19 – Close up view of frass from borer activity (tree# 7)

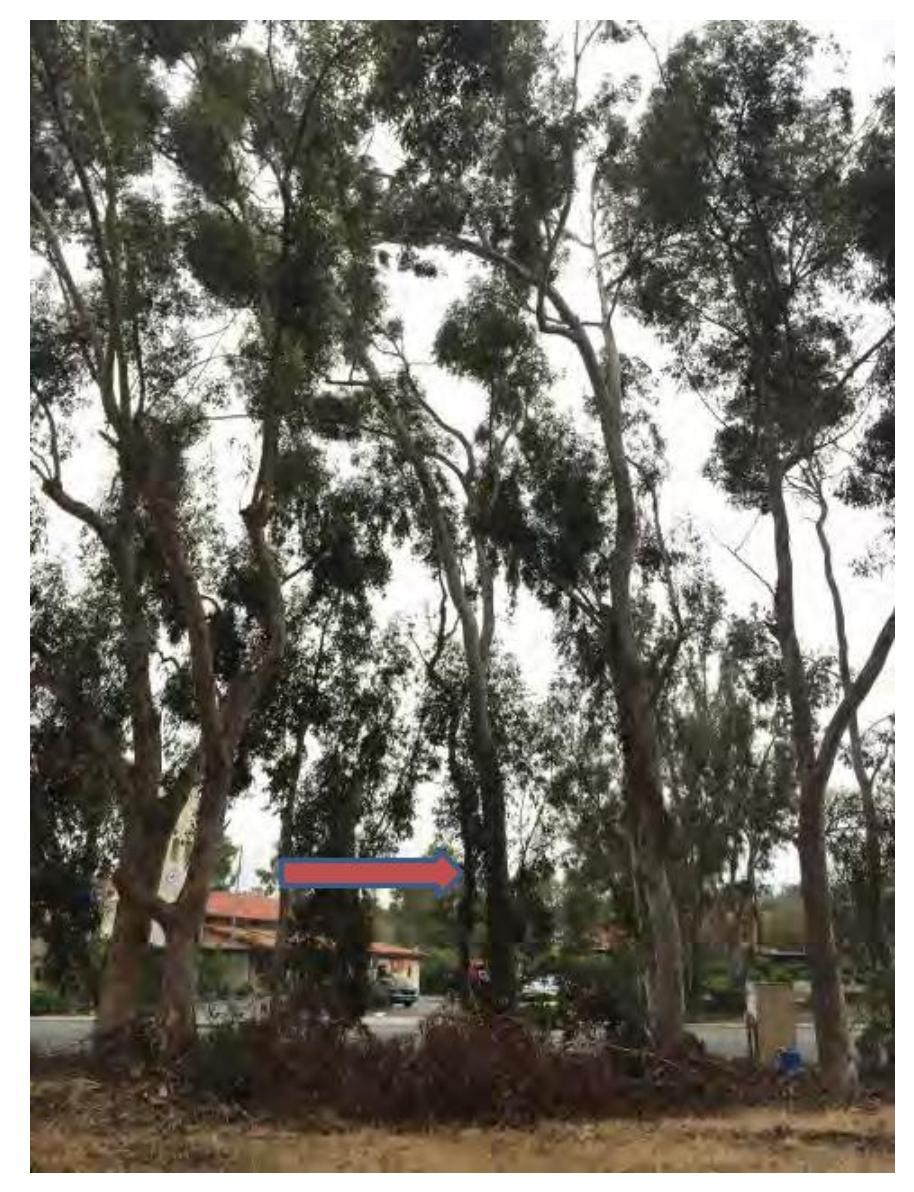
Photograph 20 – View of tree # 7

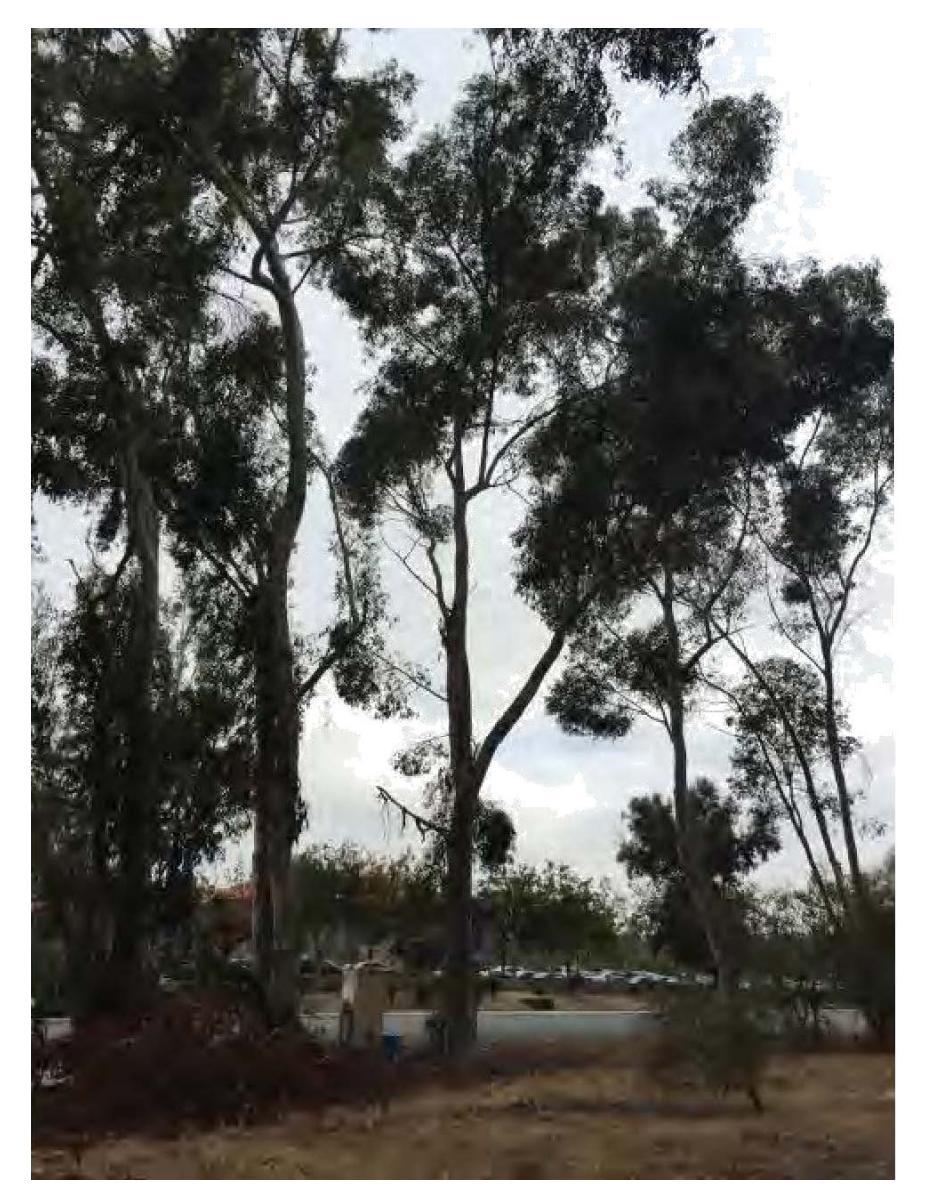
Photograph 25 – View of tree #9

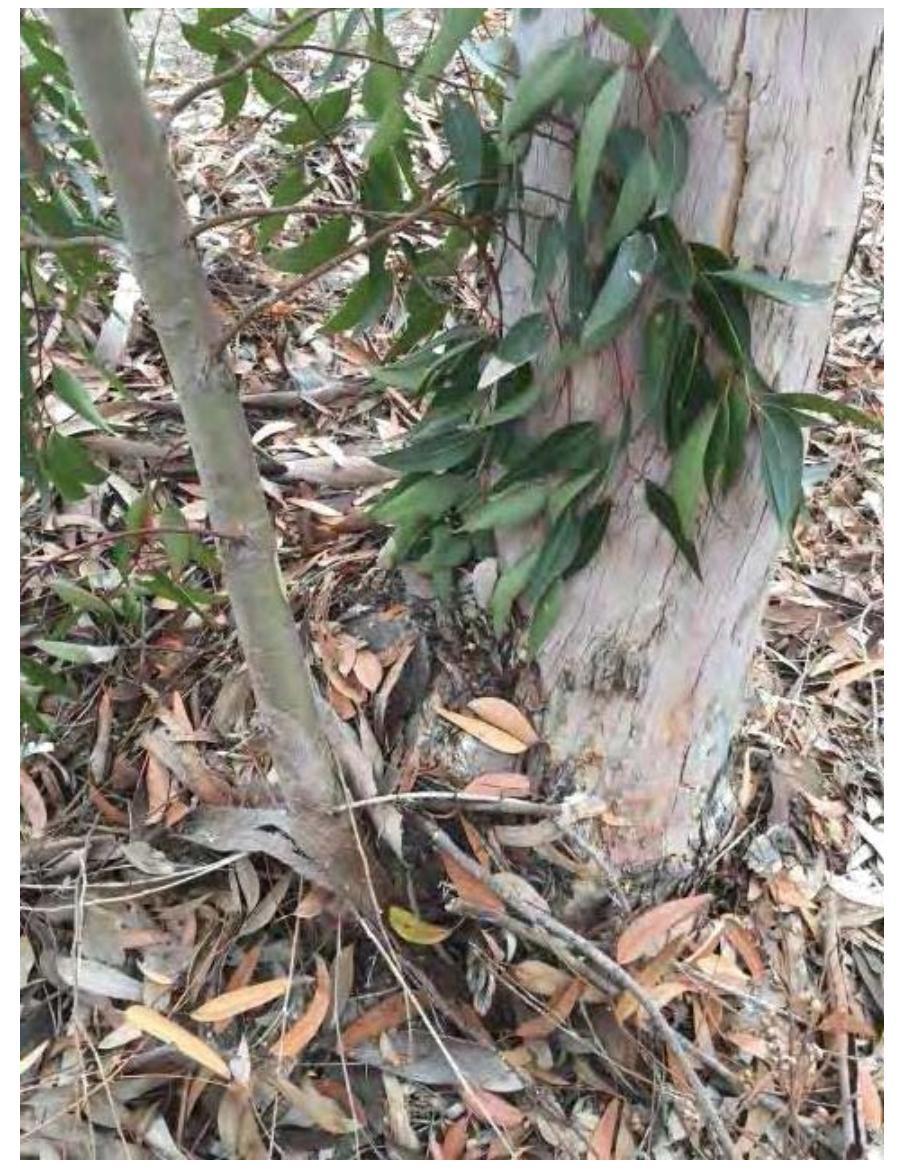
Photograph 29 – Close up view of old basal wound (tree #10)

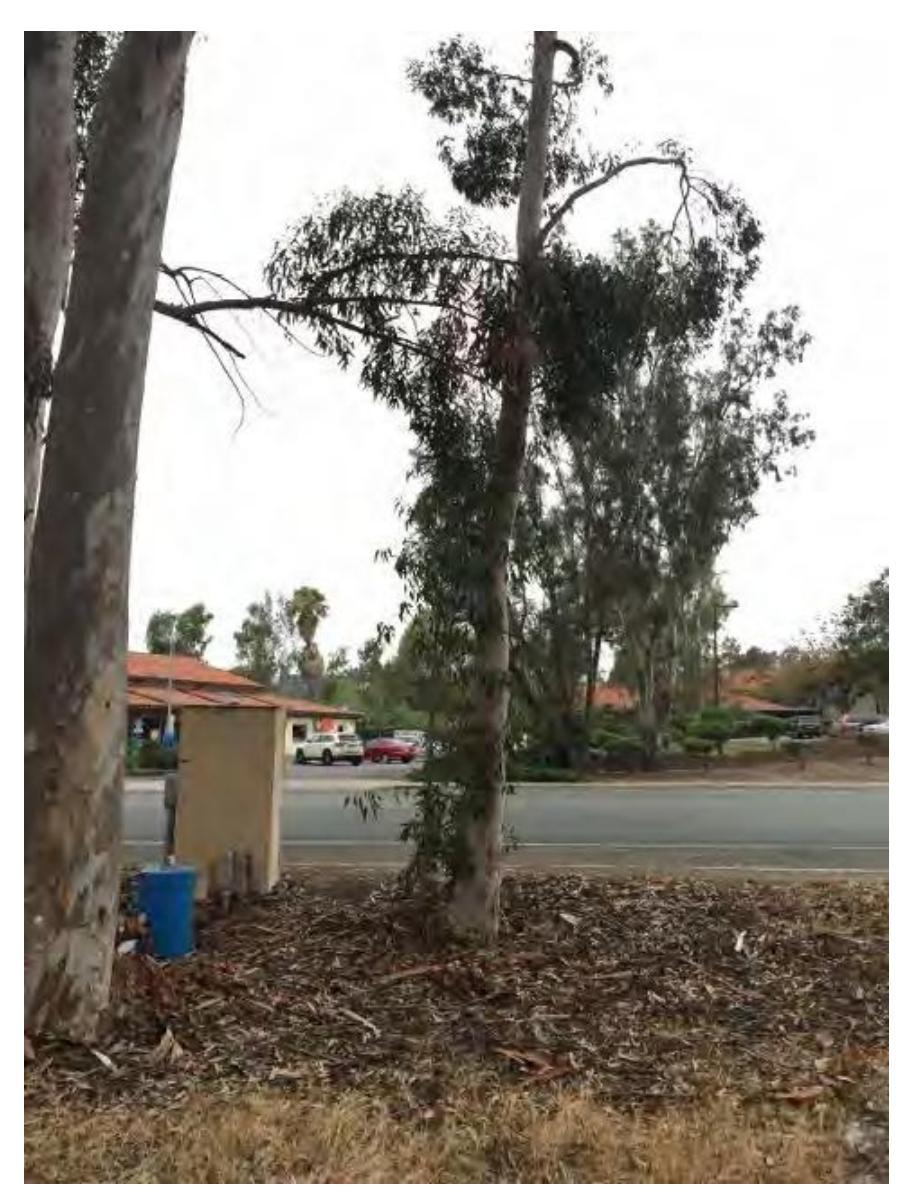
Photograph 30 – View of main stem (tree # 10)

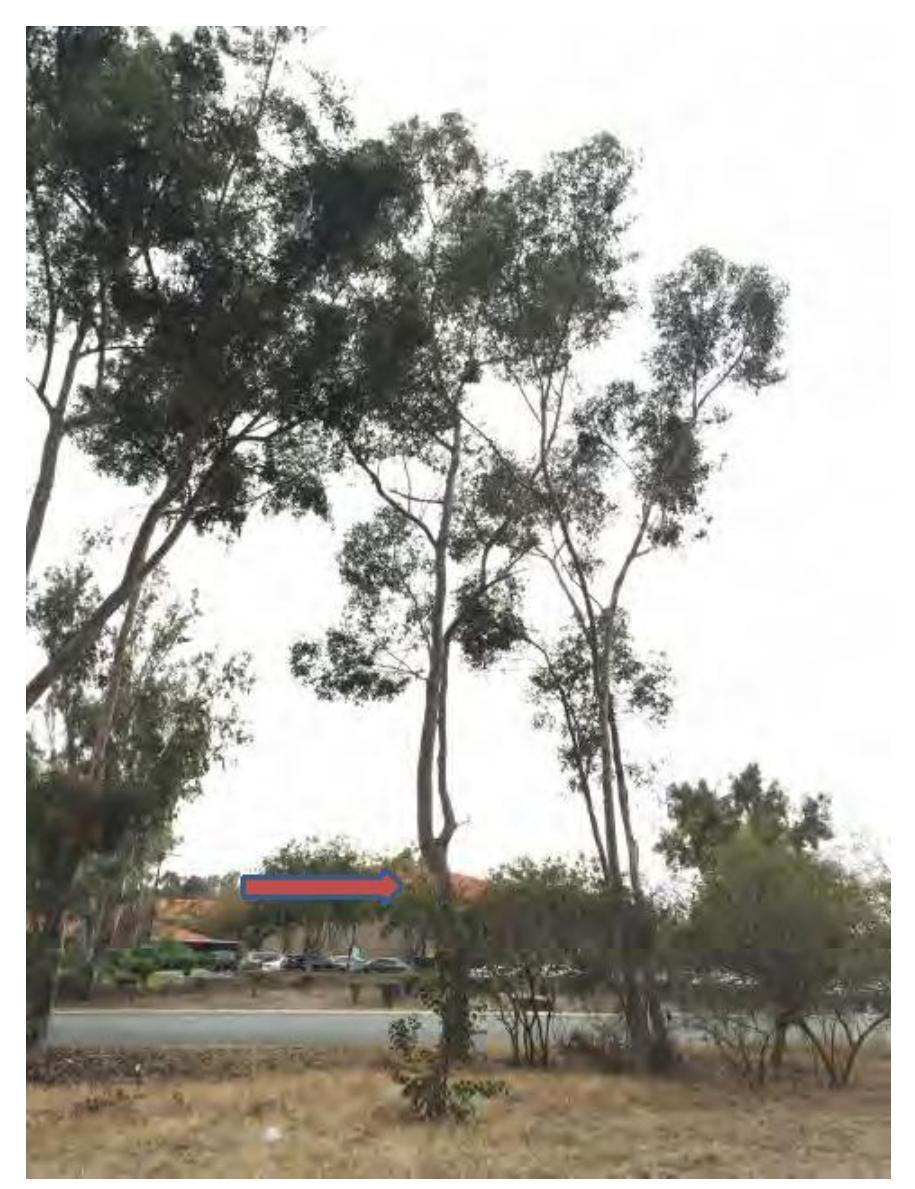
Photograph 34 – View of tree #11

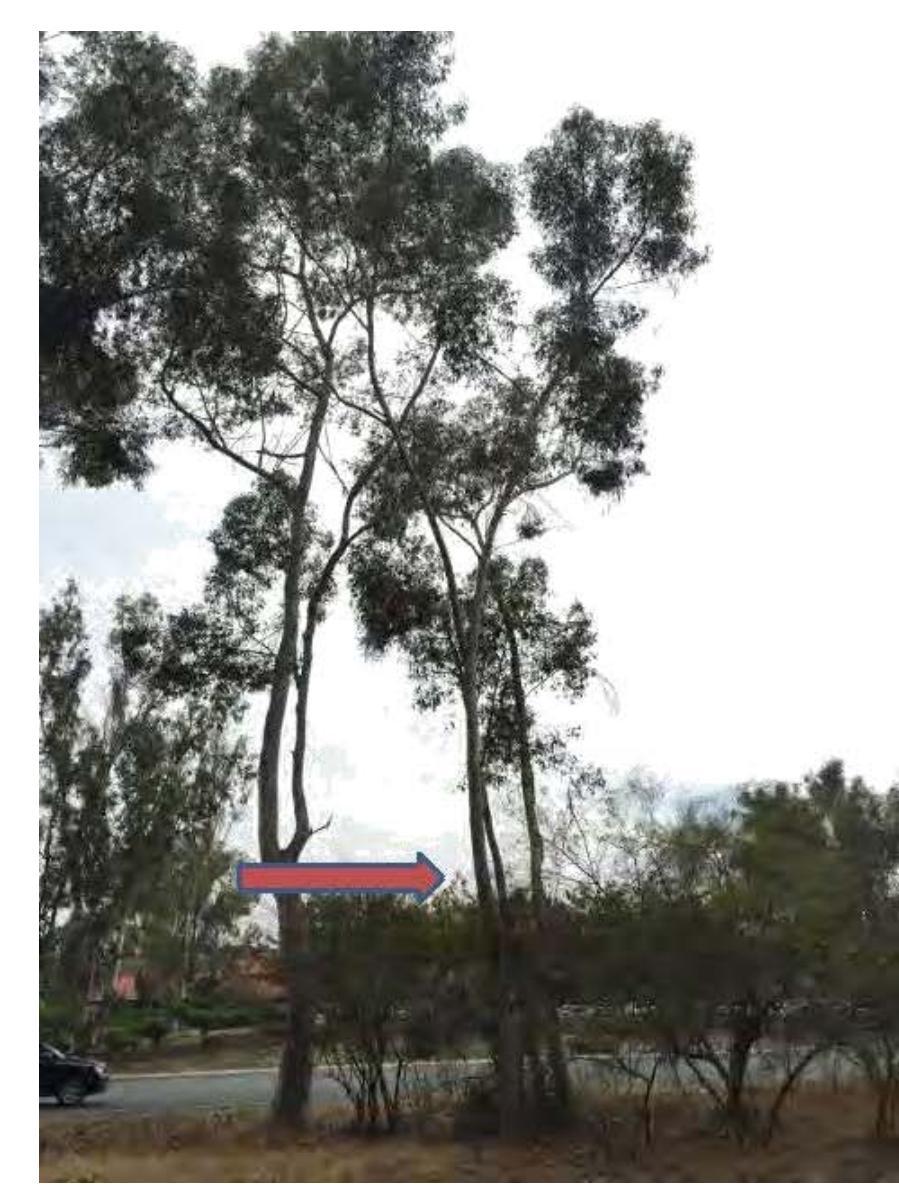
Photograph 35 - View of tree # 12

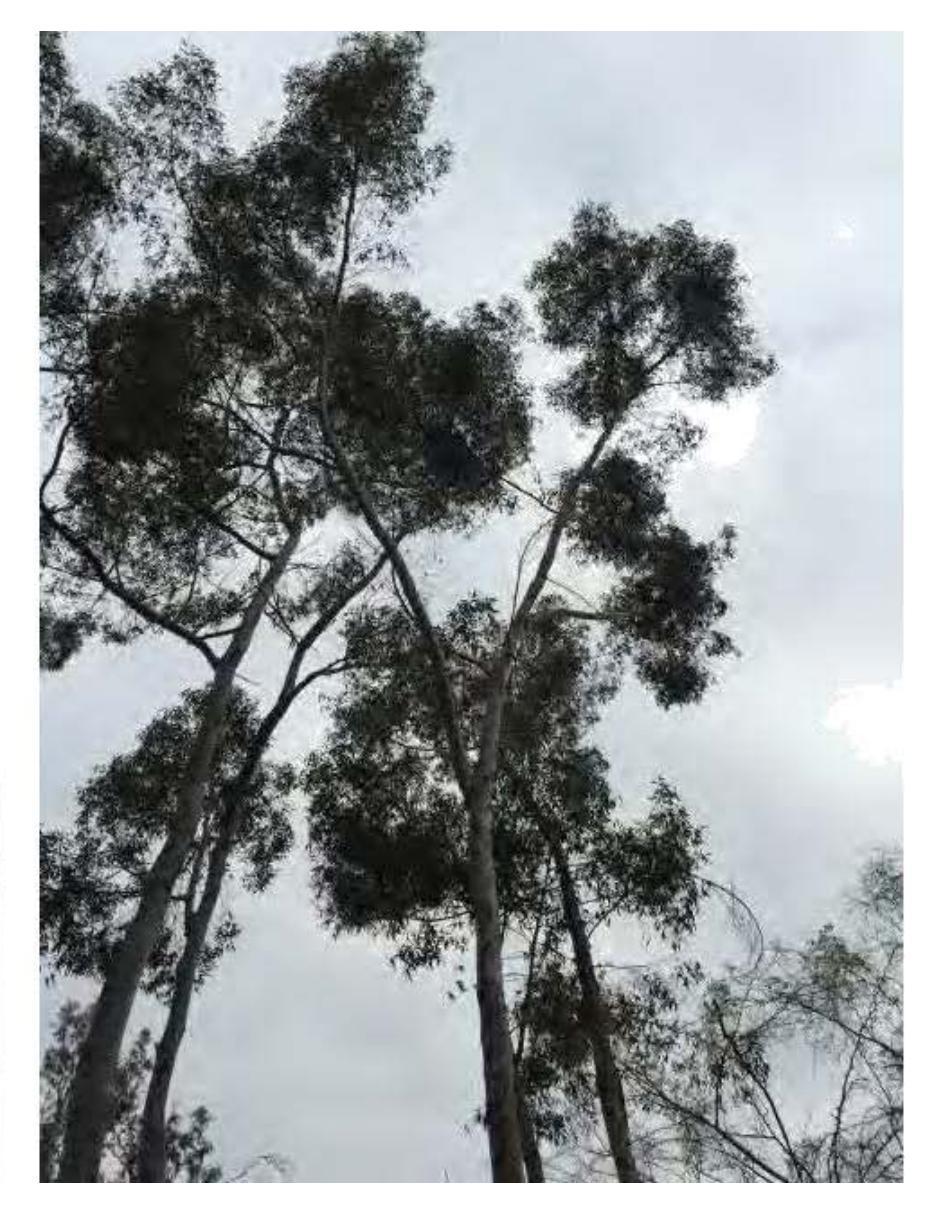
Photograph 36 – View of canopy (tree #12)

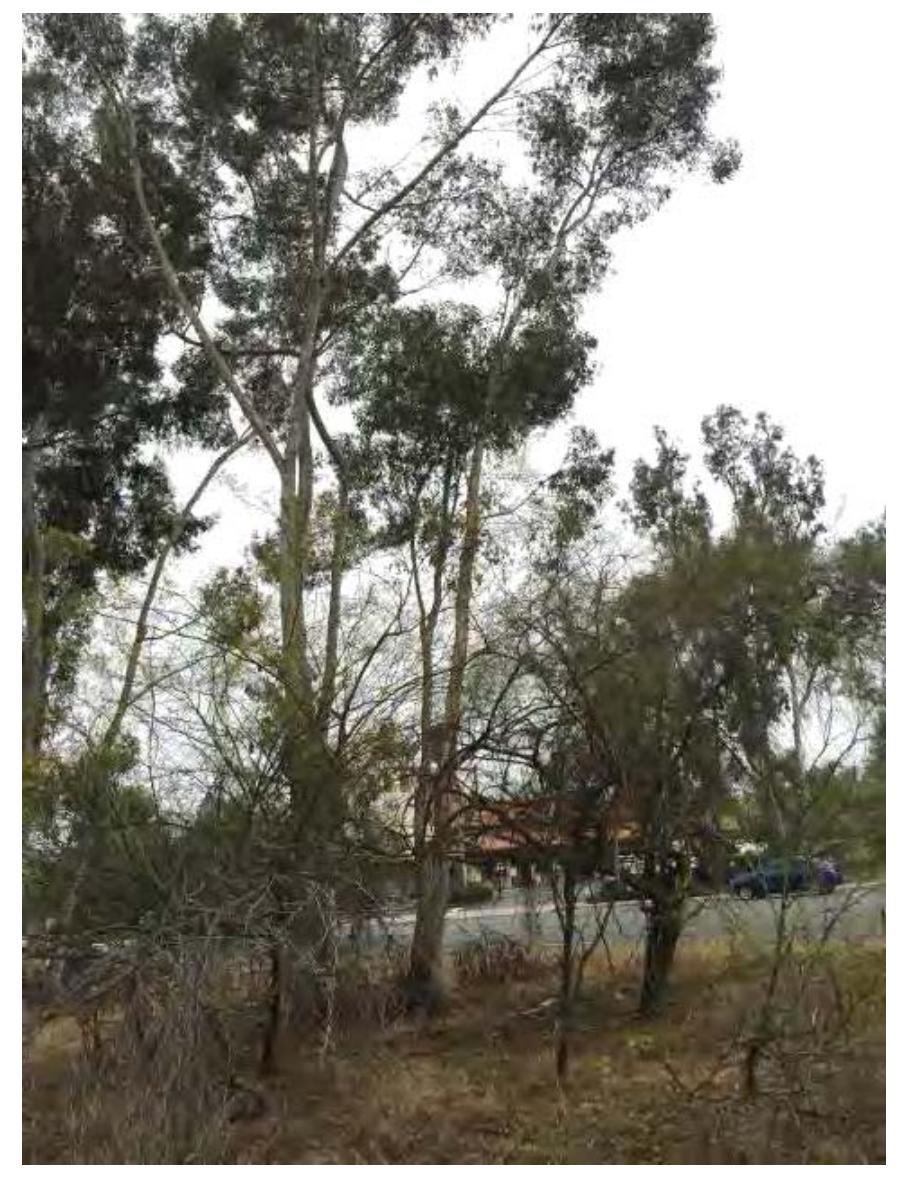
Photograph 37 – View of tree # 13 surrounded by Palo Verde

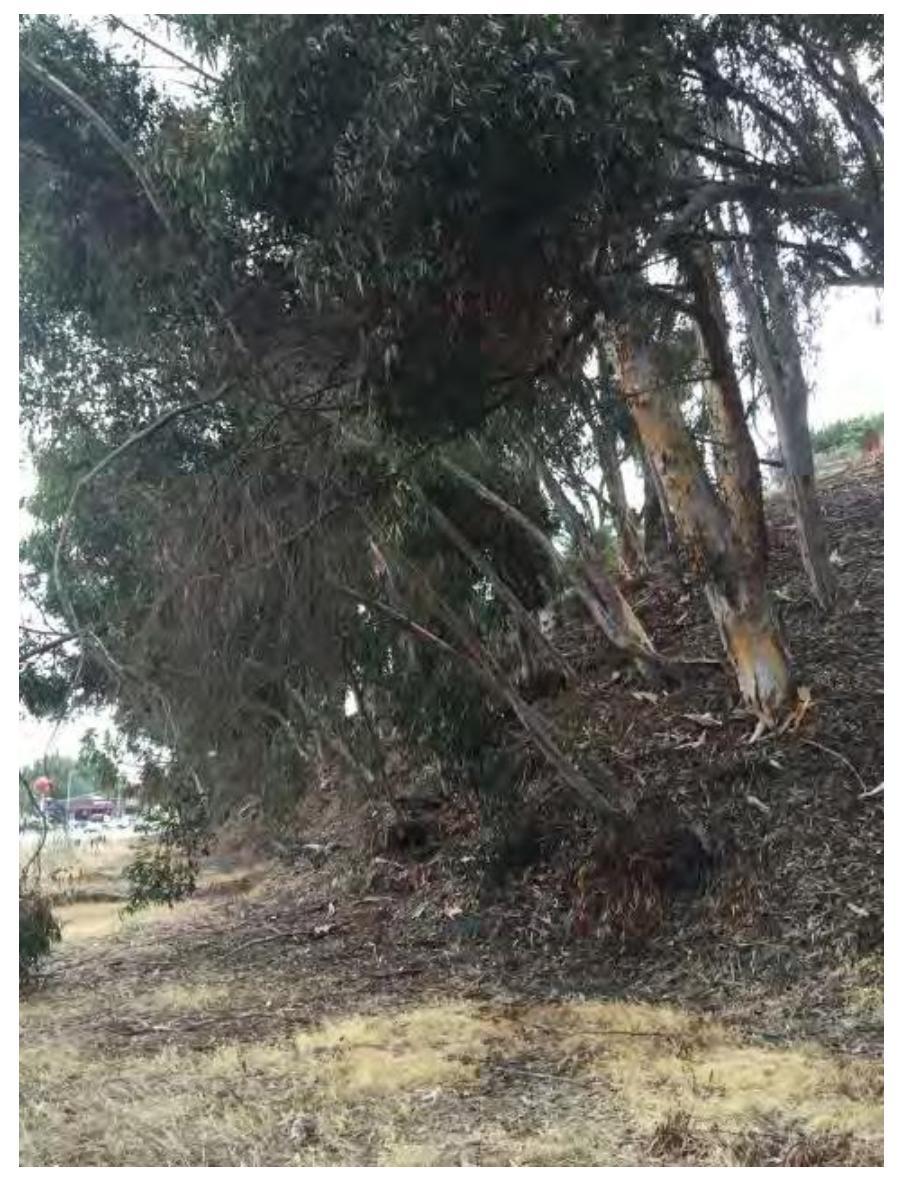
Photograph 38 – View of tree #14

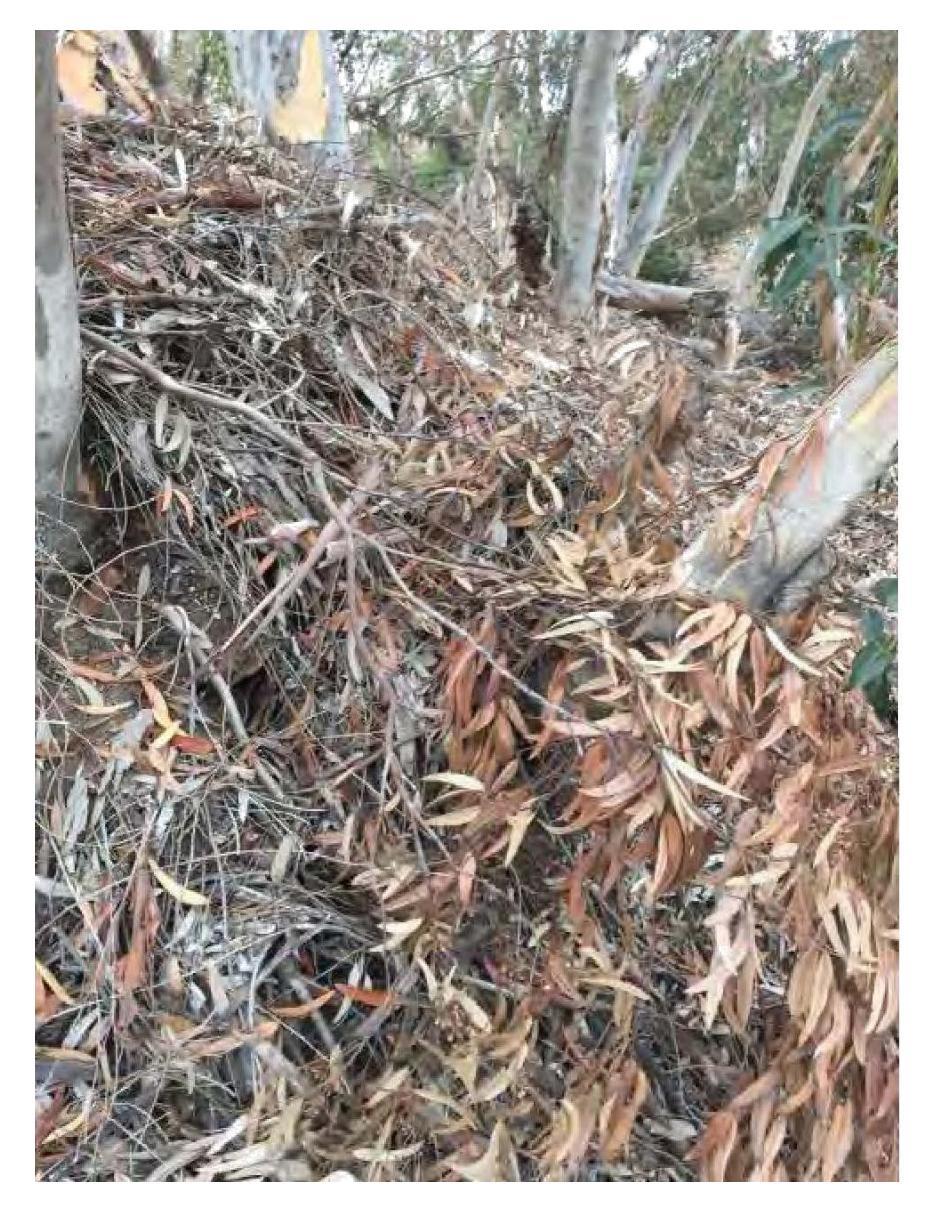
Photograph 40 – View of tree # 15

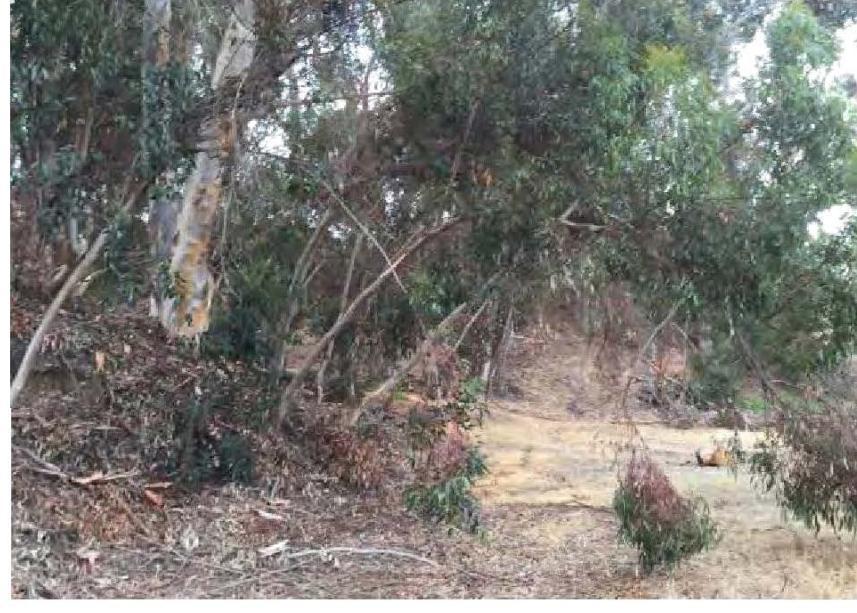
Photograph 39 – Close up view of resprout and excessive leaf litter and debris (tree # 14)

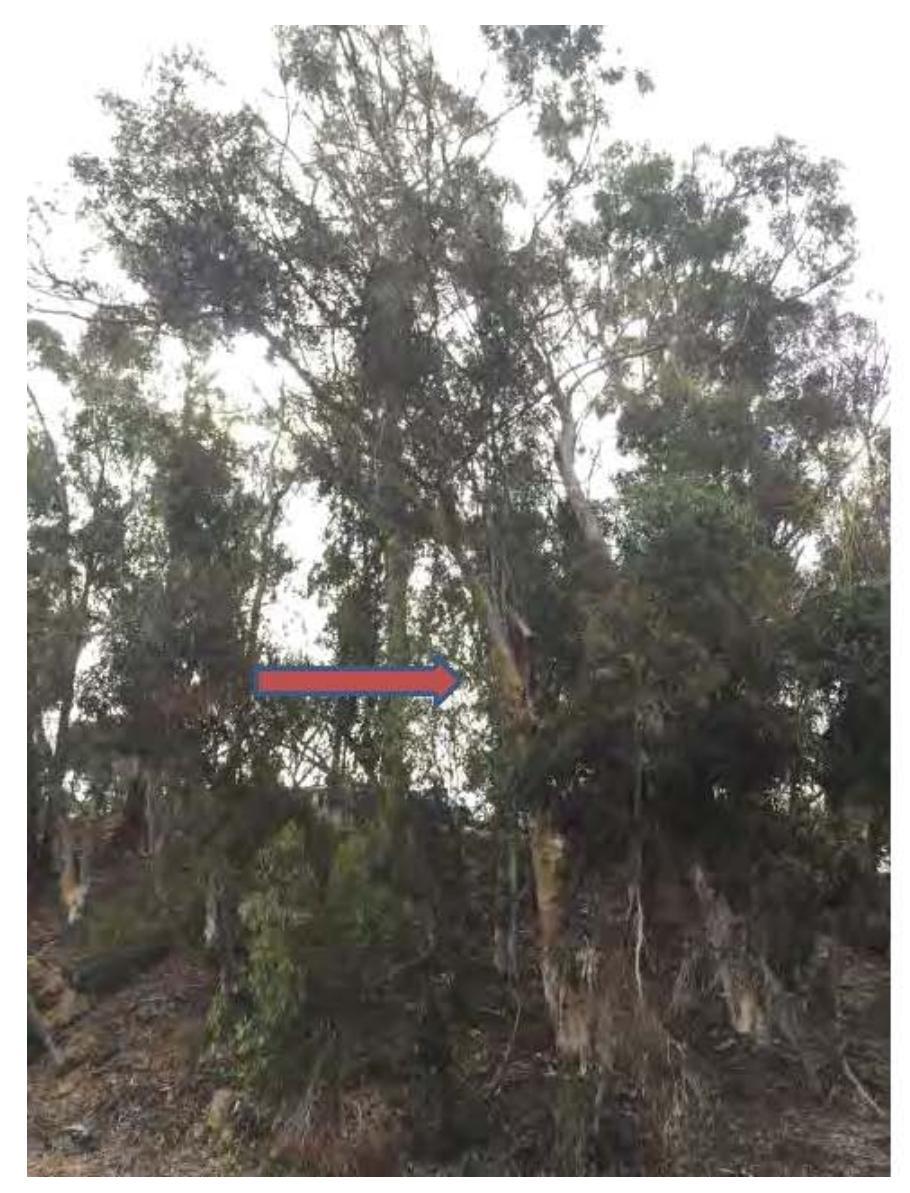
Photograph 41 – View of tree # 16

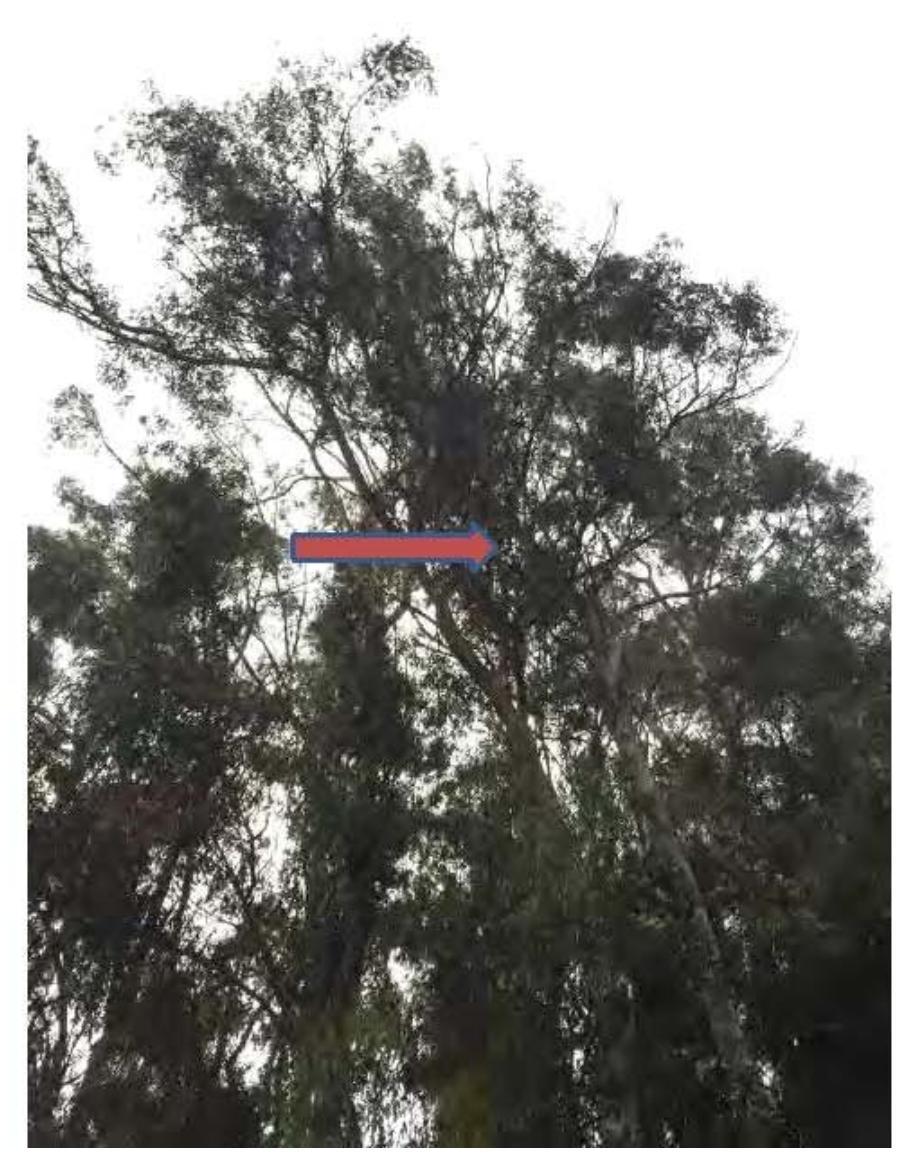
Photograph 42 – View of dieback in canopy (tree #16)

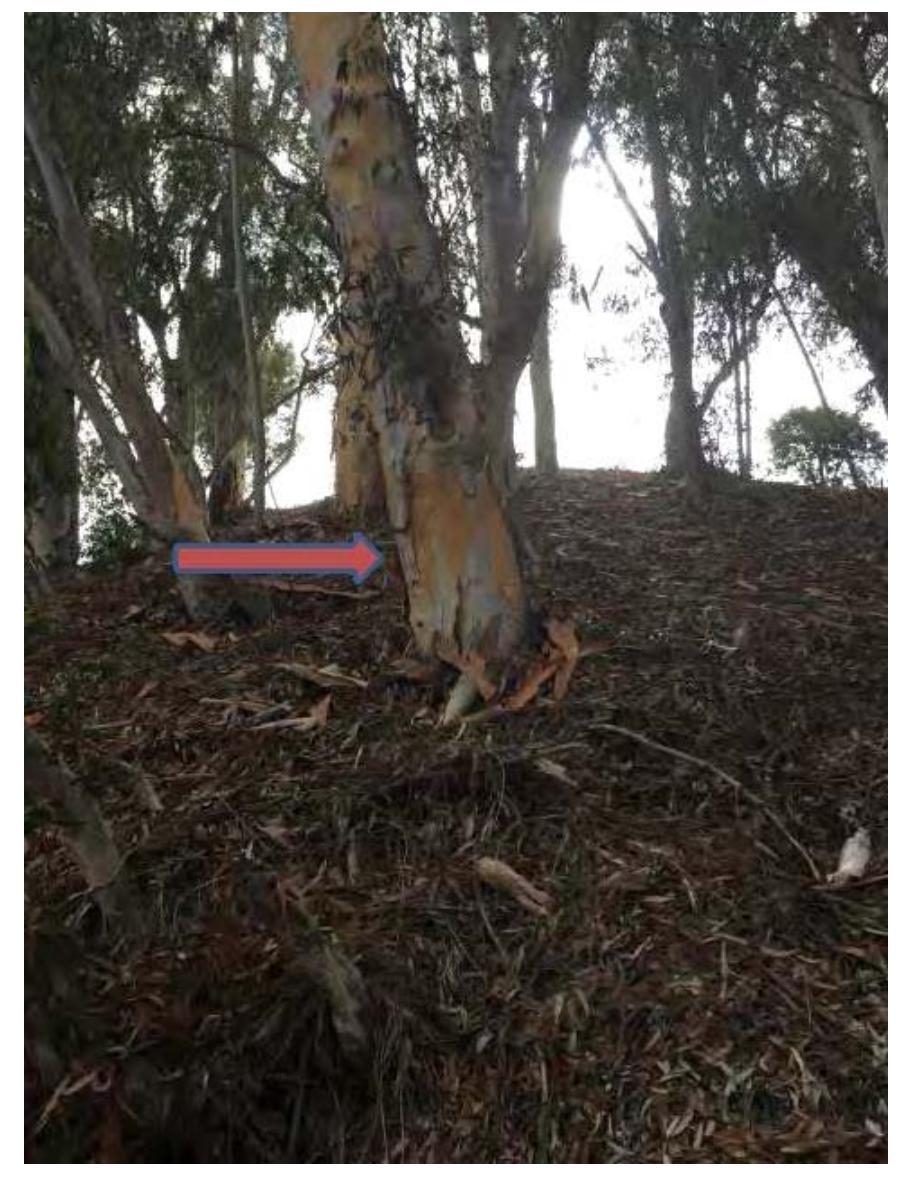
Photograph 43 – view of main stem on steep slope (tree #16)
