CALIFORNIA TREE SERVICE, INC.

July 17, 2015

Subject: Bonita Pump Station Project: Tree Risk Evaluation

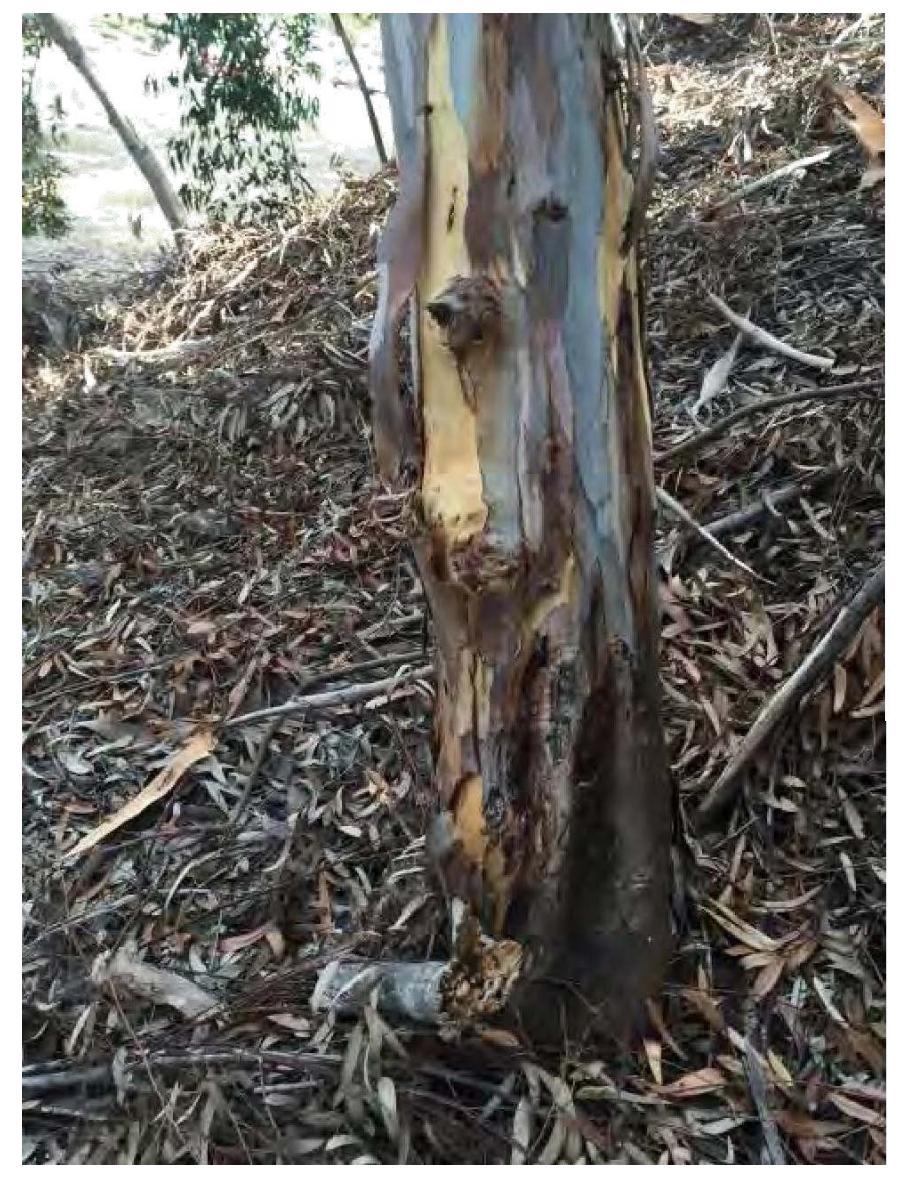
Photograph 45 – view of main stem (tree # 17)

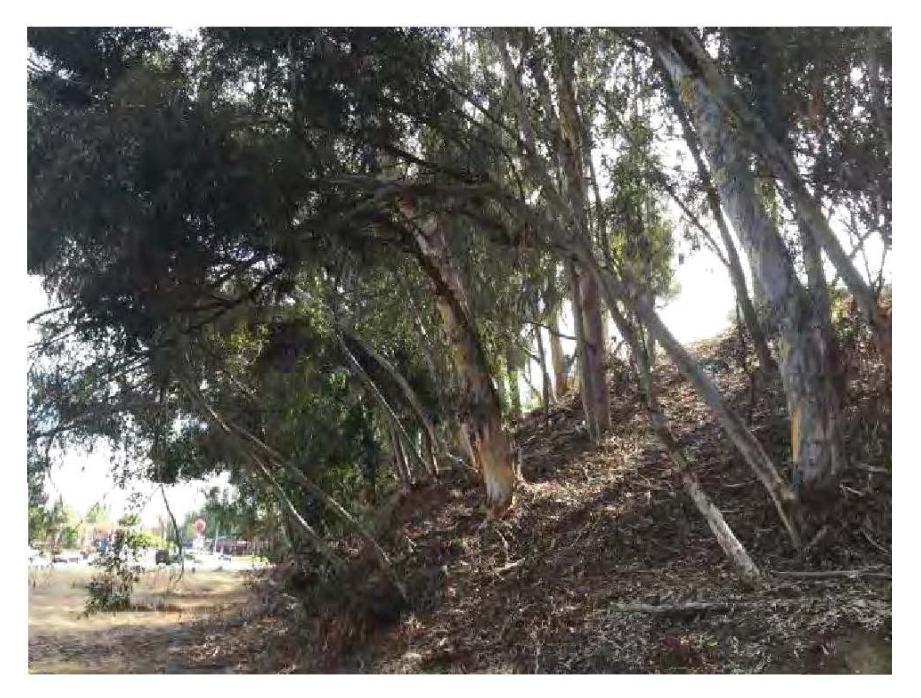
Photograph 46 – View of tree # 17

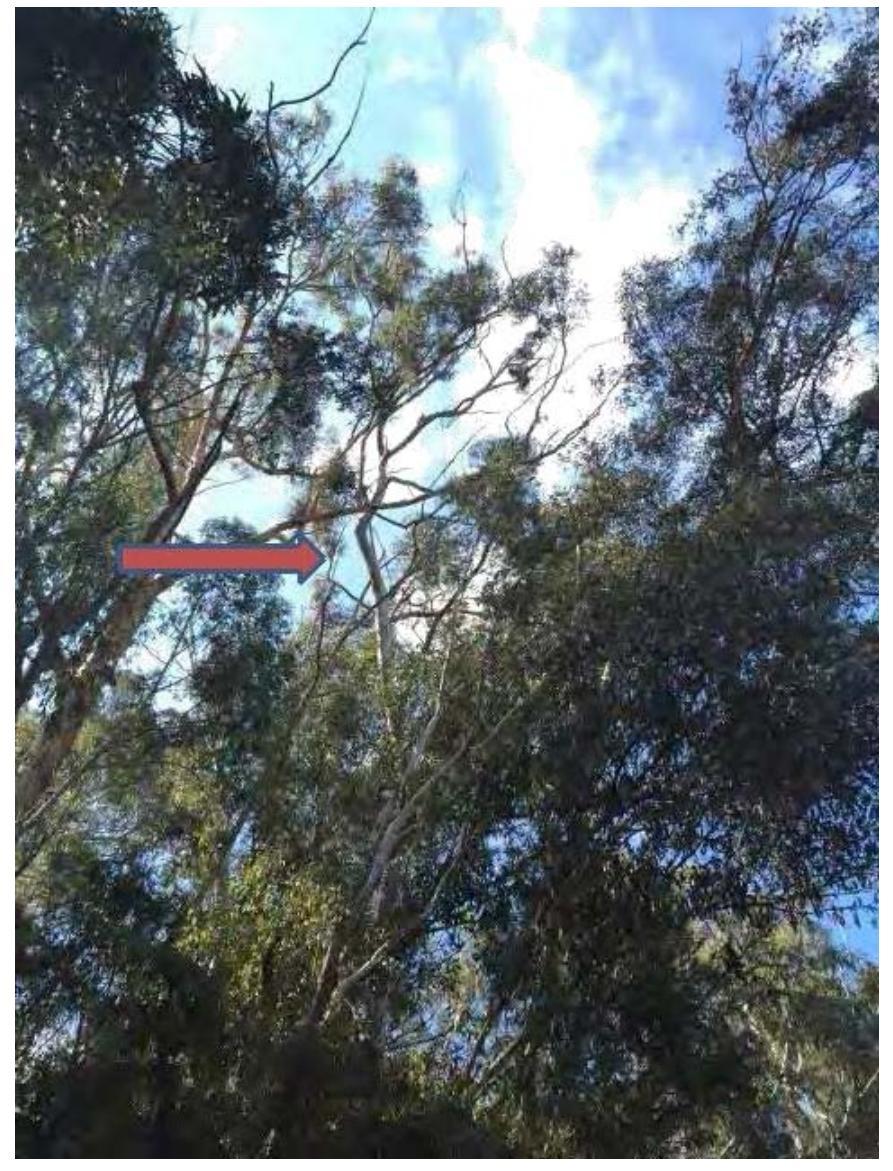
Photograph 47 – View of tree # 18 exhibiting branch dieback

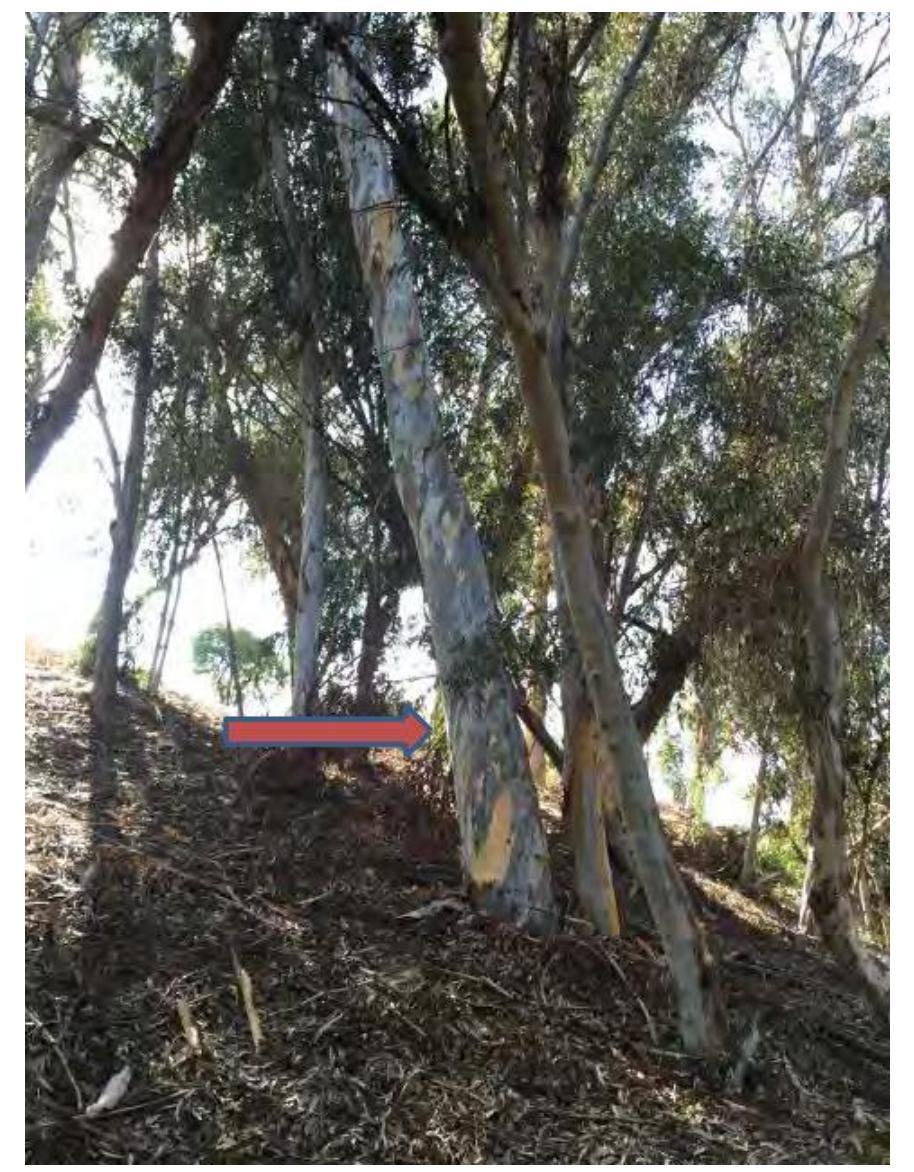
Photograph 48 – View of main stem on steep slope (tree # 18)

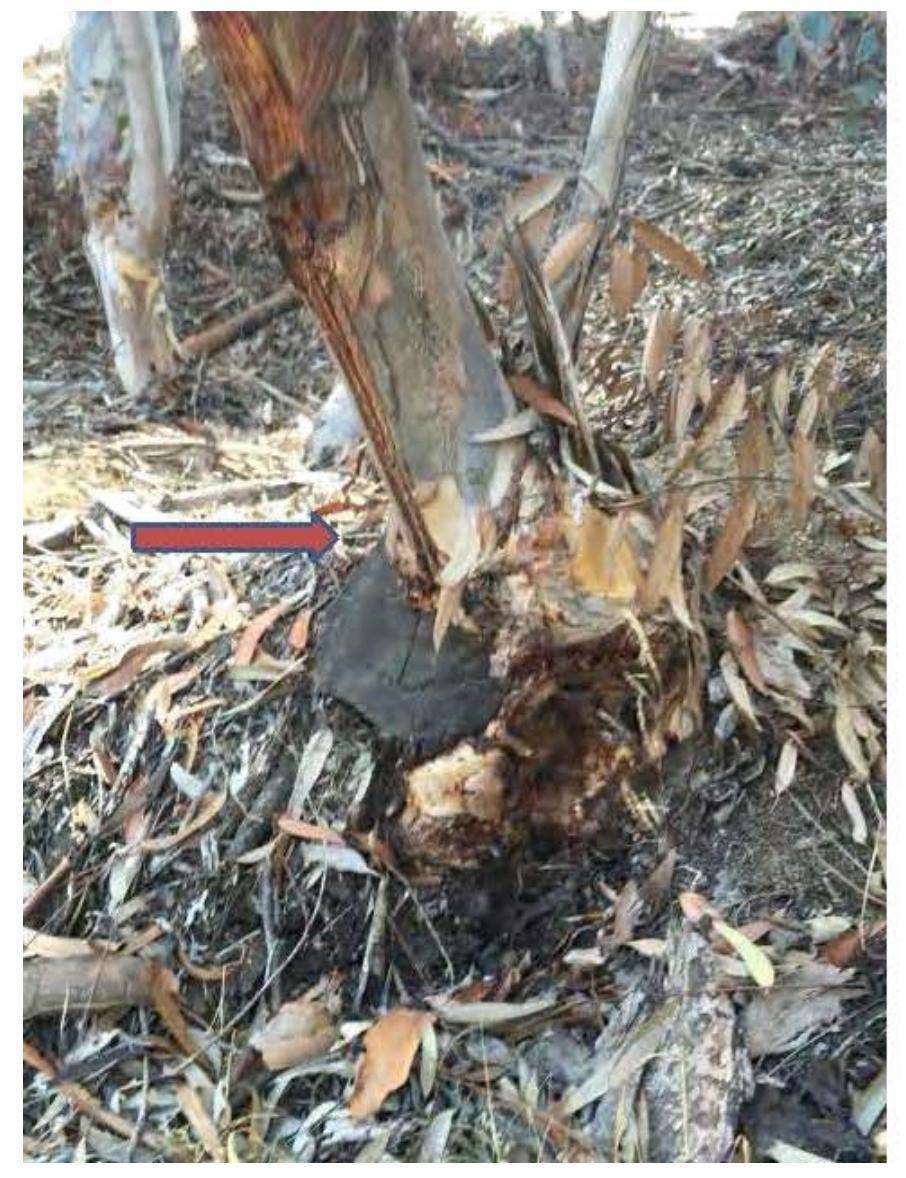
Photograph 51 – Close up view of re-sprout (tree # 20)

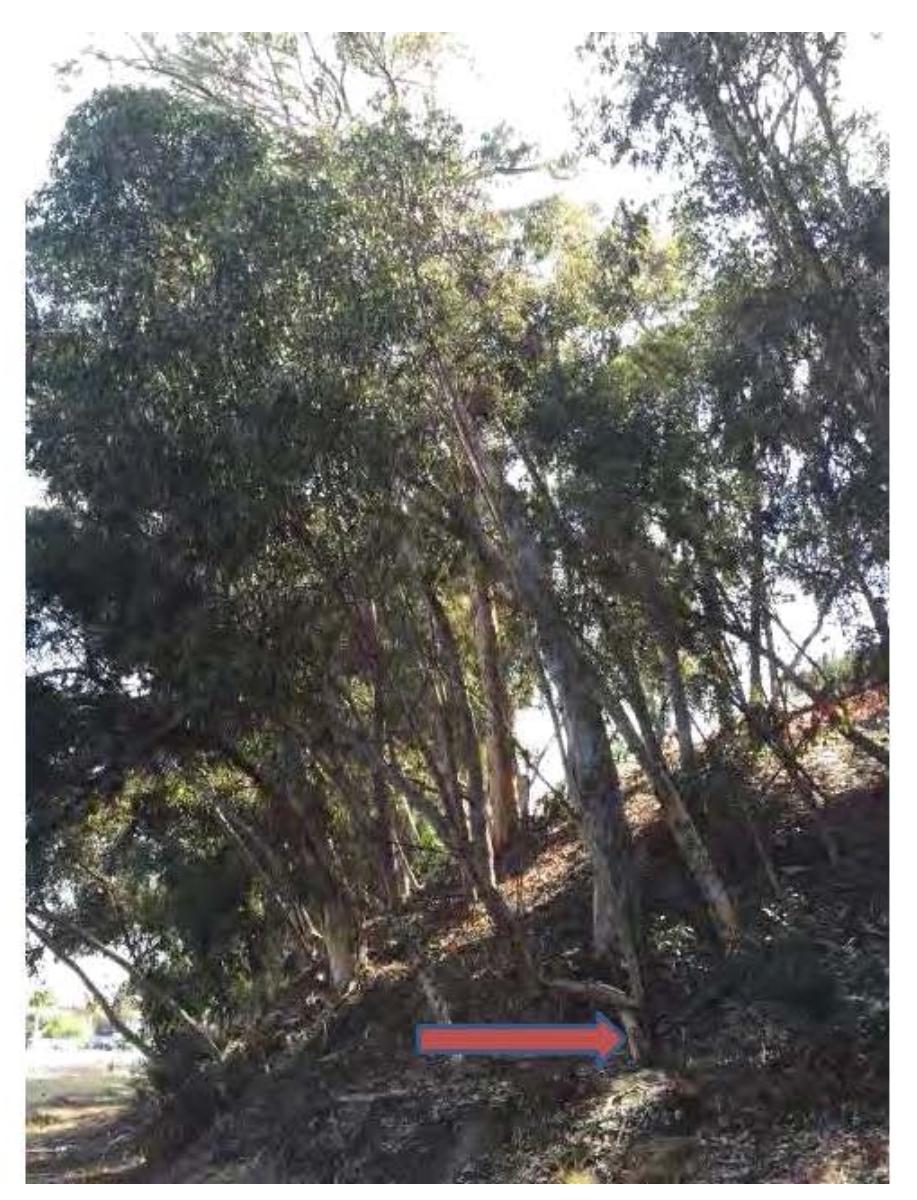
Photograph 52 – View of tree # 20

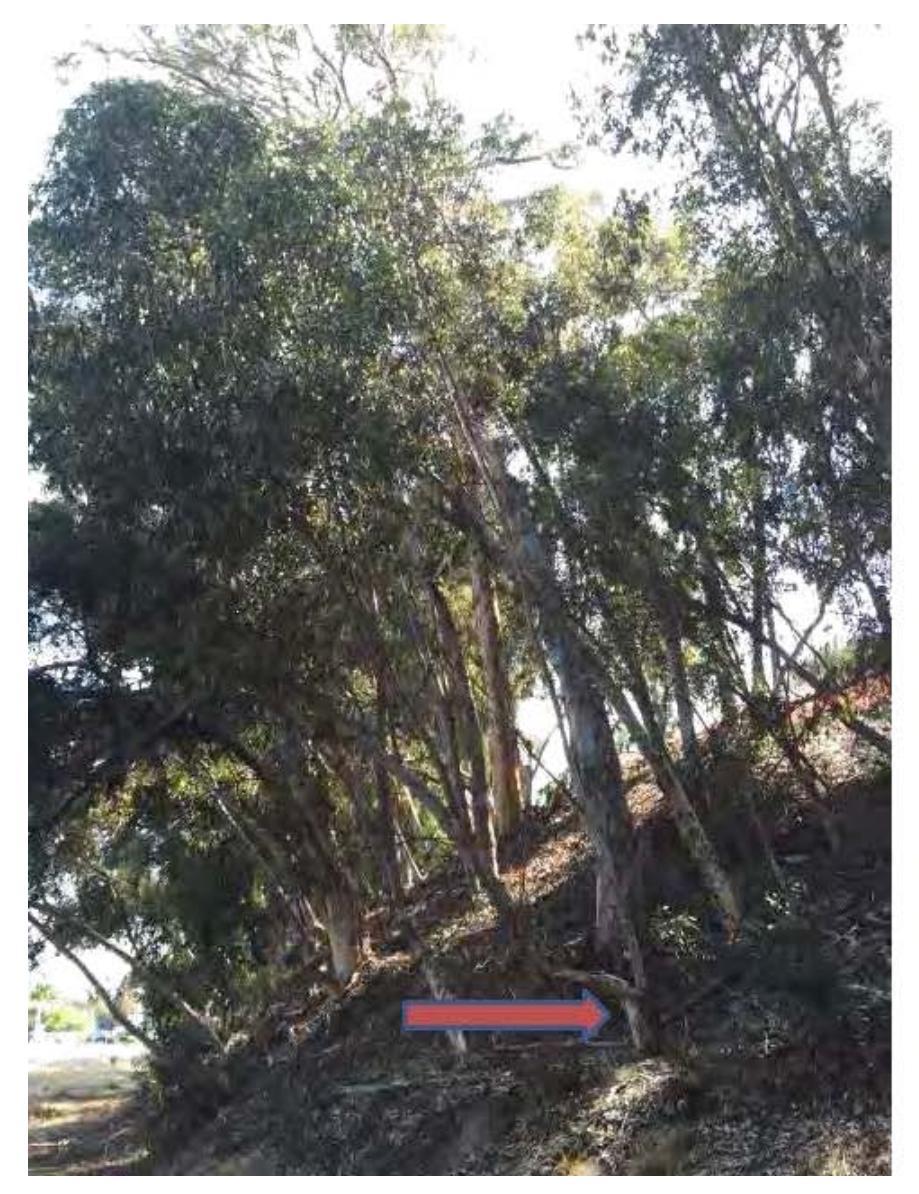
Photograph 53 – View of tree # 20

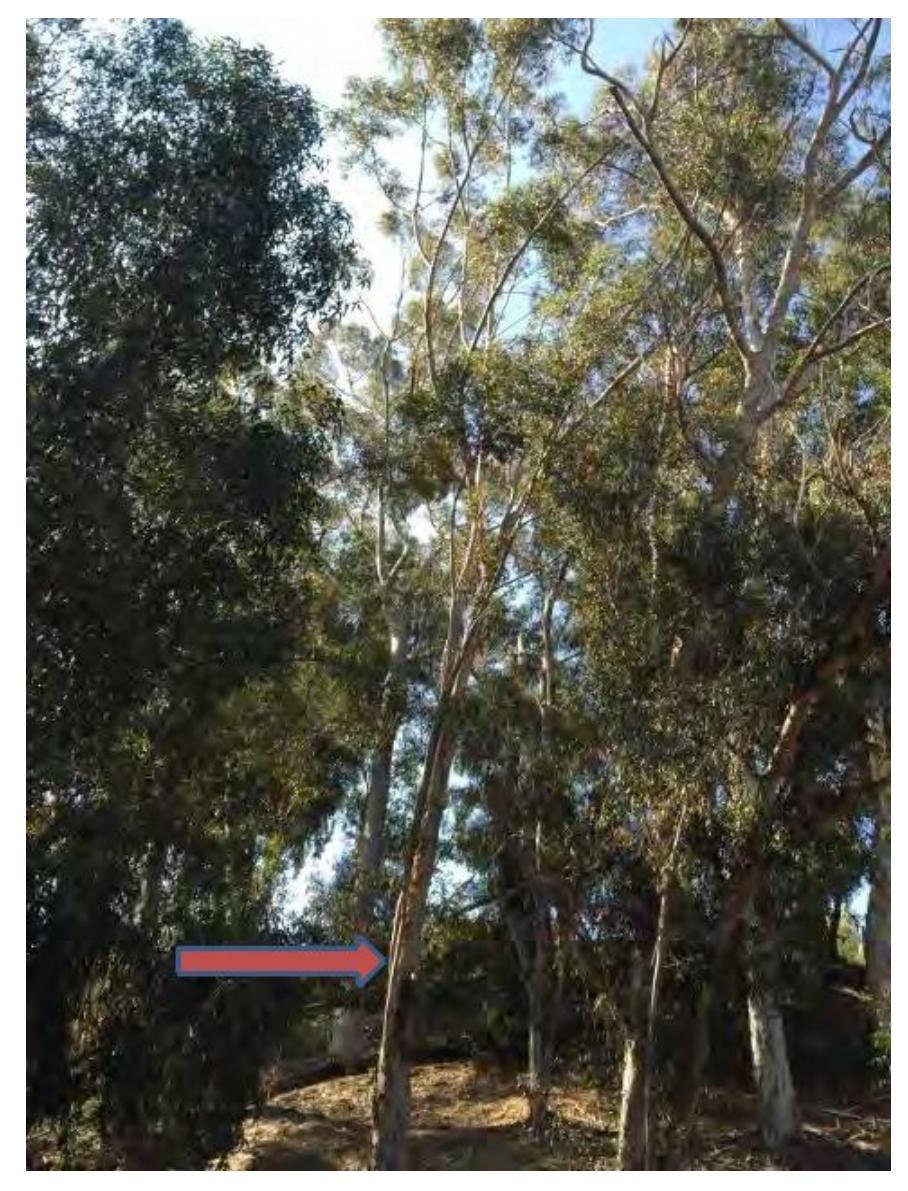
Photograph 58 – View of tree # 21

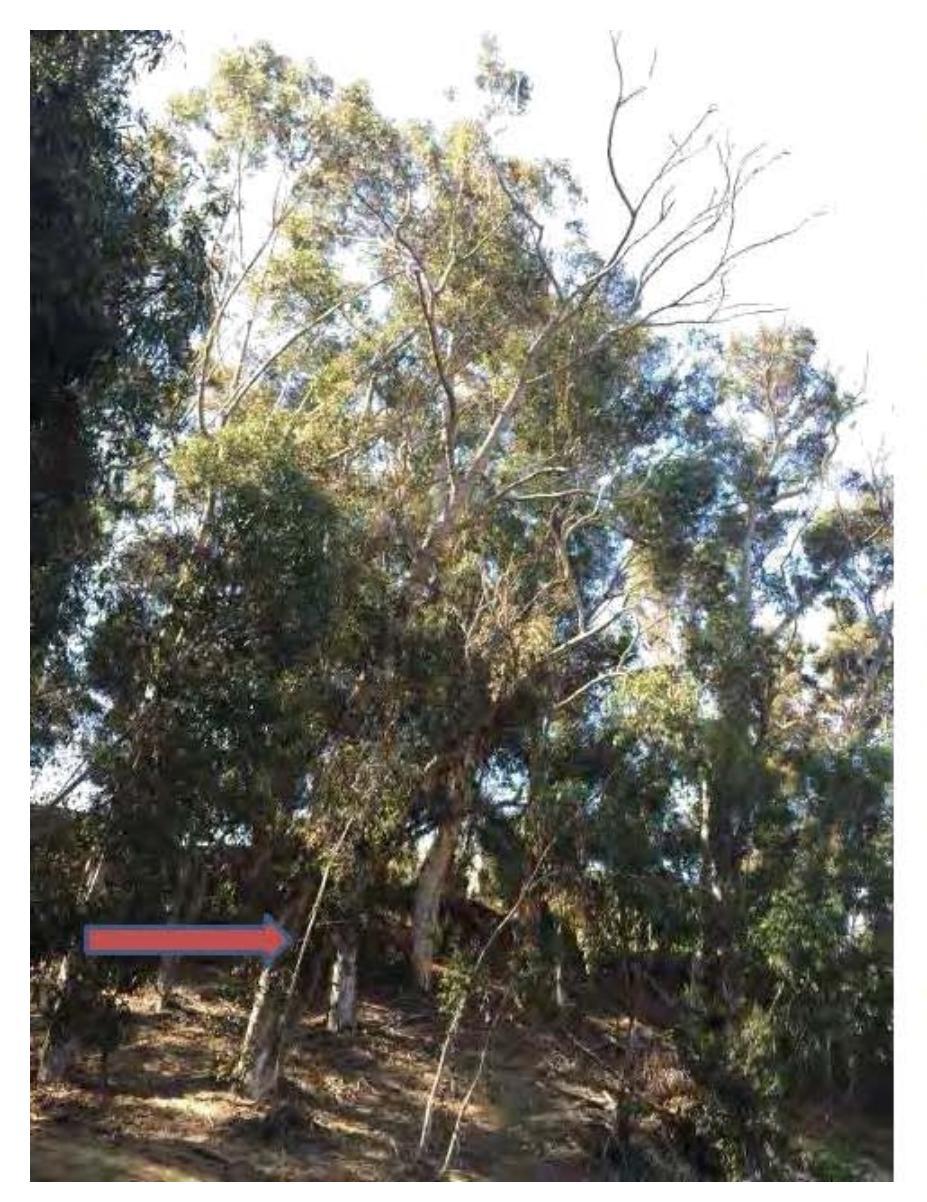
Photograph 59 – View of tree # 22

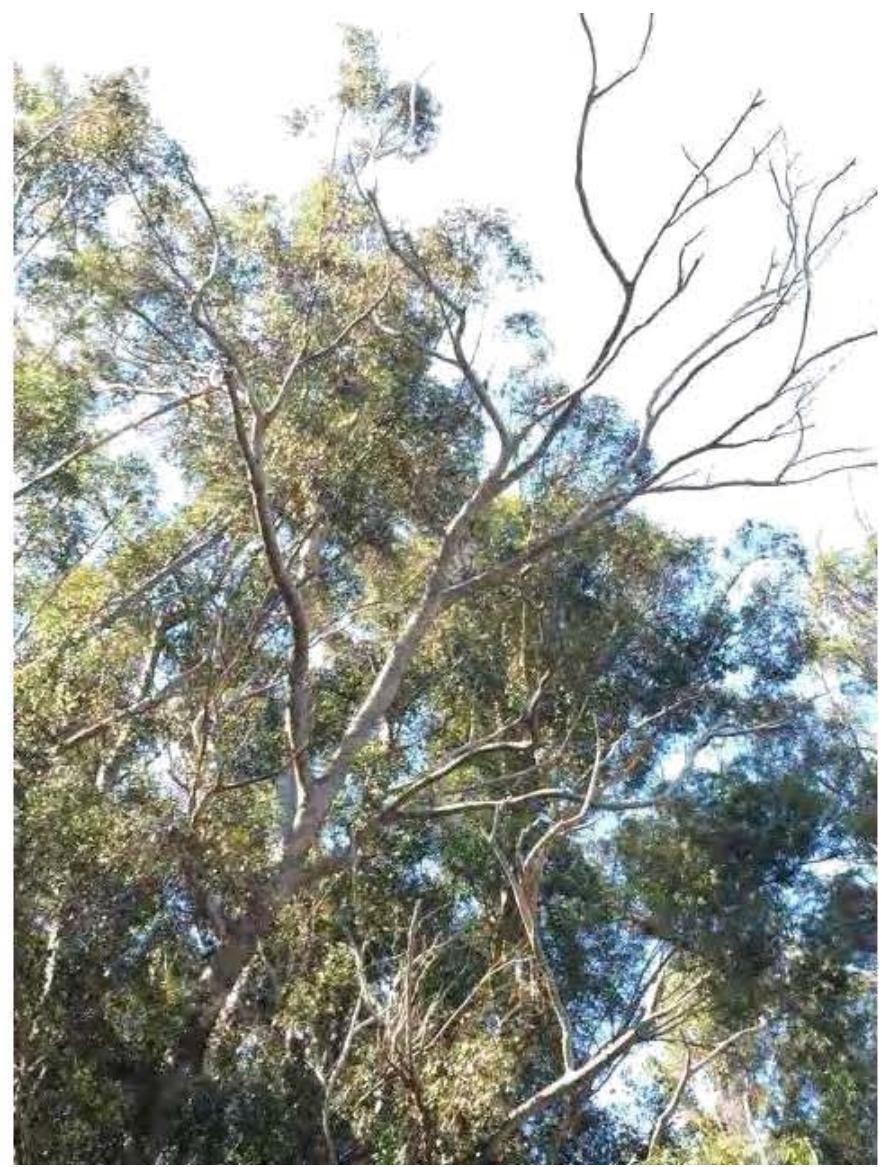
Photograph 60 – View of dead canopy (tree # 22)

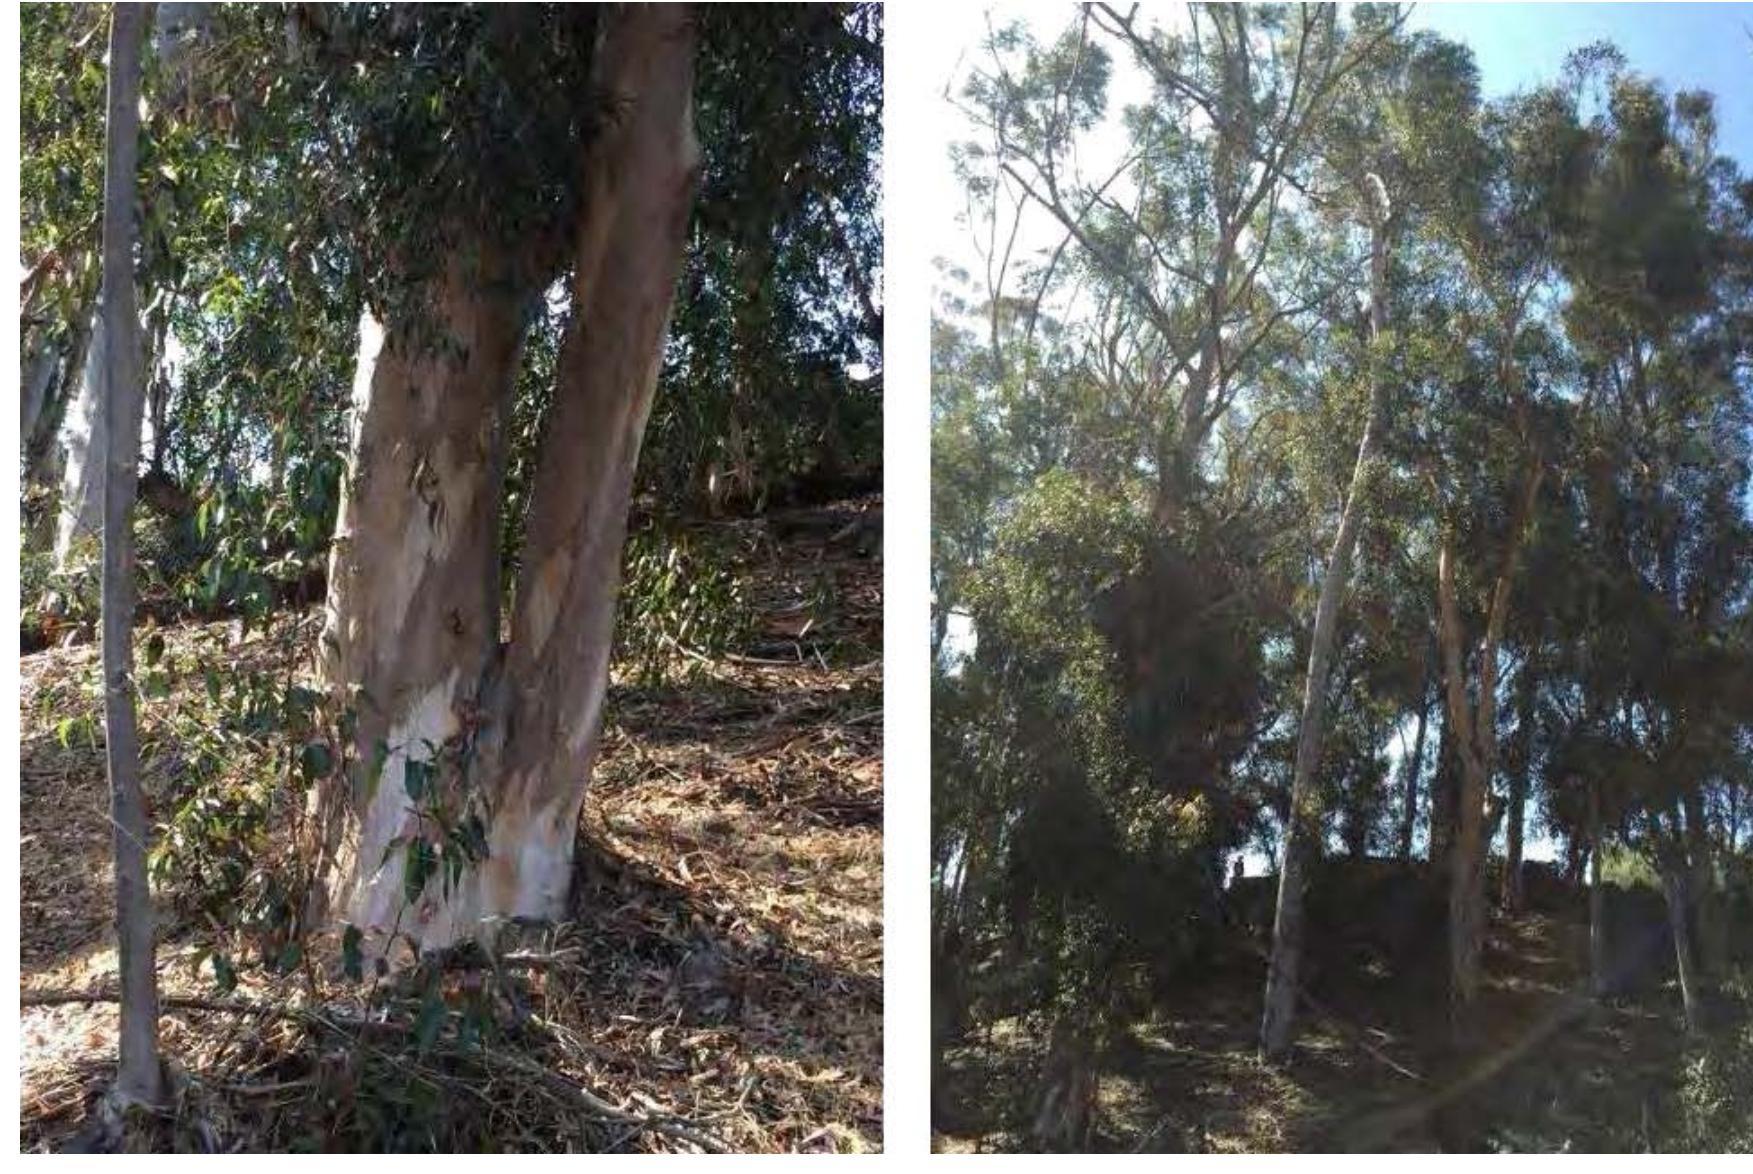
Photograph 62 – View of tree # 23

Photograph 61 – View of main stem (tree # 22)

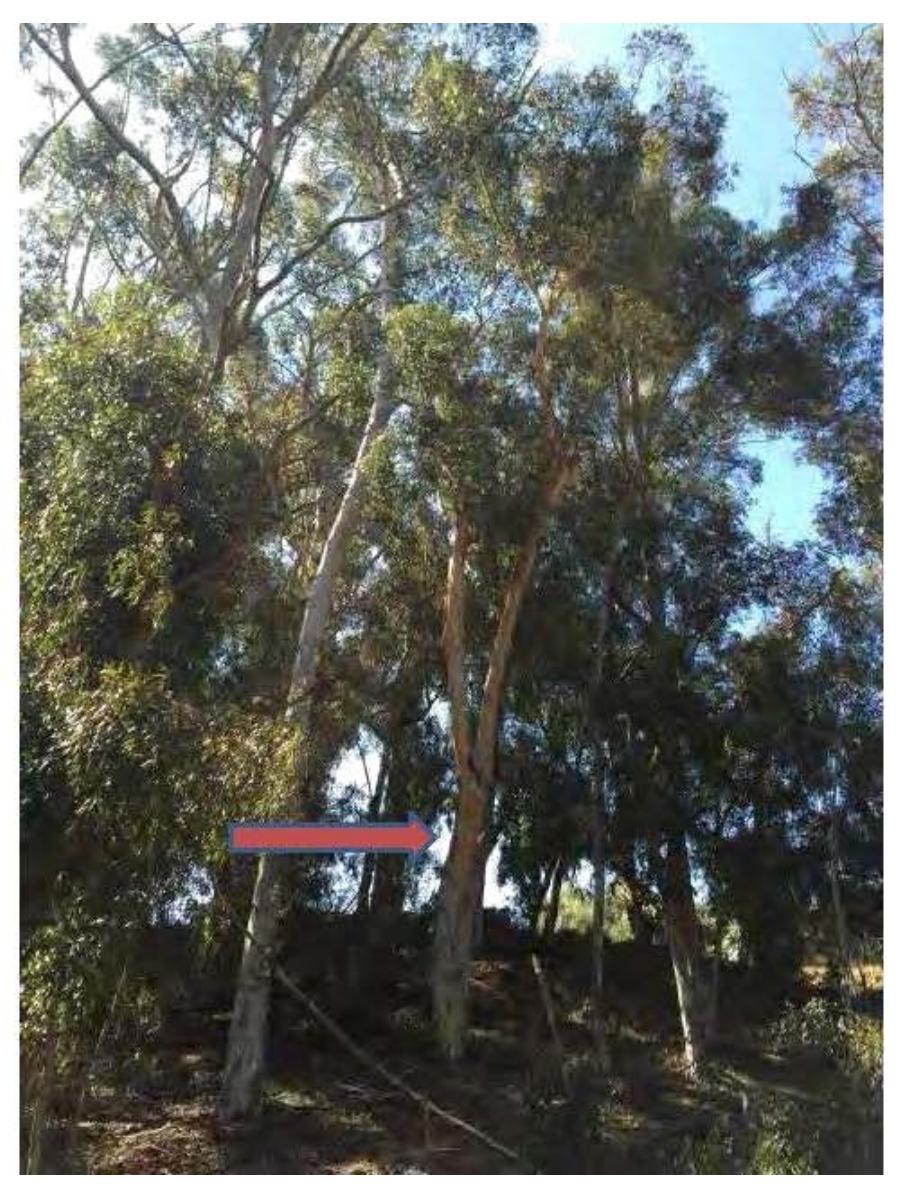
Photograph 66 – View of tree # 24

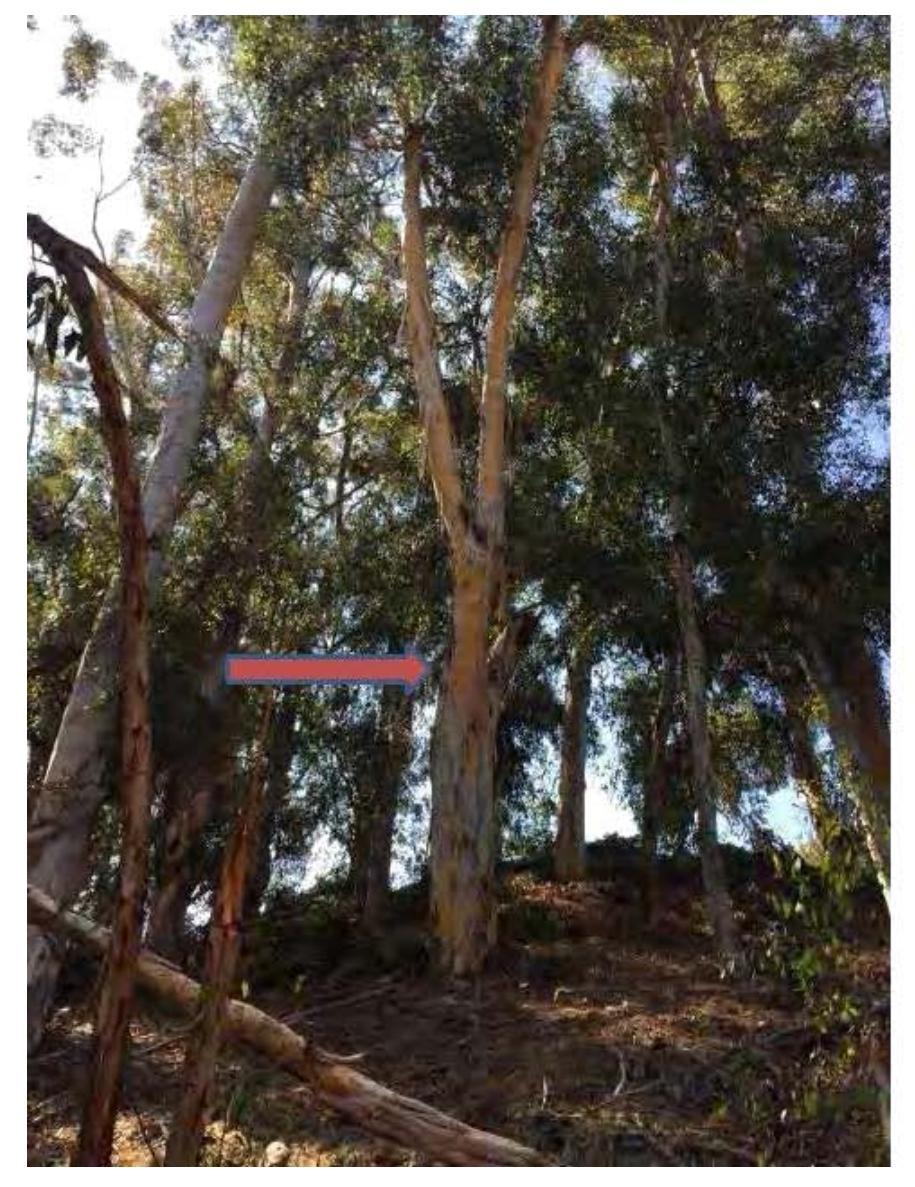
Photograph 67 – View of main stem (tree # 23)

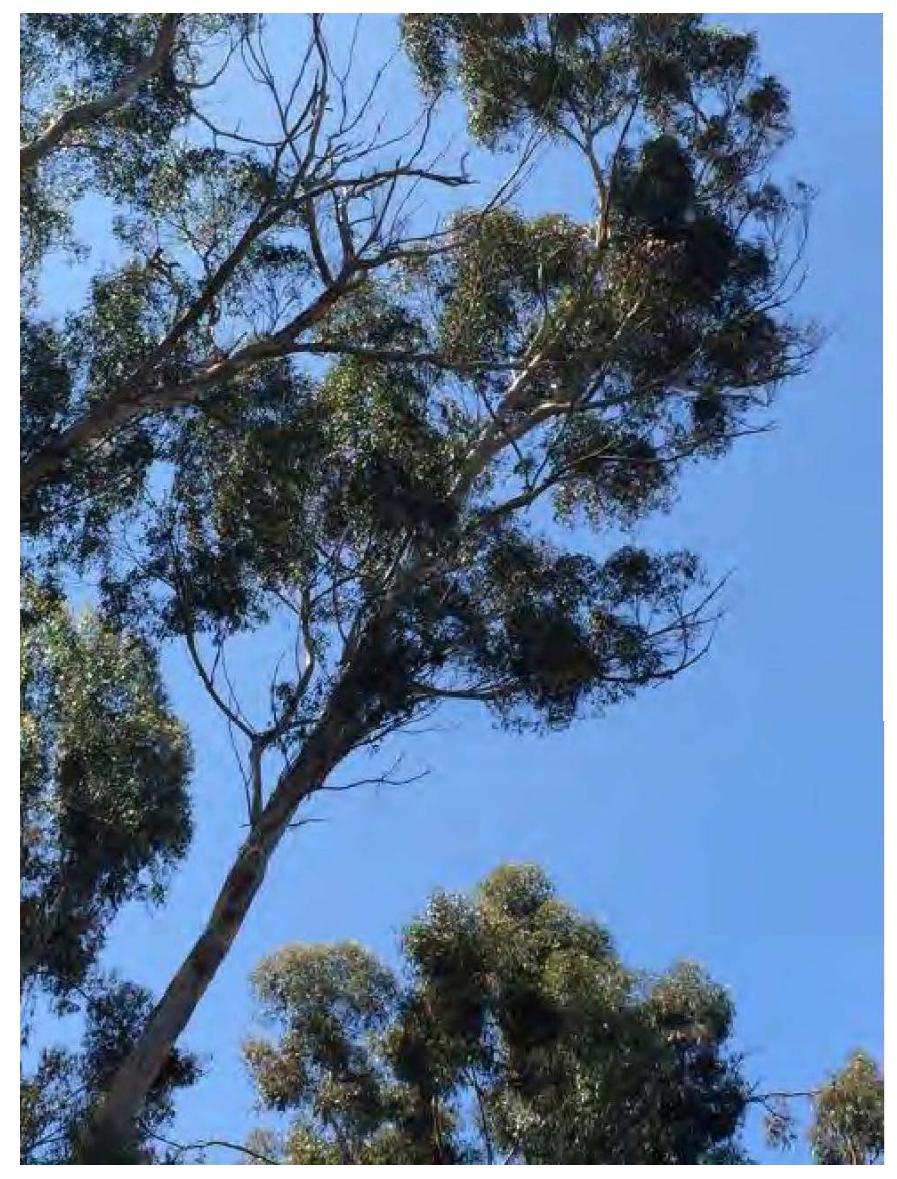
Photograph 73 - View of deadwood in canopy (tree # 26)

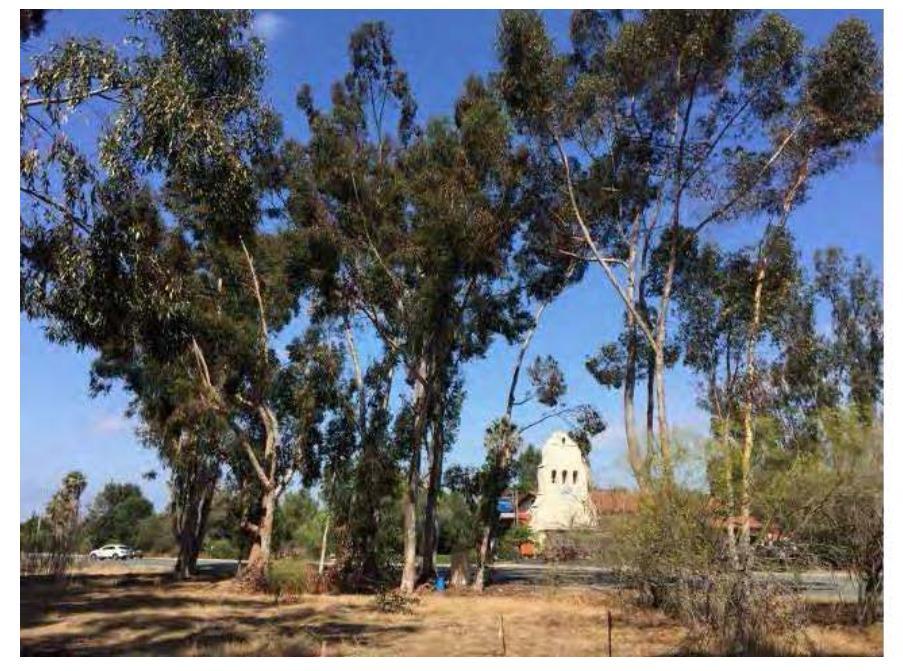
Photograph 79 – Overview of tree #'s 1 - 13

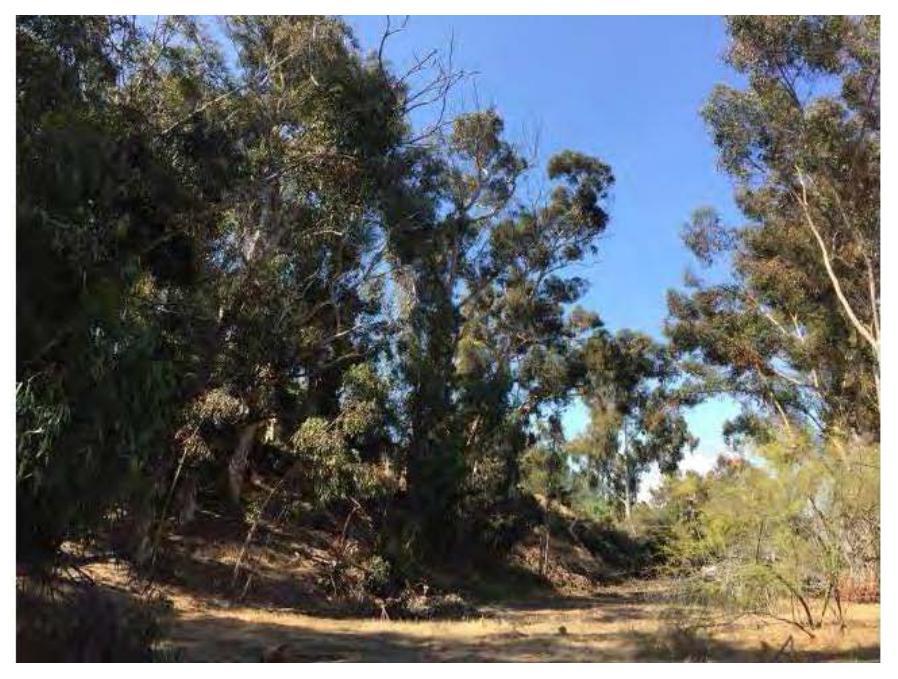
Photograph 80 – Overview of tree #'s 21 - 26

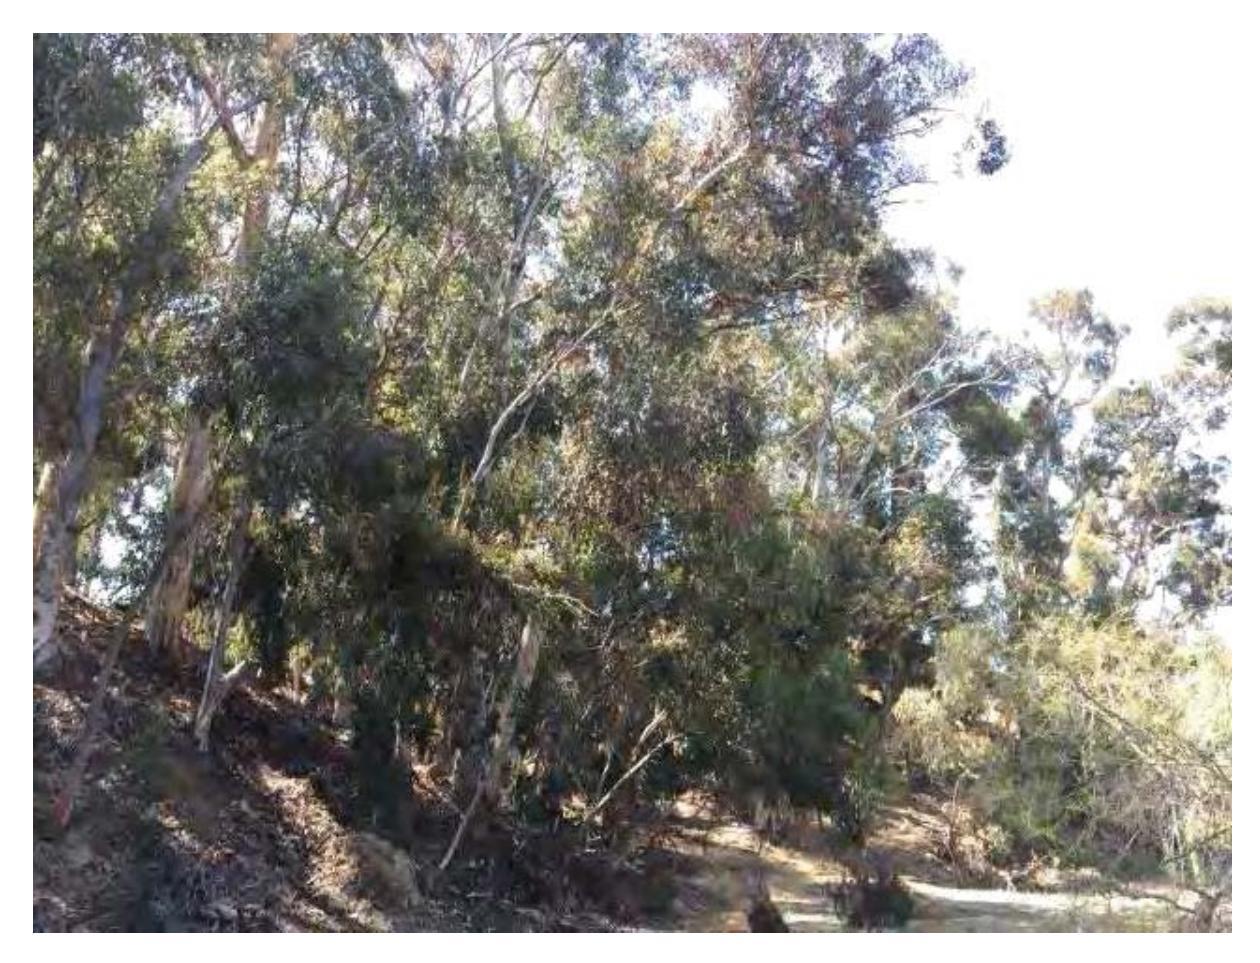
Photograph 81 – Overview of tree #'s 14 - 20

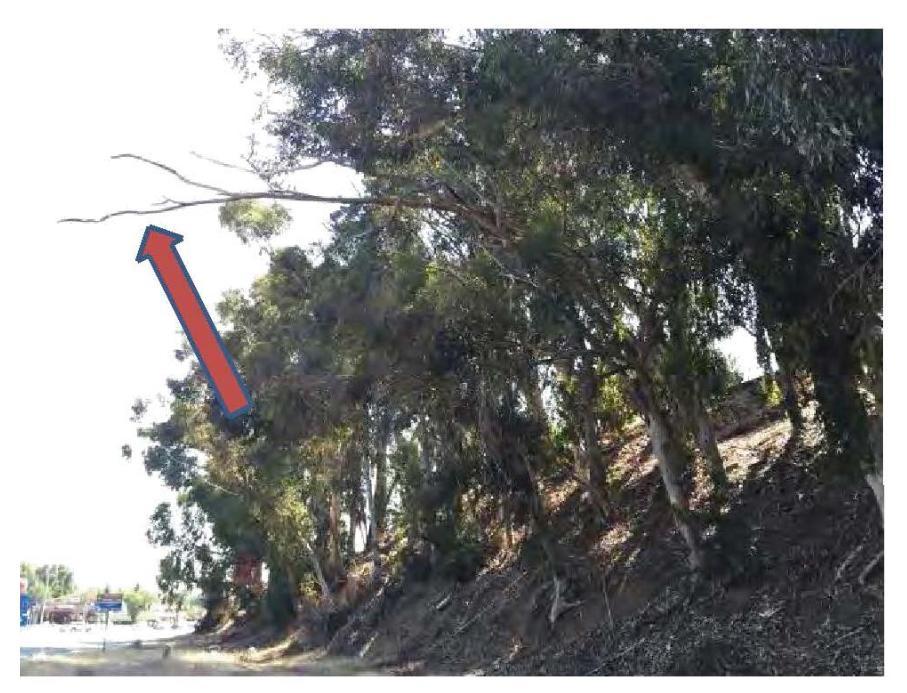
Photograph 82 – View of additional trees on steep slope. Large dead limb overhanging open area.

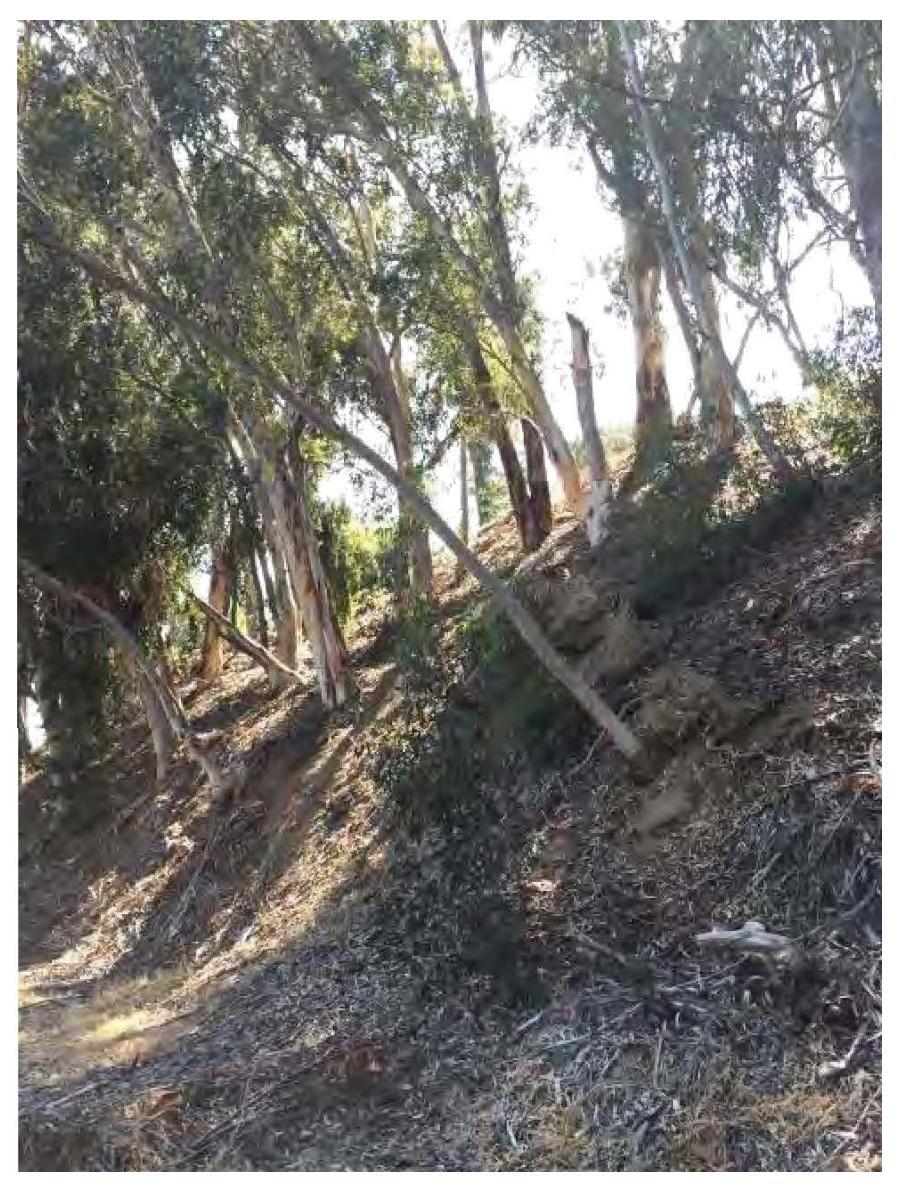
Photograph 83 – View of additional trees on steep slope

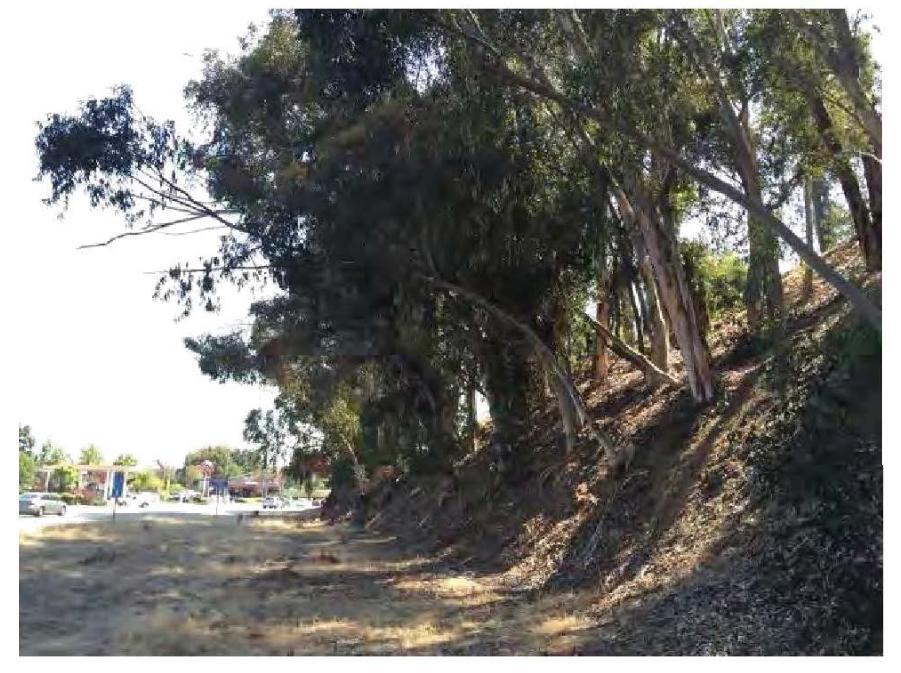
Photograph 84 – View of additional trees on steep slope

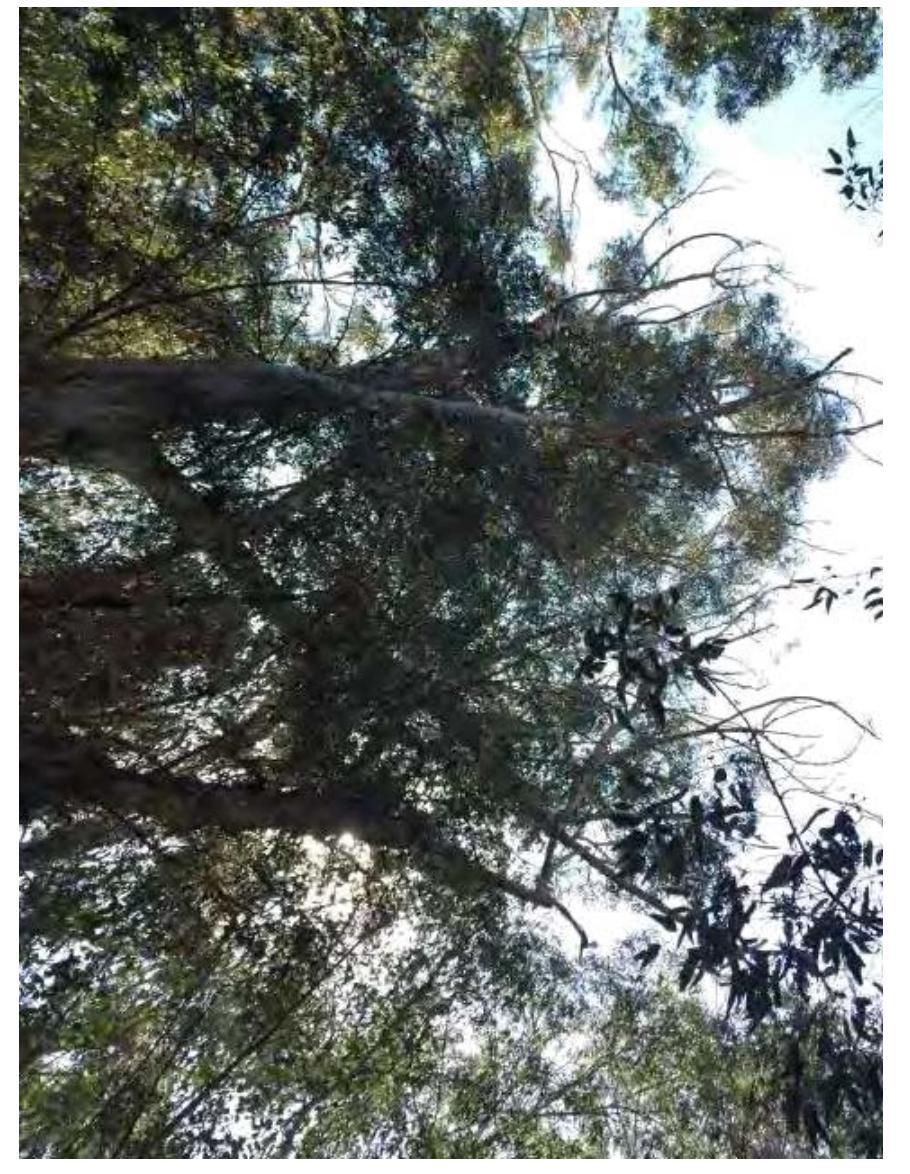
Photograph 86 – View of declining canopy (tree # 27)
